REMEDIAL ACTION REPORT

OPERABLE UNIT 1 – REMEDIAL ACTION PHASE 2 FORMER KIL-TONE COMPANY SUPERFUND SITE VINELAND, NEW JERSEY PROPERTY ID: 014 – 527 E. Cherry Street

CONTRACT NO.: W912DQ-16-D-3003 Task Order: W912DQ-18-F-3031

October 2020

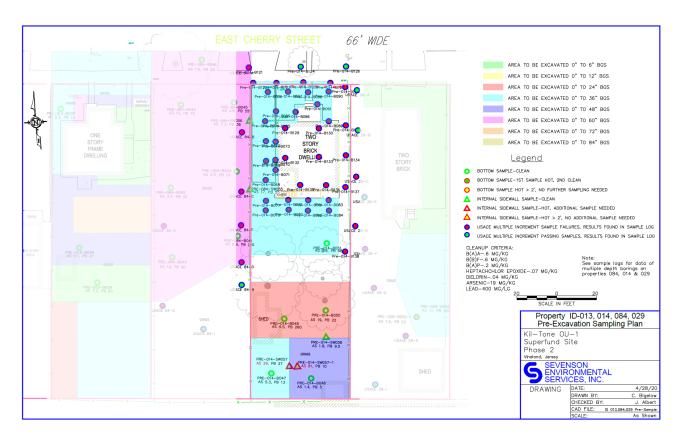
Figure 3.1.1 Property ID 014 Pre-Excavation Sample Locations

samples so remediation of the property could be achieved. Property 014 started with an initial round of sampling which identified contamination deeper than 16' around the dwelling. Additionally, extremely high amounts of arsenic and lead were found with a maximum of 13,000 mg/kg of arsenic and 31,000 mg/kg of lead were identified on property ID 014 (527 E Cherry St) in boring B081, approximately 6' bgs. This warranted 2 additional pre-excavation sampling rounds for property 014 which also included coring through the foundation of the house in the basement. Although results weren't near the maximum found prior, several areas under the building remained contaminated well above clean-up criteria. Eventually property ID 014 was removed from SES scope of work and pushed to a future phase of work.

A second mobilization for core sampling was made at the direction of USACE. An additional 18 boring locations were provided, to be sampled at 12" intervals or until the water table was reached. This also included six core samples through the basement floor. A majority of the sample locations resulted in some level of contamination with the highest concentration of arsenic at 9,500 mg/kg while lead had a high concentration of 12,000 mg/kg. All investigation core samples can be found below in table 3.1.2 with all sample locations shown in Figure 3.1.1, above.
