**Subject: Incident Report - Weeks #71 Barge
Gowanus Canal Superfund Site
Unilateral Administrative Order (UAO) Docket Nos. CERCLA 02-2019-2010 and
CERCLA 02-2020-2003**

B&B Engineers & Geologists of New York, P.C. (B&B), an affiliate of Geosyntec Consultants, respectfully submits on behalf of the Gowanus Canal PRP Group the Incident Report regarding the submersion of the Weeks #71 Barge at Bay Ridge Flats over the weekend of January 23, 2021. The Incident Report is the outcome of a thorough investigation conducted by the PRP Group to obtain information regarding the cause of the incident. The Incident Report and the associated attachments describe the details of the incident, the root cause and contributing factors, corrective measures, and overall safety program for the project. This cover letter gives an executive summary of the events, with the attachments providing further details.

Incident Report Cover Sheet

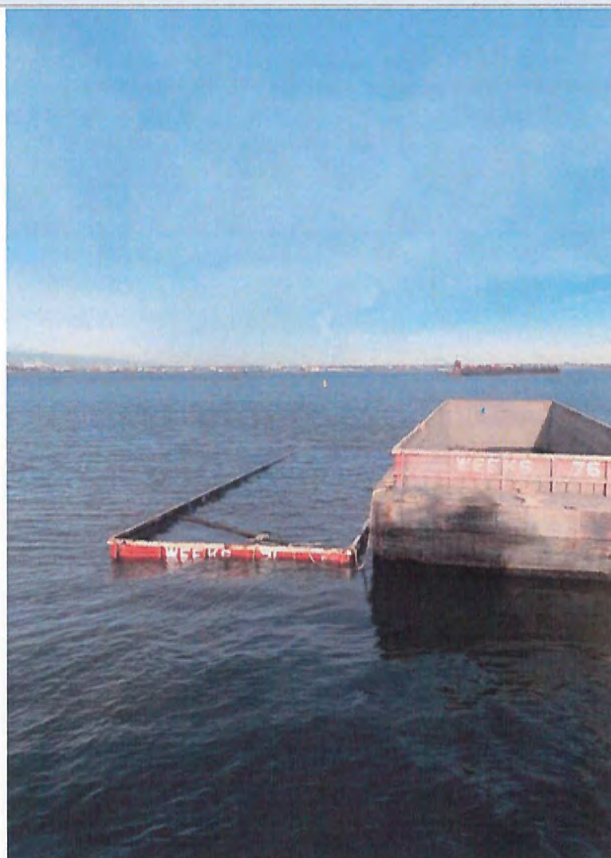
One of Weeks Marine boat captains was contacted by a fellow captain working for a different company (he preferred not to give the name) who was transporting a vessel through the Bay on Monday morning. The captain transporting the vessel forwarded a photo of the Weeks barge in a submerged state to the Weeks Marine captain, who in turn forwarded the same image to me (Jim Greco, Division Manager at Weeks Marine). I then called Chris Sheedy at Cashman at approximately 8:52 am notifying him of the situation and followed up by sending him the same photo via text."

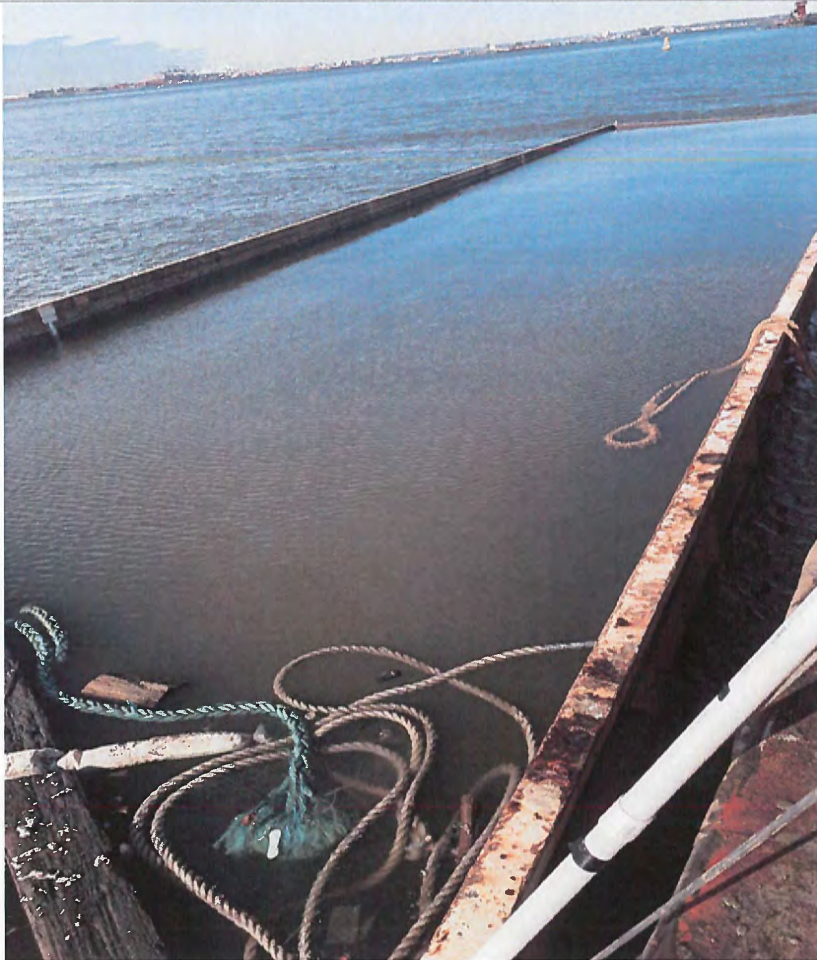
Top view of the Weeks 71 barge

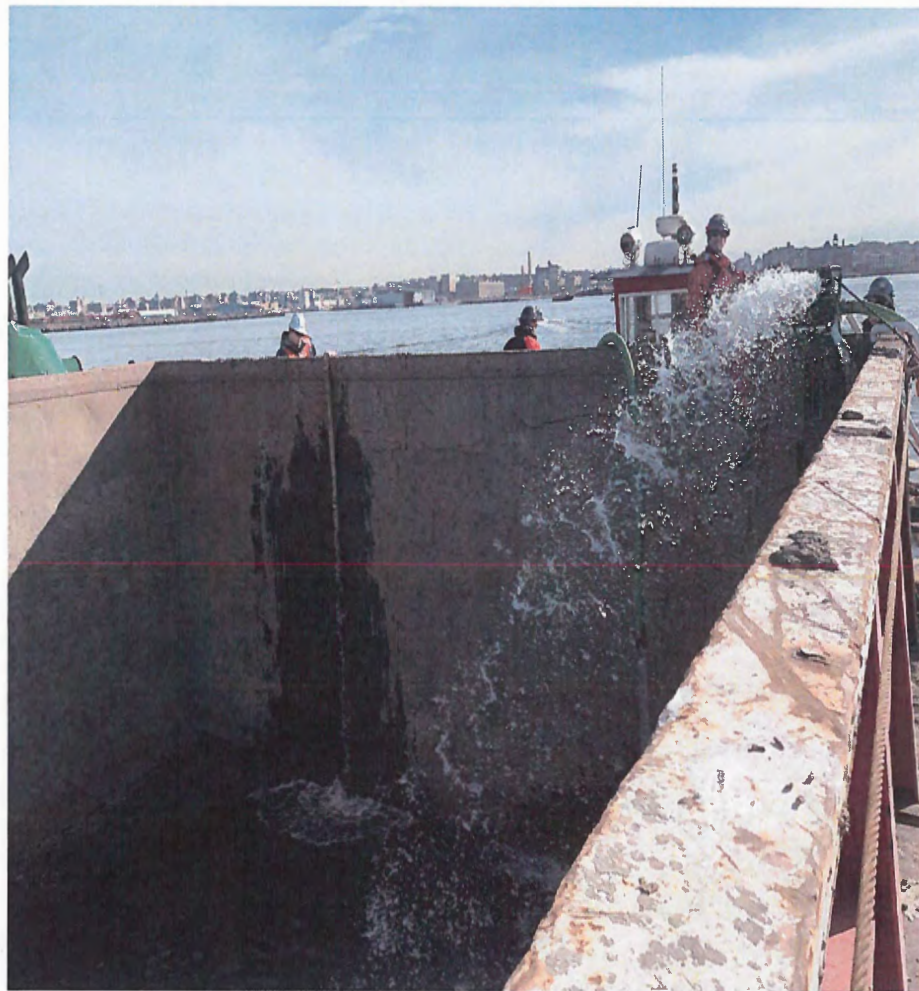
Water being discharged into the Weeks 76 barge

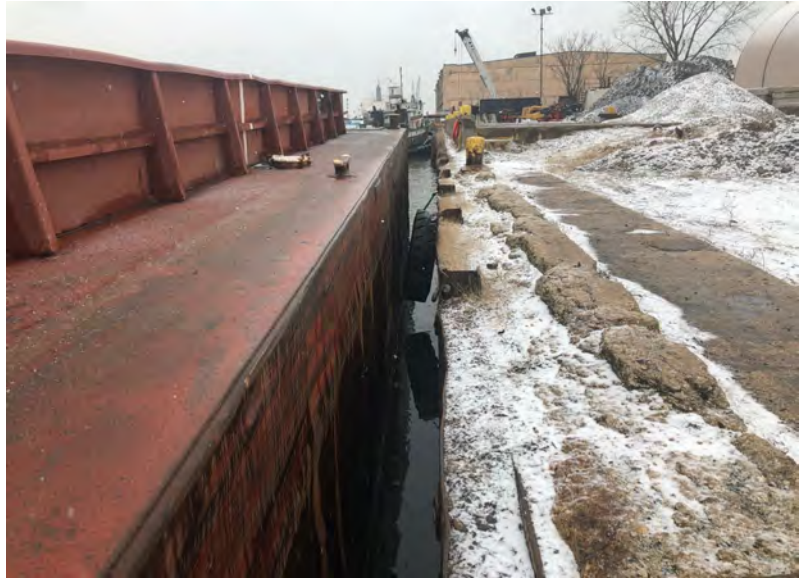
This photo is of the Berth facing Southeast. Missing several Tire Fenders

- The tire fendering at Clean Earths facility must be restored. All H-piles must have tire fenders. No barges will be moved to Clean Earth until documentation/confirmation of the repairs are received. Cashman is of the strong opinion that the damage to the Weeks 71 barge occurred at the CE facility during the unloading process. A report of the findings of an inspection conducted at the Clean Earth facility on Monday, January 26 is included with this incident report. The report includes photographs showing missing tire fenders and protruding steel from the bulkhead H-piles. It should be noted that Cashman confirmed the missing fender tires were replaced prior to the delivery of the next hopper barge. Starting now and going forward, the barges and docking facilities at Clean Earth, Citizens Site, and any other future facility, will be inspected prior to landing or receiving a barge. The inspection reports will be included in the daily reports.

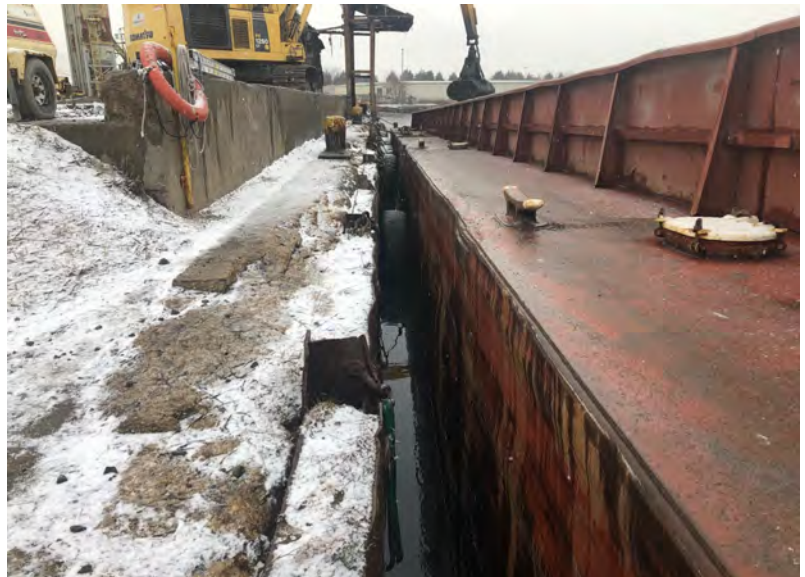
Clean Earth.2

This photo is of the Berth facing Northwest. Missing a couple Tire Fenders

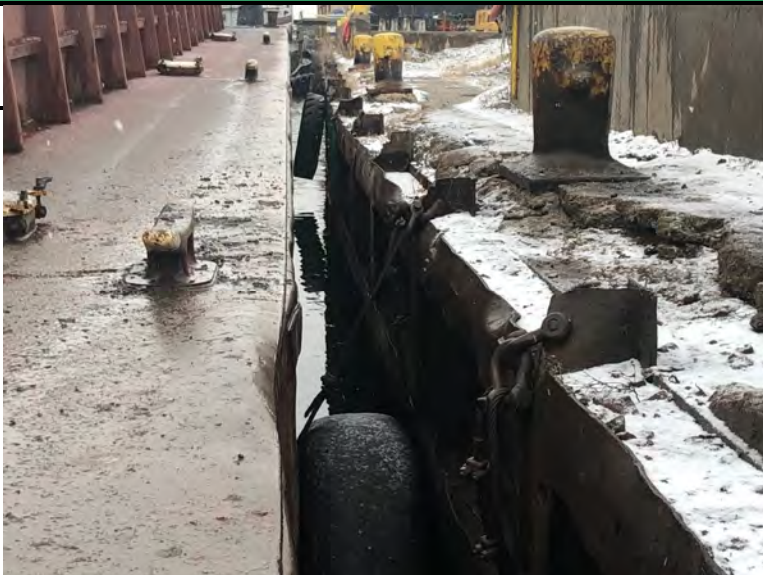
Gap between the Bollards show Vertical H-Pile with Shackles beyond the edge of the Bulkhead missing Tire Fenders

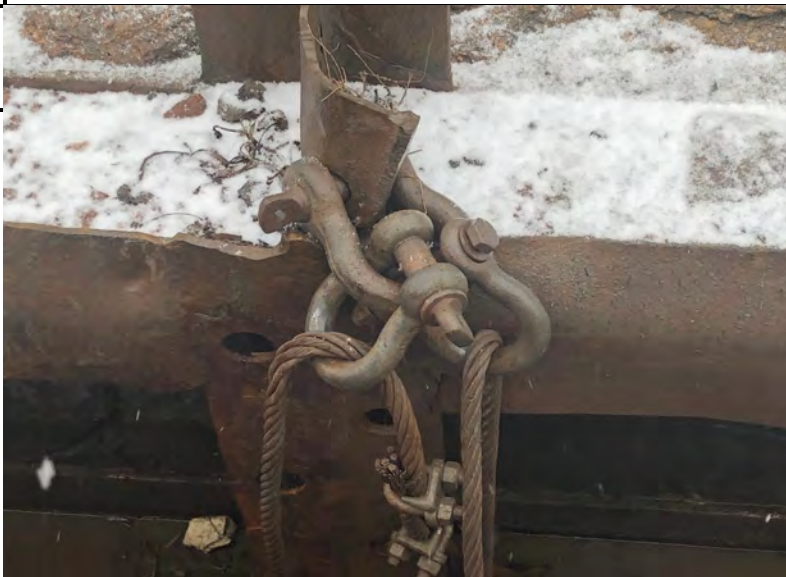
Clean Earth.4

Vertical H-pile with Shackles outside the horizontal plane of the bulkhead

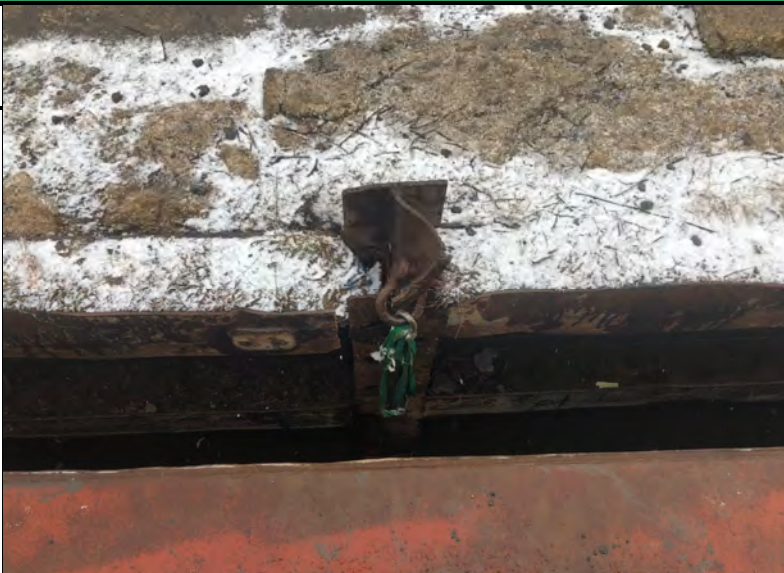
Vertical H-Pile with Shackle with missing Tire Fender. John Huhn described this as recent damage. Depending on Barge Draft and tide levels, this structure has the potential to cause damage similar to what we have experienced on the Weeks 71 and Weeks 73

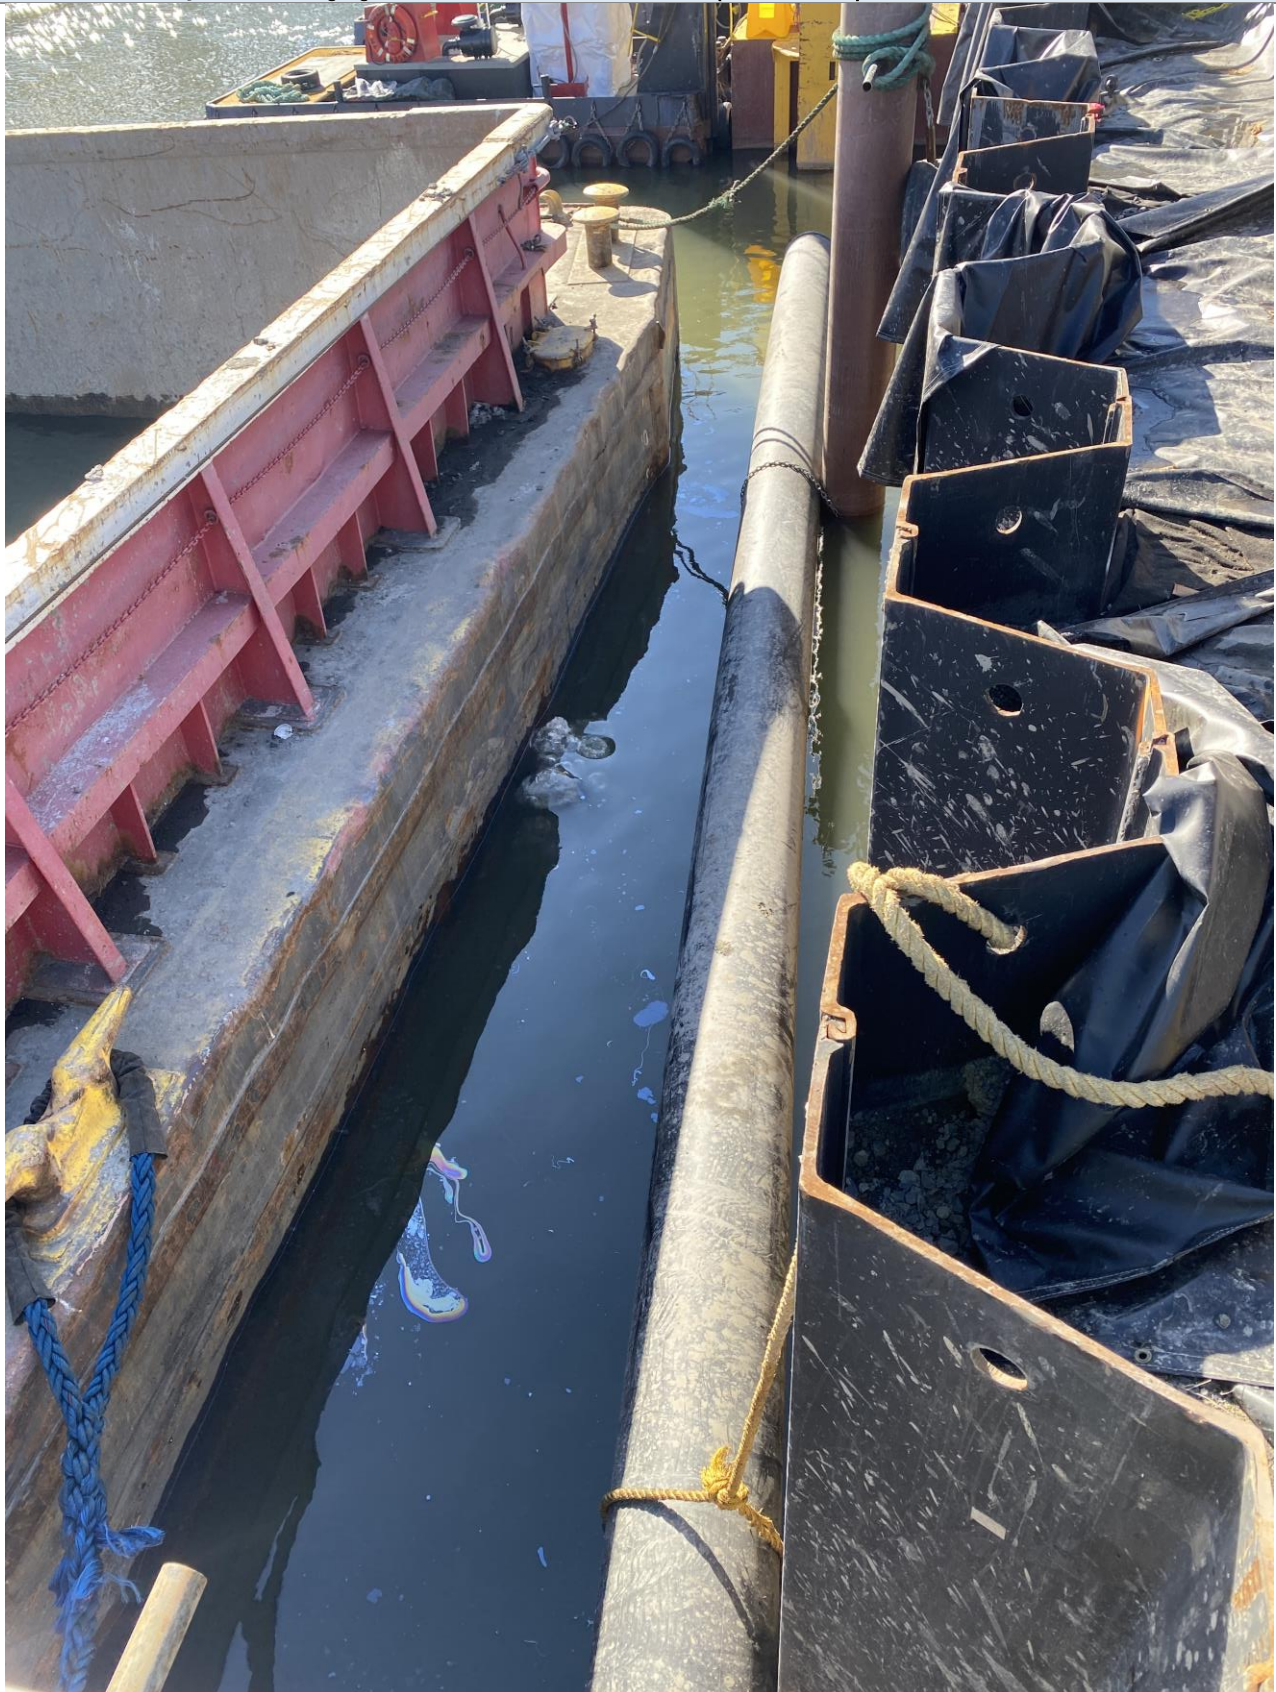
Pile and Camel fender system at Staging Site within the Gowanus Canal (Citizens Site)

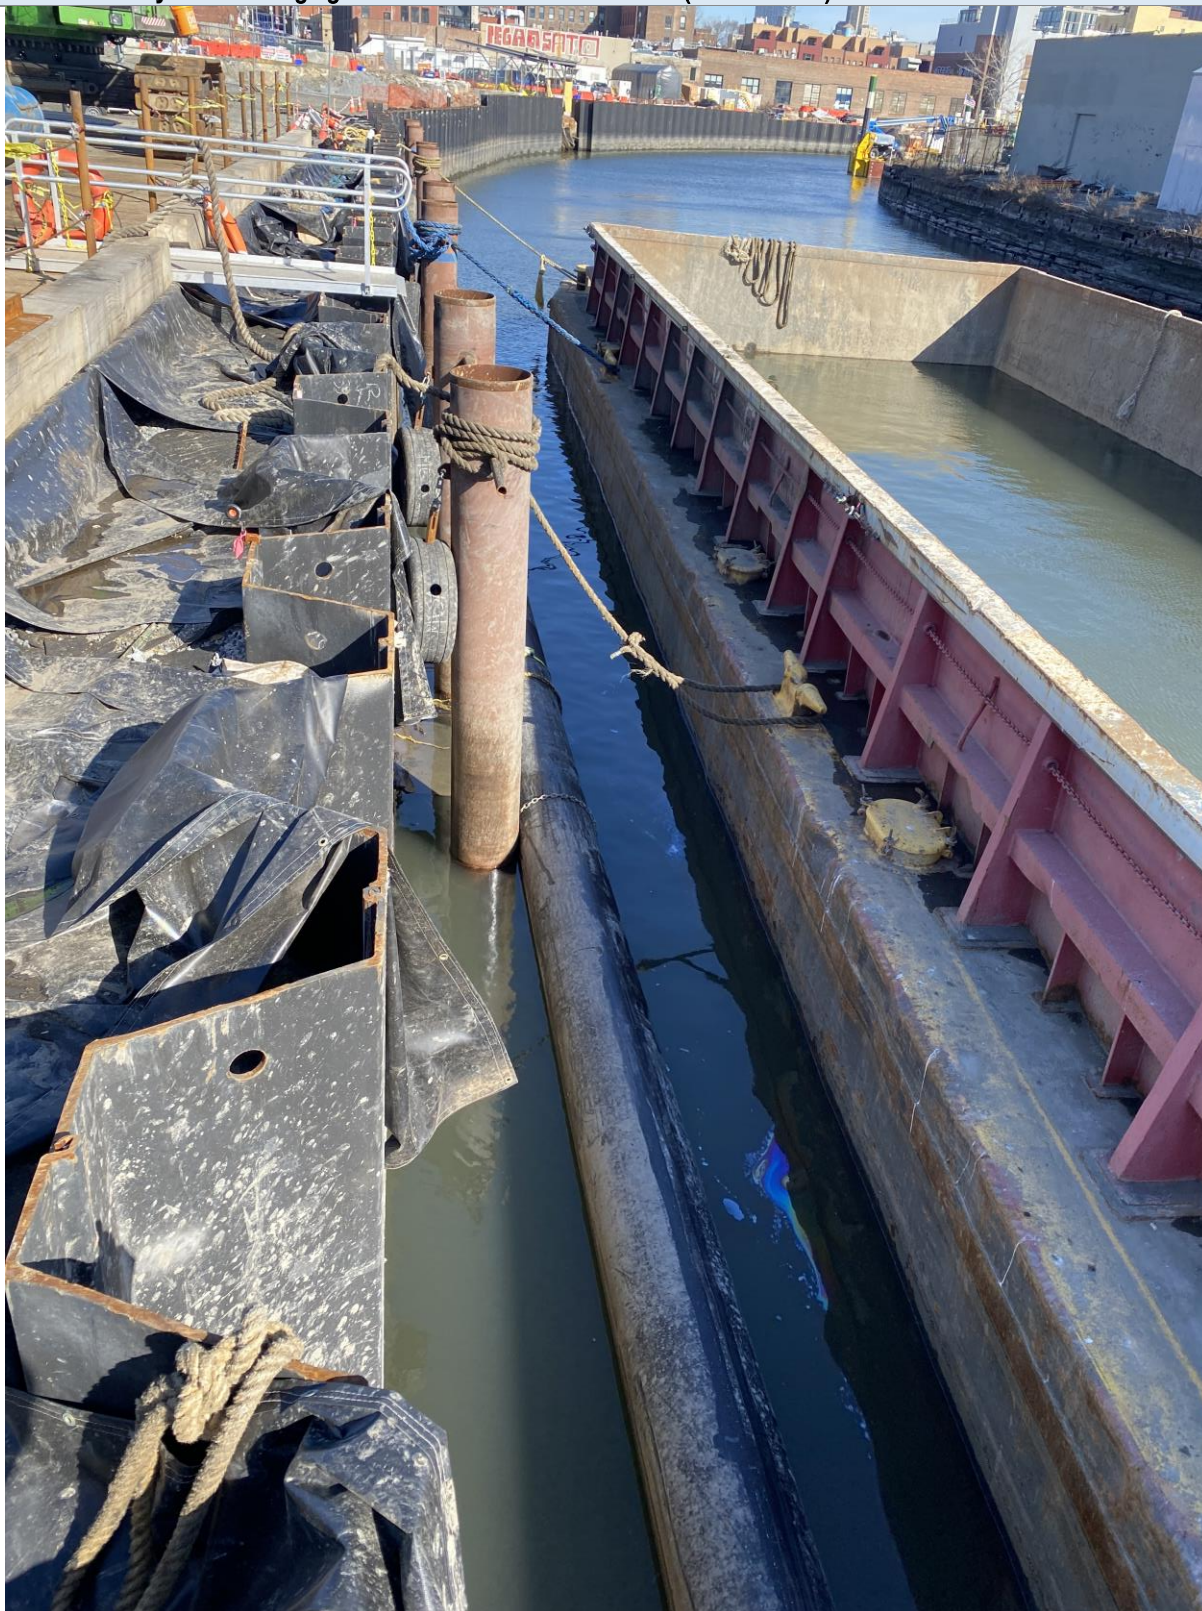
Pile and Camel fender system at Staging Site within the Gowanus Canal (Citizens Site)

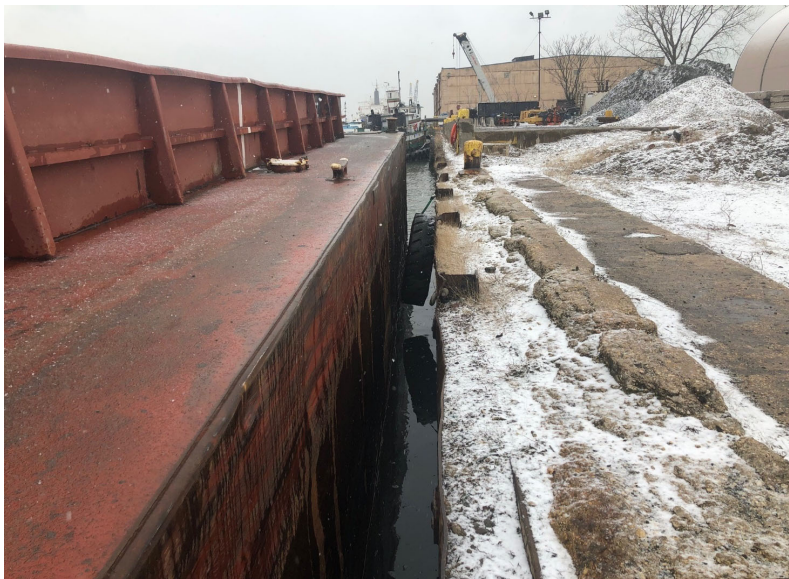
This photo is of the Berth facing Southeast. Missing several Tire Fenders

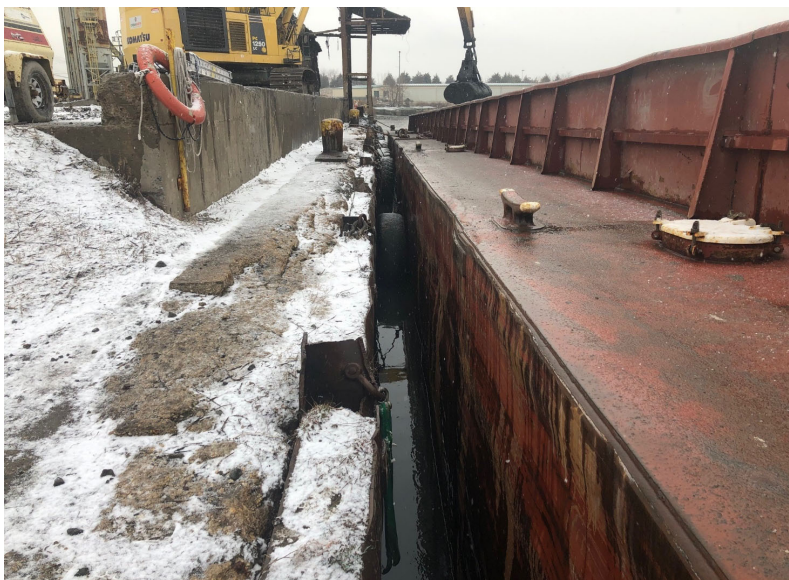
Clean Earth.2

This photo is of the Berth facing Northwest. Missing a couple Tire Fenders

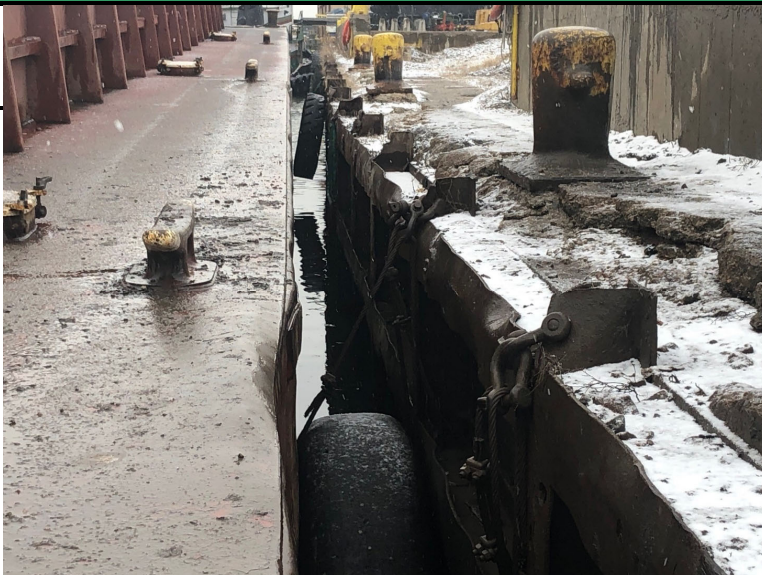
Gap between the Bollards show Vertical H-Pile with Shackles
beyond the edge of the Bulkhead missing Tire Fenders

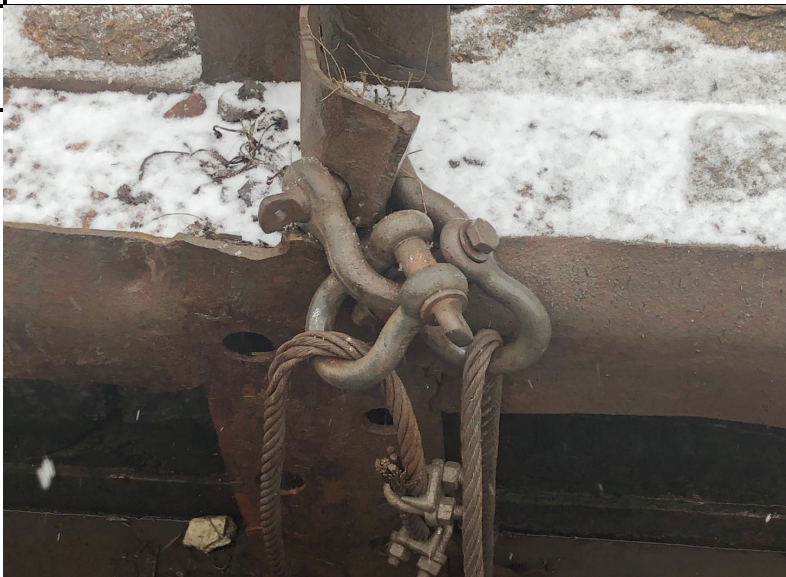
Clean Earth.4

Vertical H-pile with Shackles outside the horizontal plane of
the bulkhead

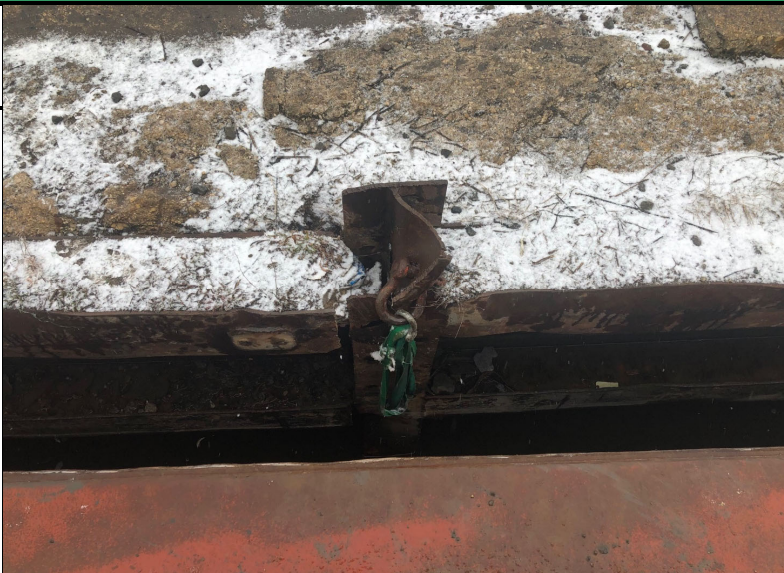
Vertical H-Pile with Shackle with missing Tire Fender. Depending on Barge Draft and tide levels, this structure has the potential to cause damage similar to what we have experienced on the Weeks 71 and Weeks 73

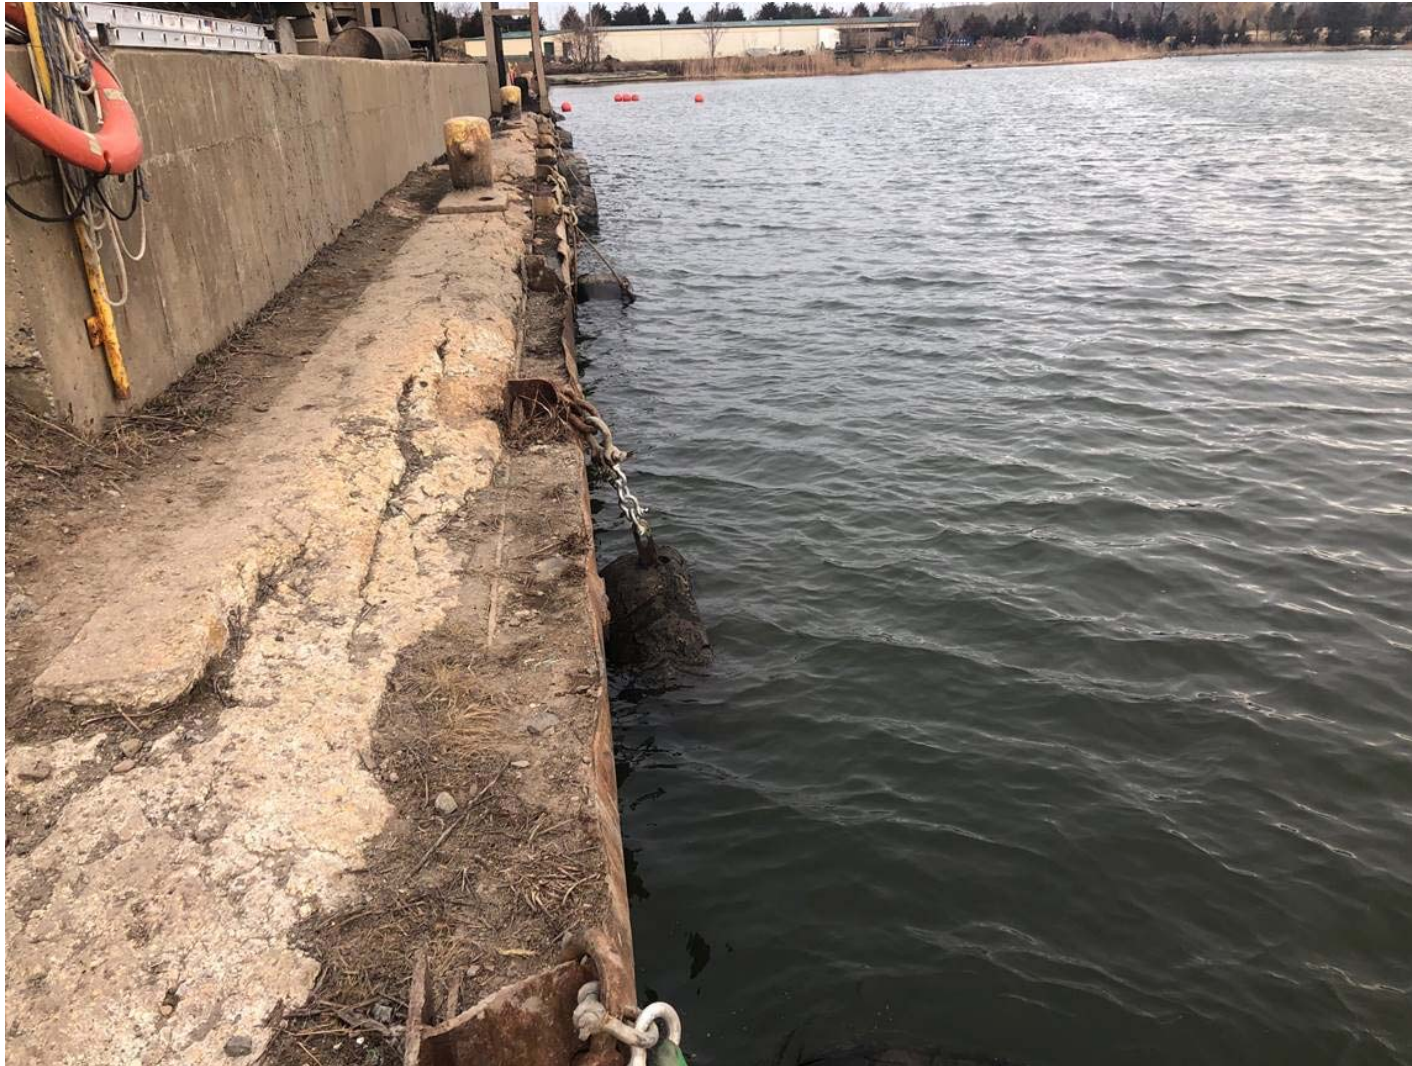
Photograph of newly installed tires serving as fenders at the docking location of the sediment processing facility. The tires protect the barge from metal shackles and H-piles along the bulkhead.

- Protect the metal protrusion via fendering at the docking facility where the hole was created. This action has already been completed, and other docking facilities have been evaluated as well. This action directly addresses the root cause of the incident. Attachment C provides photo-documentation of the implemented corrective measures.

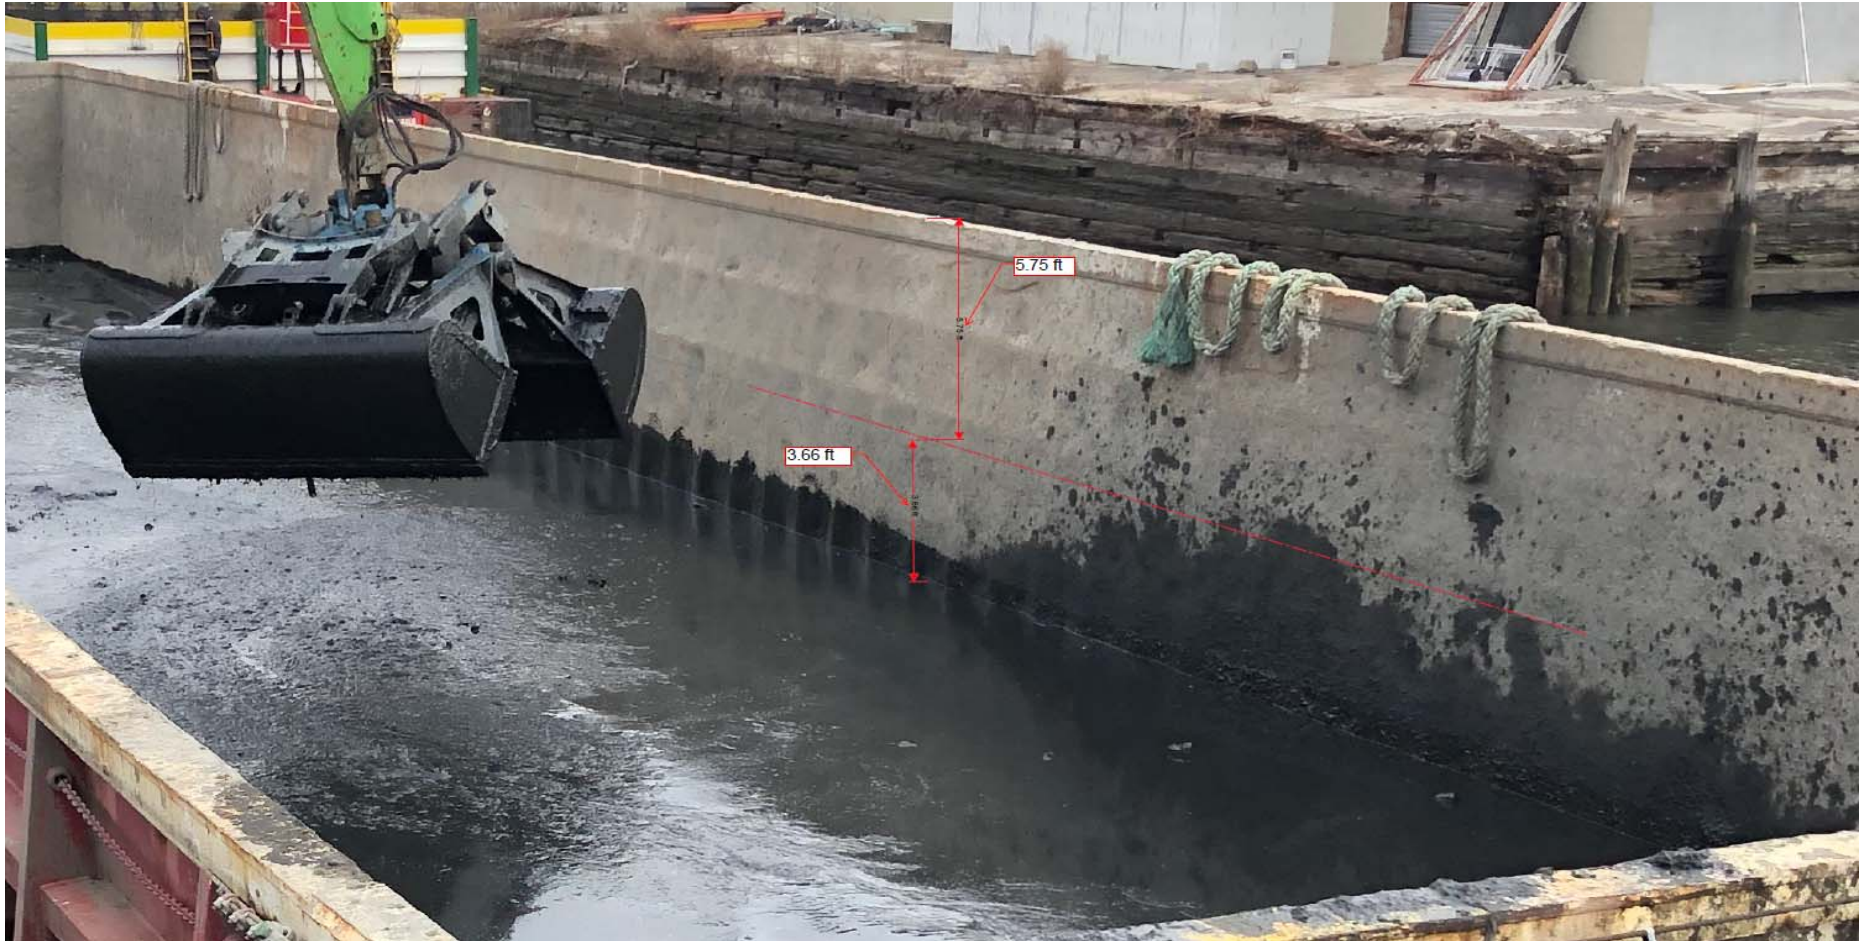
Photograph collected on Friday, January 22, 2021 prior to the Weeks #71 barge being transported to the Bay Ridge Flats mooring location. Distance from the weld line to the top of sediment is estimated as 3.66 ft.
