SUBJECT: Site Analysis Keystone Sanitation Landfill,
Adams County, Pennsylvania - Report

TS-PIC-86133
October 1985

Site Analysis Keystone Sanitation Landfill Adams County, Pennsylvania

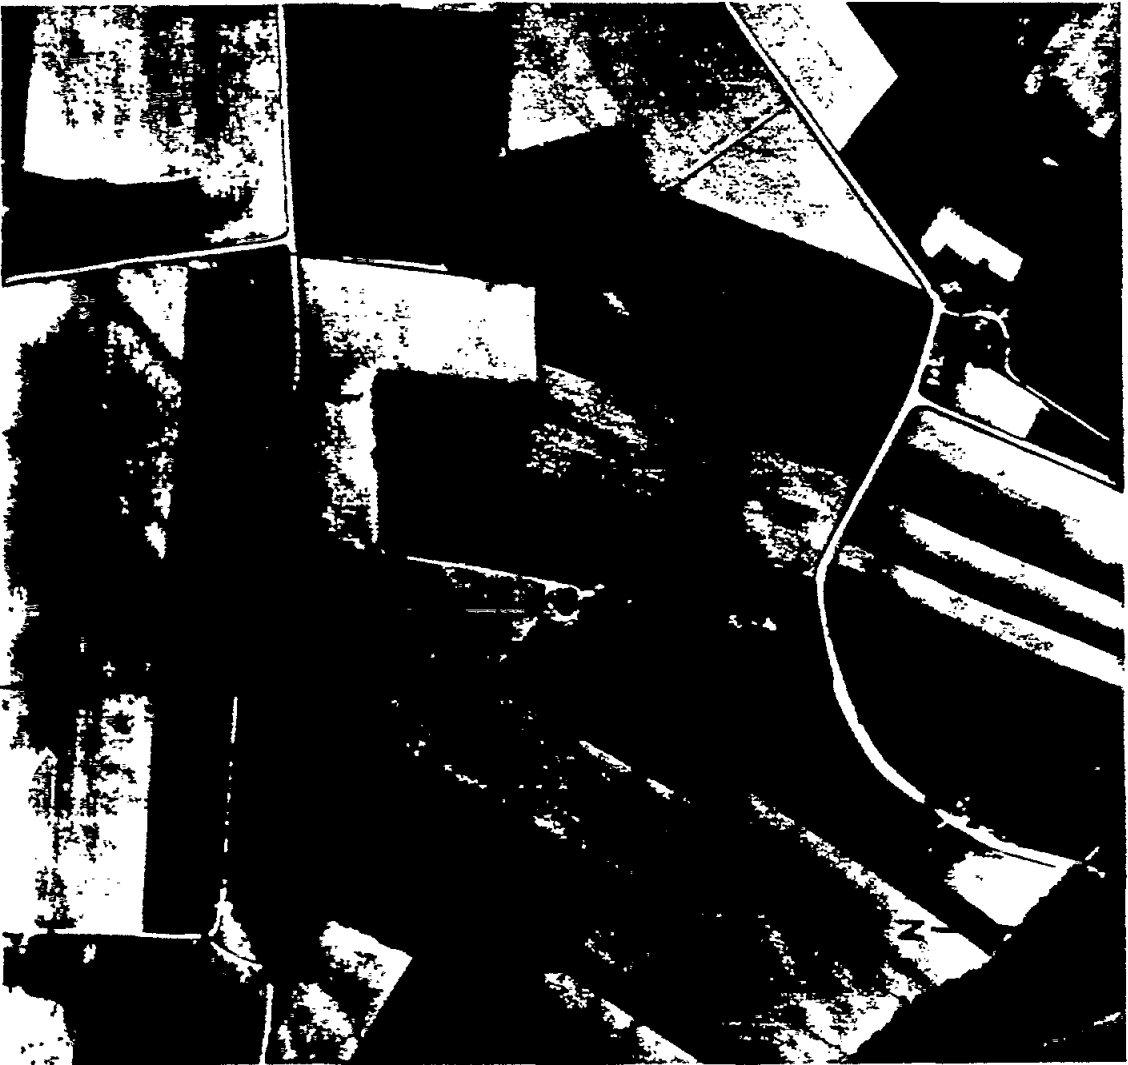
FIGURE 3
KEYSTONE SANITATION LANDFILL

No landfiling activities are seen at this time. The site is composed of four buildings (B) and four sheds. Access to the central building compound extends south from the northern boundary road. Although no landfiling activities can be seen at this time, a shallow excavation is visible north of the central building compound. This excavation contains possible standing liquid (SL) and could be a farm pond.

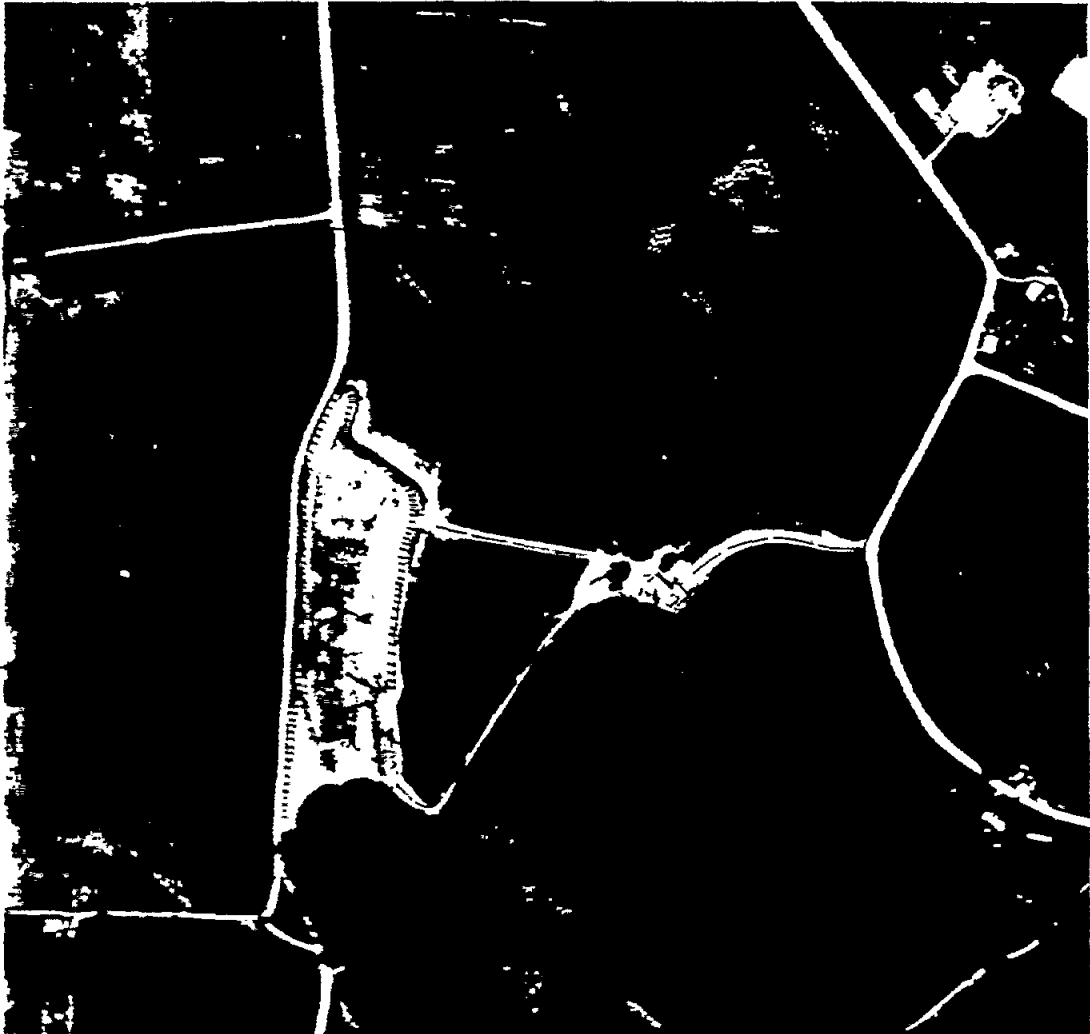
FIGURE 4
KEYSTONE SANITATION LANDFILL

Landfilling activities can be seen in the southern section of the site at this time. All four sheds and Building 2 have been removed from the central section of the site. An apparent maintenance shed (Building 5) has replaced Building 2. Possible equipment (E) is seen on the north side of Building 5. Building 3, located in the south central portion of the compound, has been expanded.

The access road that leads into the central compound from the north has been altered. Two access roads extend from the central compound to the fill area (FA) located in the southern section of the site. The top landfilling is apparently ongoing in the northeast corner for the fill area where a brush pile and work area (WF) and back-filled (BF) material (M) are seen. A vent (V) is visible on the central portion of the fill area. This vent has been attached to flow southward along the western edge of the fill area.
