RE: 2013 Five-Year Review Report
Naval Air Station (NAS) Patuxent River
Patuxent River, Maryland

Five-Year Review Report

Figure 1-2
Locations of ER Sites
2013 Five-Year Review Report
NAS Patuxent River
St. Mary's County, Maryland

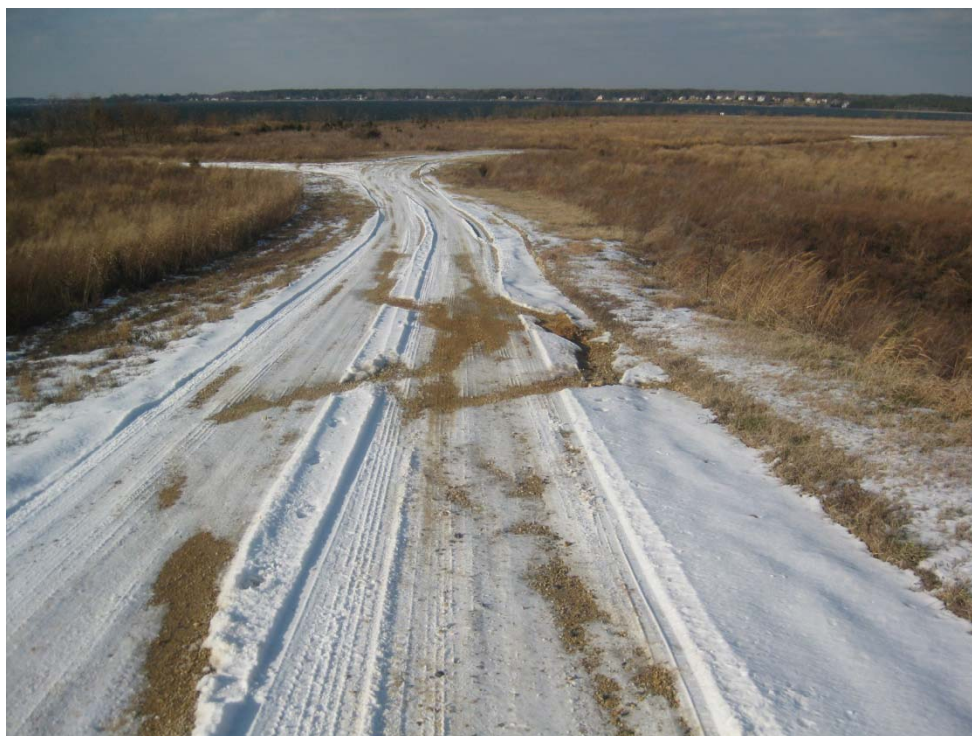
Main recreational entrance to Site 1 – tire damage

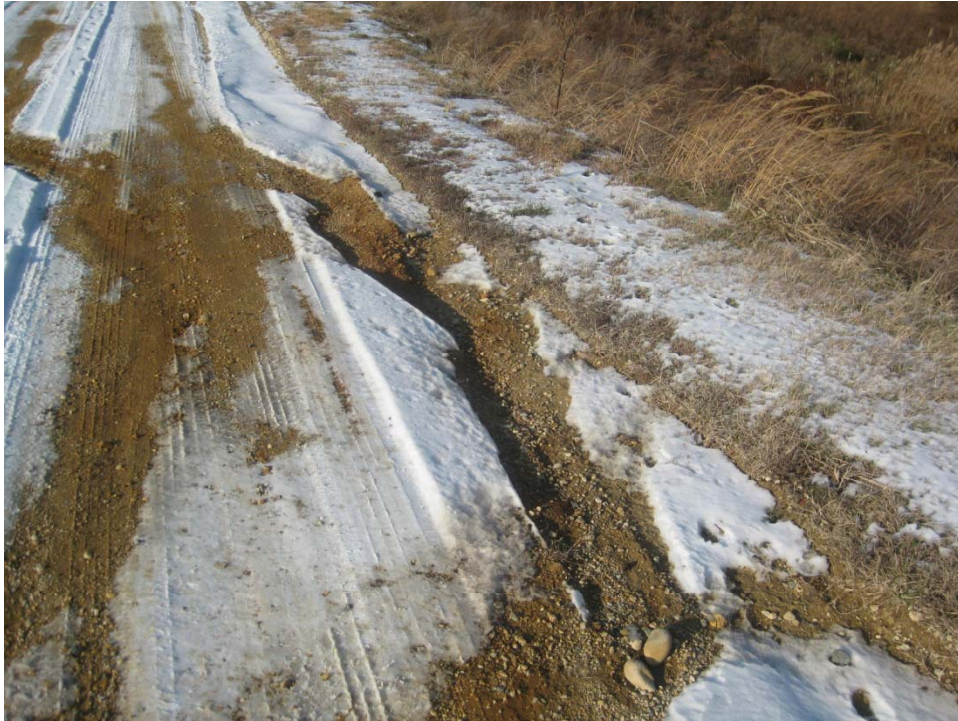
Close-up of tire rut, main recreational entrance to Site 1.

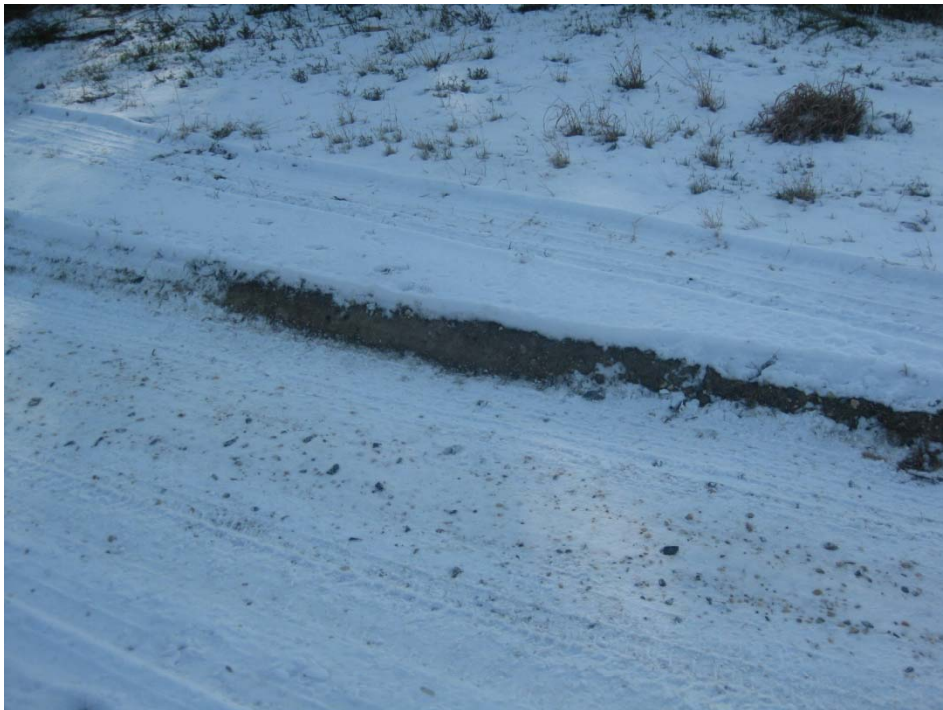
Tire rut on main access road to Site 1.

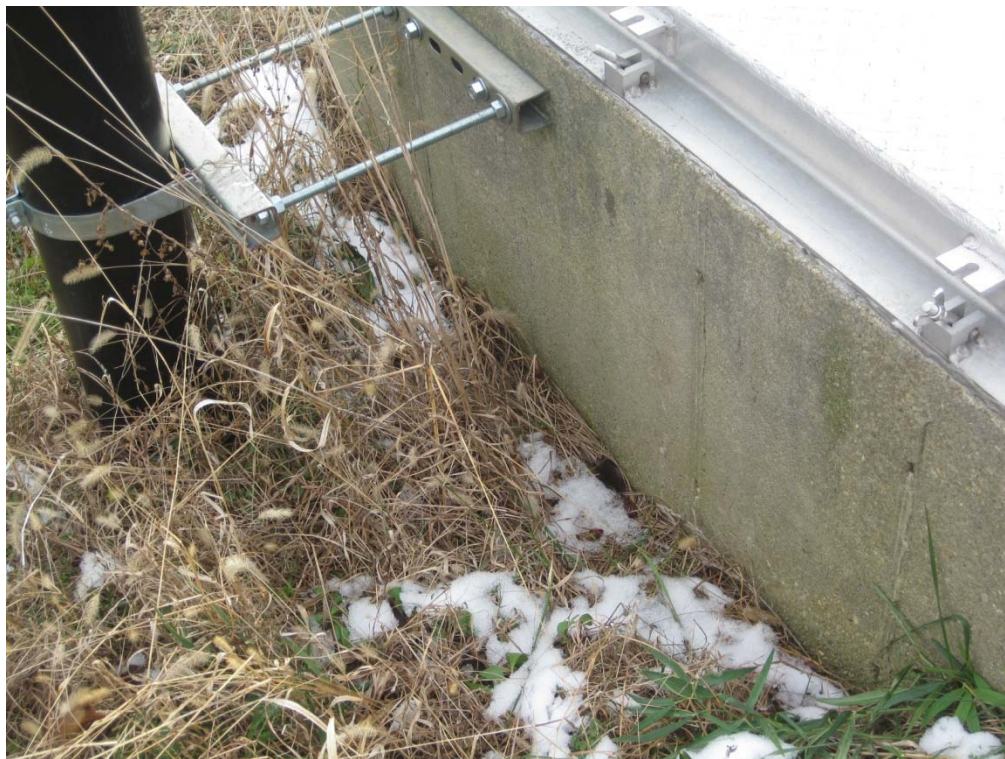
Soil Depression next to EWV-2

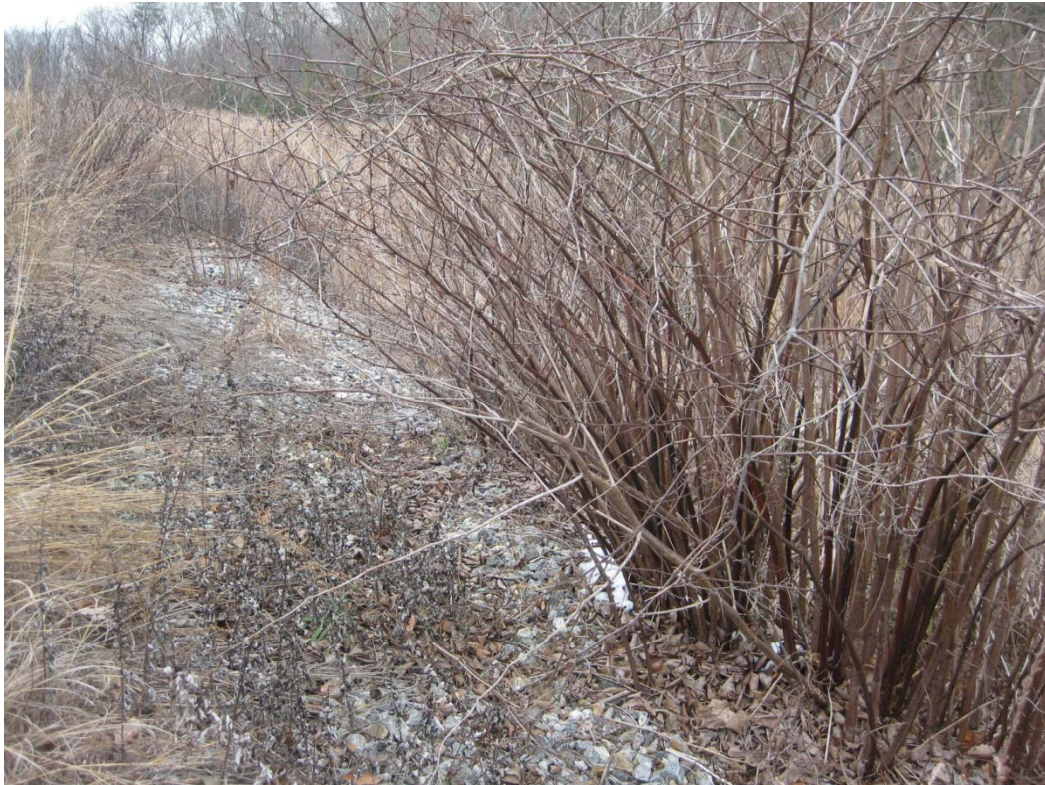
Woody vegetation at southeast toe of slope.

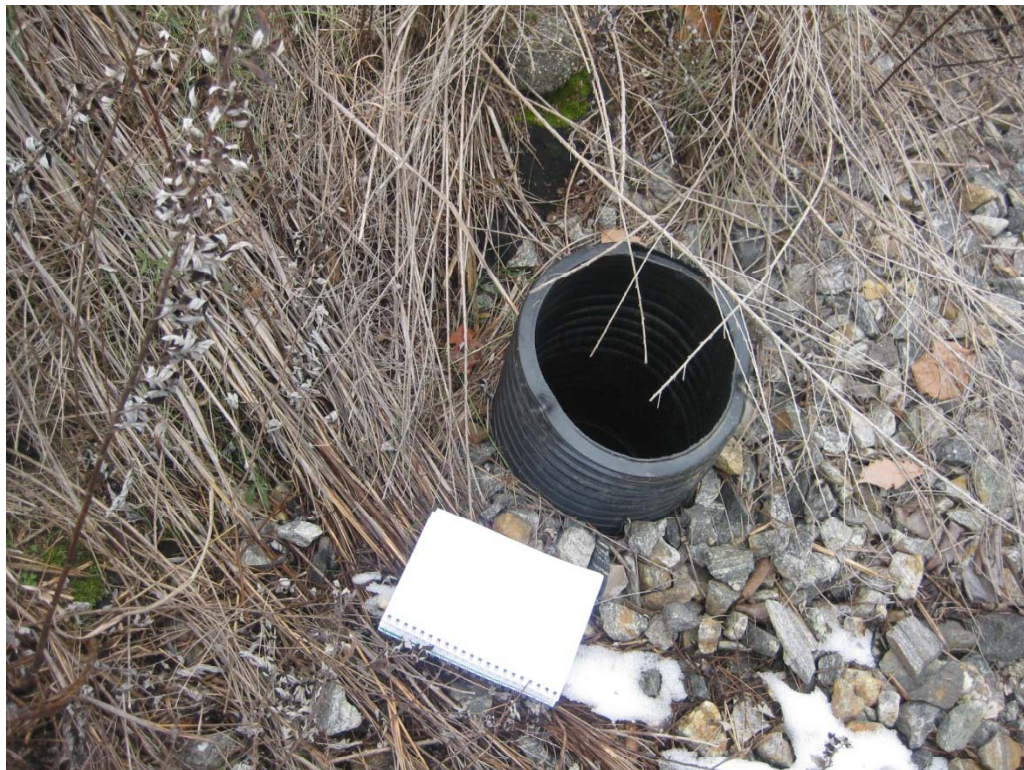
Missing cover on perimeter underdrain cleanout

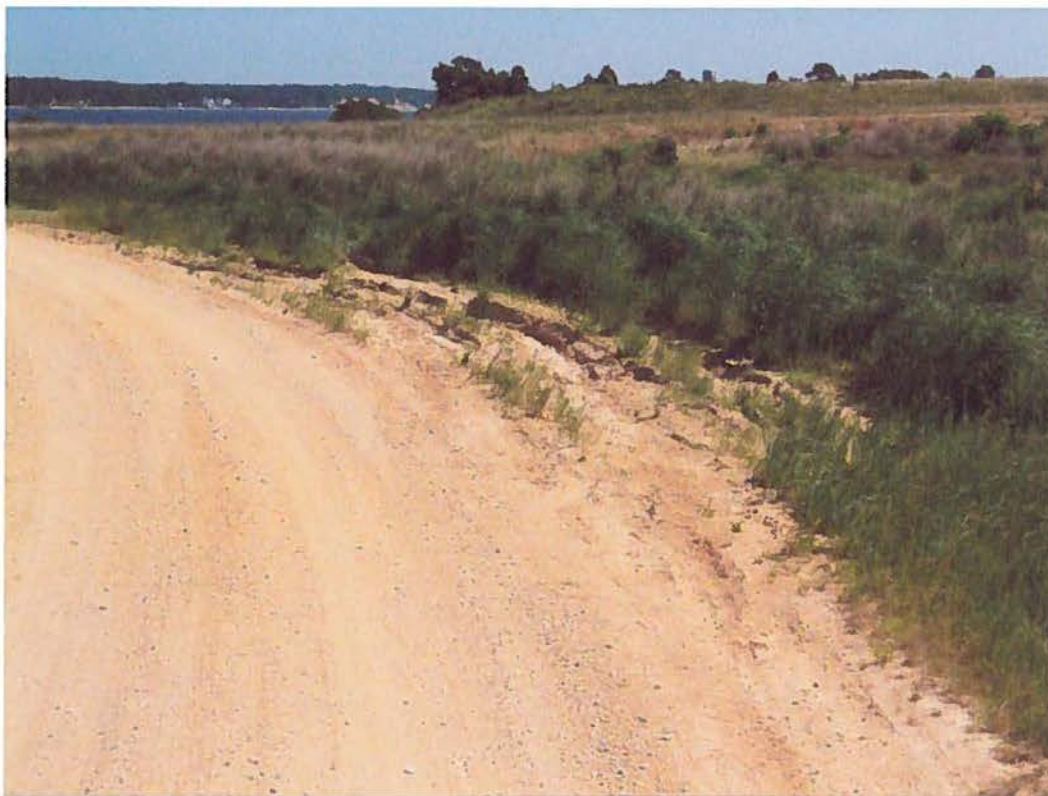
Photo 1
Tire ruts at eastern edge of central access road.
Site 1

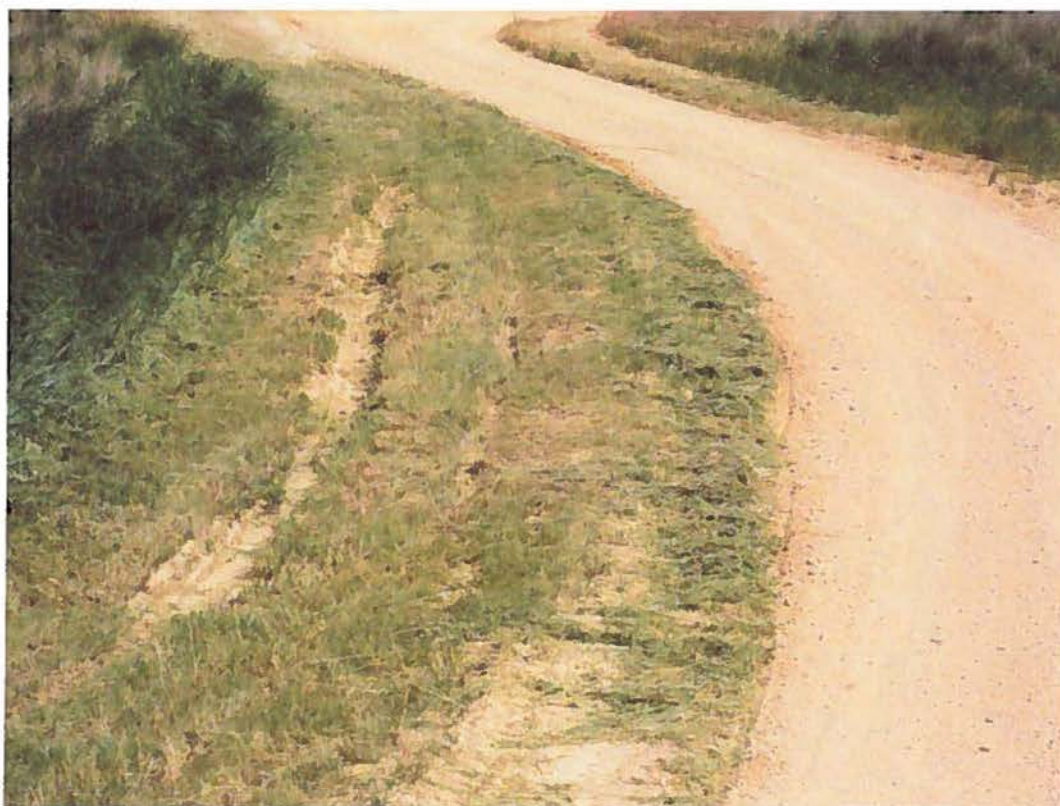
Photo 2
Tire rut off west edge of central access road
Site 1

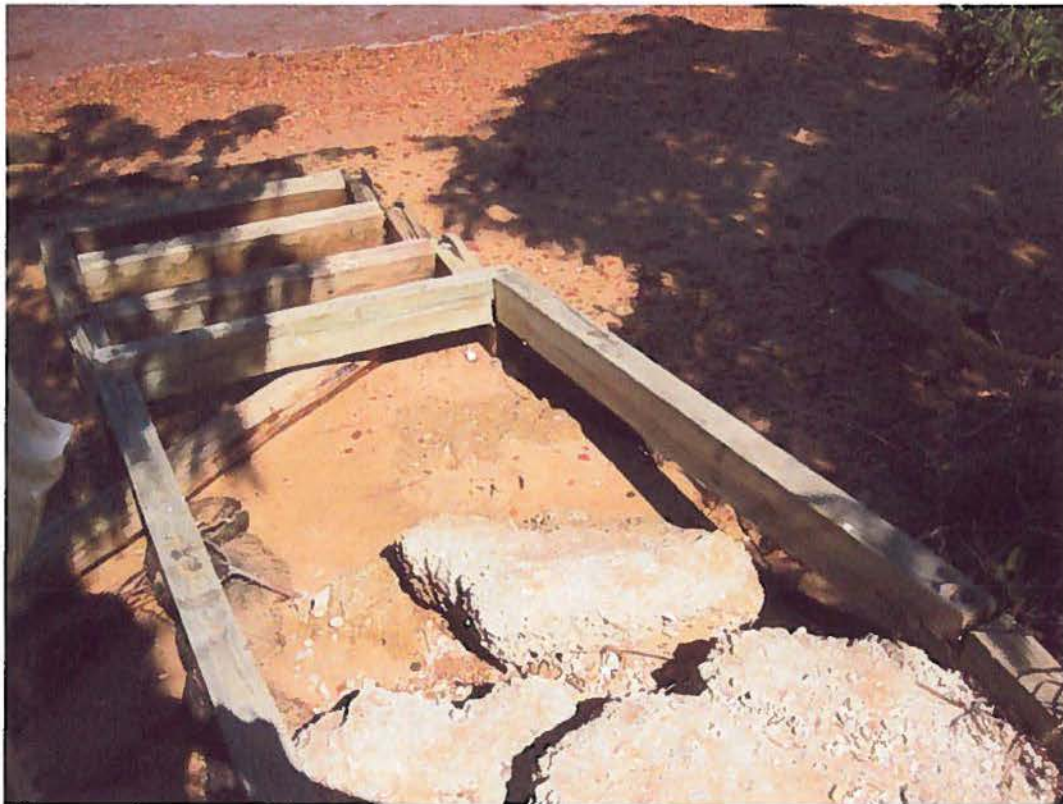
Photo 3
Storm damage to beach access timber stairs
Between swales AA and BB, Site 1

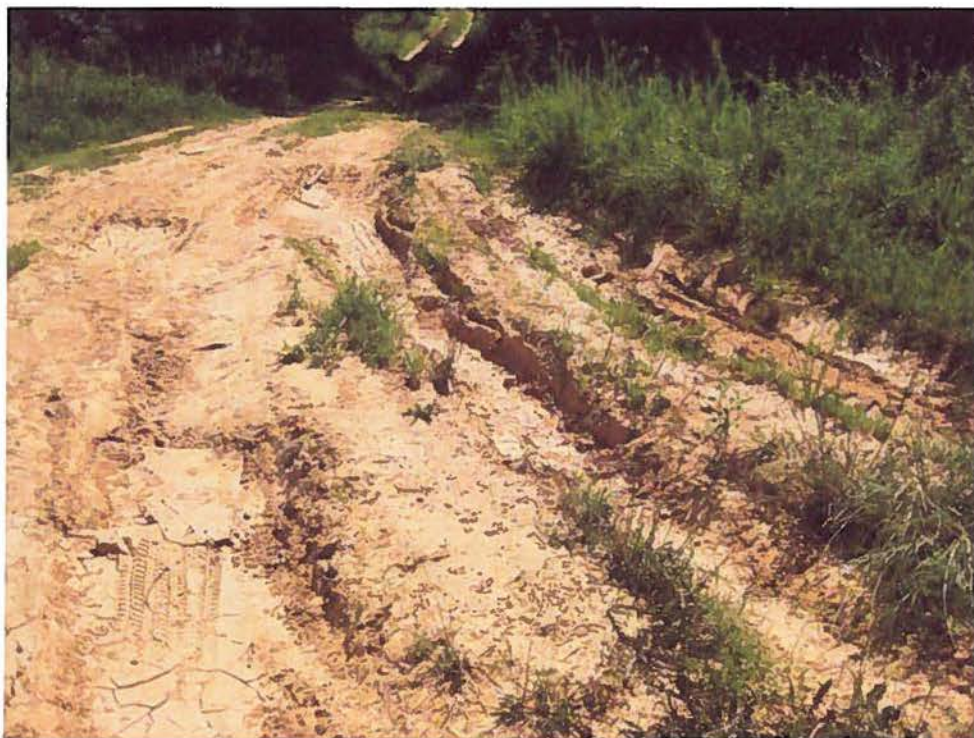
Photo 4
Tire ruts near northeast corner of Site 1, near IMW-7A,
outside LUC boundary of Site 1 and 12

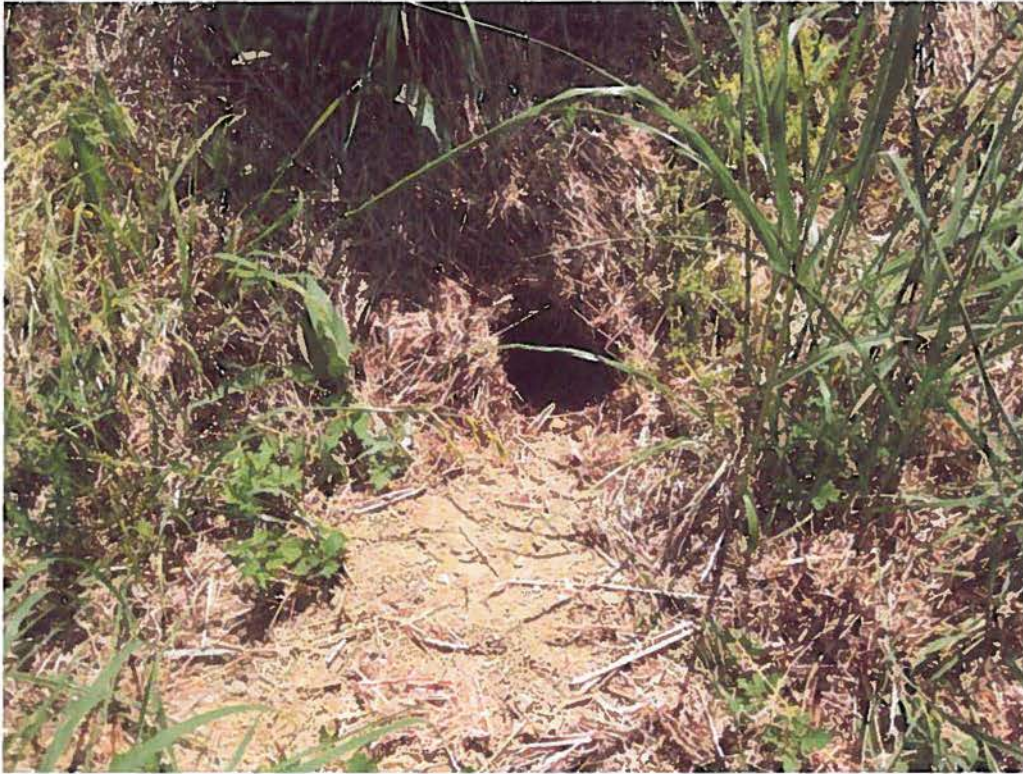
Photo 1
Inactive rodent hole on Northwest landfill slope
(filled subsequent to inspection date)

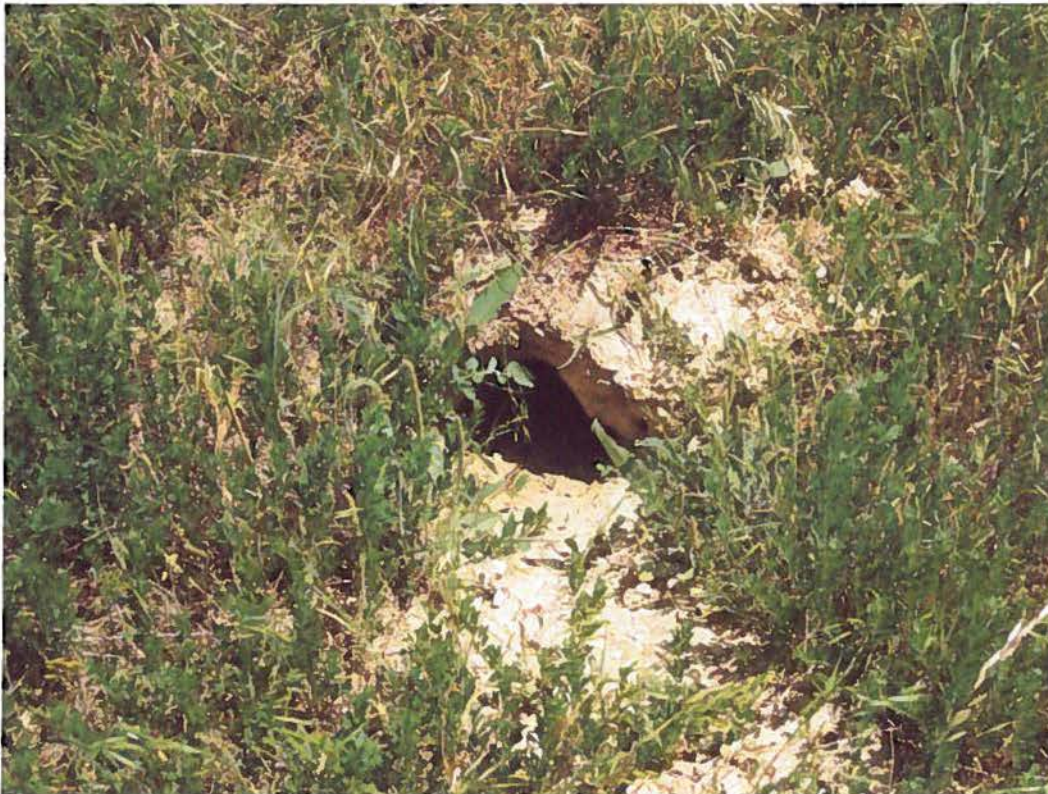
Photo 2
Abandoned rodent hole - northeast corner of landfill
(filled subsequent to inspection date)

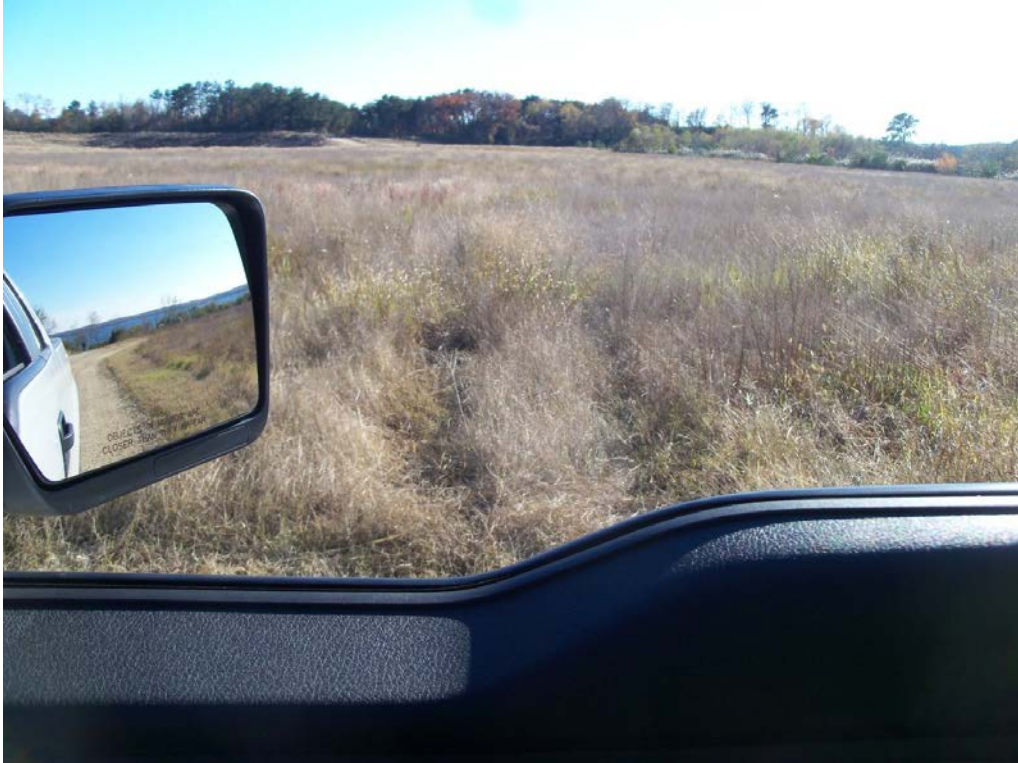
Minor vehicular traffic footprint on Site 1 cover observed during 11-16-12 inspection.

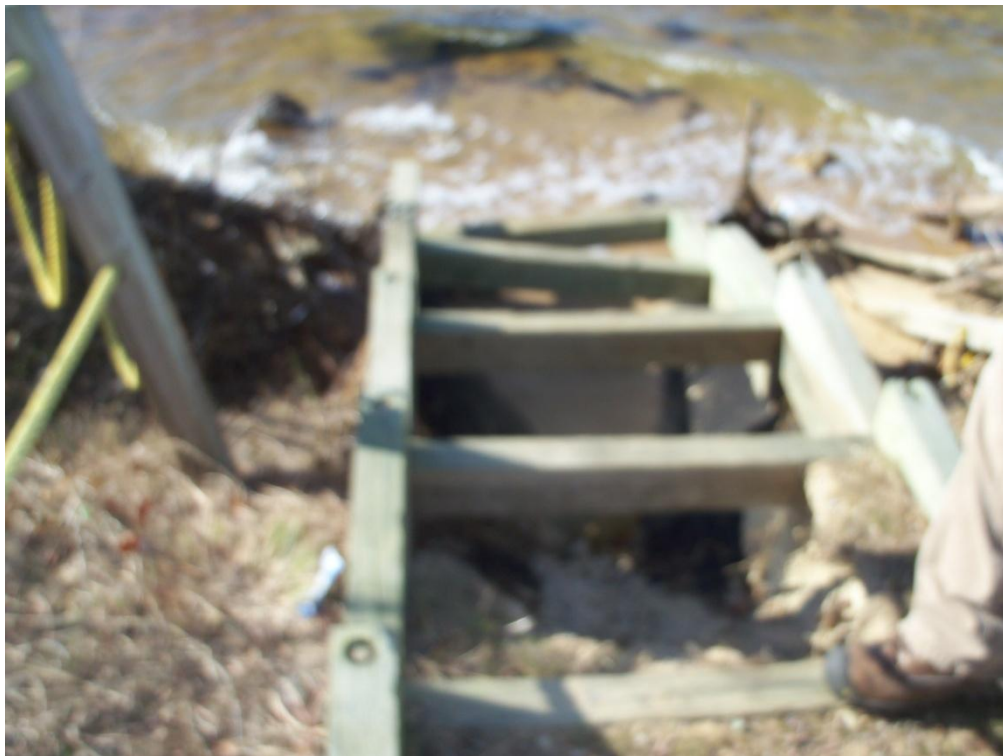
Erosion beneath stairway at Site 1 boundary observed during 11-16-12 inspection.

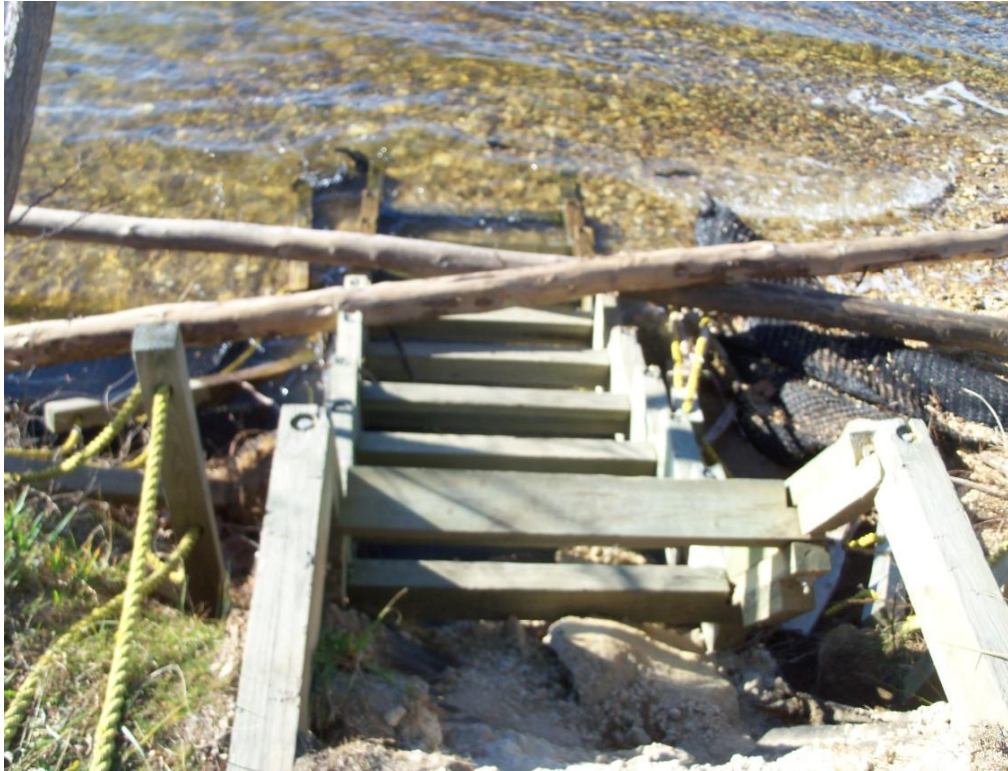
Erosion beneath stairway at Site 1 boundary observed during 11-16-12 inspection.

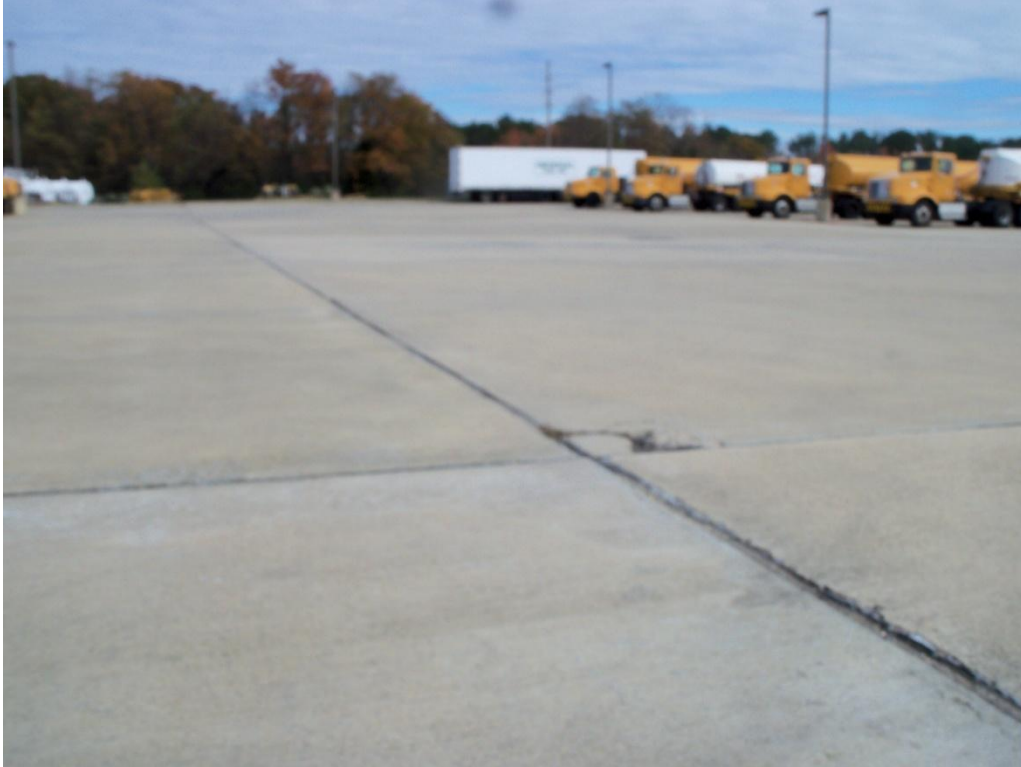
Very minor crack on concrete cover.

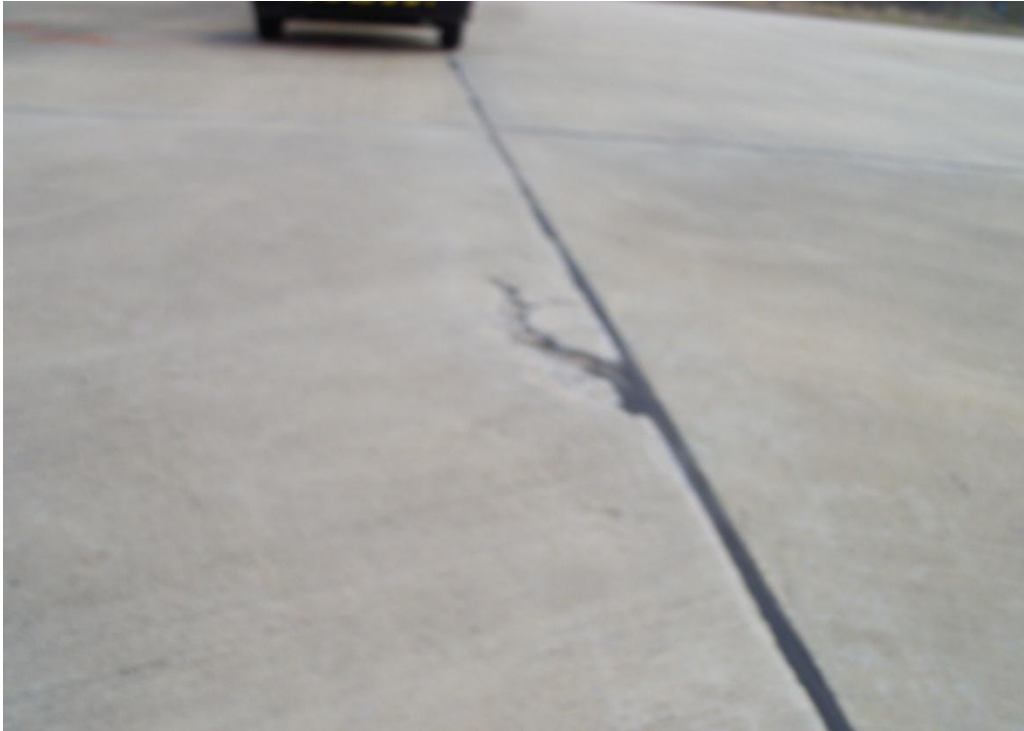
Very minor crack on concrete cover.

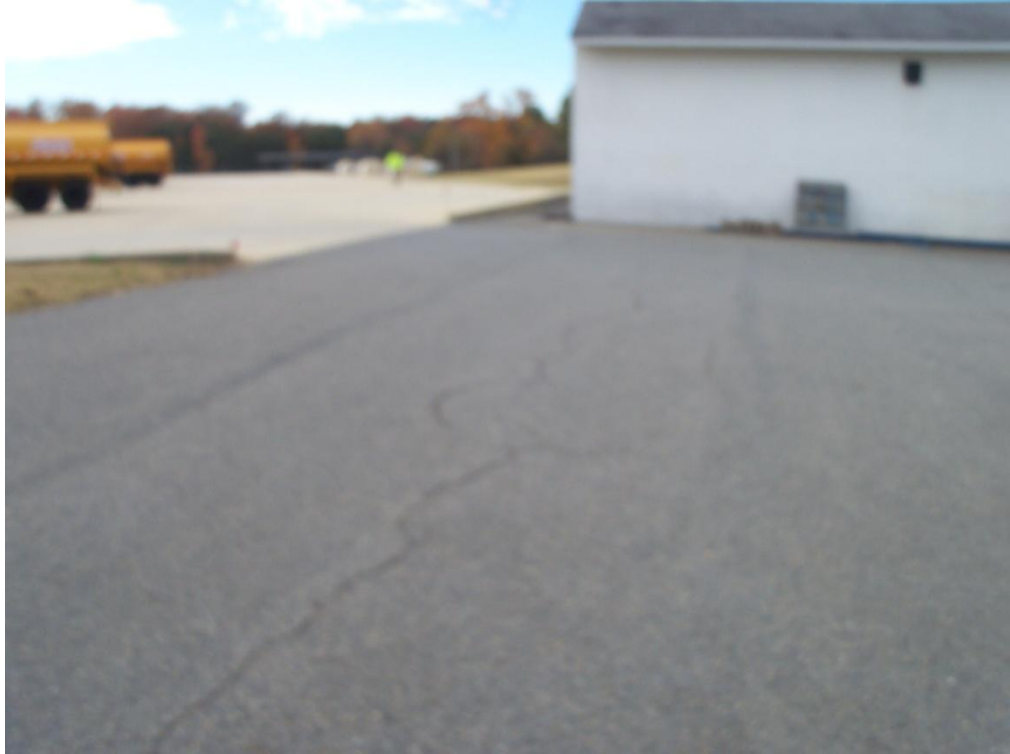
Minor crack on asphalt cover.

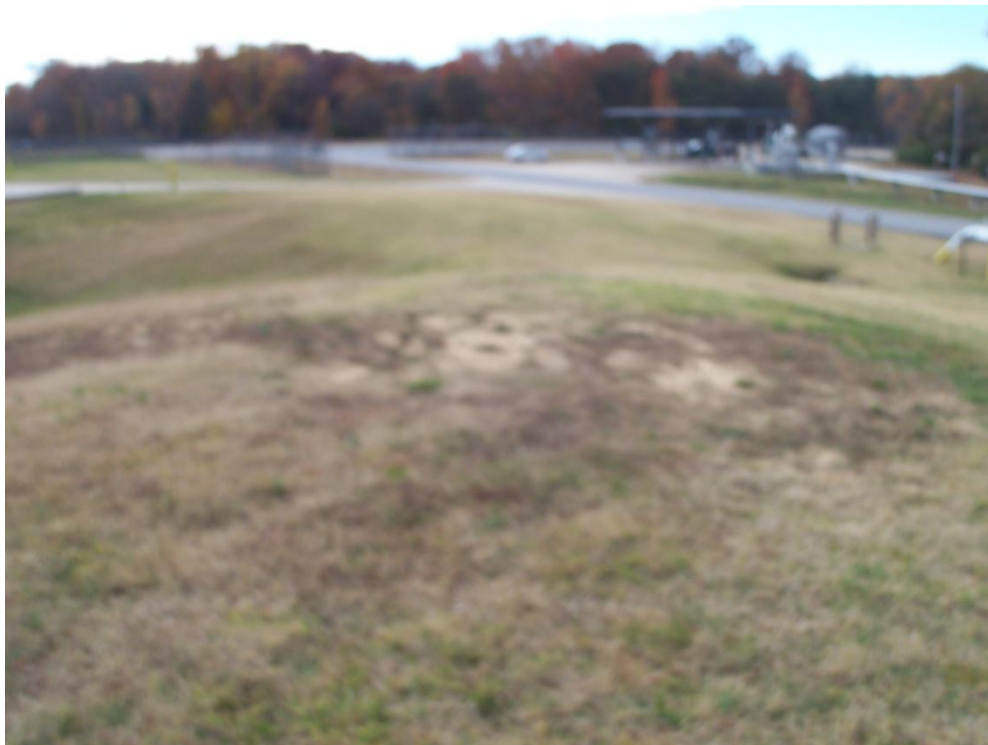
Very minor erosion on soil cover along western site boundary.

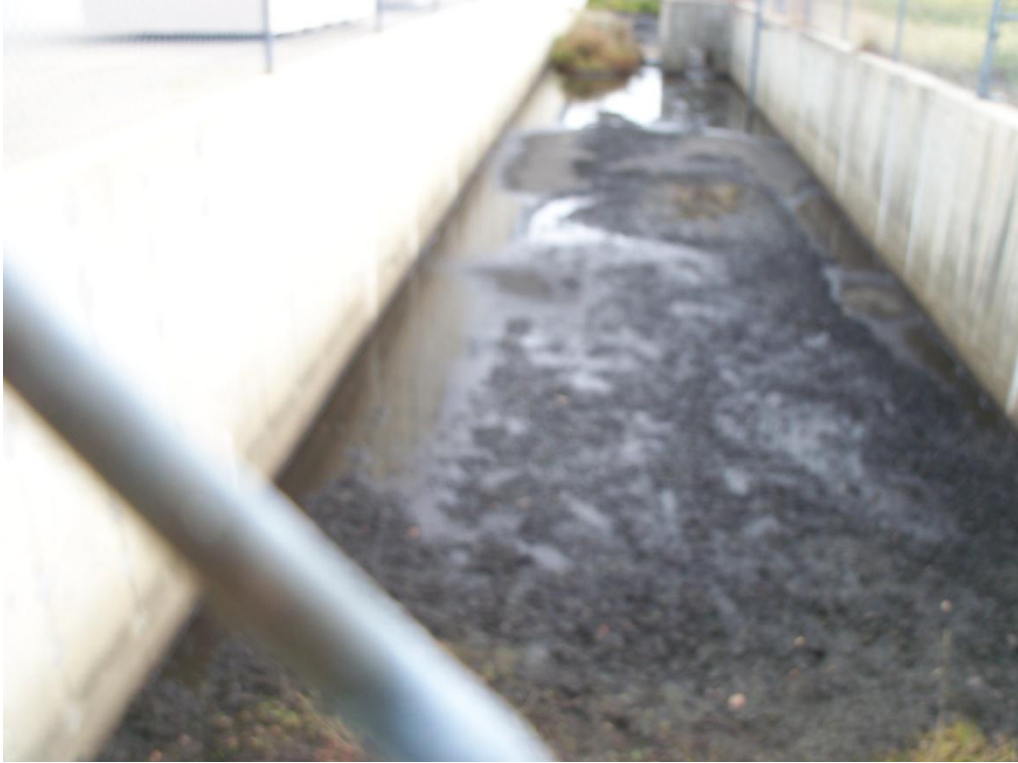
Minor sedimentation in containment area.

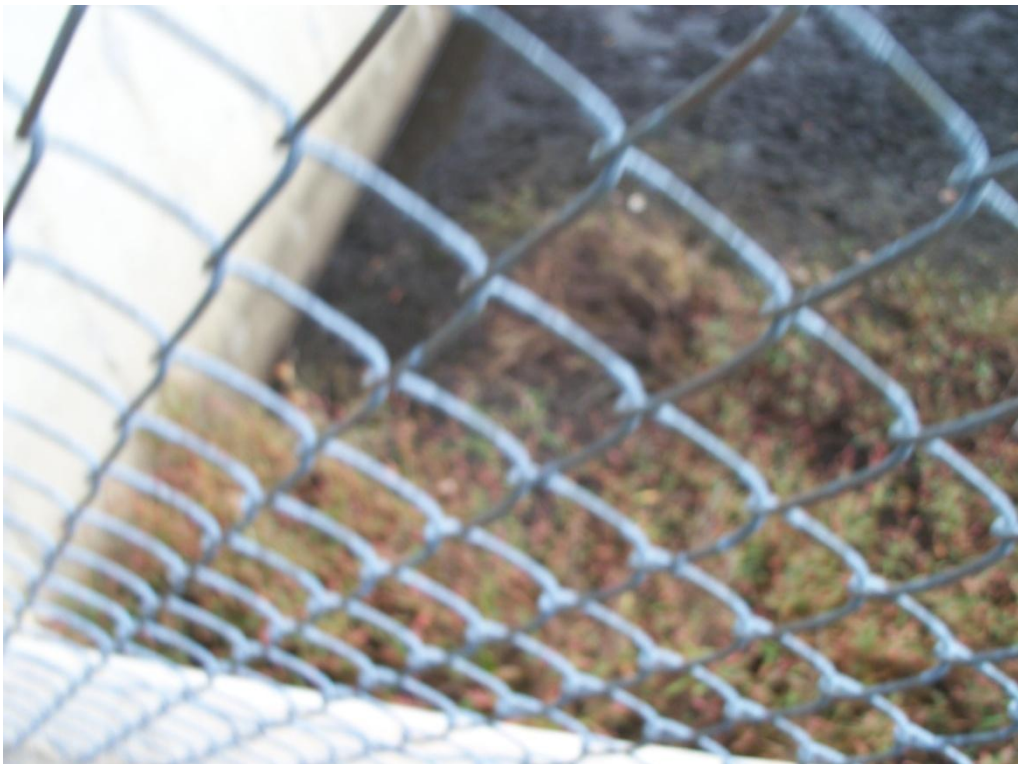
Minor vegetation in containment area.
