**FOURTH FIVE-YEAR REVIEW REPORT FOR THE
HELLERTOWN MANUFACTURING CO. SUPERFUND SITE
NORTHAMPTON COUNTY, PENNSYLVANIA**

April 2015

**U.S. Environmental Protection Agency
Region III
Philadelphia, Pennsylvania**

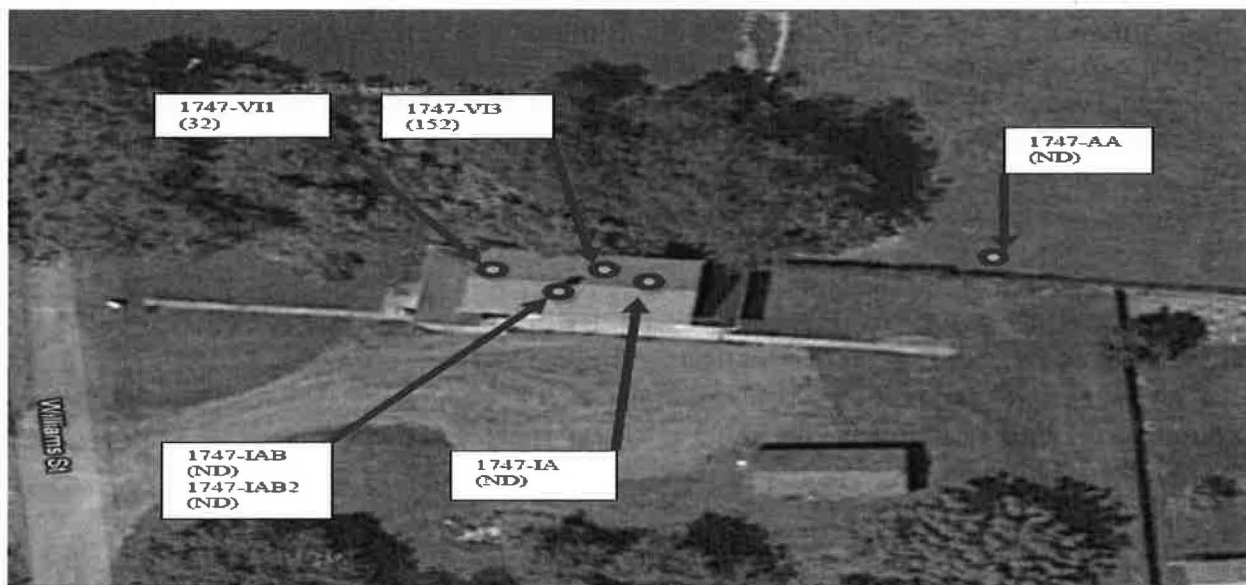
Figure 6 - Property B Sample Locations (and TCE concentrations in $\mu\text{g}/\text{m}^3$)

In February 2013, HGL performed another round of VI sampling at Property B. Samples were collected of the indoor air, outdoor air, and subslab air. Figure 6 shows the air sample locations along with their associated TCE concentration. A summary of the results is contained below.

- Indoor air – Three indoor air samples were collected from the presumed breathing spaces; one sampling canister was placed on the first floor and two (one duplicate) sampling canisters were placed in the basement of the residence. Eleven VOCs were reported in the indoor ambient air samples. All detections were reported at concentrations below their respective residential health-based risk values with the exception of benzene. Benzene was detected at a J-qualified 1 microgram per cubic meter ($\mu\text{g}/\text{m}^3$) of air in all indoor ambient air samples, which exceeds the residential health-based risk screening value of $0.31 \mu\text{g}/\text{m}^3$. Of the eleven VOCs reported in the indoor air, only 4-methyl-2-pentanone and cyclohexane were not also detected in the outdoor ambient air sample.

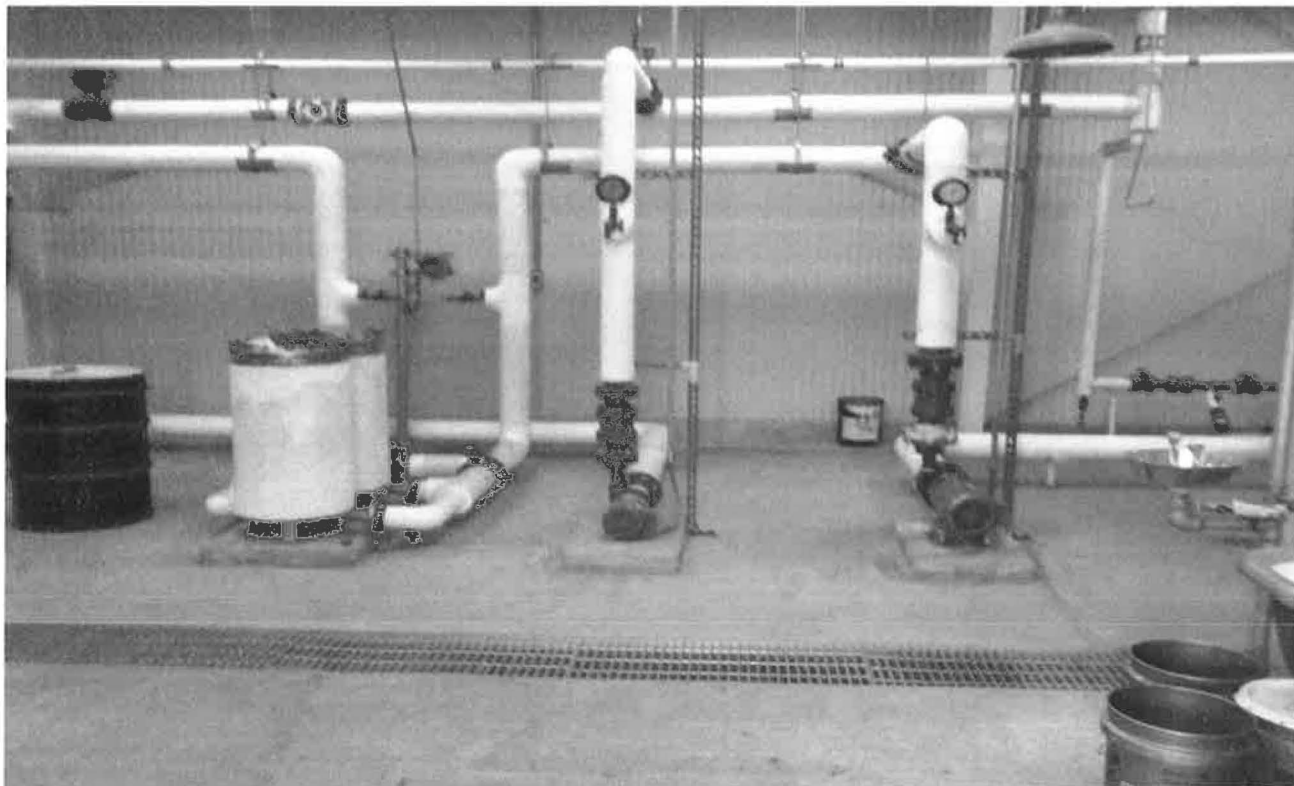
**Hellertown Manufacturing Co. Superfund Site - Fourth Five-Year Review
Groundwater Treatment Plant - Cartridge Filters and Process Piping**

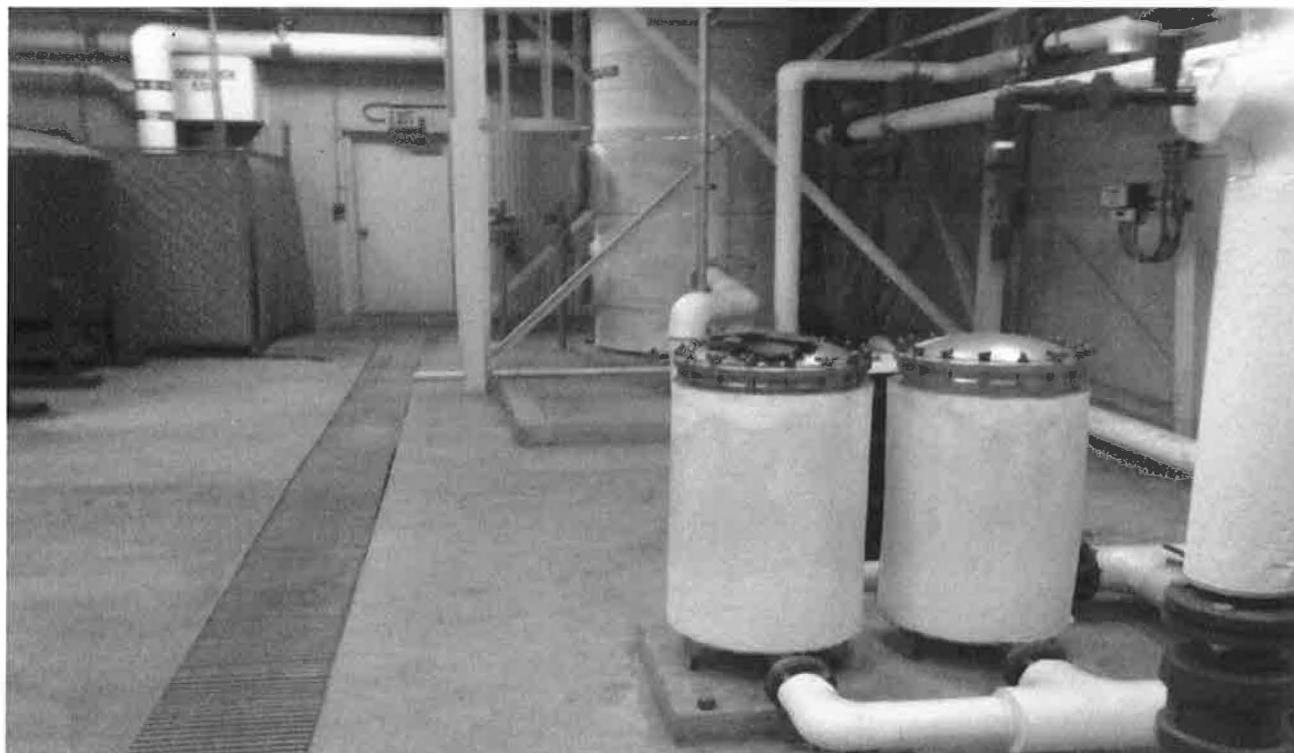
**Hellertown Manufacturing Co. Superfund Site - Fourth Five-Year Review
Groundwater Treatment Plant – Cartridge Filters and Air Stripper**

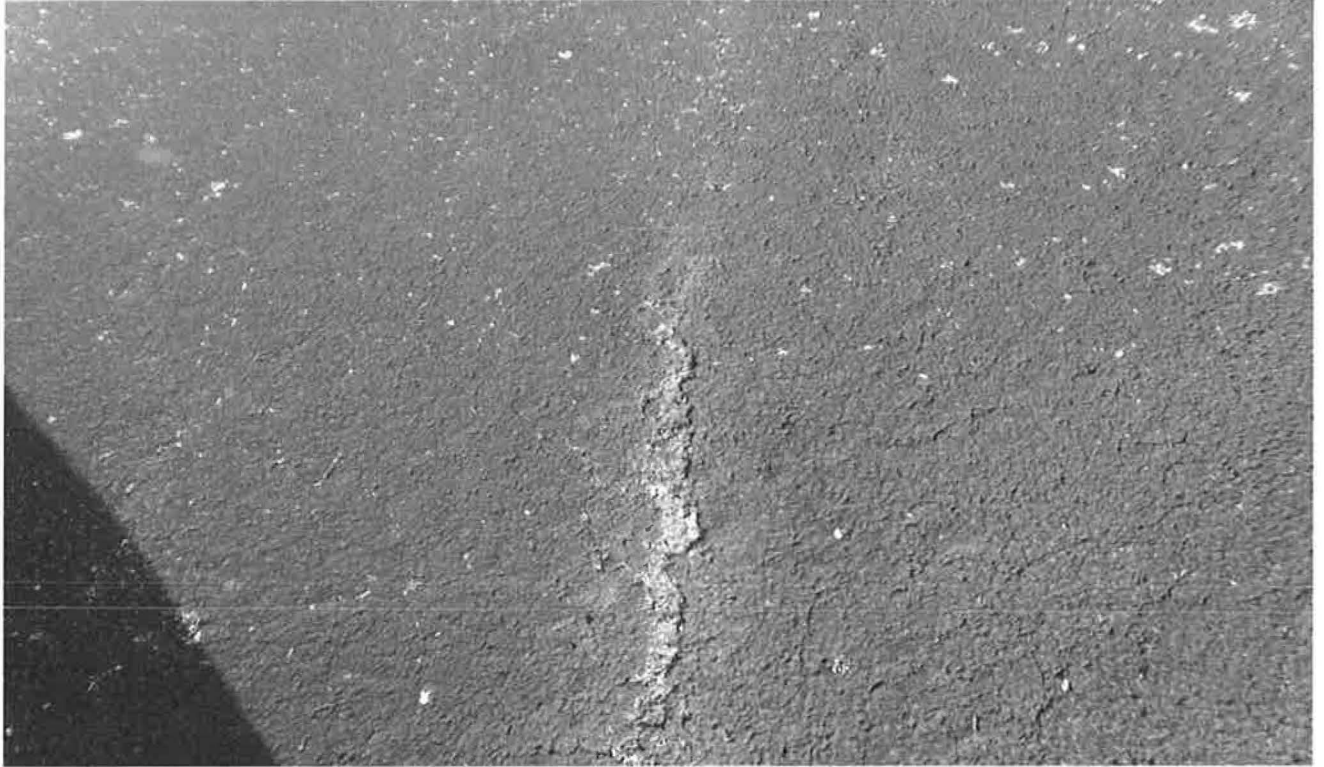
**Hellertown Manufacturing Co. Superfund Site - Fourth Five-Year Review
Minor Surface Cracking in Paved Former Lagoons Area**

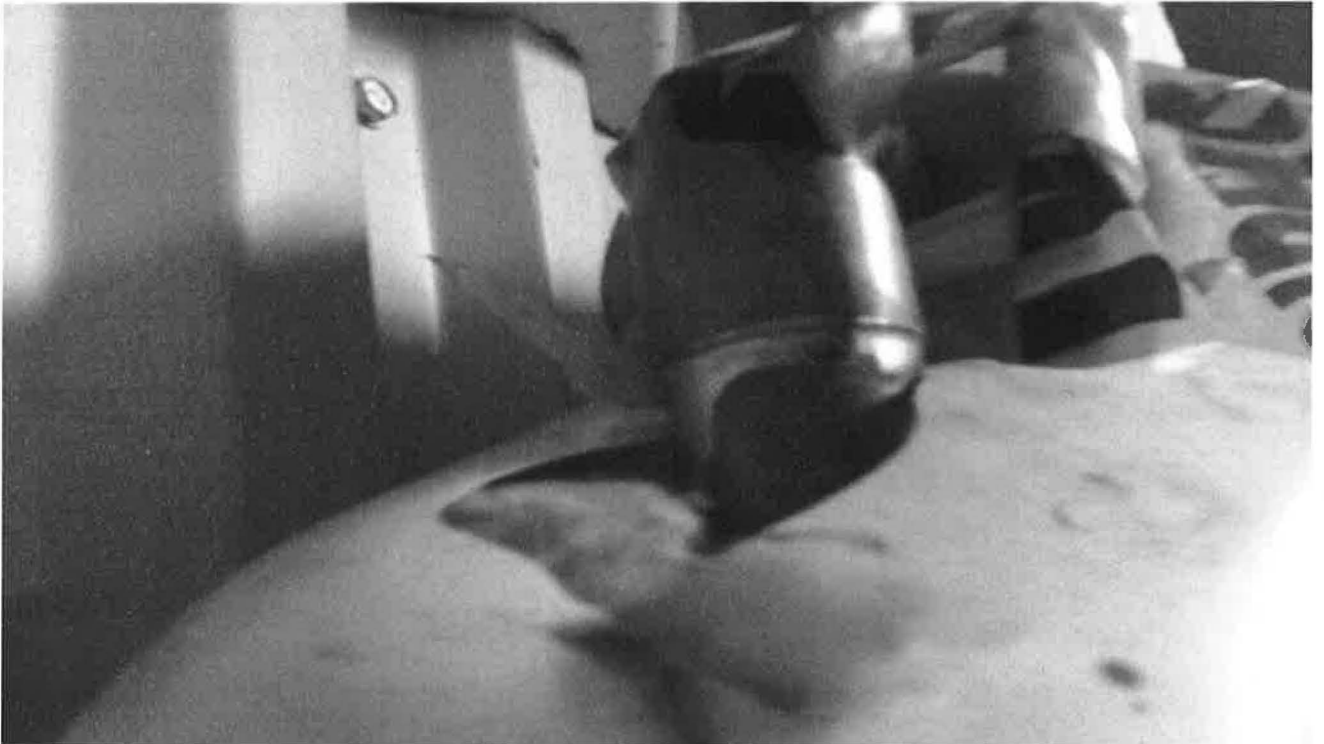
Along with the extraction well pump failure, the groundwater treatment system itself experienced significant damage during the harsh winter of 2013 – 2014. As stated in the AECOM Final 2013 Annual Groundwater Monitoring and Operation and Maintenance Report, dated May 2014:

It should also be noted that in January 2014...the building boiler heating system failed and all residual water in the plant froze, causing damage to the piping systems. Additionally it was discovered that the transfer pump that pumps water from the Equalization Tank to the treatment system had seized. A replacement pump and some pipe repairs are required prior to restarting the system. AECOM also recommends an alternative heating system, such as natural gas space

**Hellertown Manufacturing Co. Superfund Site - Fourth Five-Year Review
Freeze/Thaw Damage to Treatment Plant Piping**
