FOURTH FIVE-YEAR REVIEW REPORT FOR
Moyer's Landfill Superfund Site
Montgomery County, Pennsylvania

U.S. Environmental Protection Agency
Region III
Philadelphia, Pennsylvania

FIVE-YEAR REVIEW SUMMARY FORM

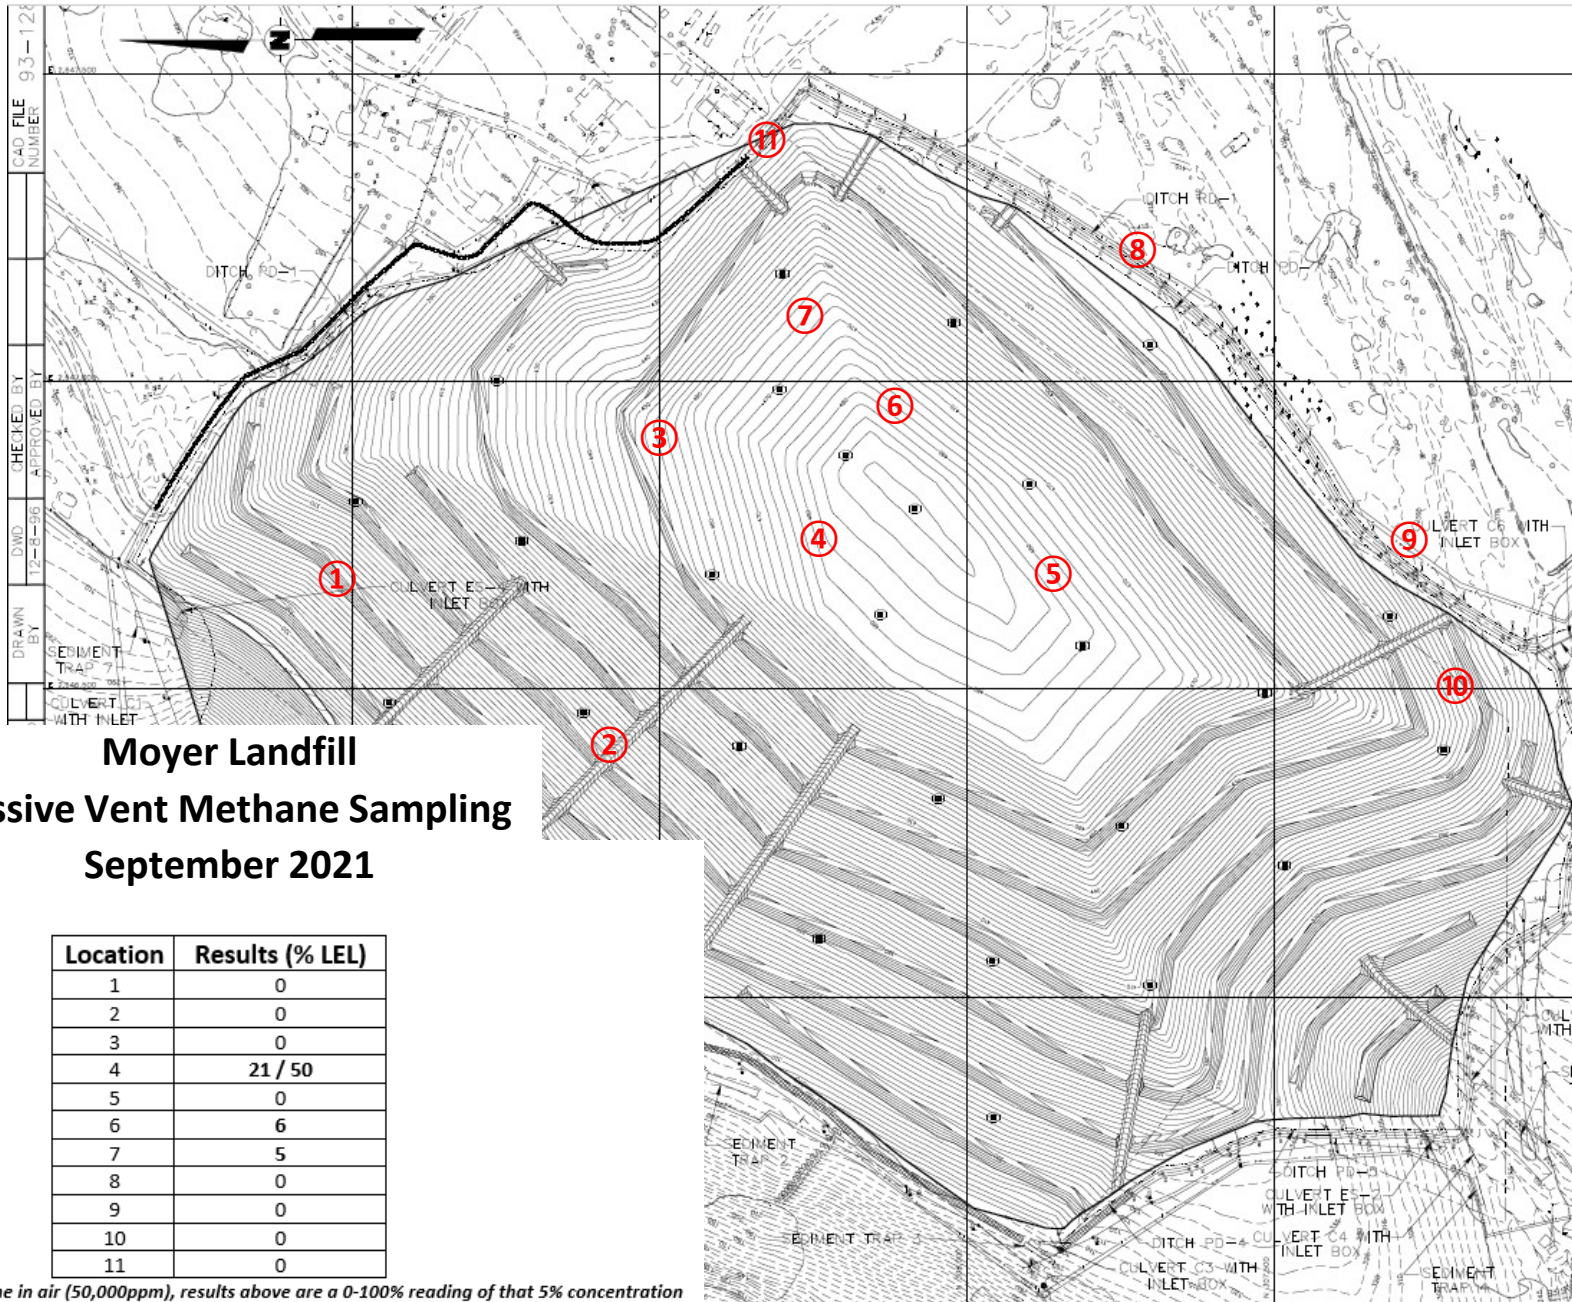
APPENDIX F – PASSIVE GAS VENT METHANE SAMPLING PROVIDED BY PADEP

On September 17, 2021, PADEP completed methane sampling of eleven passive gas vents as marked on the figure shown in Appendix F. Readings were taken from sample ports located near the bottom of the vent pipes using a MultiRae PID, a portable multi-gas monitor. Table 3 shows there were no detectable levels of methane found at the gas vents along the perimeter of the site (locations 8, 9, 10 and 11). Three vents at the site's crest (locations 4, 6 and 7) had detectable methane levels less than 100% of the Lower Explosive Limit. Two readings were taken at location 4 since that location had the highest reading. Although these three vents had detectable methane, most of the landfill is generating very little methane gas. Since methane was not detected above its Lower Explosive Limit along the perimeter of the site nor anywhere on the landfill, the landfill gas is not migrating and causing a hazard to nearby residents.

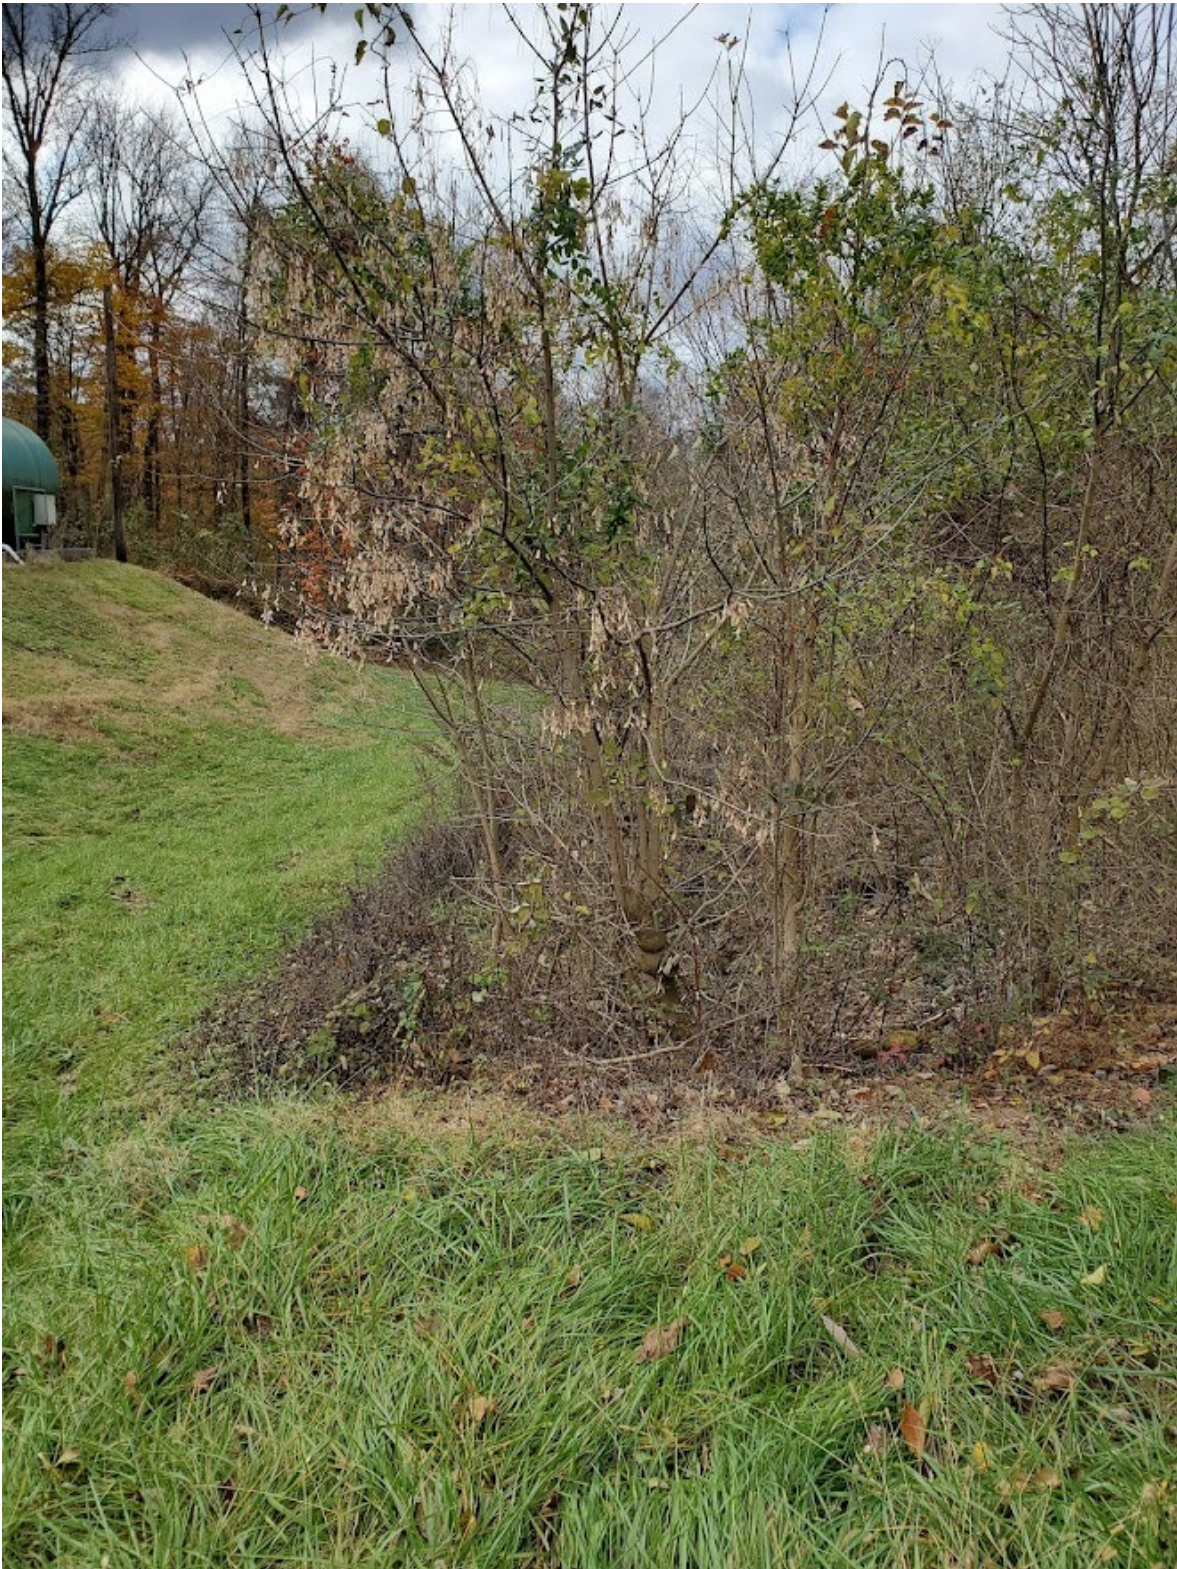
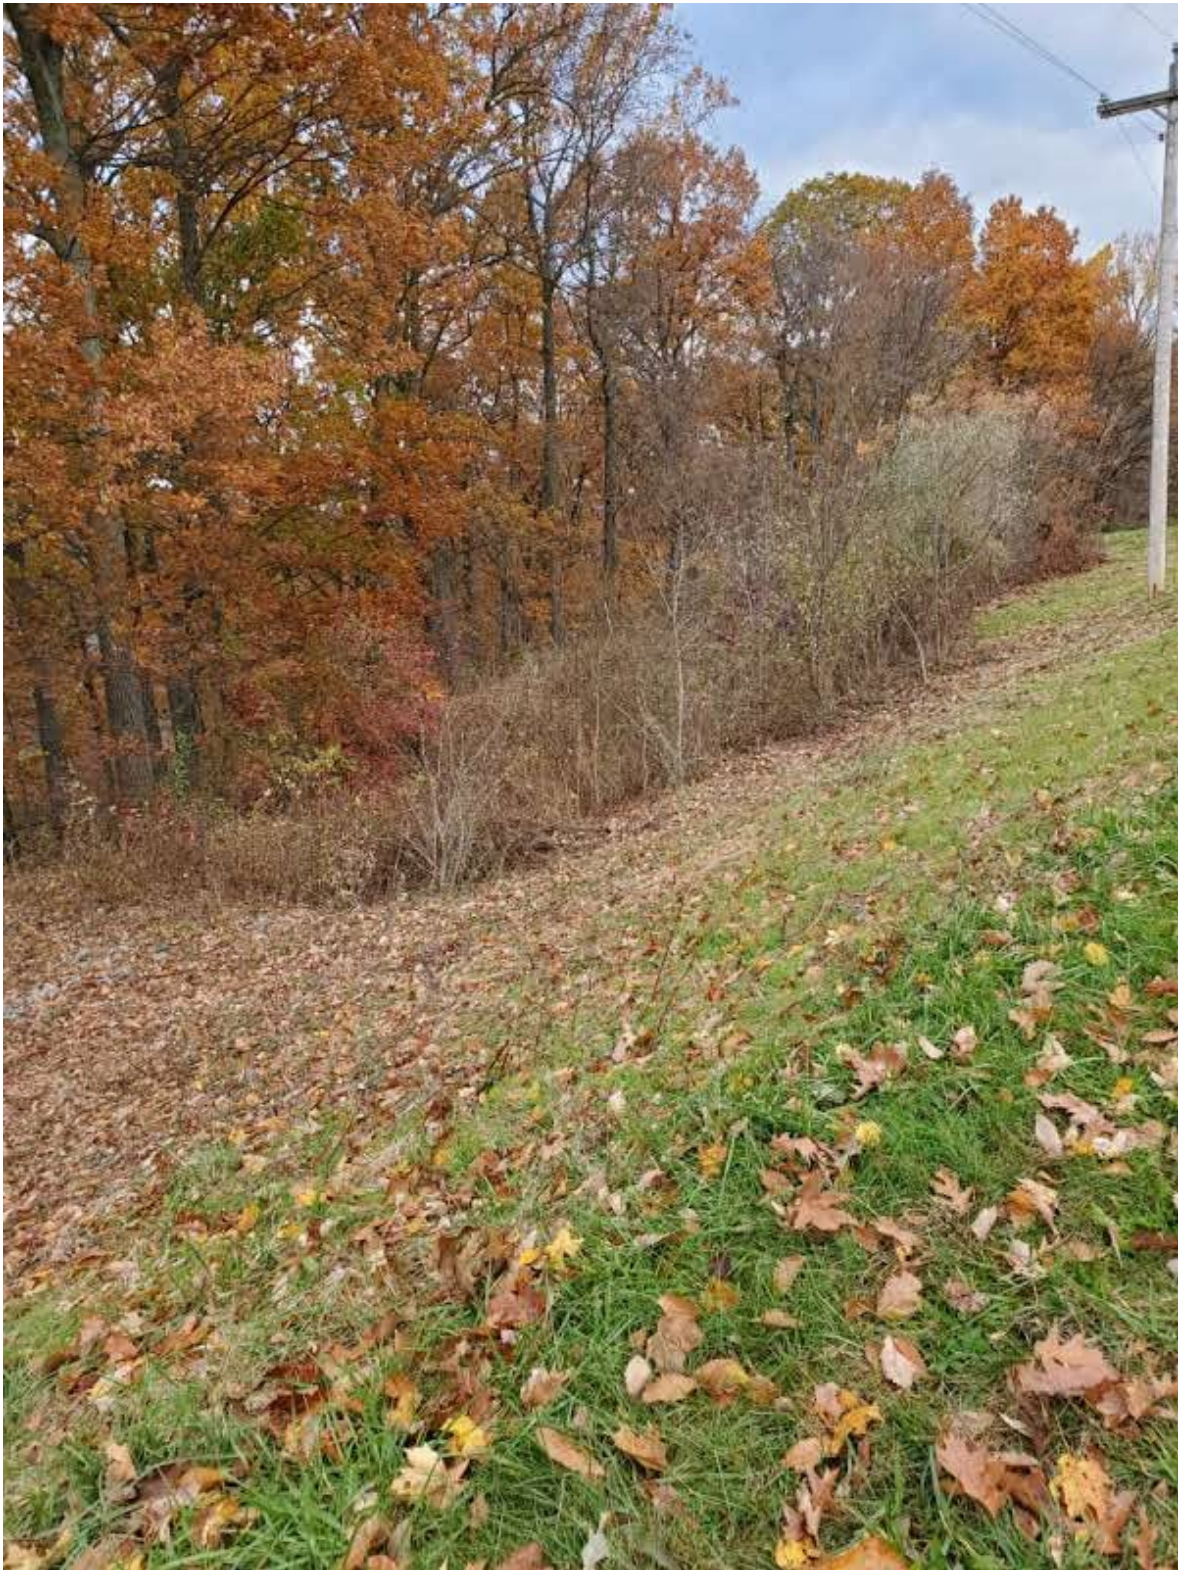
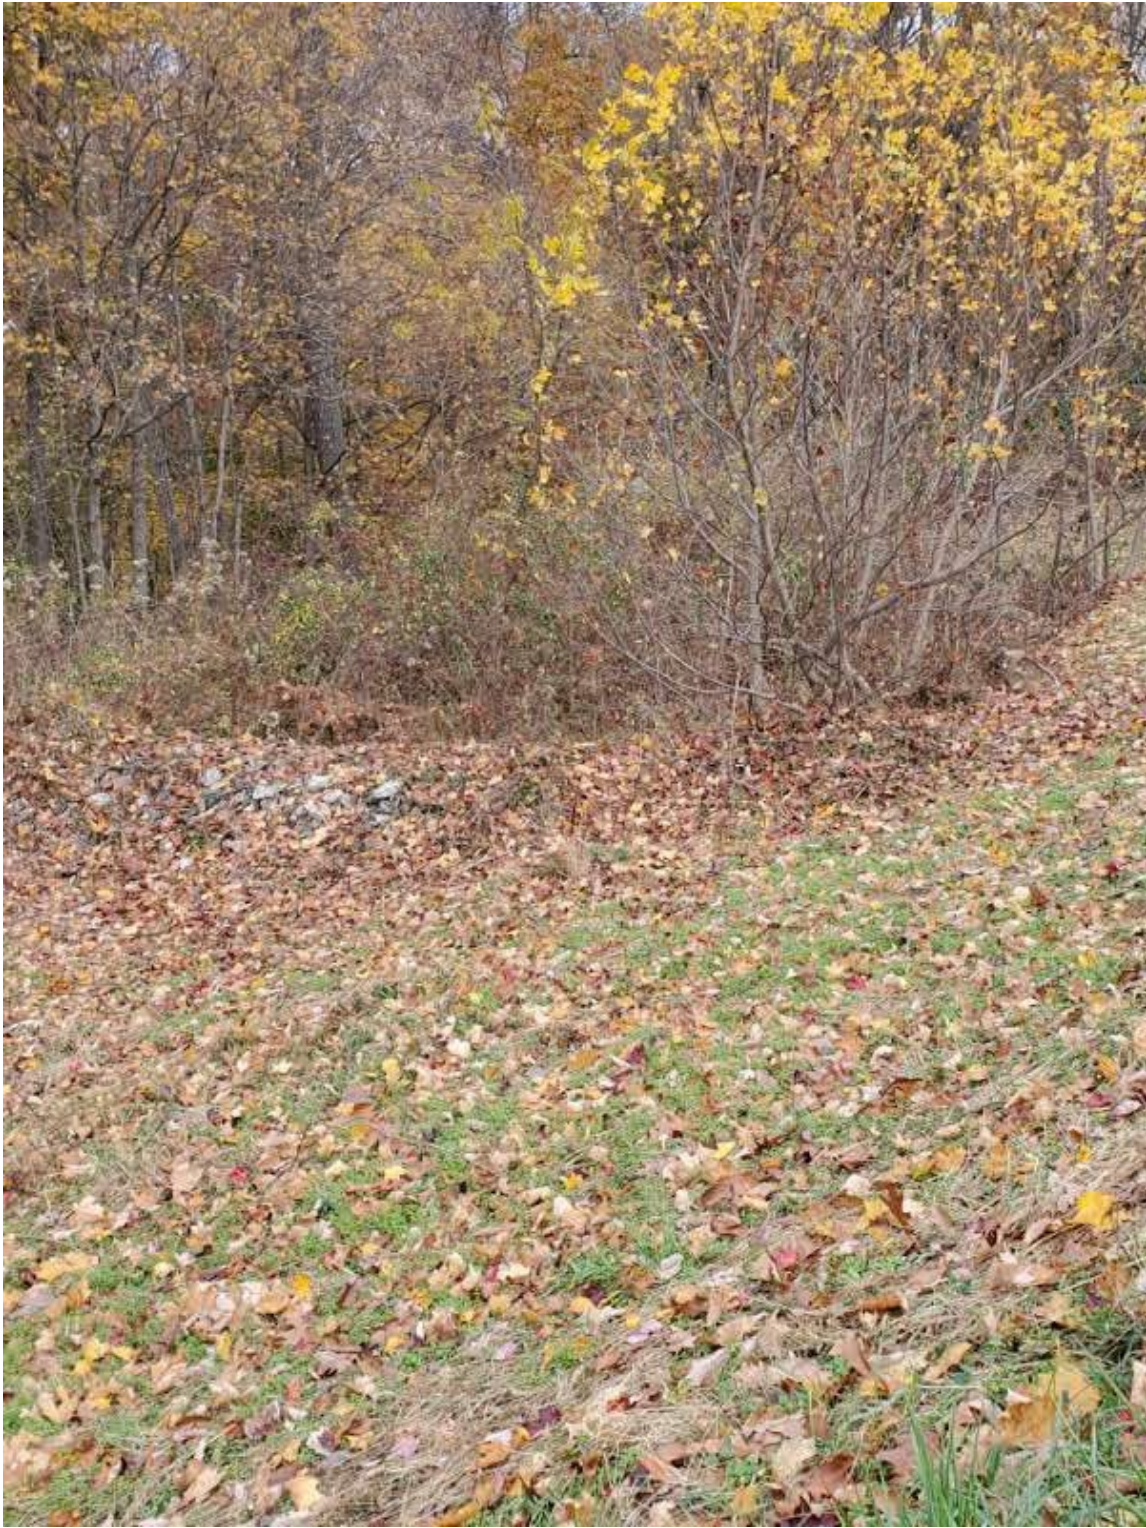
Overgrown drainage basin in South Valley

Overgrown drainage basin on West side

Overgrown drainage basin on West side.

- Drainage basins are heavily vegetated. There were no signs that drainage capacity was restricted by the vegetation but recommend monitoring for any signs of compromised drainage capacity such as rivulets emerging from basins or downgradient erosion. Additionally, due to the vegetation within the basins being defoliated, EPA was unable to identify if any invasive species had taken root. During the growing season, recommend visually inspecting the vegetation and removing any invasive species. EPA's BTAG can provide assistance.

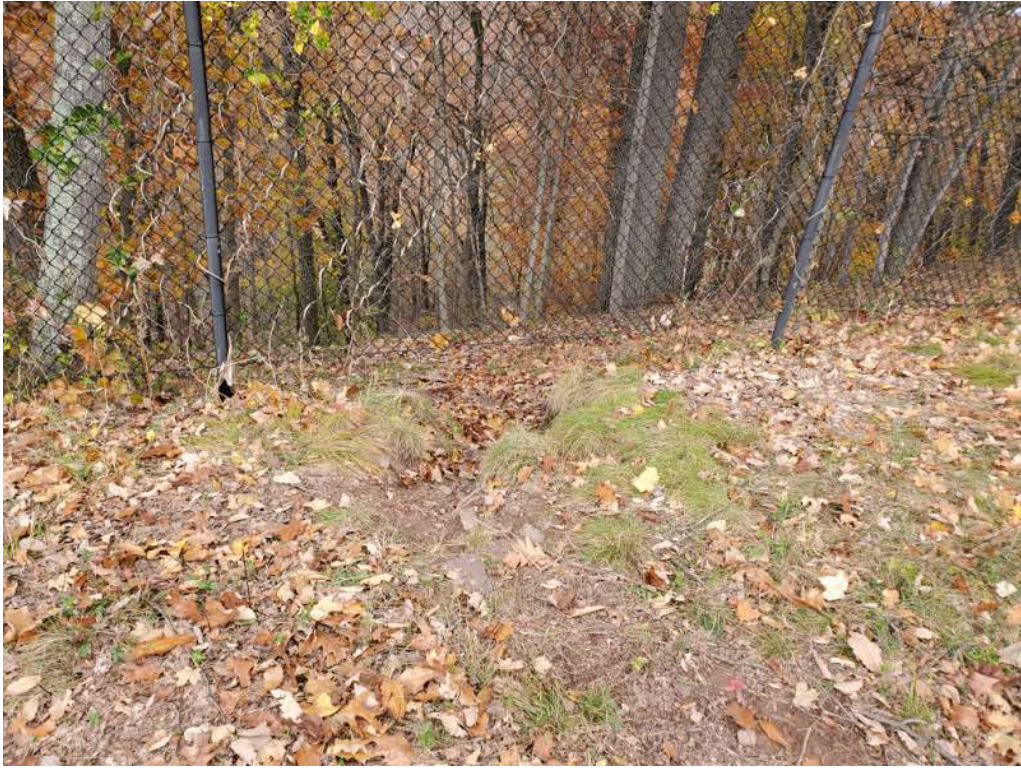
Erosion under fence on West side

- Some erosion was observed beneath the fence on the West side of the Site which EPA recommends filling.
- Portions of grout bag spillways are covered in mat-like vegetation. The coverage did not allow visual inspection of underlying condition of grout bags; however, there was no evidence of any scouring or erosion along or at the base of the spillways. EPA recommends monitoring spillways for any signs of compromised functionality.

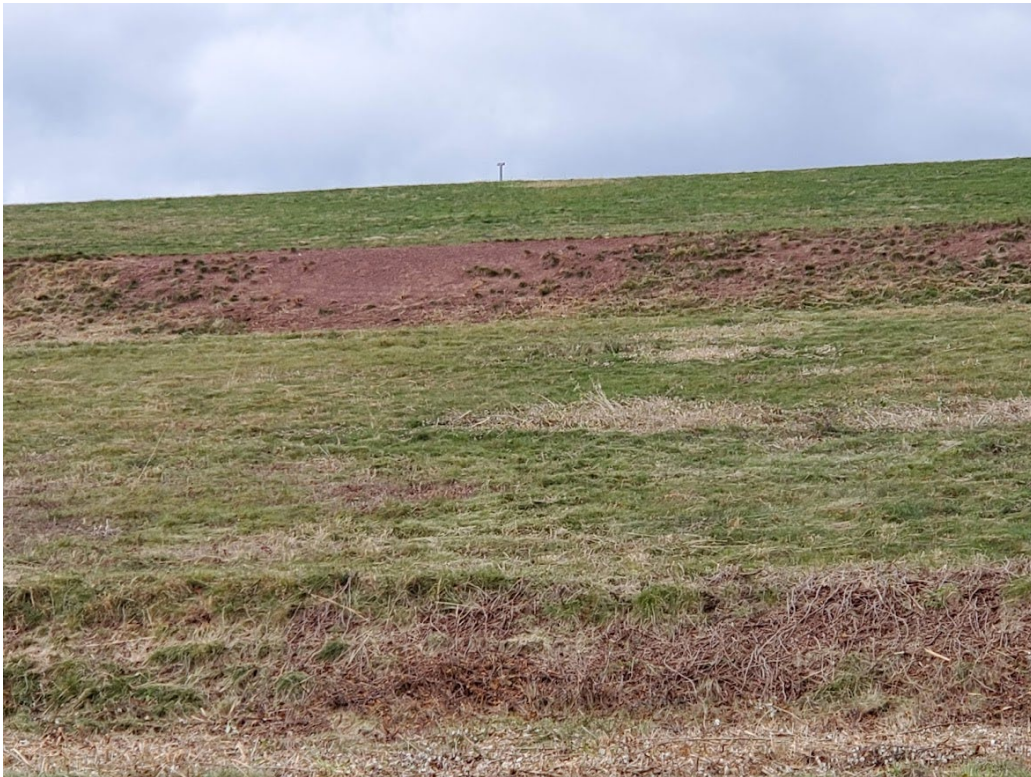
Bare area on East side

- East side of cap has a bare spot which should be seeded to prevent any potential erosion. Recommendations on native seed mixtures can be provided by EPA's BTAG. EPA also recommends testing soil to determine what seed mixture will best germinate under current soil conditions.

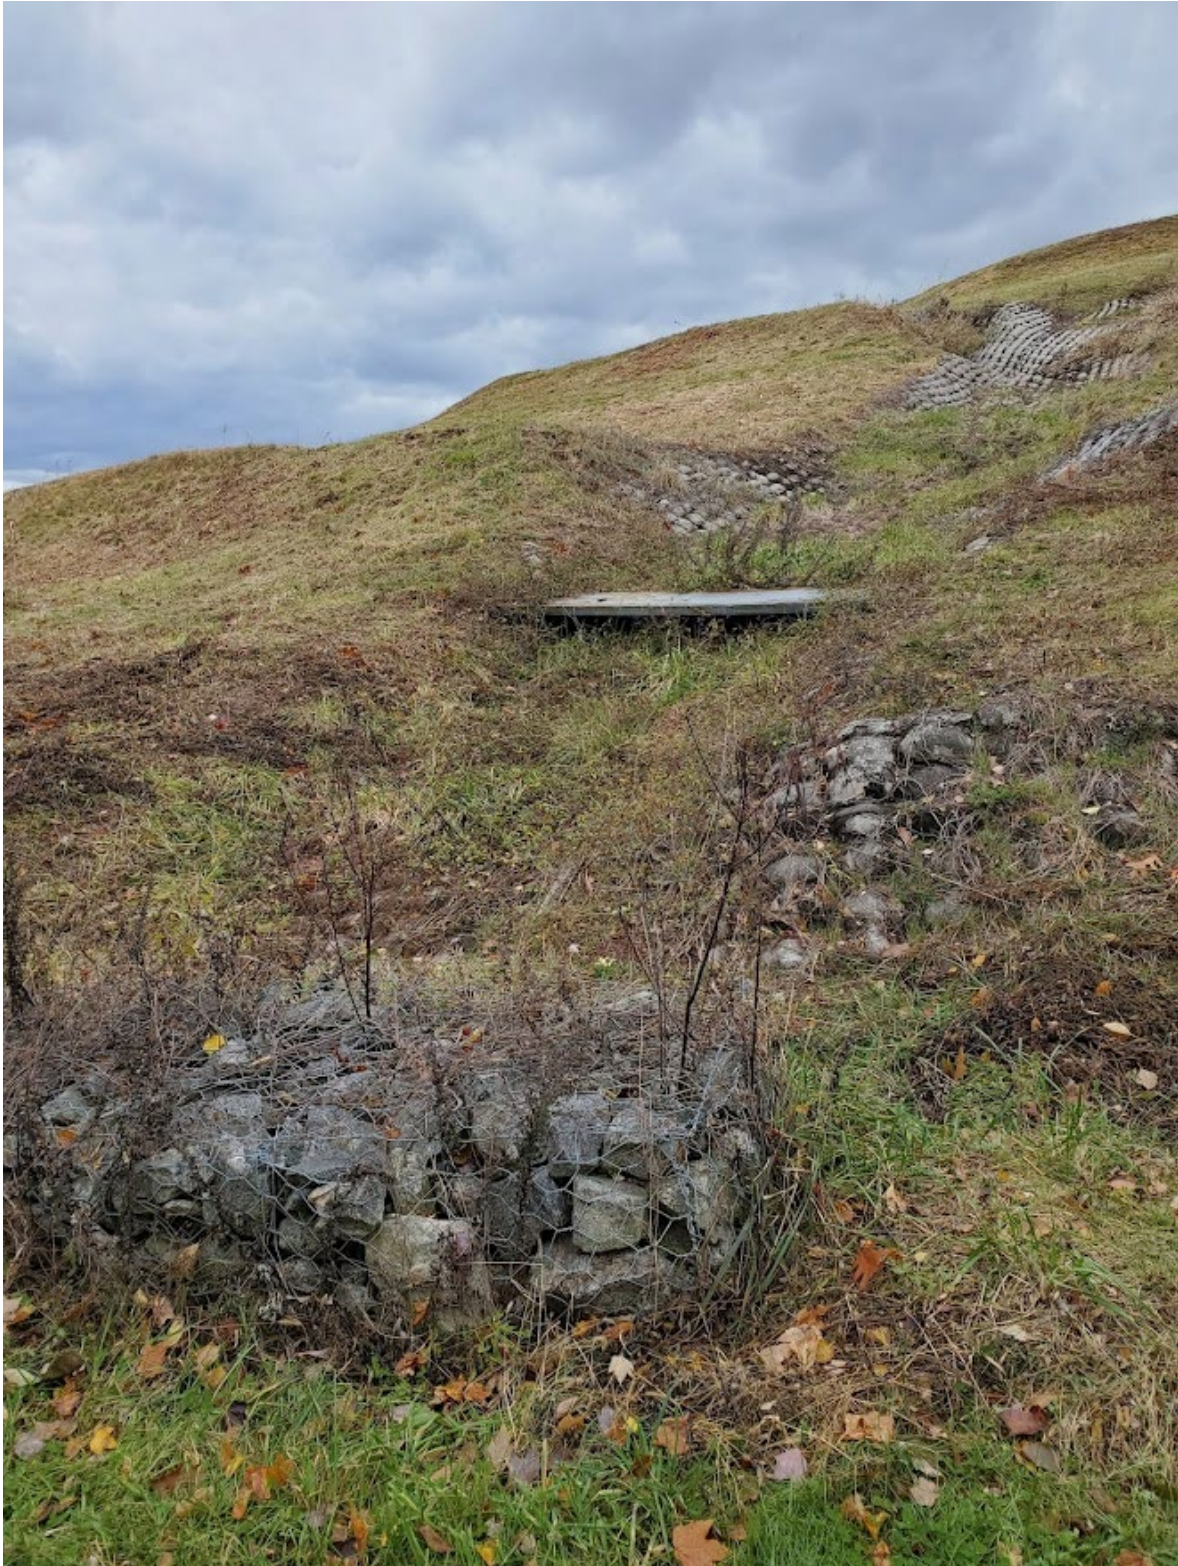
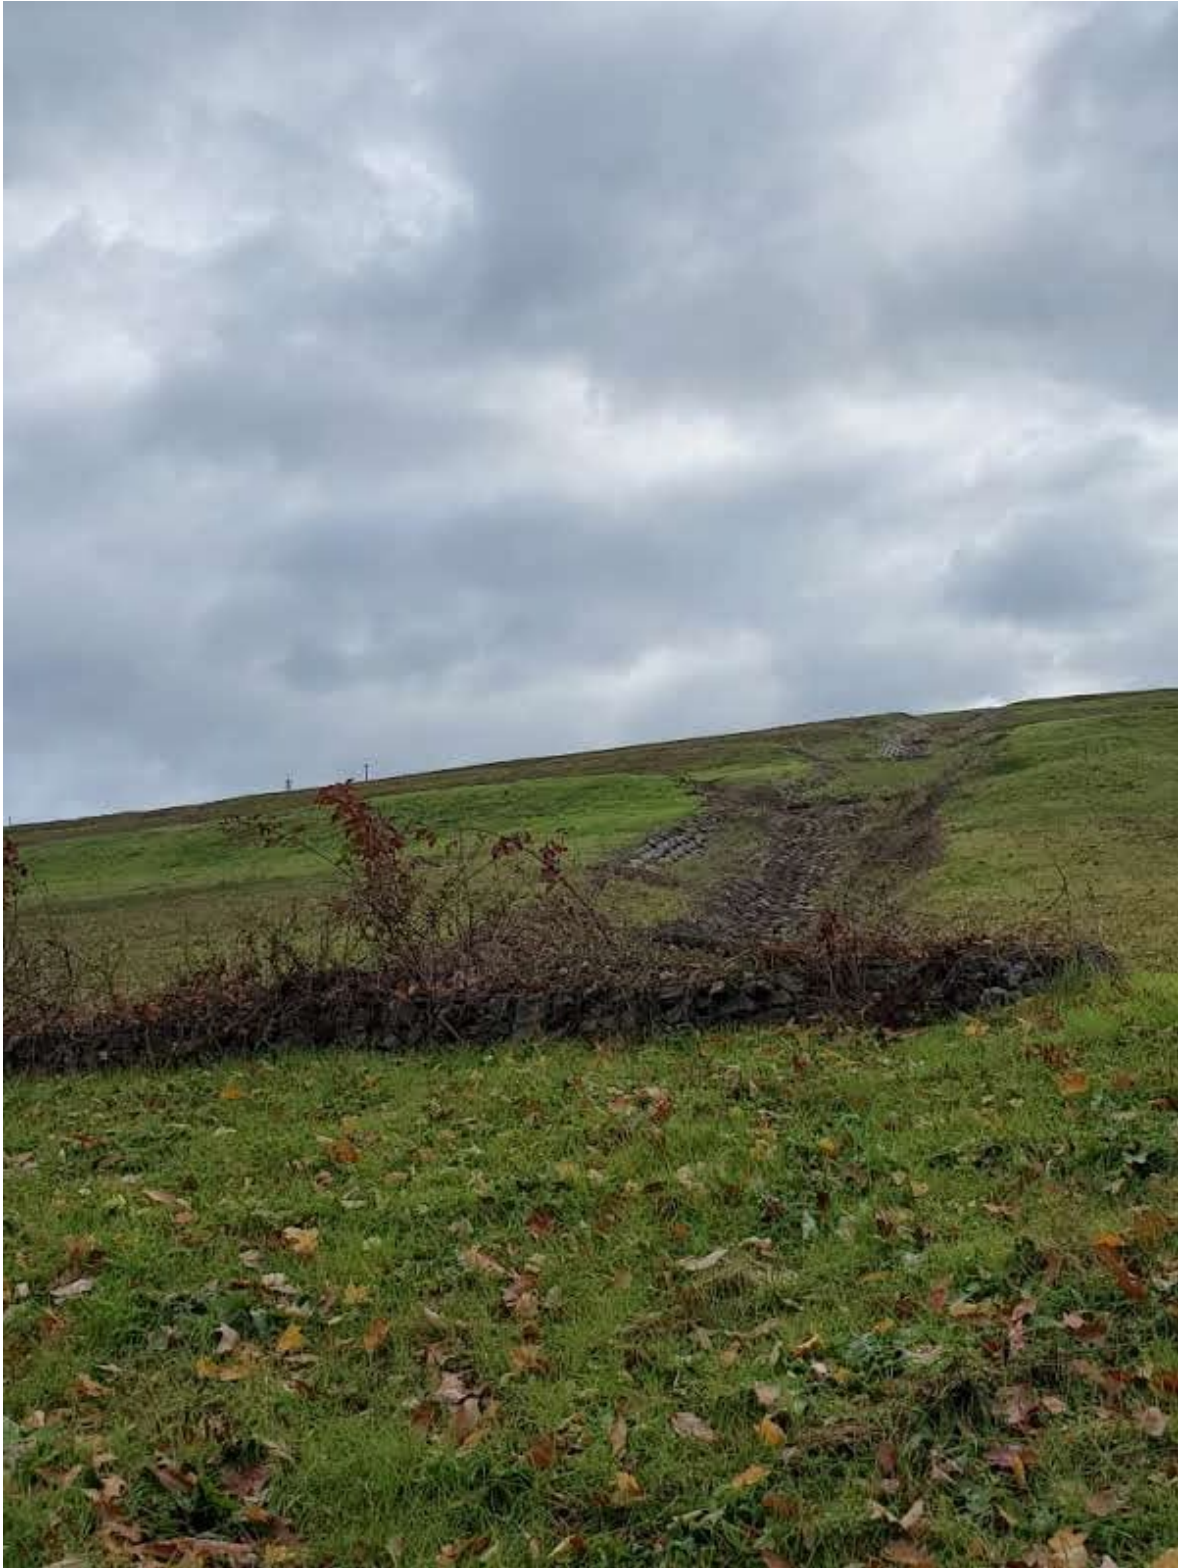
Grout bag on East side covered in vegetation

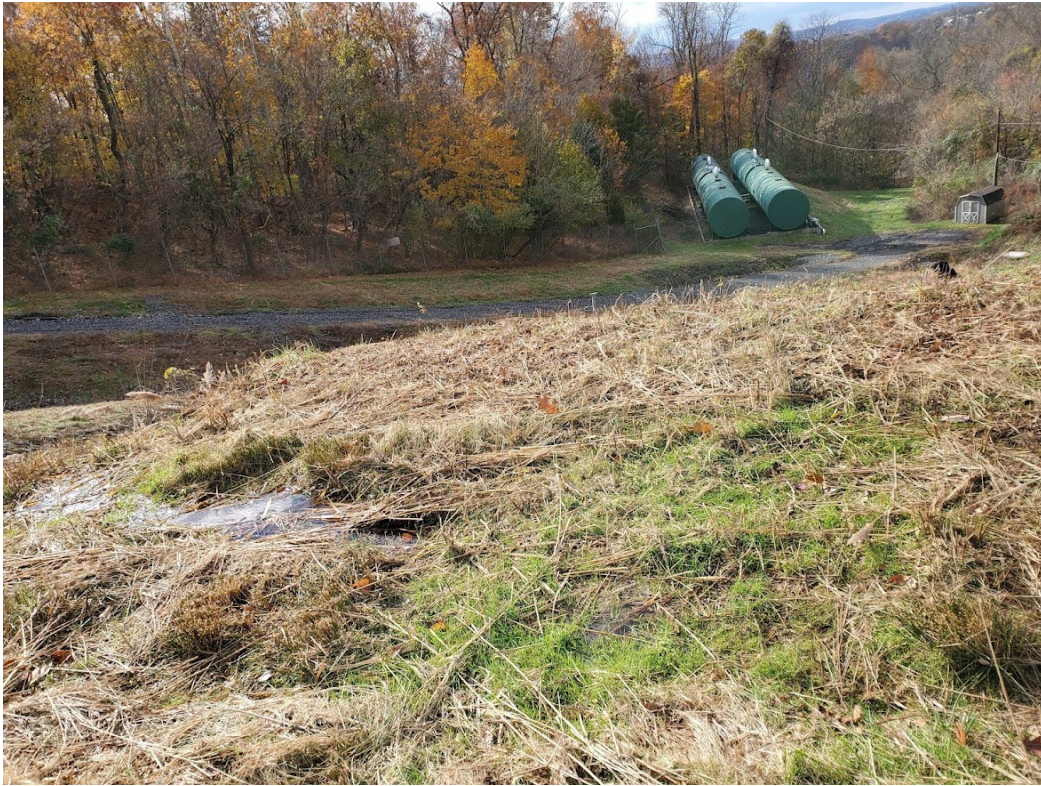
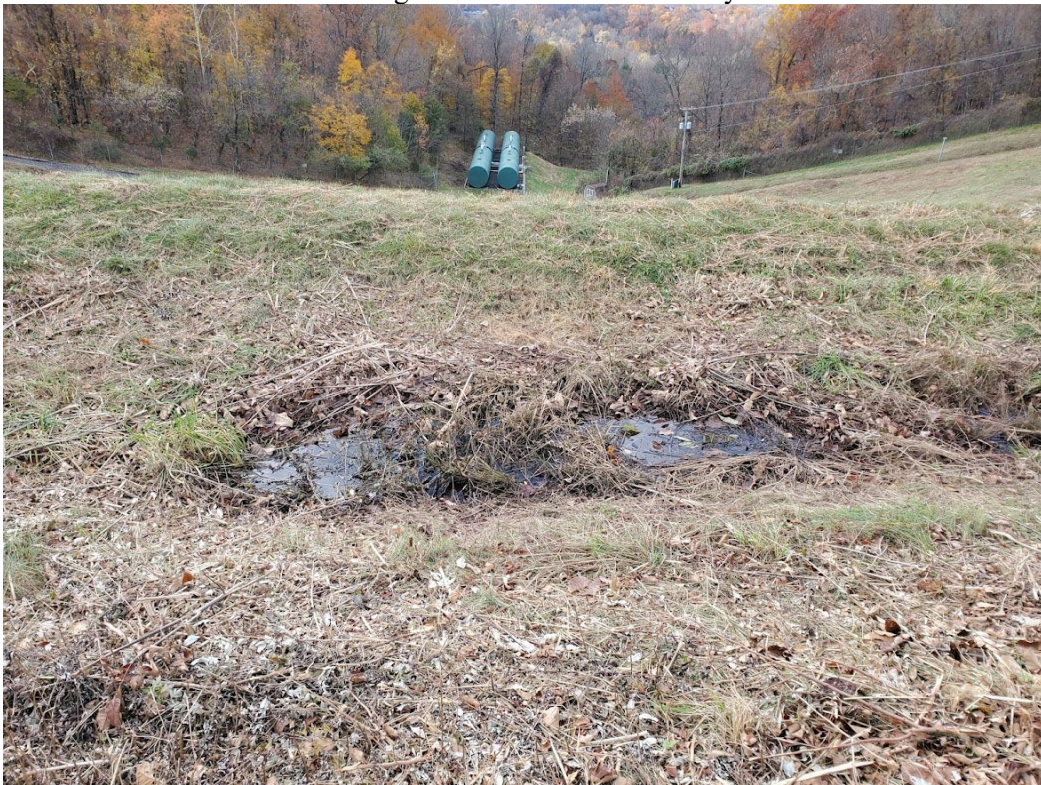
Ponding on benches in South Valley

- Some ponding was observed on South Valley benches. EPA recommends filling in places where vegetation may be sparse to prevent erosion.
- A large gap beneath the fence and ground was observed in South Valley by the tank farm which appeared large enough for a person to crawl beneath. A tire was observed on the other side of fence. EPA recommends adding mesh to seal gap.

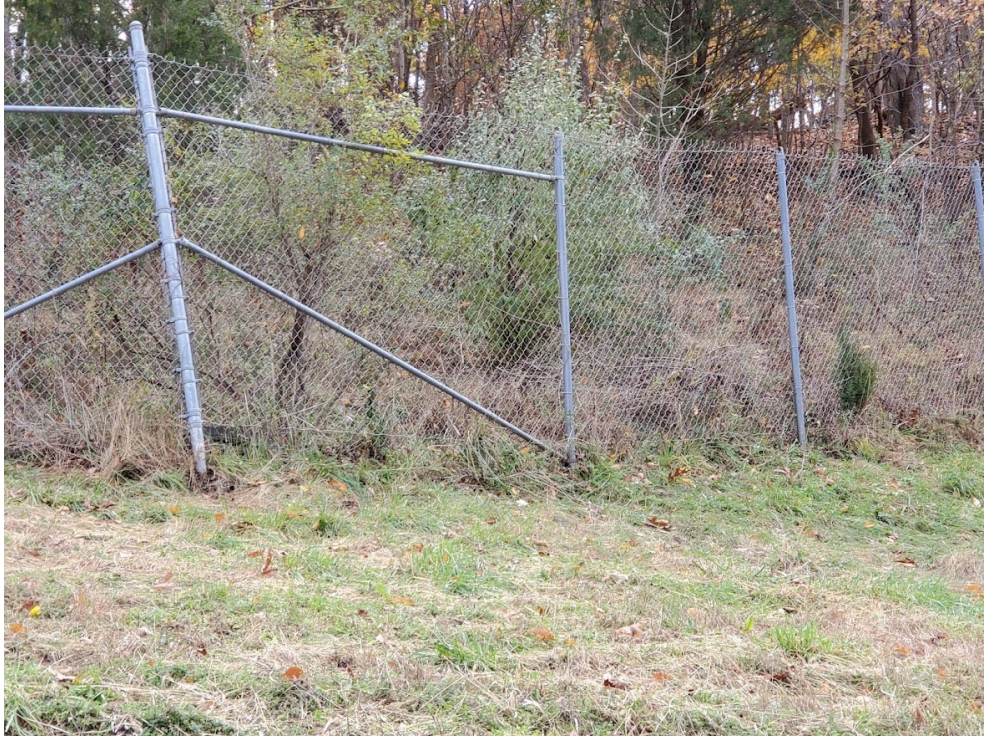
Gap between South Valley fence and ground

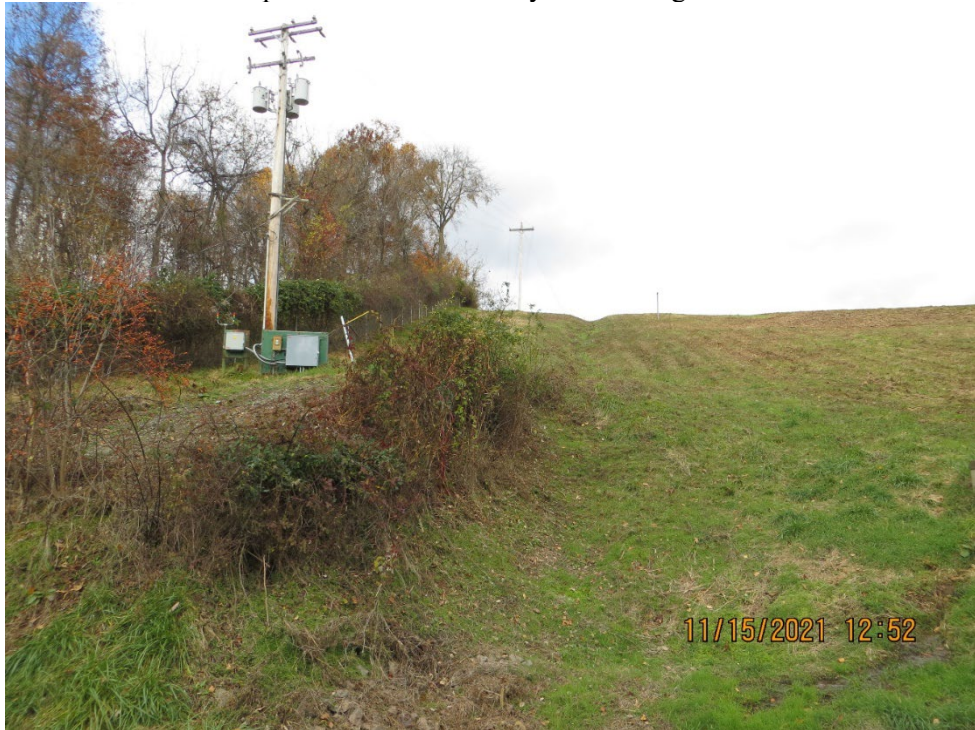
South Valley pump station off

- Leachate discharge overflow was evident due to South Valley Pump Station being off. PADEP's contractor brought the station back to operational status on November 19, 2021. EPA recommends informing owner/O&M workers that they should avoid contact with leachate from the landfill within the South Valley manhole if exposures exceed 50 days/year for 6 hours a day. Additionally, continued monitoring of the area is recommended. If the power to the pump station continues to be unreliable, a secondary containment or back-up power source should be discussed.

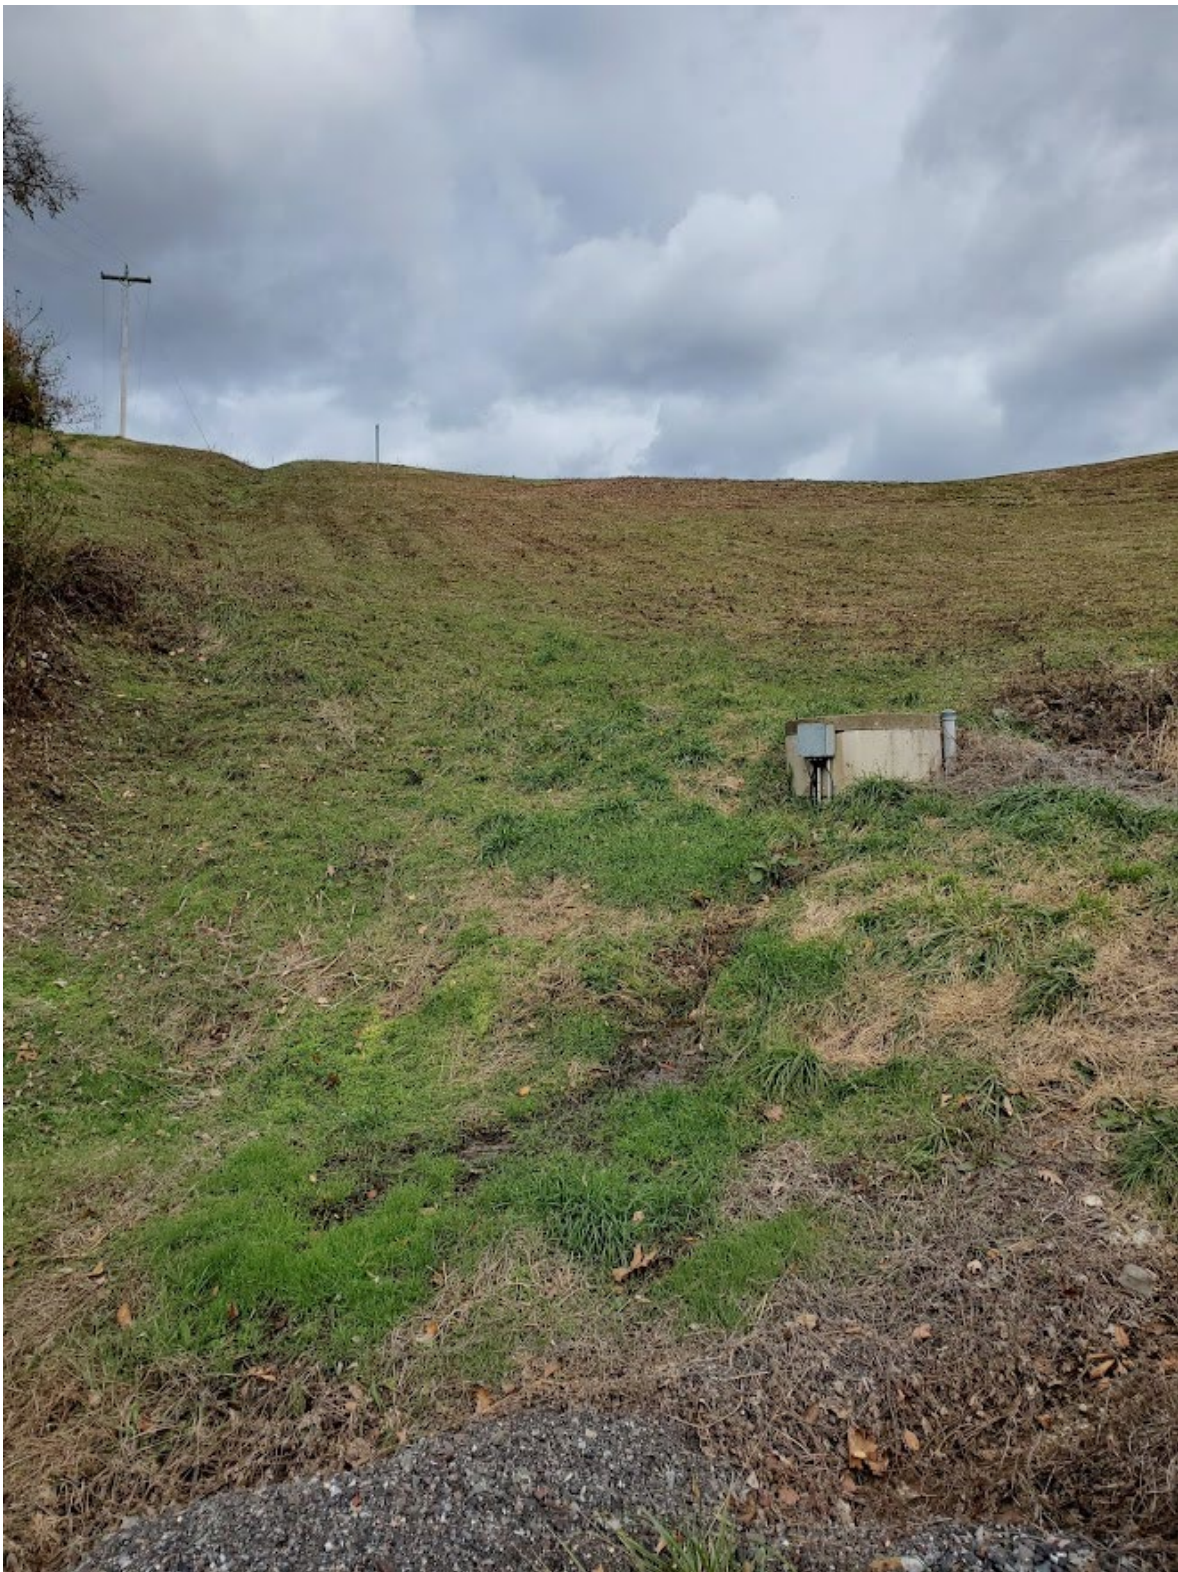
Overflow of leachate discharge from South Valley manhole

I recommend informing the landfill Owner/Grass Cutter/Maintenance Worker be informed he should avoid contact with leachate from the landfill within the South Valley Manhole if exposures exceed 50 days/year for 6 hours a day.

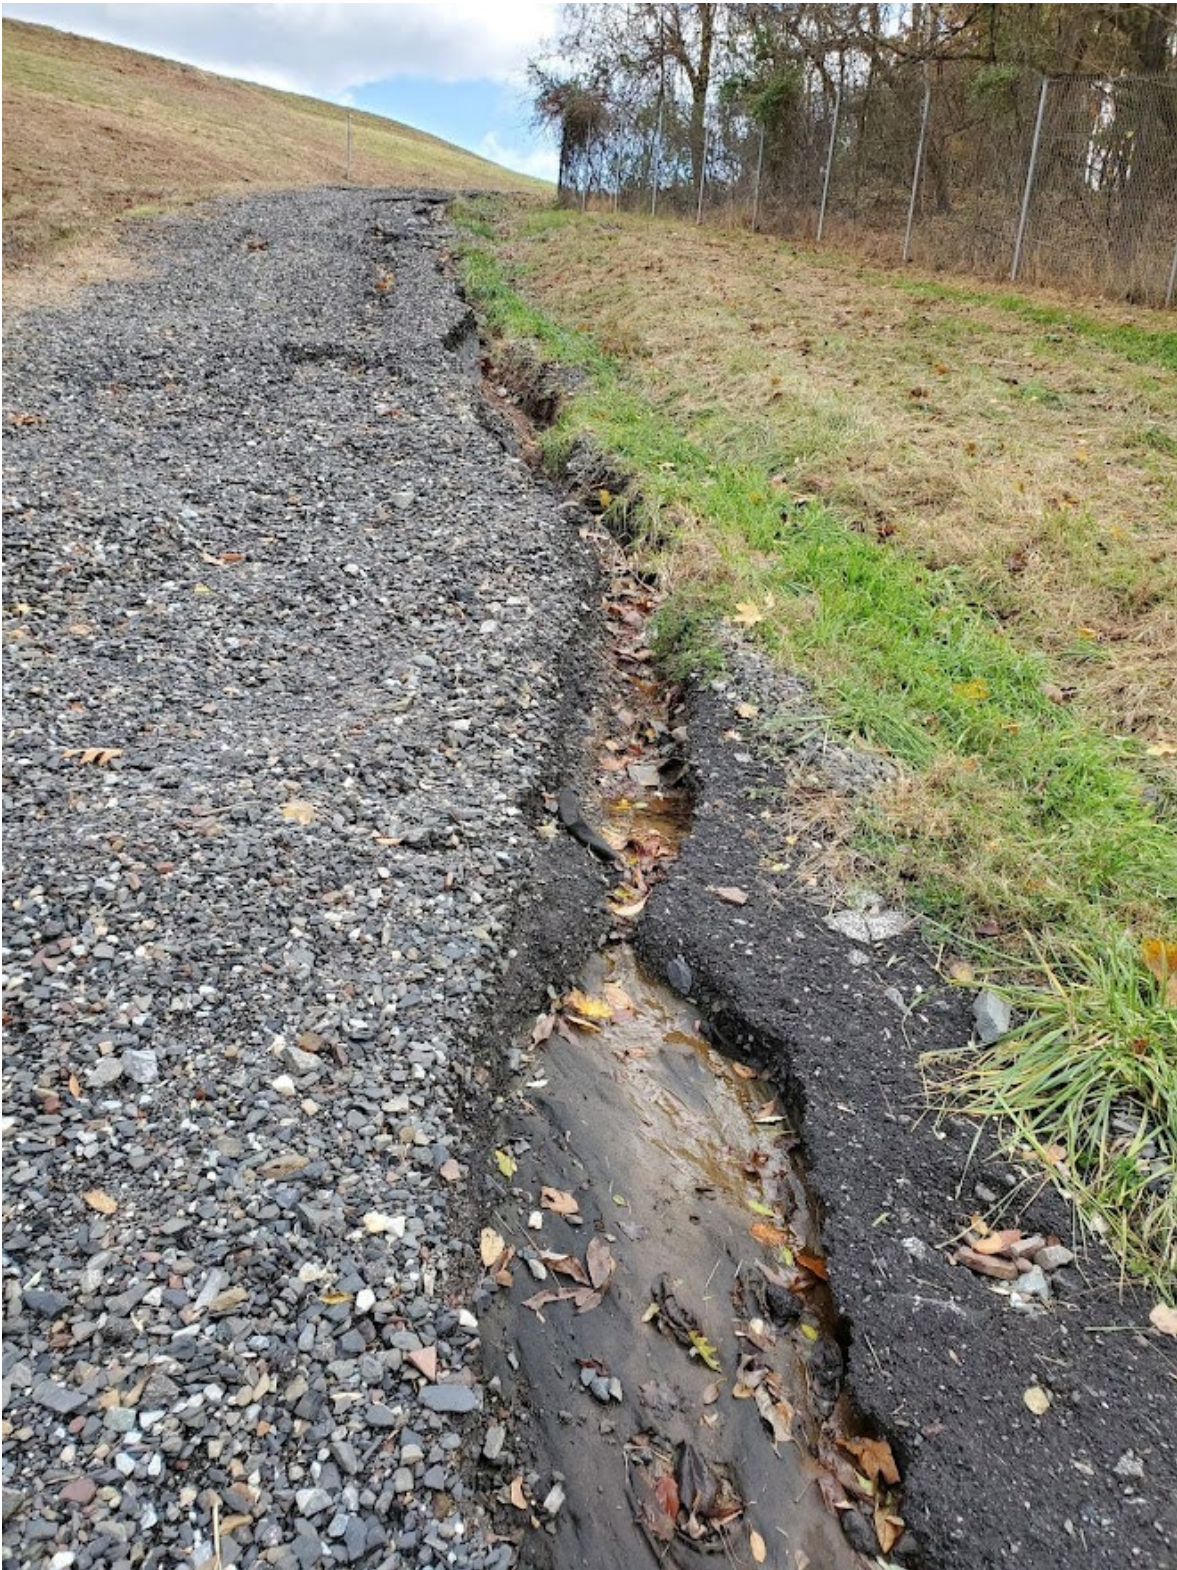
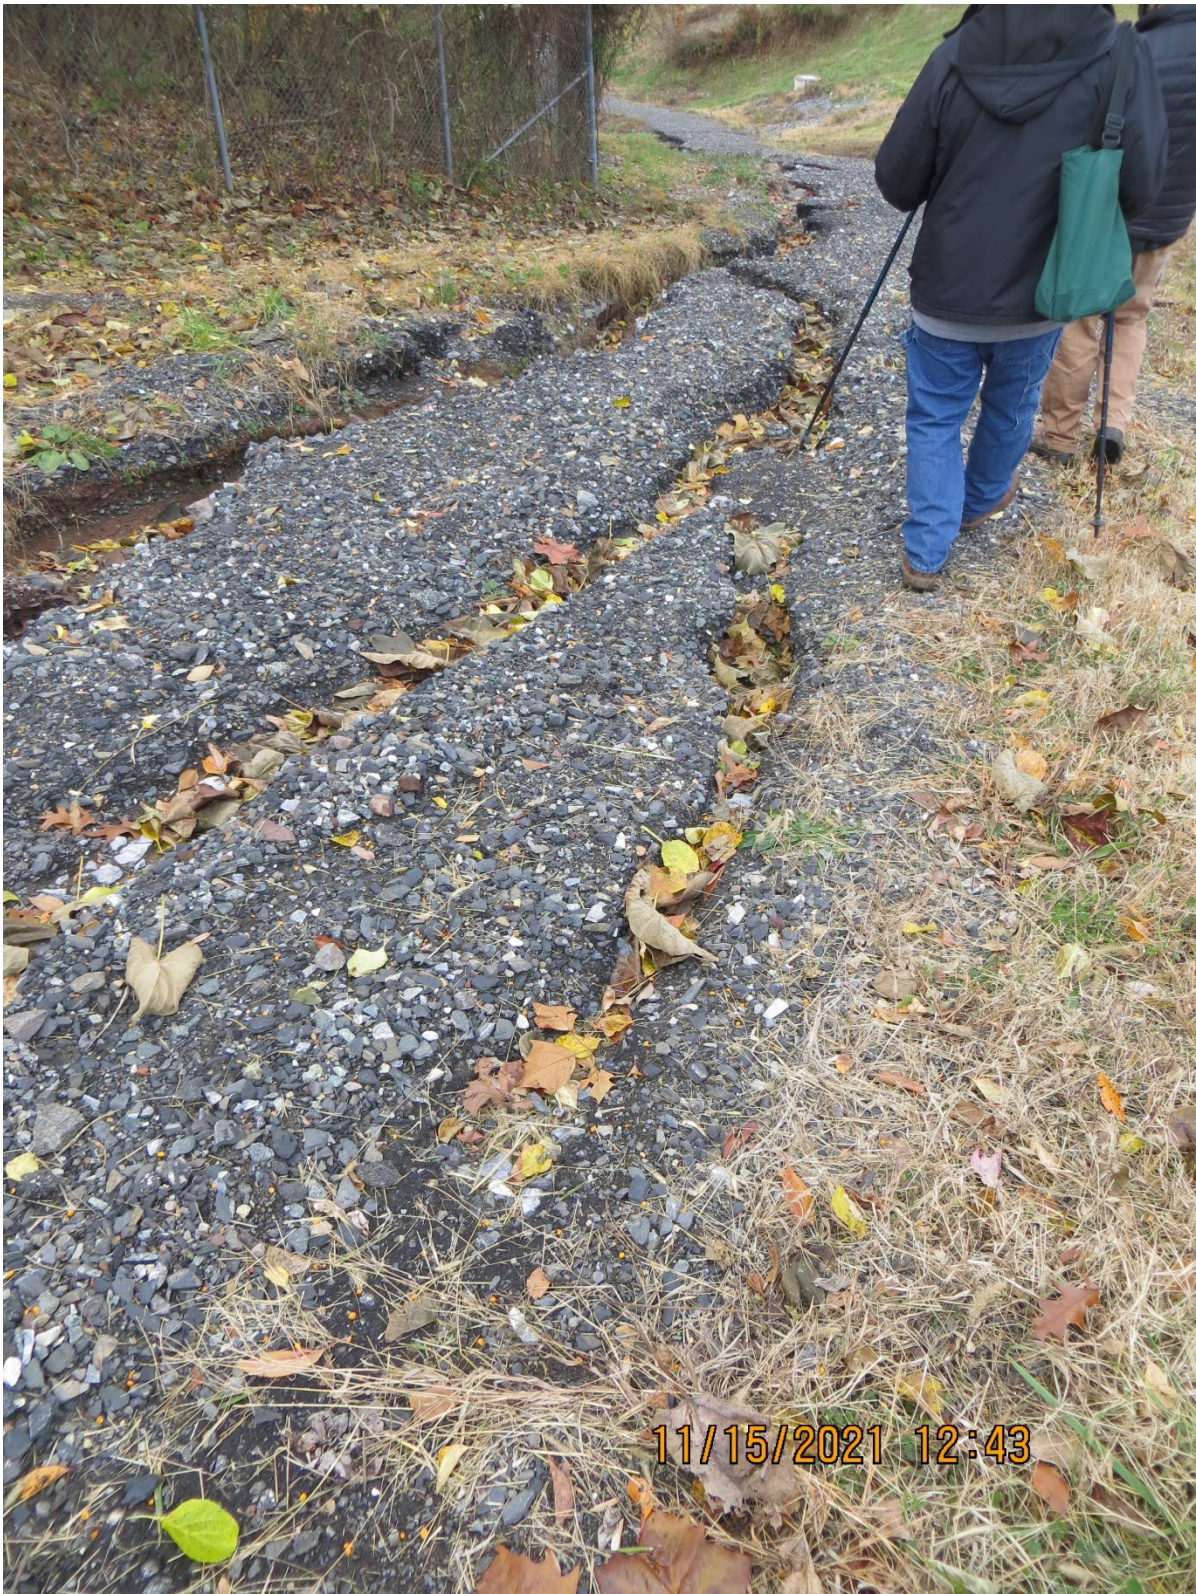
South Valley access road erosion

- A large dead tree was observed swaying in the wind just along the fence on the East side. EPA recommends removing to prevent potential fence damage.
- Extensive erosion to South Valley access road was observed. PADEP, was in the process of scheduling their contractor to address the issue.
