**FIVE-YEAR REVIEW REPORT FOR
ICG ISELIN RAILROAD YARD SUPERFUND SITE
JACKSON, MADISON COUNTY, TN**

Prepared by
Tennessee Department of Environment and Conservation, Division of Remediation,
Jackson Environmental Field Office

Prepared for
U.S. Environmental Protection Agency
Region 4
Atlanta, GA

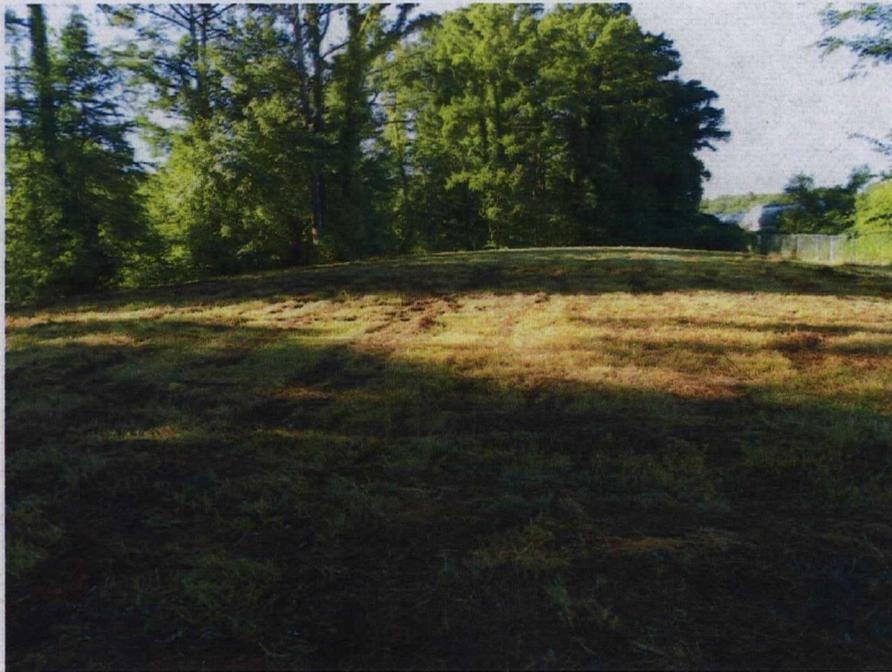
Picture 1

Date of Photo: July 16, 2014. Photo taken by Kevin Smith. Location/Site Name: ICG Iselin Railroad Yard Superfund Site (57-513). TDEC Personnel Present: Kevin Smith (TDoR-JFO). Remarks: Picture is of recently mowed rail tie clay cap area. Picture was taken standing at north end of the rail tie clay cap facing south.

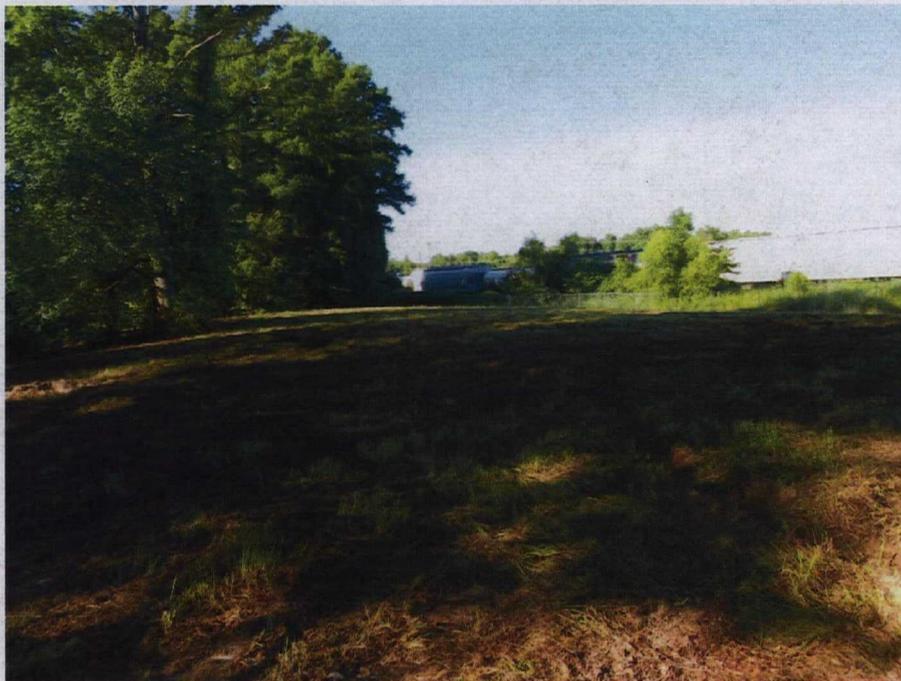
Picture 2

Date of Photo: July 16, 2014. Photo taken by Kevin Smith. Location/Site Name: ICG Iselin Railroad Yard Superfund Site (57-513). TDEC Personnel Present: Kevin Smith (TDoR-JFO). Remarks: Picture is of rail tie clay cap area. Notice ruts. Picture was taken standing at northeast end of the rail tie clay cap area facing southwest.

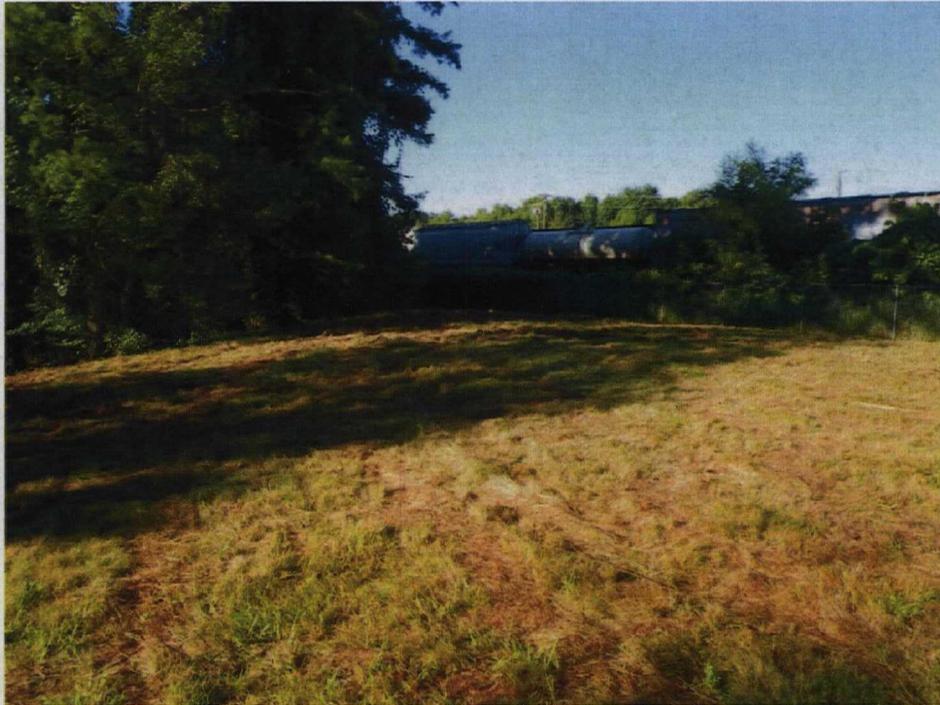
Picture 3

Date of Photo: July 16, 2014. Photo taken by Kevin Smith. Location/Site Name: ICG Iselin Railroad Yard Superfund Site (57-513). TDEC Personnel Present: Kevin Smith (TDOR-JFO). Remarks: Picture is of center portion of the rail tie clay cap area. Picture was taken facing southwest.

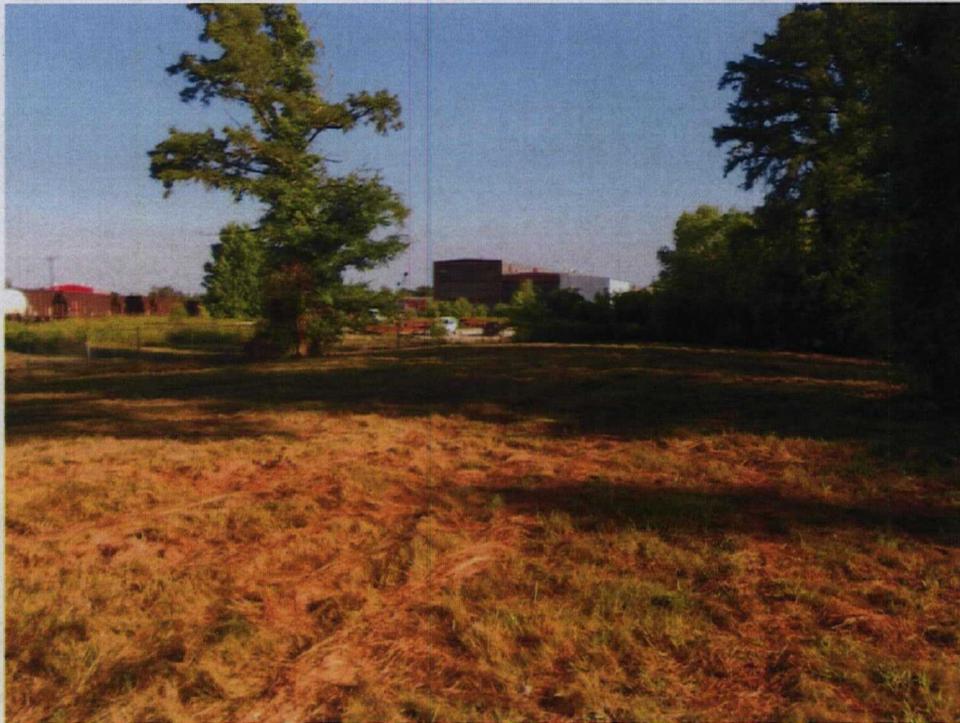
Picture 4

Date of Photo: July 16, 2014. Photo taken by Kevin Smith. Location/Site Name: ICG Iselin Railroad Yard Superfund Site (57-513). TDEC Personnel Present: Kevin Smith (TDOR-JFO). Remarks: Picture is of the rail tie clay cap area. Picture was taken standing on the southeast portion of the rail tie clay cap facing northwest.

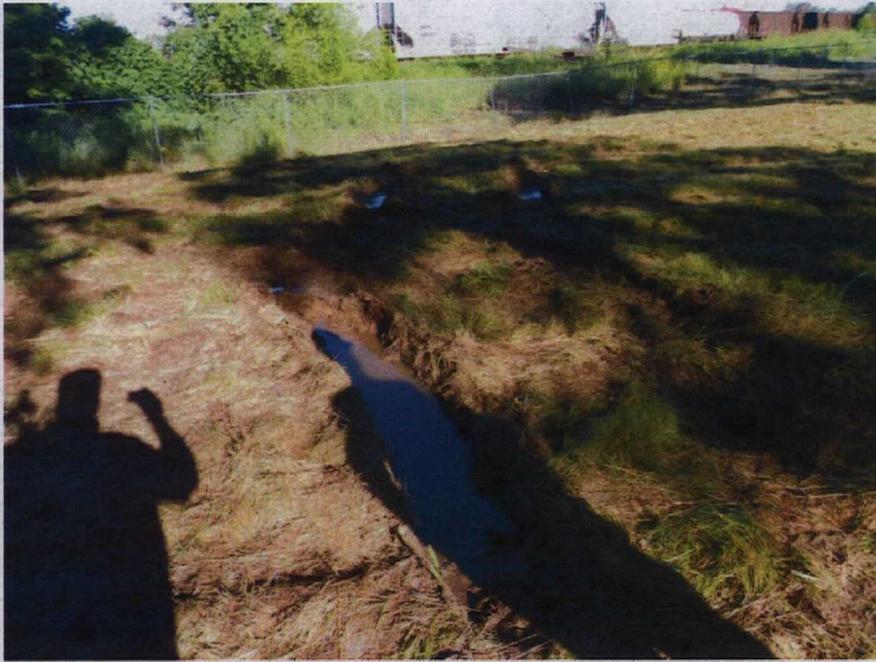
Picture 5

Date of Photo: July 16, 2014. Photo taken by Kevin Smith. Location/Site Name: ICG Iselin Railroad Yard Superfund Site (57-513). TDEC Personnel Present: Kevin Smith (TDOR-JFO). Remarks: Picture is of ruts left from contractor when mowing the rail tie clay cap area. Ruts were located on the southern portion of the rail tie clay cap area. Picture was taken standing on east side of capped area facing west.

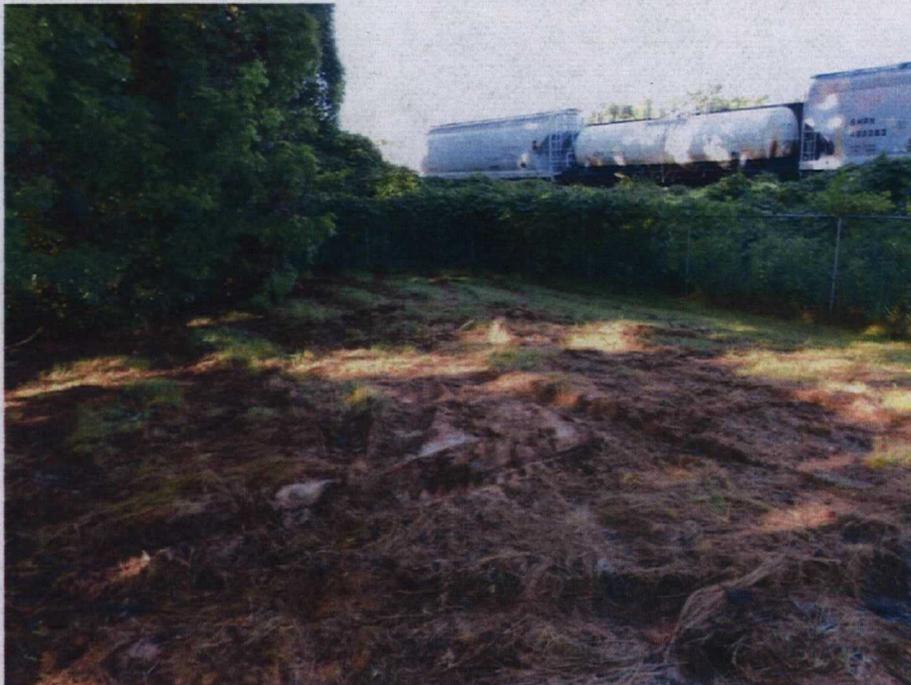
Picture 6

Date of Photo: July 16, 2014. Photo taken by Kevin Smith. Location/Site Name: ICG Iselin Railroad Yard Superfund Site (57-513). TDEC Personnel Present: Kevin Smith (TDOR-JFO). Remarks: Picture is of southwest corner of the rail tie clay cap area. Picture was taken facing southwest.

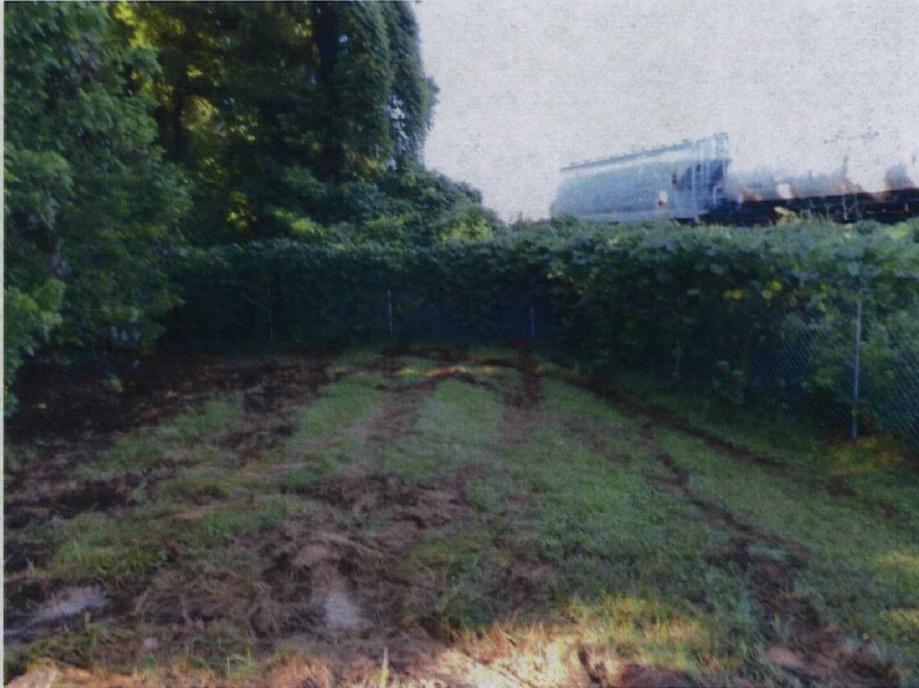
Picture 7

Date of Photo: July 16, 2014. Photo taken by Kevin Smith. Location/Site Name: ICG Iselin Railroad Yard Superfund Site (57-513). TDEC Personnel Present: Kevin Smith (TDOR-JFO). Remarks: Picture is of southwest corner of the rail tie clay cap area. Picture was taken facing south.

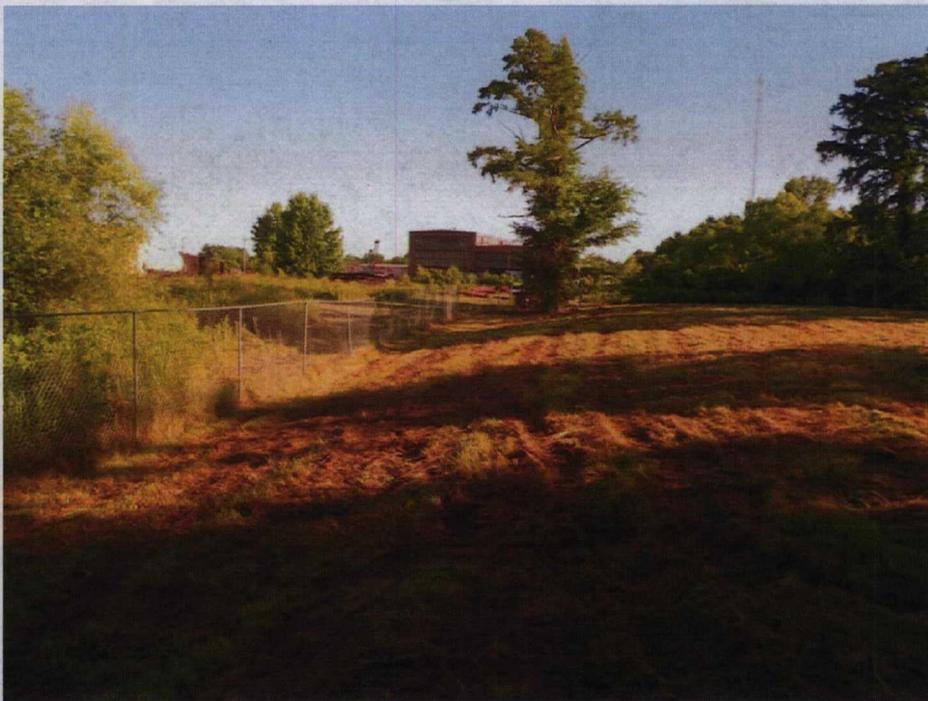
Picture 8

Date of Photo: July 16, 2014. Photo taken by Kevin Smith. Location/Site Name: ICG Iselin Railroad Yard Superfund Site (57-513). TDEC Personnel Present: Kevin Smith (TDOR-JFO). Remarks: Picture is of rail tie clay cap area. Picture was taken from the southwest corner of the rail tie clay cap area facing north.

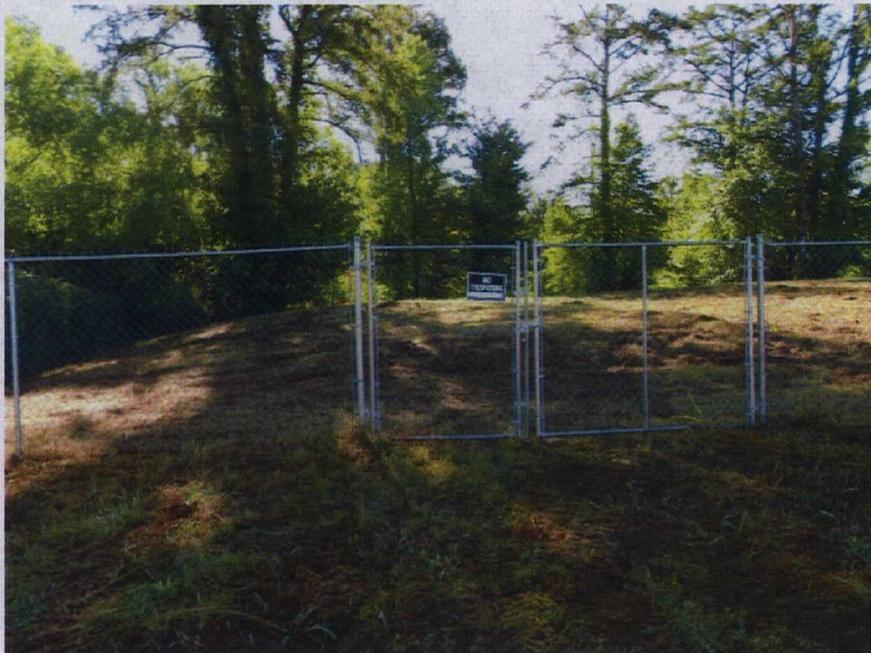
Picture 10

Date of Photo: July 16, 2014. Photo taken by Kevin Smith. Location/Site Name: ICG Iselin Railroad Yard Superfund Site (57-513). TDEC Personnel Present: Kevin Smith (TDOR-JFO). Remarks: Picture is of entrance to the rail tie clay cap area. This entrance is located on northwest side of the rail tie clay cap area.

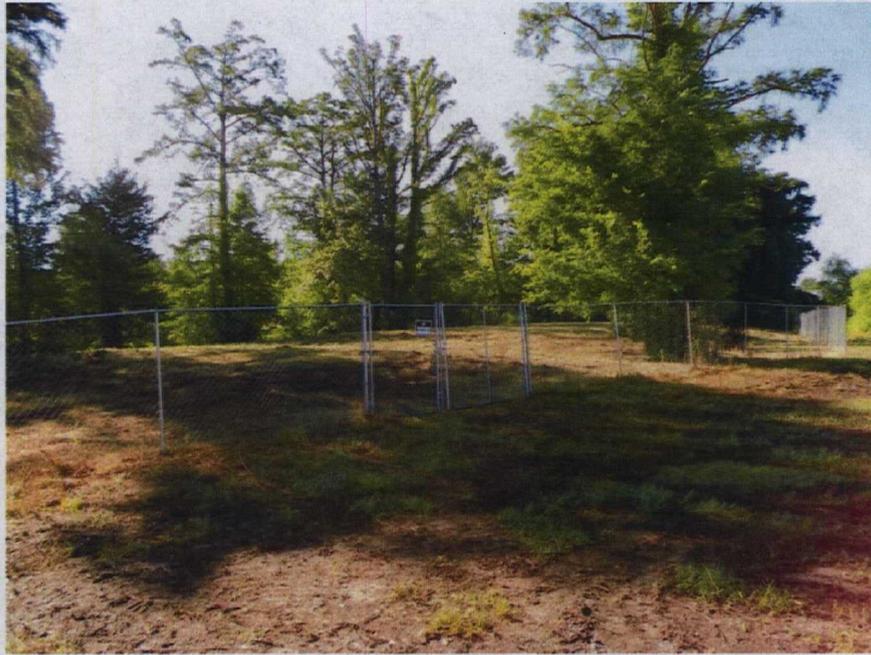
Picture 11

Date of Photo: July 16, 2014. Photo taken by Kevin Smith. Location/Site Name: ICG Iselin Railroad Yard Superfund Site (57-513). TDEC Personnel Present: Kevin Smith (TDOR-JFO). Remarks: Picture was taken standing outside of the rail tie clay cap area facing southeast. Chain-link fence appeared to be in good condition.

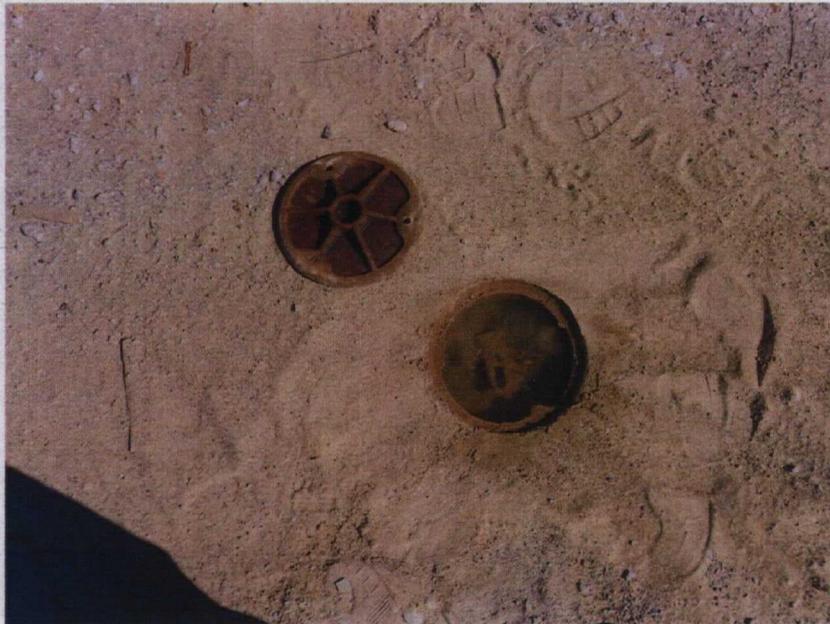
Picture 14

Date of Photo: July 16, 2014. Photo taken by Kevin Smith. Location/Site Name: ICG Iselin Railroad Yard Superfund Site (57-513). TDEC Personnel Present: Kevin Smith (TDOR-JFO). Remarks: Picture is of IYMW03. The 3 metal pieces inside the casing, which the steel plate cover bolts to, have broken off.

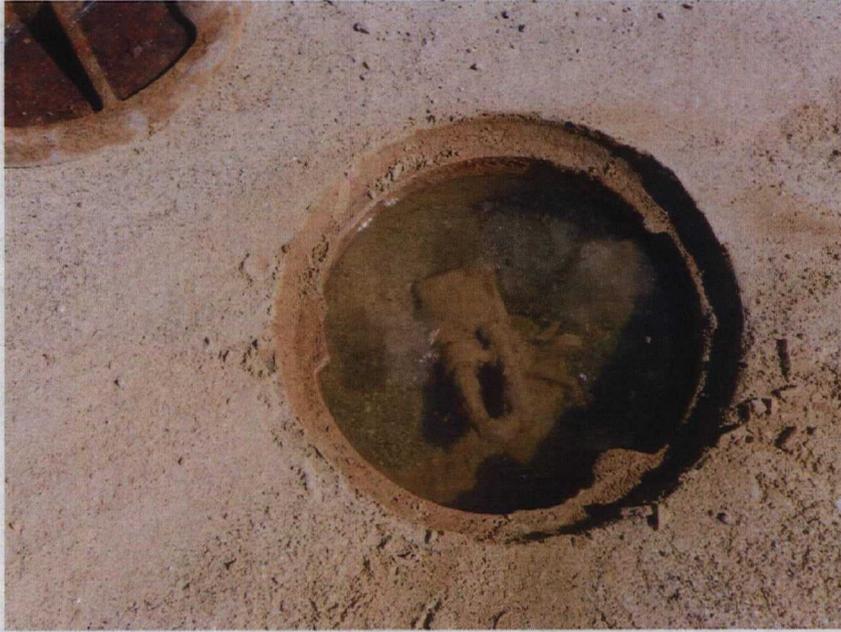
Picture 15

Date of Photo: July 16, 2014. Photo taken by Kevin Smith. Location/Site Name: ICG Iselin Railroad Yard Superfund Site (57-513). TDEC Personnel Present: Kevin Smith (TDOR-JFO). Remarks: Picture is of IYMW03. The 3 metal pieces inside the casing, which the steel plate cover bolts to, have broken off.

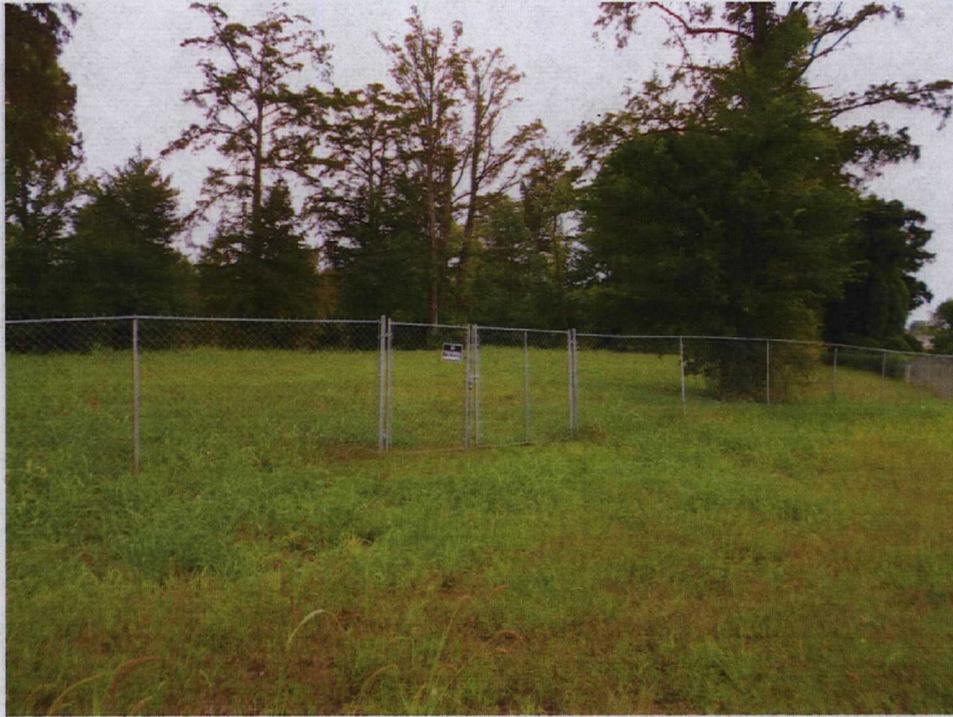
Picture 1

Date of Photo: September 16, 2014. Photo taken by Kevin Smith. Location/Site Name: ICG Iselin Railroad Yard Superfund Site (57-513). TDEC Personnel Present: Kevin Smith(TDoR-JFO). Remarks: Picture is of entrance to the capped rail tie area. Gate was secured at the time of TDoR's visit. There is a no trespassing sign located on the gate entrance.

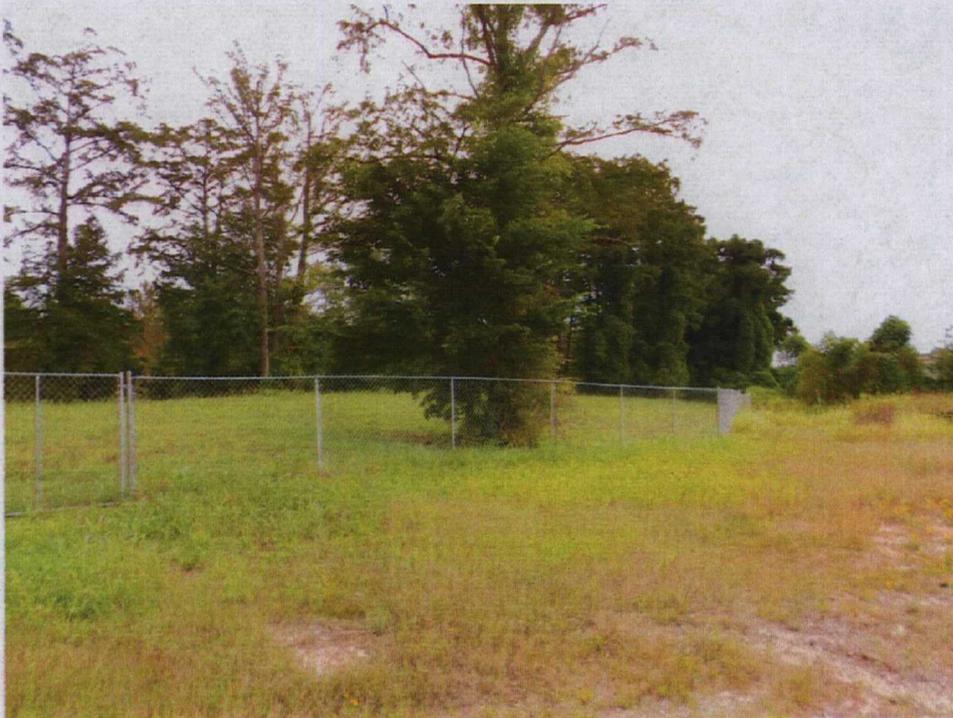
Picture 2

Date of Photo: September 16, 2014. Photo taken by Kevin Smith. Location/Site Name: ICG Iselin Railroad Yard Superfund Site (57-513). TDEC Personnel Present: Kevin Smith(TDoR-JFO). Remarks: Picture is of chain link fence which surrounds the capped rail tie area.

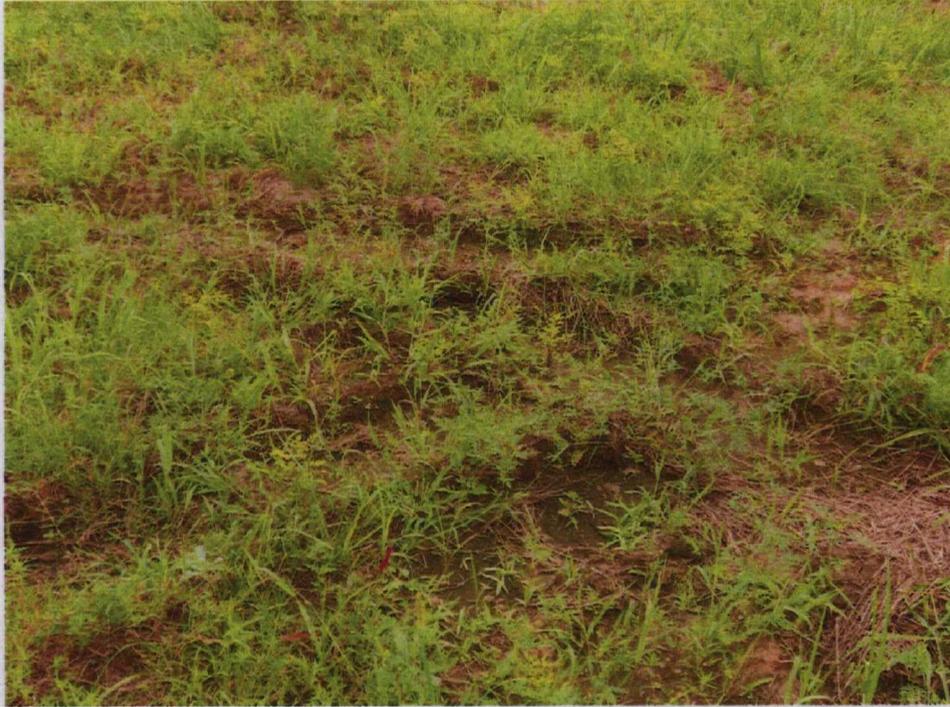
Picture 5

Date of Photo: September 16, 2014. Photo taken by Kevin Smith. Location/Site Name: ICG Iselin Railroad Yard Superfund Site (57-513). TDEC Personnel Present: Kevin Smith(TDoR-JFO). Remarks: Picture is of some minor ruts observed on the north end of the capped rail tie area.

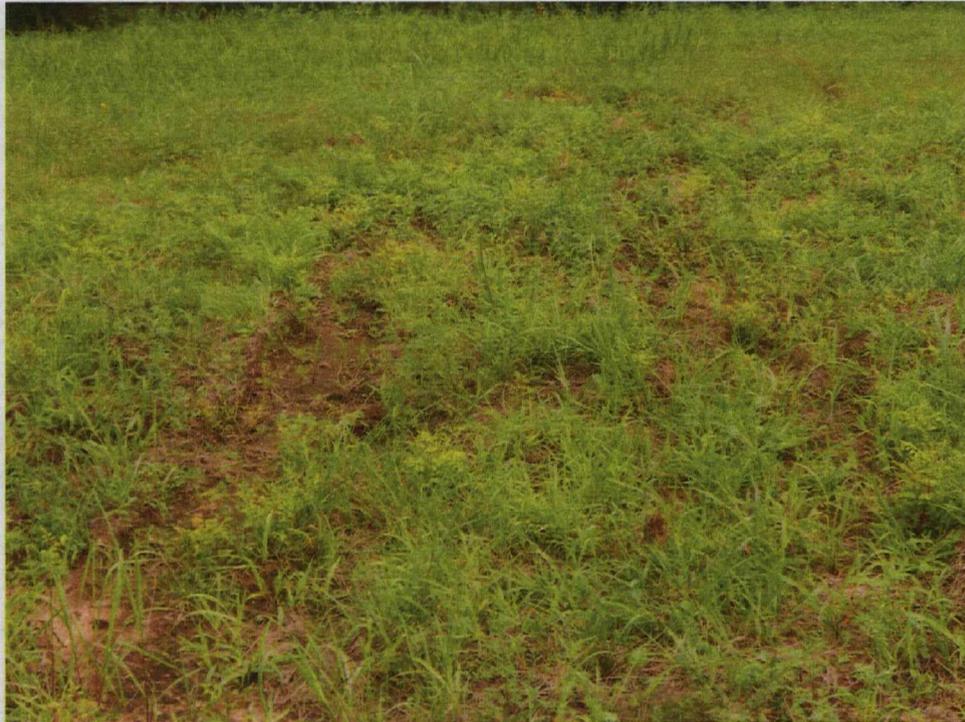
Picture 8

Date of Photo: September 16, 2014. Photo taken by Kevin Smith. Location/Site Name: ICG Iselin Railroad Yard Superfund Site (57-513). TDEC Personnel Present: Kevin Smith(TDoR-JFO). Remarks: Picture is of some minor ruts located on north portion of capped rail tie area.

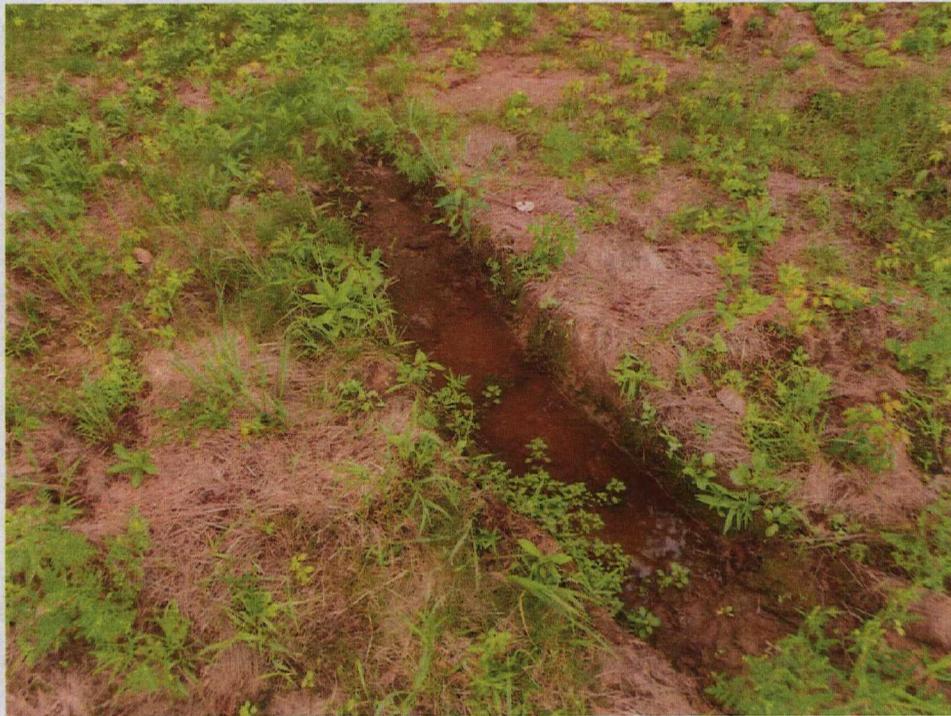
Picture 12

Date of Photo: September 16, 2014. Photo taken by Kevin Smith. Location/Site Name: ICG Iselin Railroad Yard Superfund Site (57-513). TDEC Personnel Present: Kevin Smith(TDoR-JFO). Remarks: Picture is of rut located on southern portion of the capped rail tie area.
