**Fourth Five-Year Review Report
for
Petroleum Products Corporation
FLD980798698**

**Pembroke Park
Broward County, Florida**

December 2015

United States Environmental Protection Agency
Region 4
Atlanta, Georgia

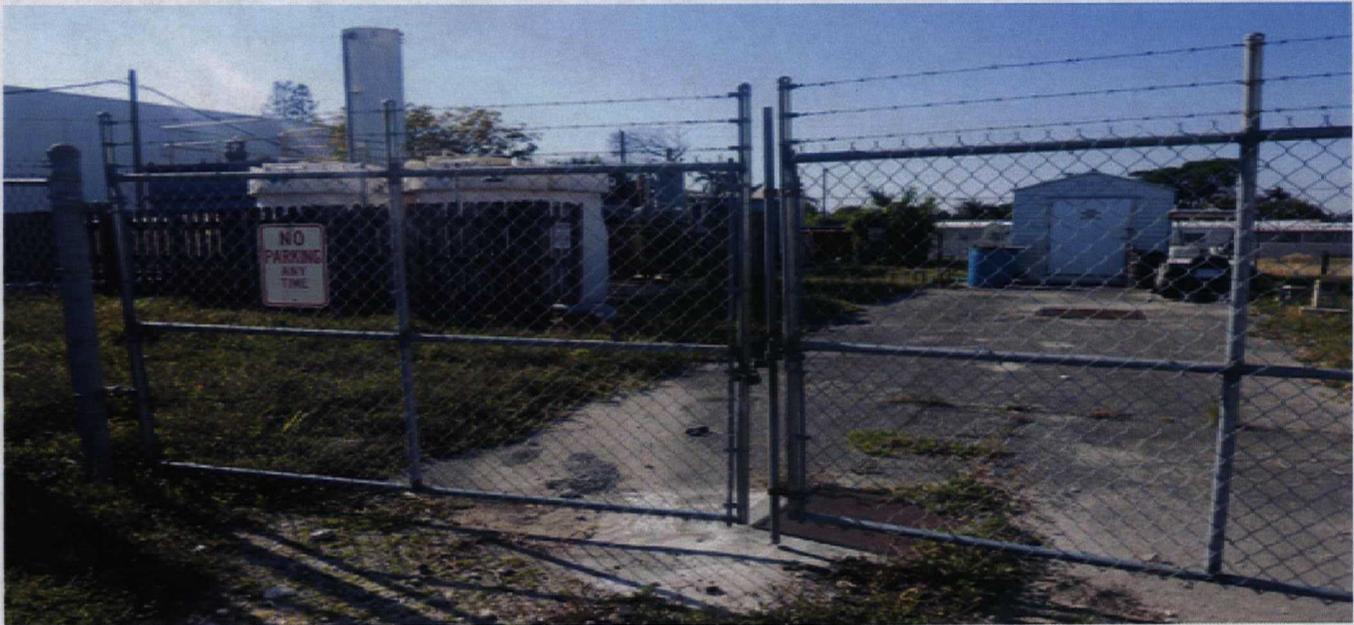
Locked and secured entry gate to the bioslurping unit on the southern end of the Site.

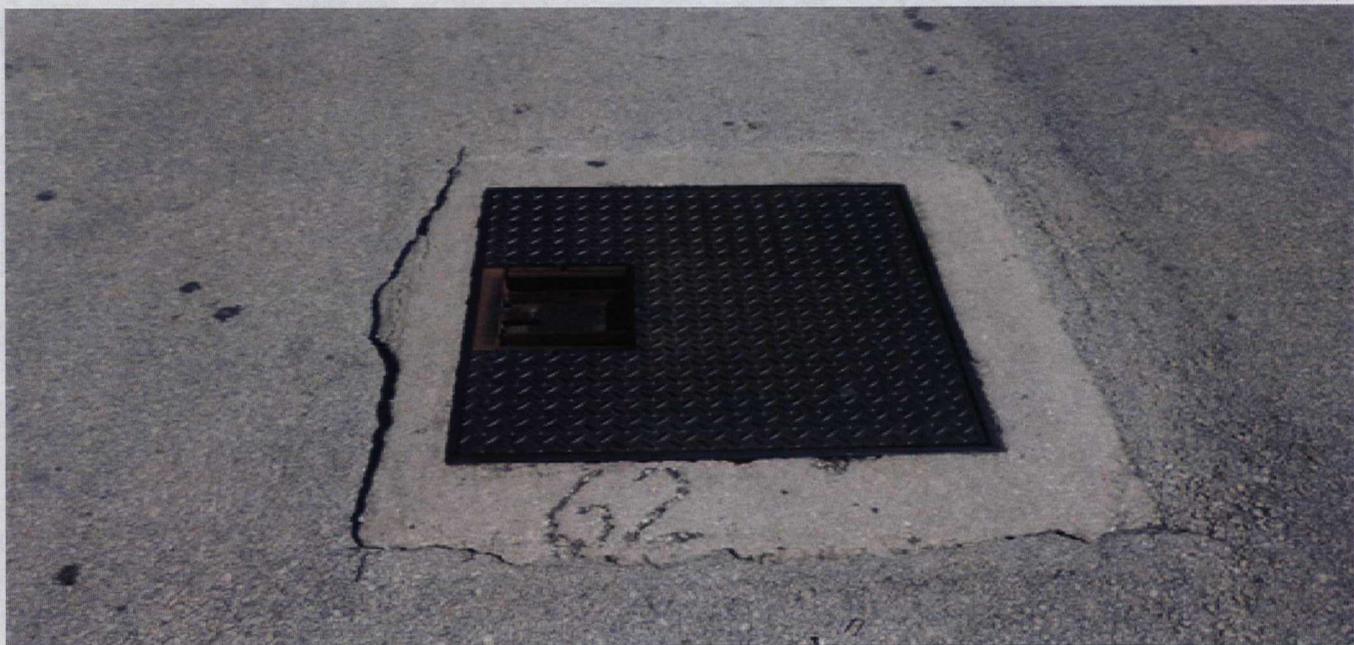
Access point to the bioslurping unit drainage pipes in an alleyway.

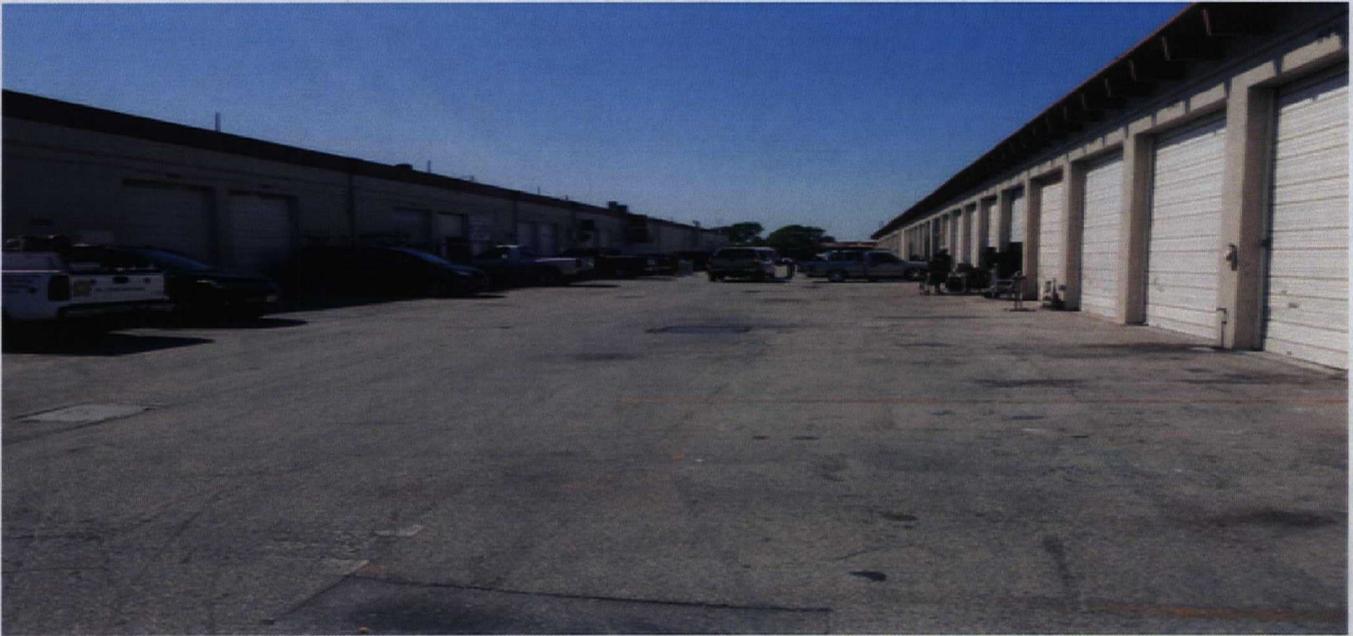
View of the alleyway between warehouse buildings near the source area, facing south, with the bioslurping unit access points and monitoring wells in the middle.

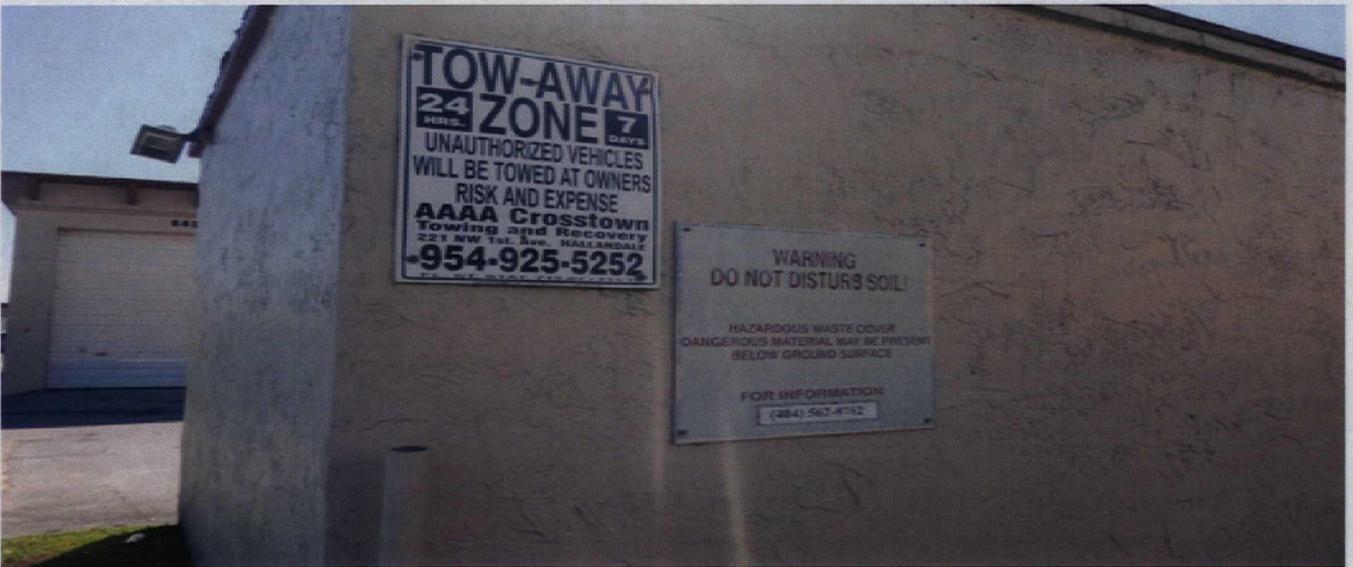
During the FYR site inspection, several signs were missing. It is suspected some of the metal signs were taken for recyclable value. FDEP and the EPA replaced these signs after the site inspection. The signs have been placed around the property warning about potential hazardous substances and providing FDEP and EPA emergency contacts.

Warning sign about disturbing contaminated soils and materials at the Site with emergency contact information.

- The EPA recommends that FDEP or the PRP Group should replace or repair several broken well caps to ensure that no wells remain unsecured.
- The EPA recommends that FDEP should replace several stolen or missing signs that warned tenants and visitors about potential site contamination and listed emergency contact information.

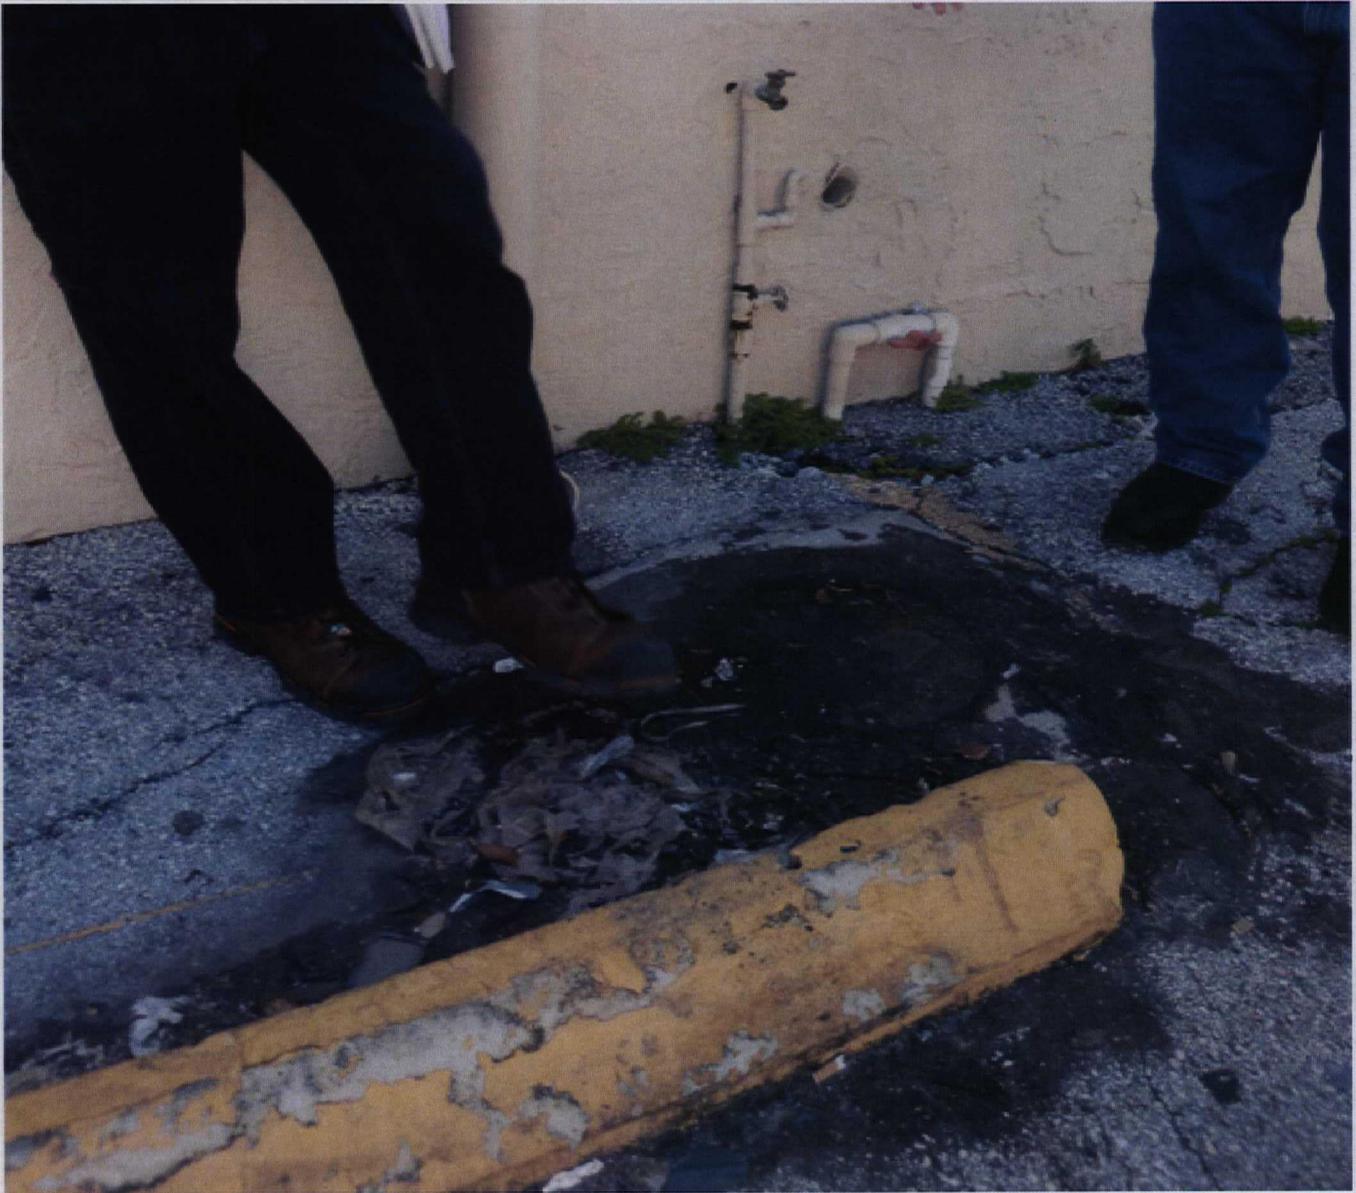
A water spigot mounted on the side of a warehouse building and evidence of an oil seepage at a well.

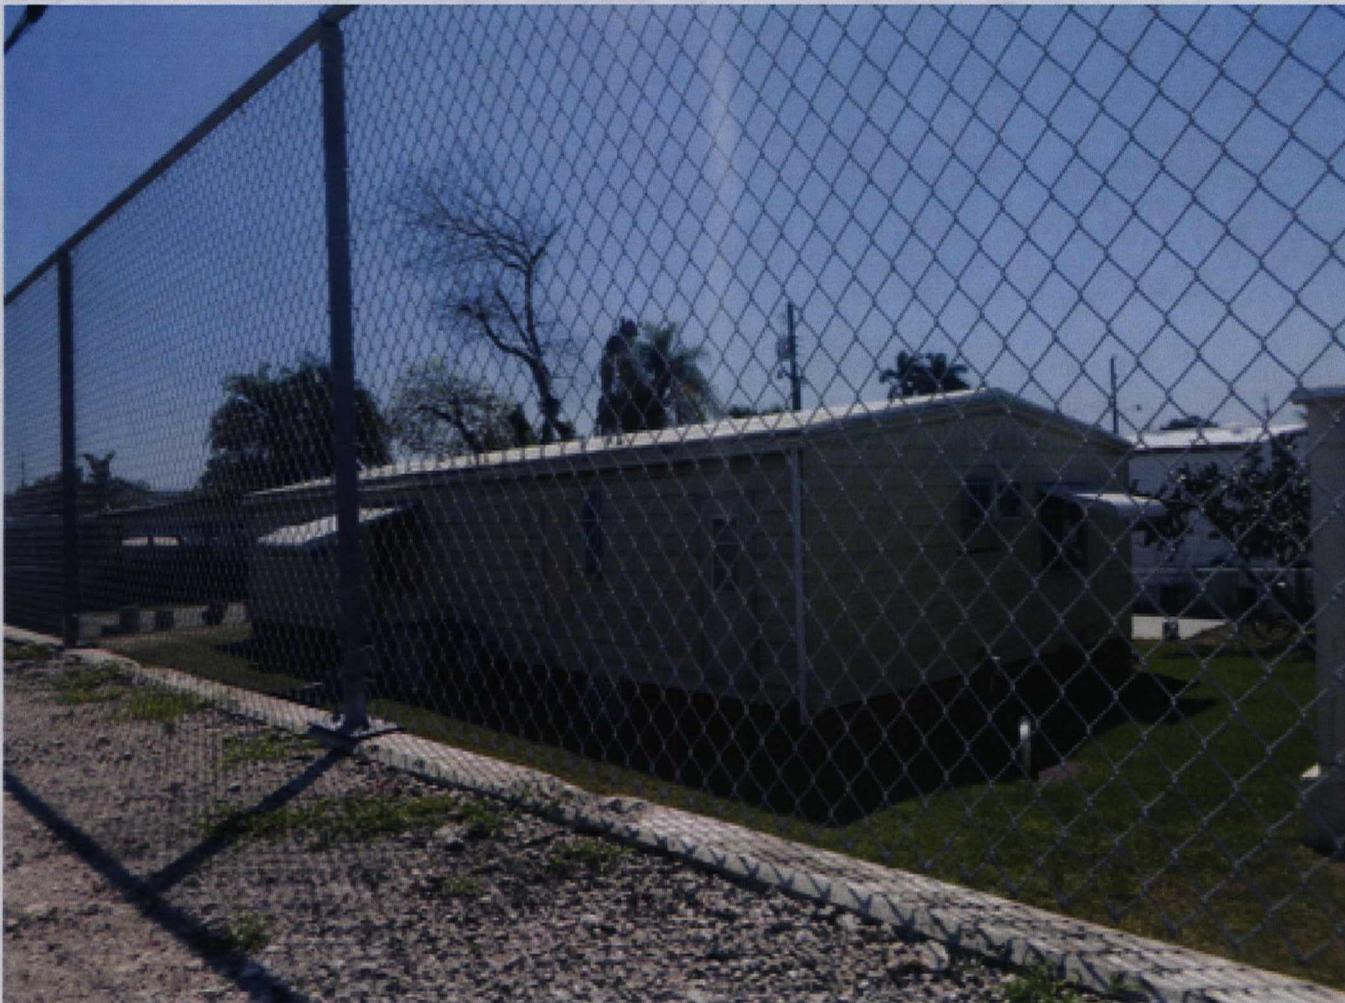
Unoccupied trailer where the EPA conducted a 2011 removal of soil and contaminated sludge.
