**Fourth Five-Year Review Report
for
Florida Steel Corporation
FLD050432251**

**Indiantown
Martin County, Florida**

September 2016

United States Environmental Protection Agency
Region 4
Atlanta, Georgia

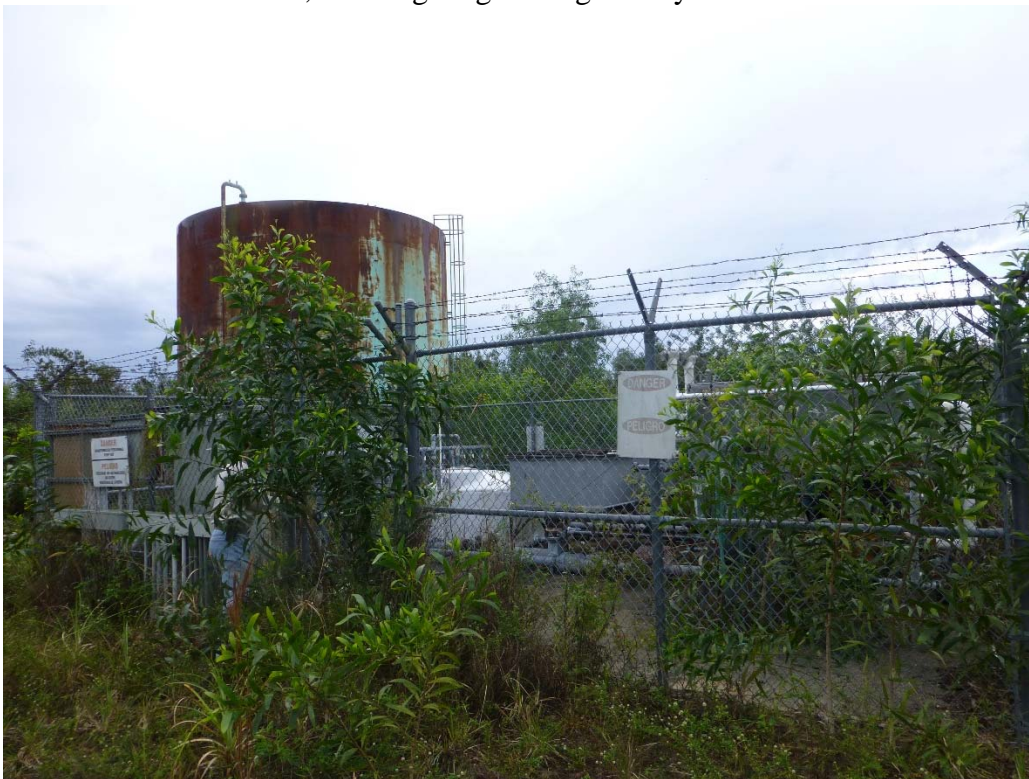
The Site is currently undergoing regular groundwater monitoring. The groundwater remediation system has not been operational since 2009, when it was destroyed by a fire. The groundwater recovery manifold remains fenced on site, but many components appear rusted and the system is not operational. Site inspection participants observed that the tank appeared rusted but is not holding Site water as the system is not in operation.

Groundwater treatment facility and water holding tank

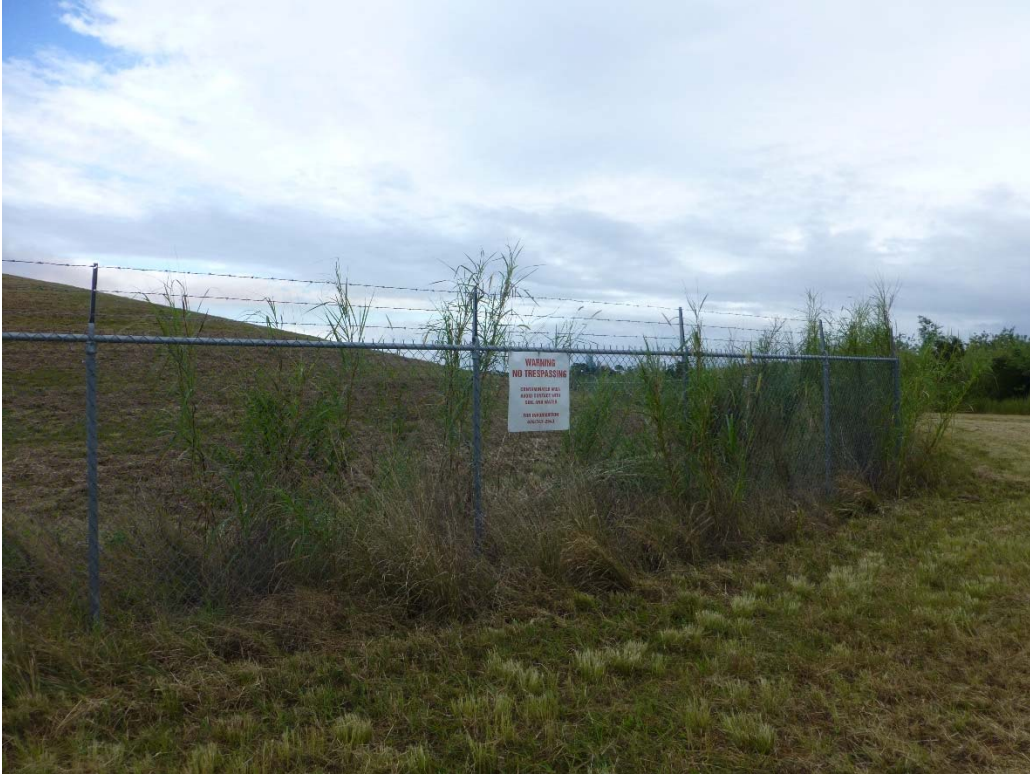
The on-site landfill is surrounded by a chain-link fence and gate, which are secured and in good condition. The fence has warning signs posted along the perimeter. The landfill appeared to be well vegetated; however there appeared to be animal burrows at the top of the landfill that require maintenance. The Site contractor mentioned that leachate collection and leachate detection sump pumps have been dry in the past couple of years and are not actively operating.

Landfill perimeter fencing and signage

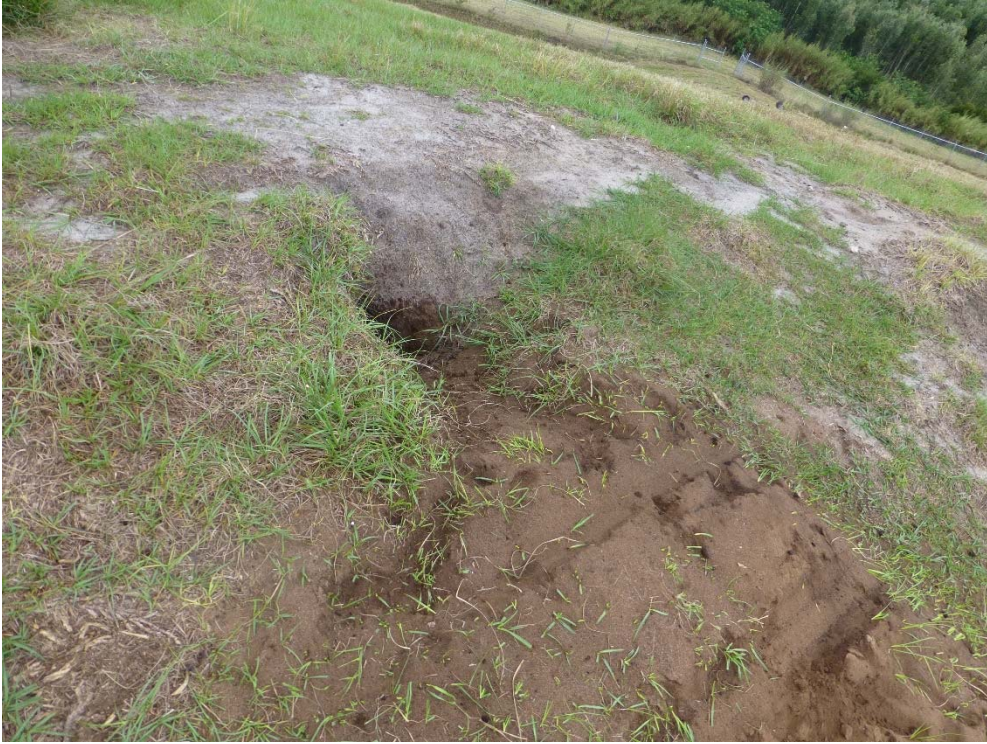
Animal burrow on the top of the landfill

OU1	Issue Category: Operations and Maintenance			
	Issue: There are animal burrows in the capped area.			
	Recommendation: Address animal burrows in cap and relocate sensitive species per state or local law.			
Affect Current Protectiveness	Affect Future Protectiveness	Implementing Party	Oversight Party	Milestone Date
No	Yes	PRP	EPA/State	1/01/2017

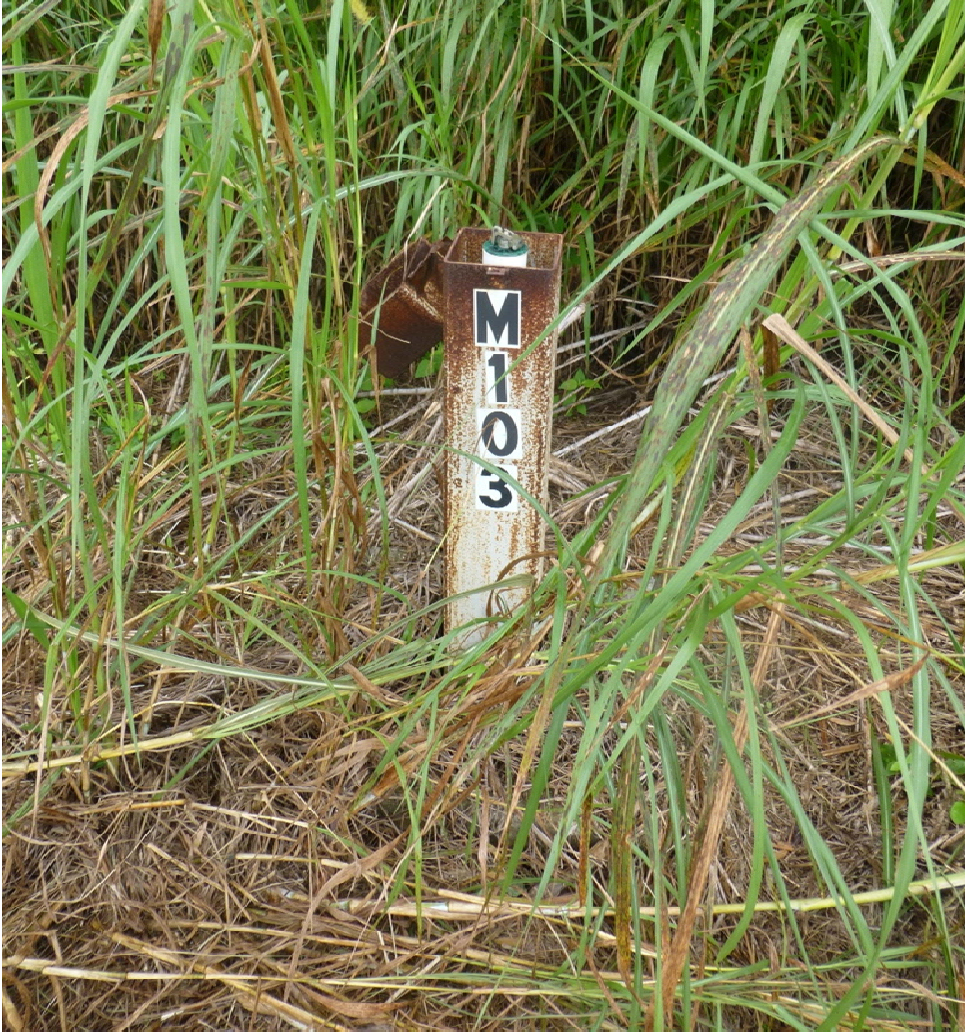
Site inspection participants noted that several monitoring wells were found to be unlocked and in need of re-labeling. Because sitewide perimeter fencing is discontinuous and damaged, it is necessary to secure all wells. The nearby site O&M operator passed away and oversight is now based out of an office further away from the Site. As a result, physical site inspections occur less frequently and less consistently than in years past. However, the Site inspection participants noted that trespassing is no longer a problem since the on-site buildings were demolished in 2015. These demolitions were made to

Unlocked monitoring well, M-103

- The EPA recommends that Gerdau Ameristeel lock, label and secure all site remedial wells by the close of calendar year 2016.
- The EPA recommends that the Site’s full administrative record, including decision documents and the last three FYRs, be sent to the site repository.
- The landfill letdown channels that could not be found during site inspection. The EPA recommends locating channels and removing vegetation overgrowth and obstructions as needed.
- The EPA recommends that Gerdau Ameristeel submit an updated O&M plan to the EPA to document the discontinuation of surface water sampling and OU1 COCs in groundwater.

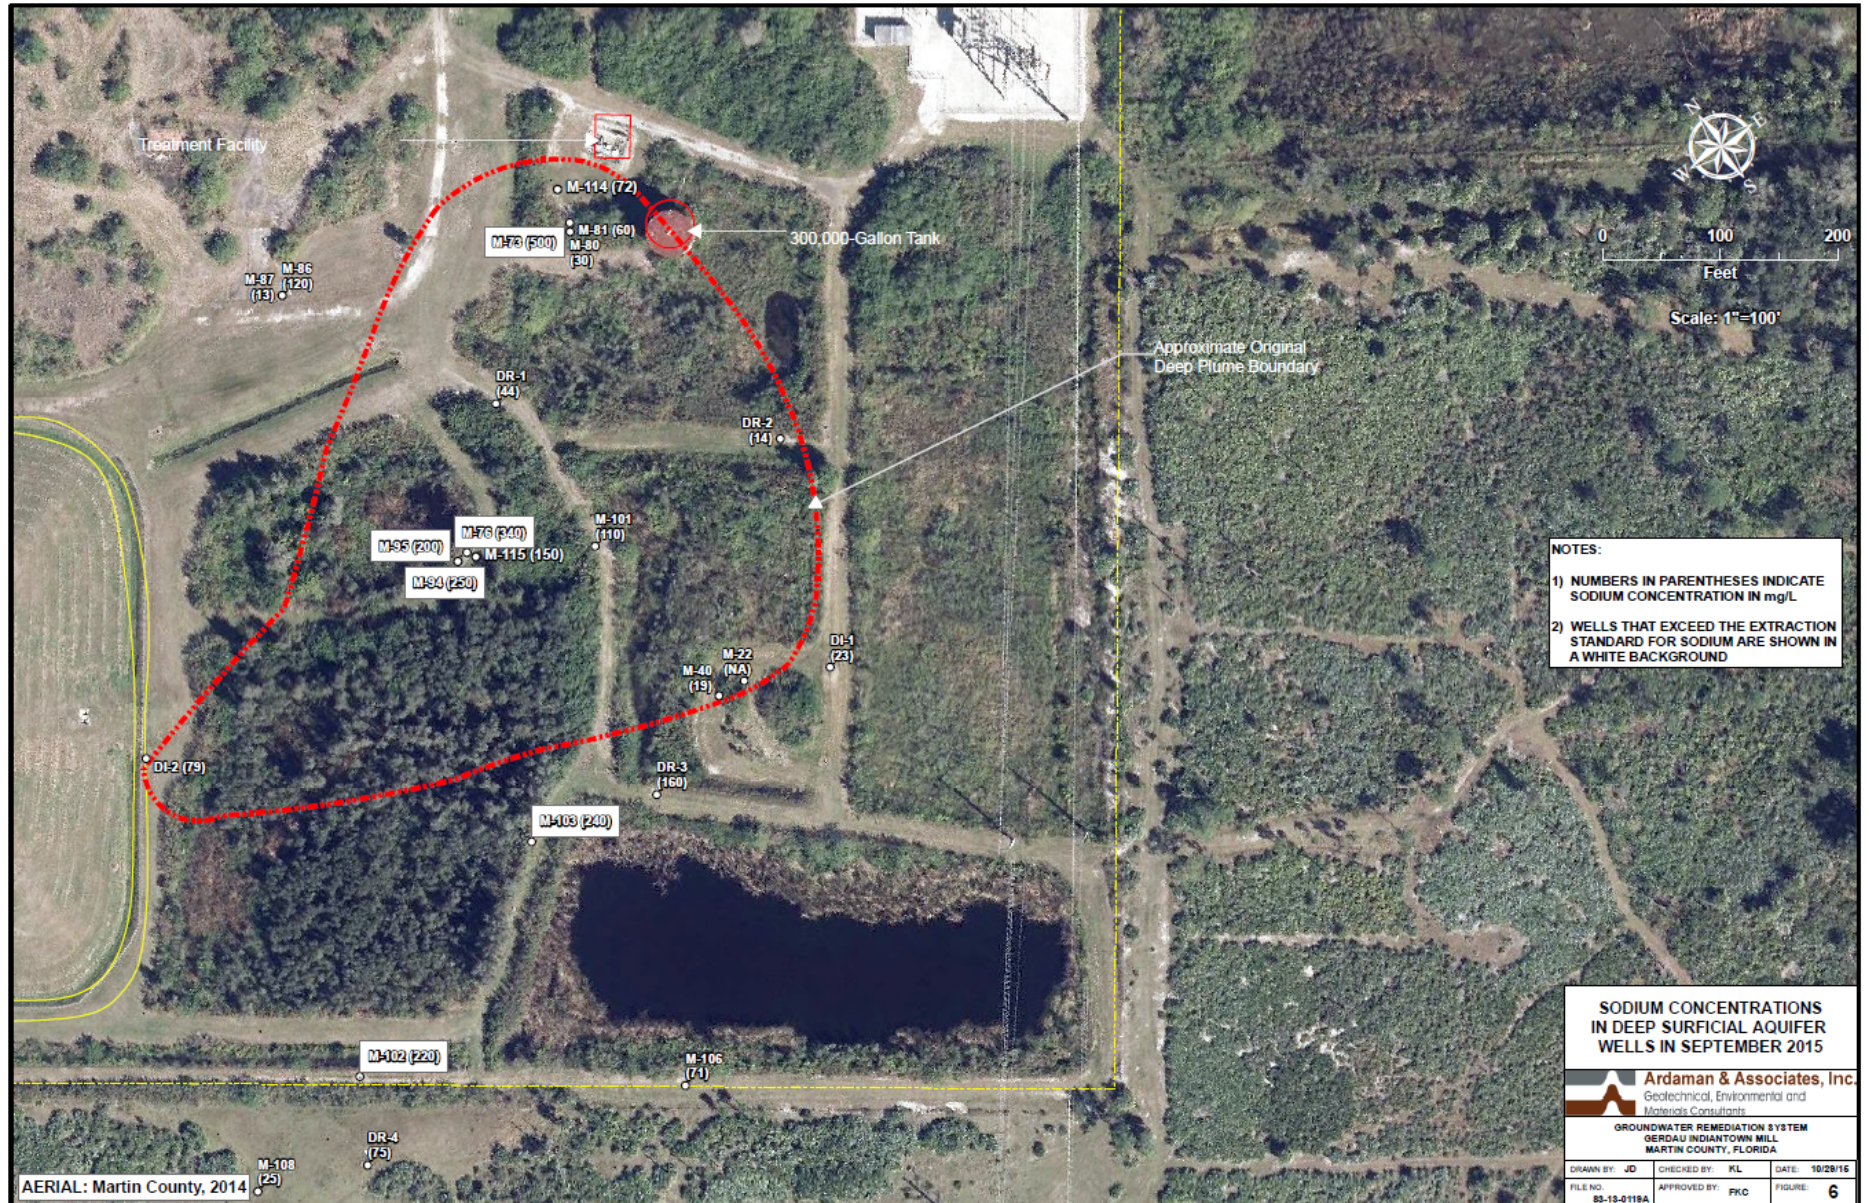
Figure F-2: September 2015 Sodium Concentrations in Deep Aquifer Wells

Sodium concentrations were above the performance standard in recovery well DR-3 twice during this FYR period. Concentrations in 2014 and 2015 ranged from 88 to 160 mg/L. Recovery well DR-1 had concentrations above the radium-226 + radium-228 and gross alpha performance standards during this review period; however concentrations since 2014 have been below the respective performance standards (Table F-3).

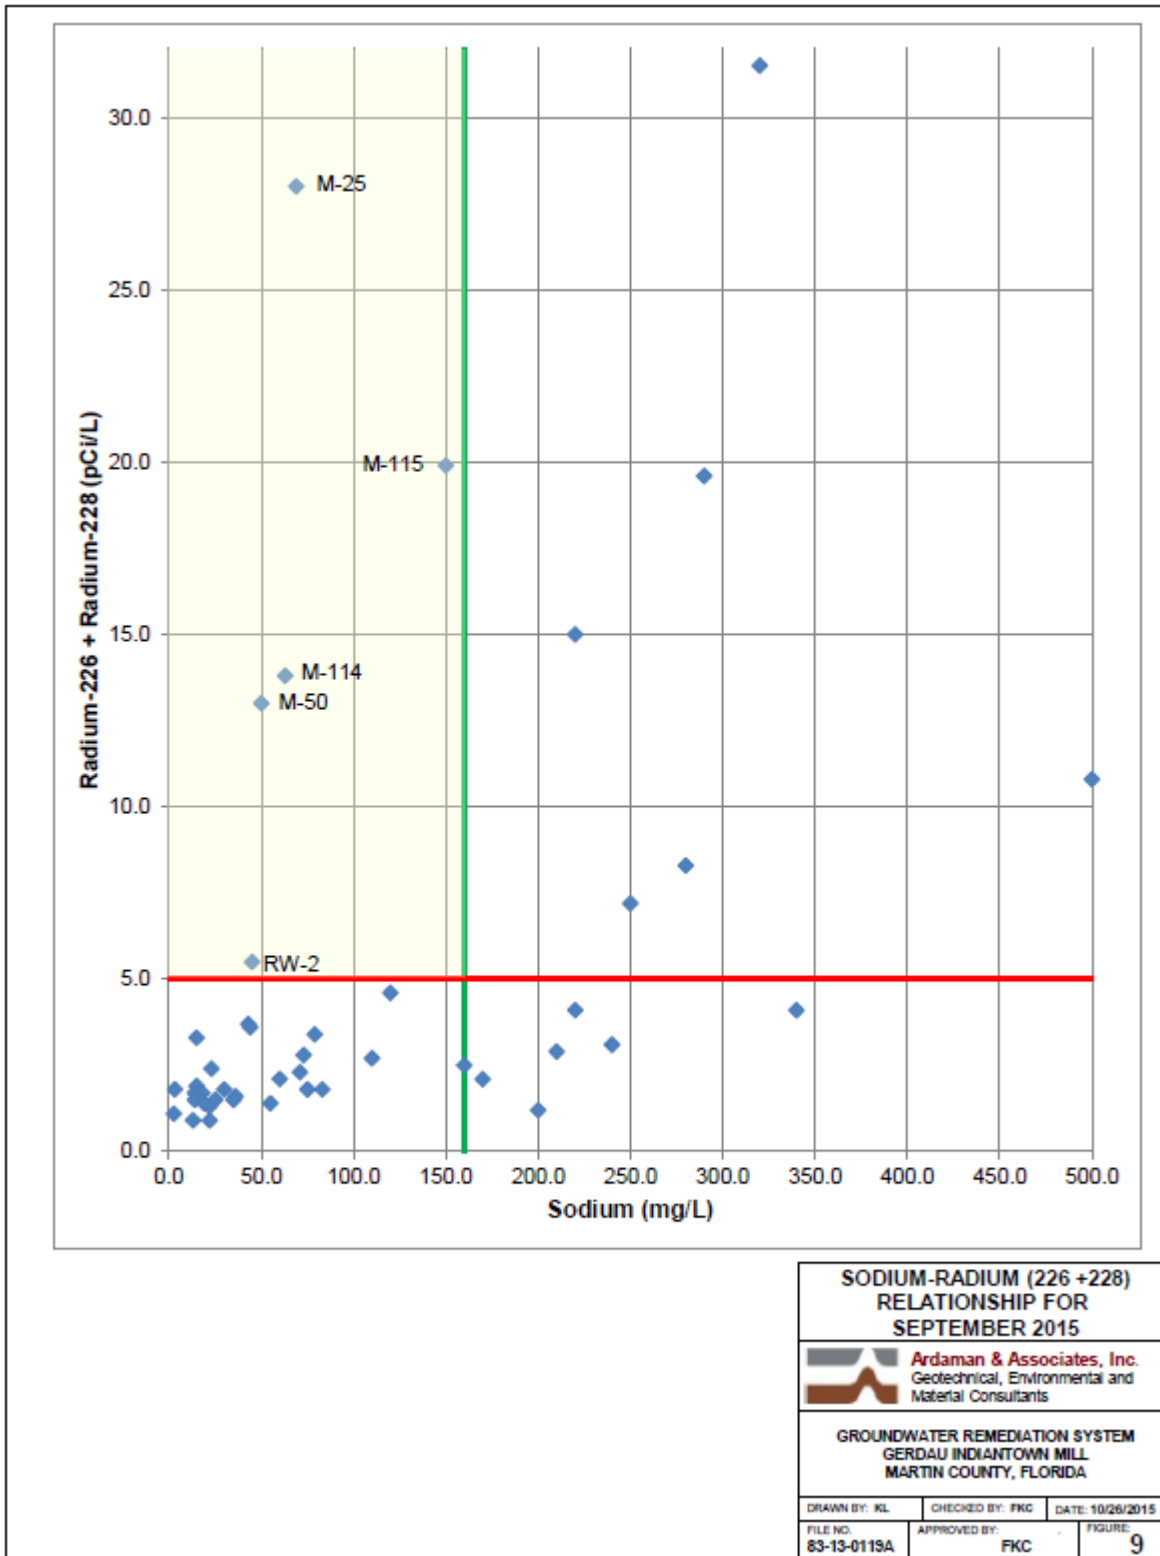
Figure F-3: Sodium-Radium-226 + Radium-228 Relationship for September 2015

There are five wells (RW-2, M-25, M-50, M-114 and M-115) that meet the sodium performance standard but not the radium-226 + radium-228 standard, and four wells (M-25, M-50, M-114 and M-115) that meet the sodium standard but not the gross alpha standard. Sodium chloride in groundwater can cause naturally occurring radium to leach from the soil. As sodium levels decrease, it is expected that radium levels will naturally decrease over time.

The 2015 Monitoring Report provided plots that depict the relationships between the sodium and radium-226 + radium-228 as well as the sodium and gross alpha concentrations in September 2015. Figures F-3 and F-4 show these plots.
