**Sixth Five-Year Review Report
for
Celanese Corporation (Shelby Fibers Operations)
NCD003446721**

**Grover
Cleveland County, North Carolina**

August 2016

United States Environmental Protection Agency
Region 4
Atlanta, Georgia

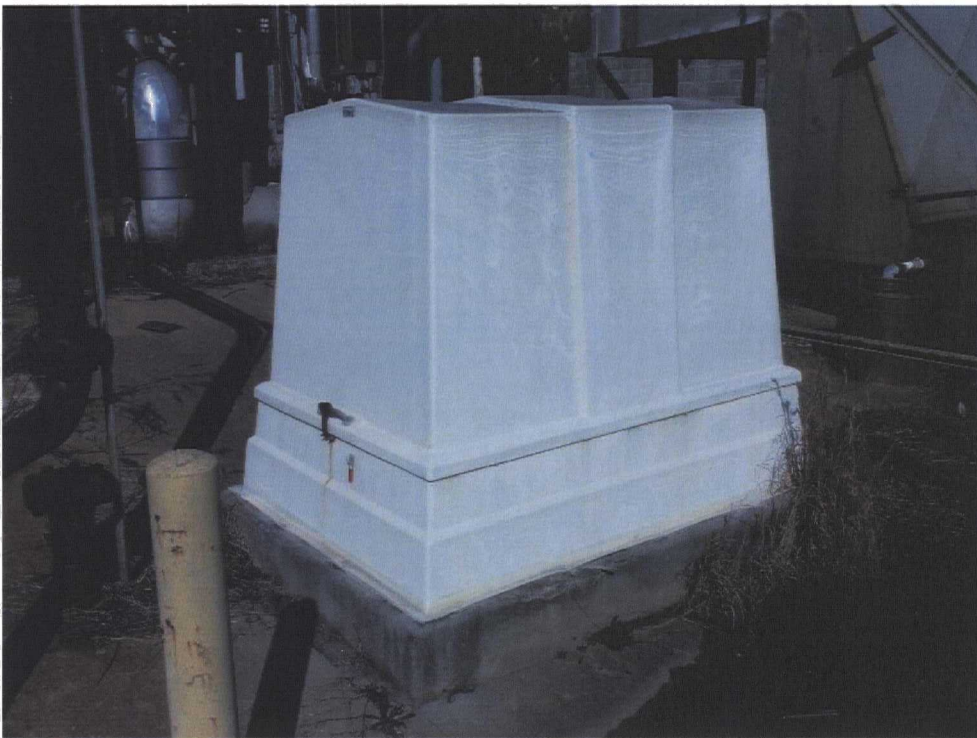
Extraction well PEW-3, located east of the main facility building

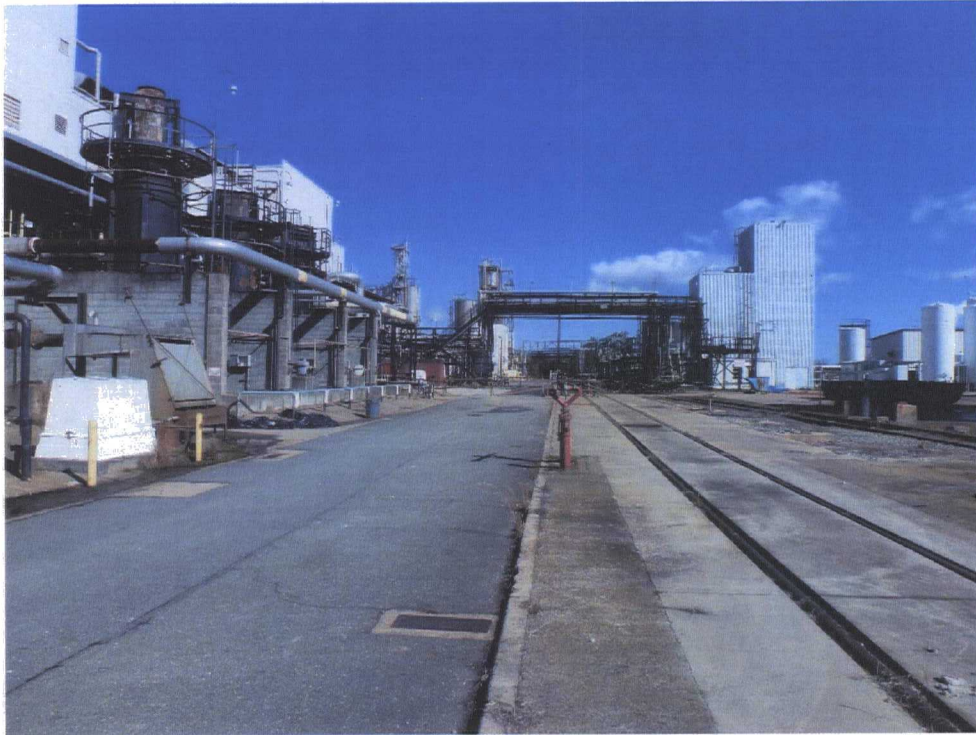
View of the back of the Celanese facility, looking north – extraction well PEW-3 is pictured to the left

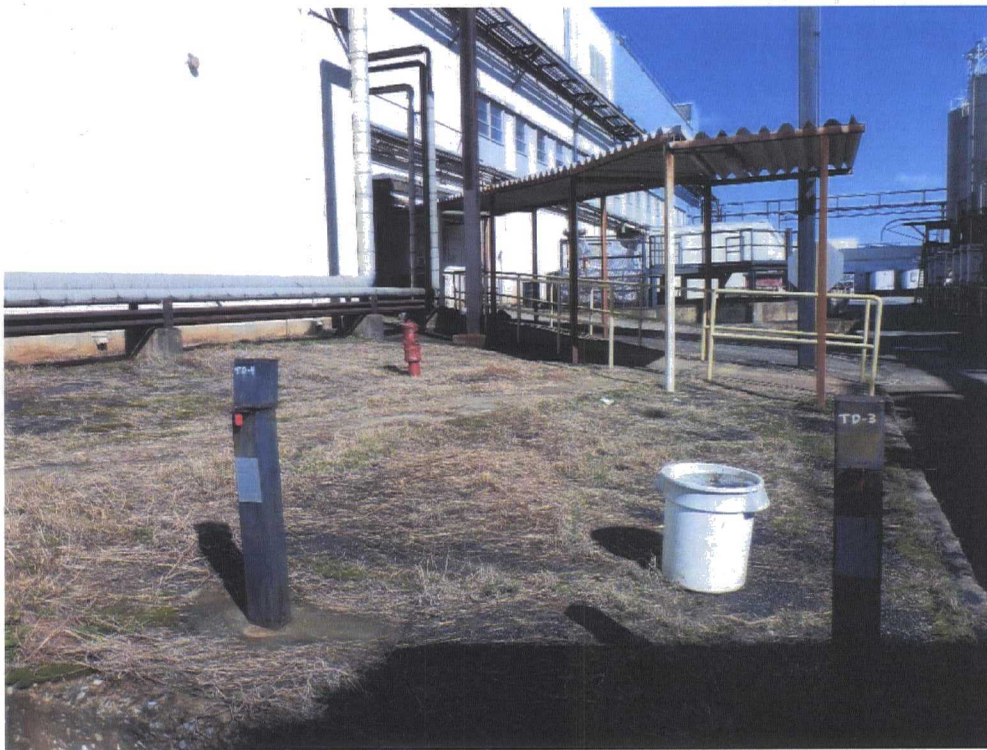
Concentrations of site-related COCs in groundwater routinely exceed North Carolina groundwater standards. TCE concentrations at wells TD-3, TD-4 and QQ-110 consistently and significantly exceed the North Carolina 2L groundwater standard of 0.003 mg/L and the MCL of 0.005 mg/L. In general, since March 2011, TCE concentrations tend to fluctuate sitewide, with no significant trends observed. Groundwater monitoring results do not indicate that MNA is effectively addressing TCE concentrations at the TD well area. Between June 2006 and March 2015, the DNAPL thicknesses measured in well F-55 showed an overall increase. This increase suggests that MNA and the operation of the GWRS may not be capable of addressing the source of DNAPL at well F-55. Monitoring data indicate that concentrations of 1,4-dioxane above the 0.003 mg/L cleanup goal are common at most site monitoring wells. Detectable concentrations of 1,4-dioxane in surface water indicates that the constituent is being discharged from groundwater into site streams. However, between March 2011 and March 2015, concentrations of 1,4-dioxane in site surface water did not exceed the NCAC 2B surface water standard of 0.08 mg/L. With the possible exception of 1,4-dioxane, groundwater monitoring data suggest that groundwater COCs are not migrating off site. It is expected that the continued operation of the GRUB area GWRS will help address the source of 1,4-dioxane. However, given the prevalence of elevated 1,4-dioxane concentrations sitewide, additional actions may be needed to adequately address the contaminant in site groundwater.

Monitoring wells TD-3 and TD-4, located immediately east of the DuraFiber facility

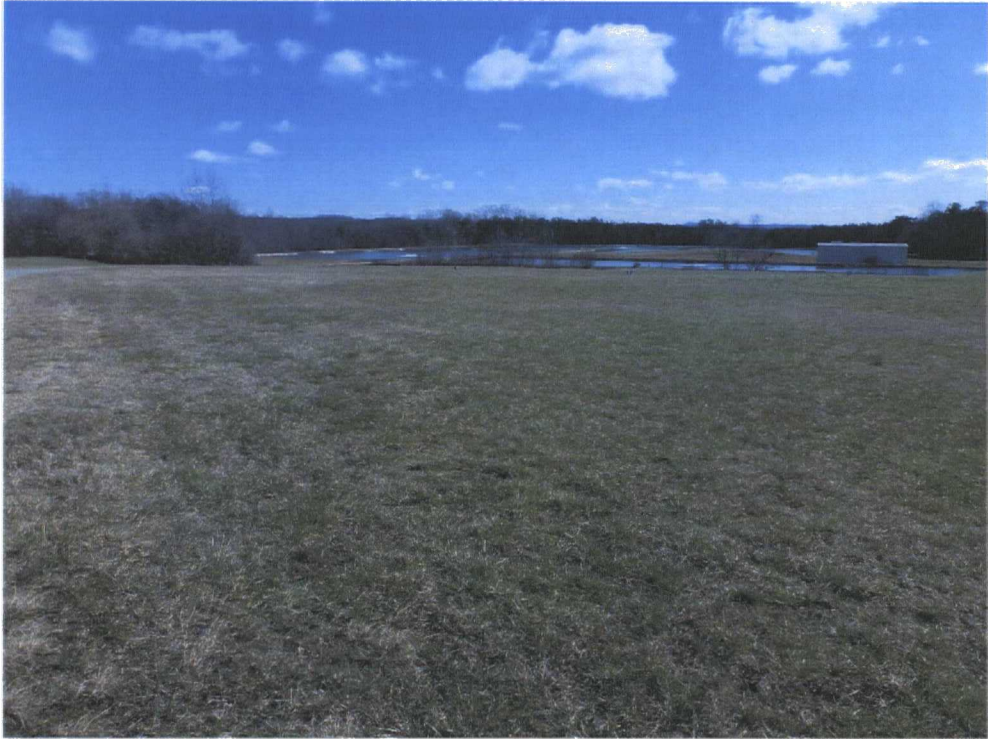
Site inspection participants observed the former GRUB area. Vegetation at the former GRUB area is well established and appeared healthy. Participants then observed the three recently installed extraction wells (IT-10, IT-11 and IT-12) and the facility's WWTP. The WWTP was operational at the time of the site inspection. All WWTP system components appeared to be functioning as designed.

View of the former GRUB area, looking northeast

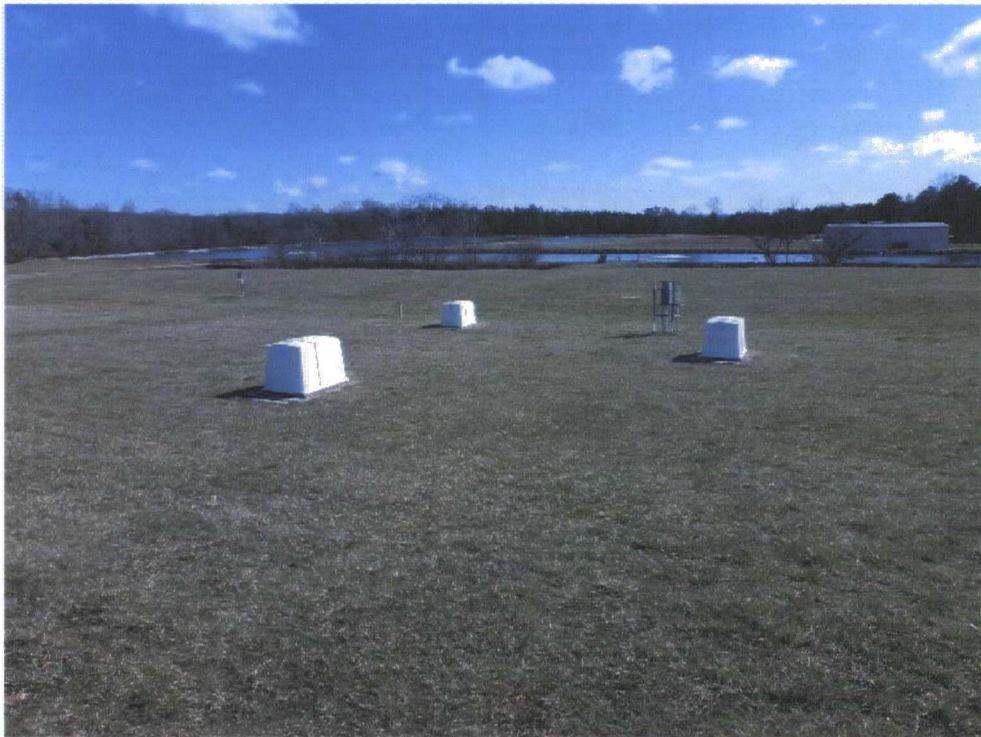
Extraction wells IT-10, IT-11 and IT-12 – WWTP ponds are pictured in the background

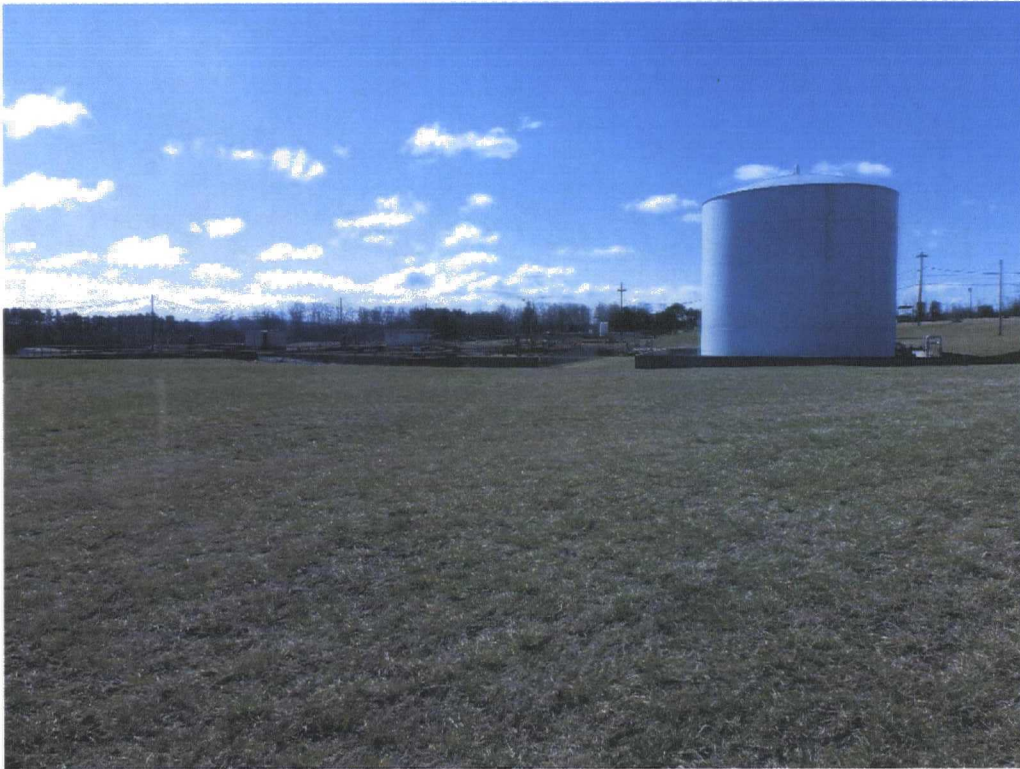
View of the WWTP, looking south from the former GRUB area

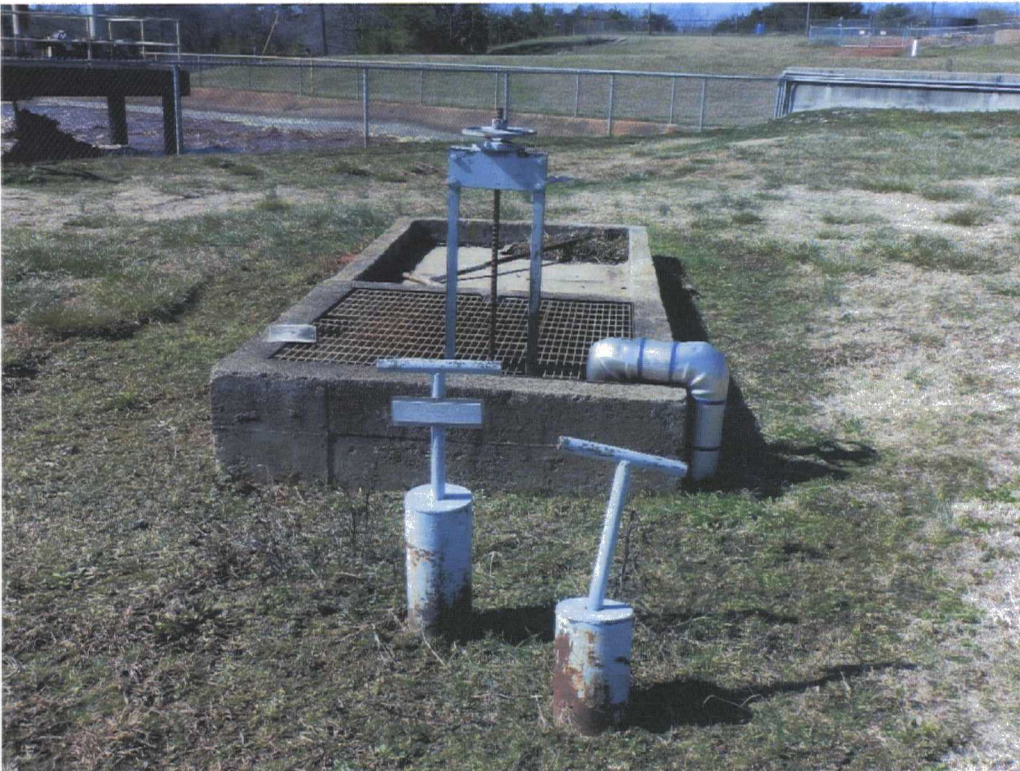
WWTP headworks

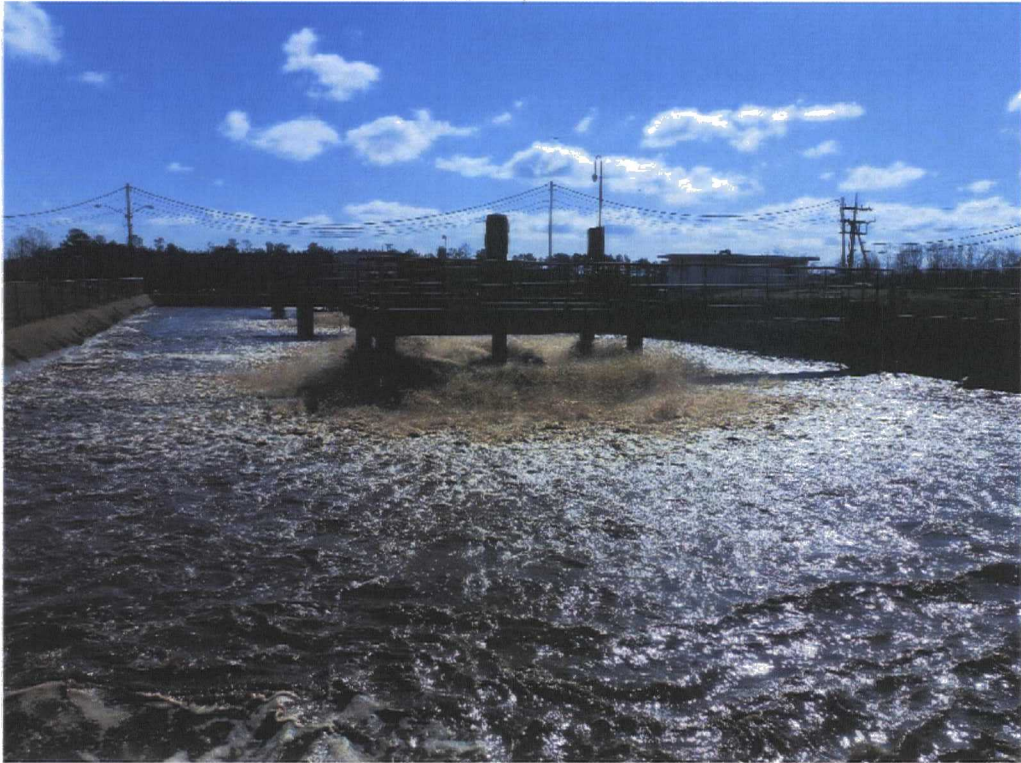
WWTP aeration basin, looking south

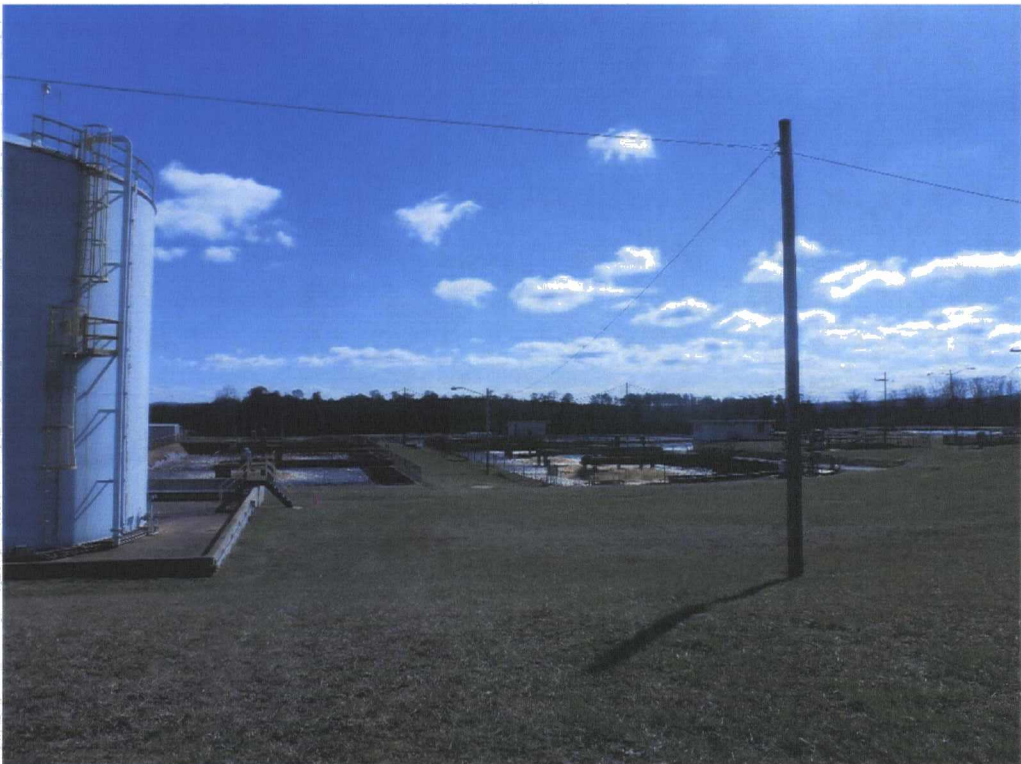
View of the WWTP, looking east

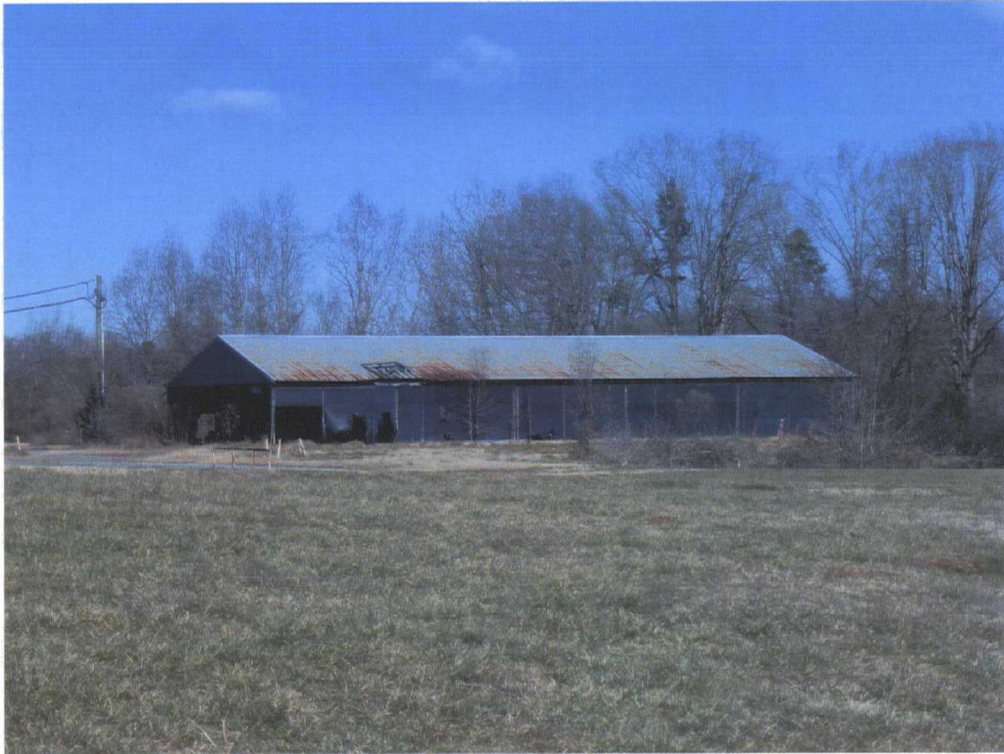
The inspection team observed the former location of the incinerator and the remains of the building previously used to stage and store materials during the operation of the incinerator. North of the former incinerator location, the site inspection team observed the section of Stream B where remediation took place, near surface water sampling point SW-5. The stormwater discharge point near SW-5 appeared to be in good condition and fully operational.

Remnants of the warehouse previously used to stage and store materials during incineration activities

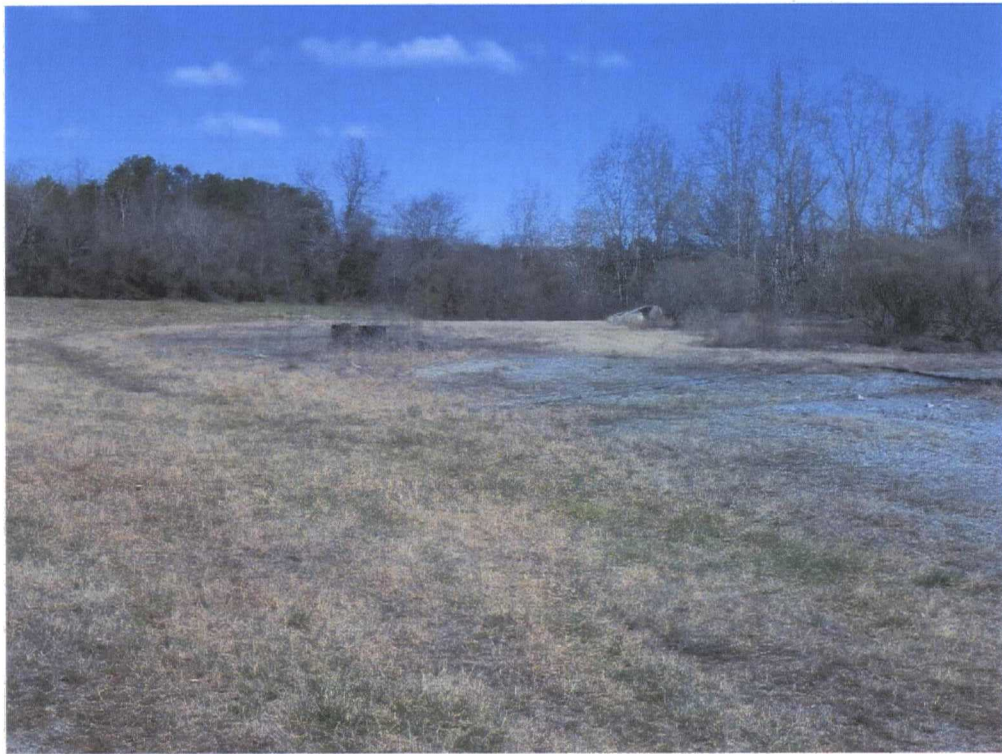
Former location of the on-site incinerator

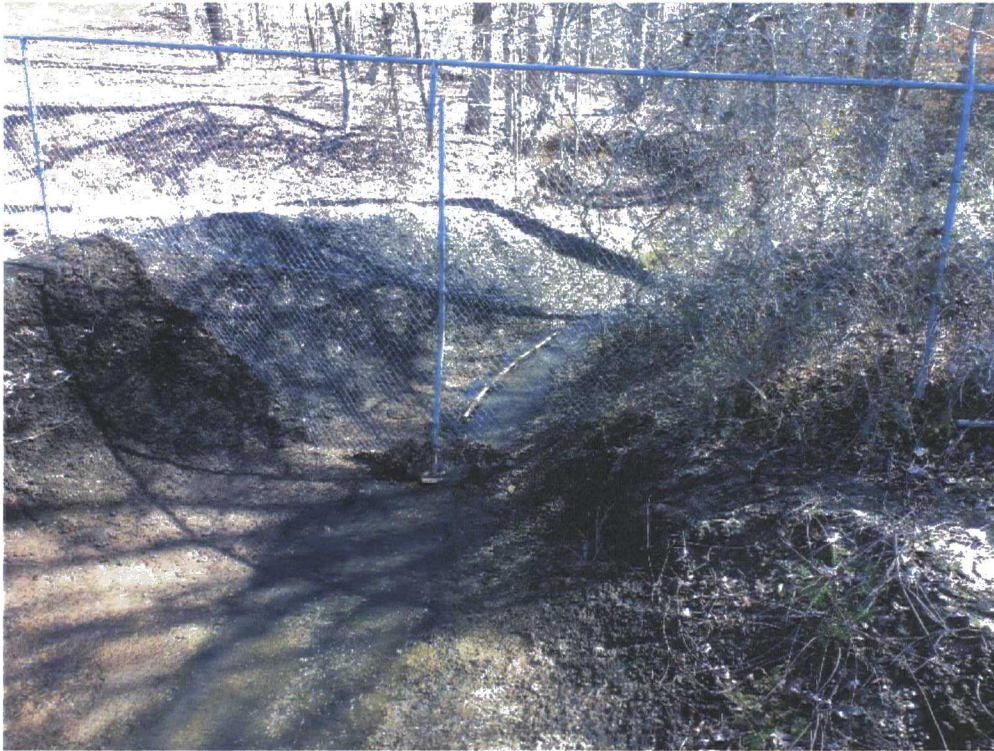
Looking east toward Stream B where remedial actions took place, and toward surface water sampling location SW-5

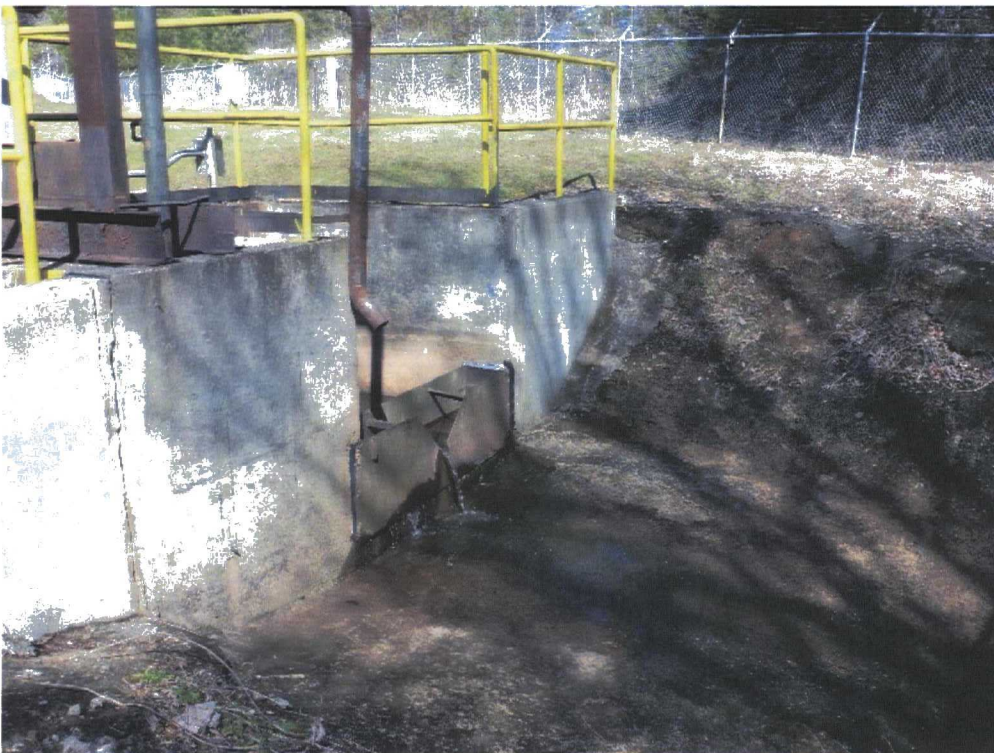
Stormwater discharge structure, located immediately upstream from Stream B
