SIXTH FIVE-YEAR REVIEW REPORT FOR A. L. TAYLOR (VALLEY OF THE DRUMS) SUPERFUND SITE BROOKS, BULLITT COUNTY, KENTUCKY

SEPTEMBER 2018

U.S. Environmental Protection Agency Region 4 Atlanta, Georgia

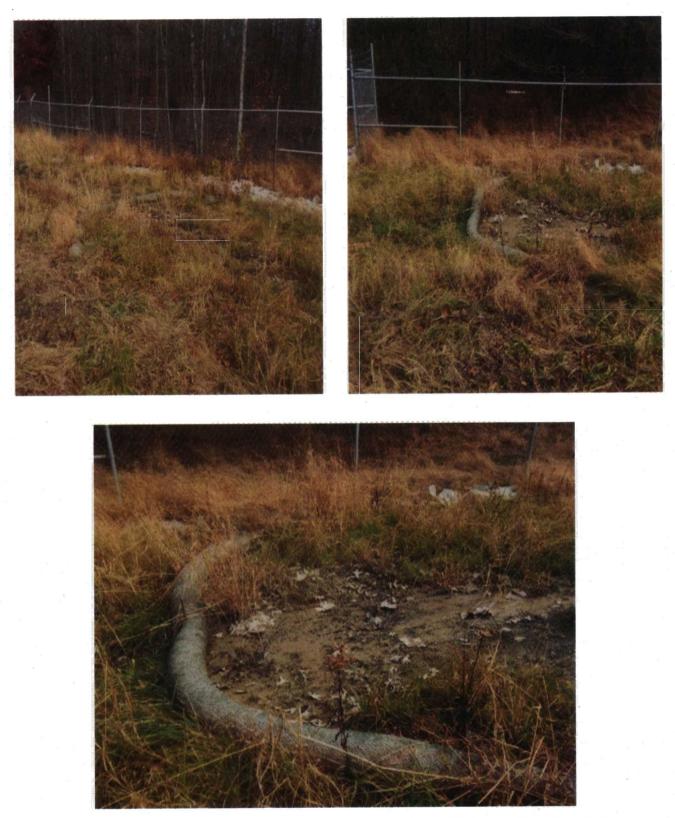
Extended fence near the eastern portion of the Site

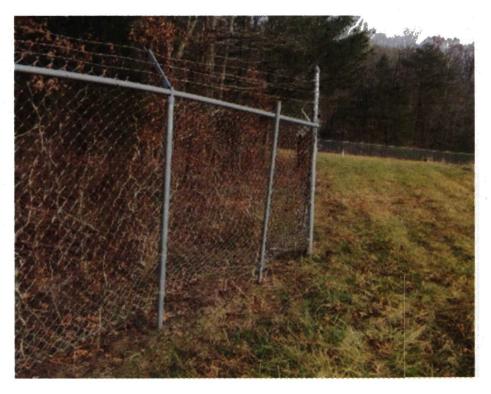
As has been noted in the previous FYRs, the southeastern portion of the cap near the fence line has been vulnerable to ponding but it has become worse in recent times. The natural topography of the area is such that the surface water/runoff flows eastward in this direction and moves towards Wilson Creek. During the current FYR site inspection in November 2017, it was observed that the area had a substantial amount of standing water. KDEP had installed berms to improve surface drainage and contain the runoff but they were not sufficient to stop the ponding of water. The drainage ditch does not have enough riprap to reduce the flow rate of water. This area including the fence were under water due to flooding in 2015. The water overflowed near the fence line due to flooding of the drainage ditch as well as overflow from the pond before moving toward Wilson Creek. If corrective measures are not taken, the integrity of the southeastern portion of the cap may be compromised. Therefore, EPA and KDEP should initiate steps to avoid ponding in the future.

OU(s): Sitewide	Issue Category: Changed Site Conditions					
	 Issue: The ponding of water in the southeastern portion of the cap has reached problematic levels. It was noted that the area became flooded during heavy rains. The drainage ditch does not have enough riprap to manage the runoff. Recommendation: Implement proper measures to address ponding. 					
						Affect Current Protectiveness
No	Yes	EPA/State	State/EPA	8/30/2019

Berms and socks installed to control runoff from the draining ditch near fence line in the southeast portion of the Site

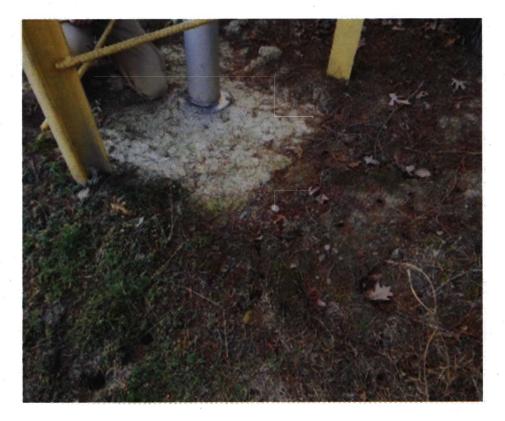
The fence around the cap was in good condition overall, although it was slightly broken near the vicinity of well ALT-10. The fence was extended in the eastern portion of the Site starting near well ALT-4 and all the way till well ALT-8. The riprap in this area was still at the same location where the original fence had been and the drainage ditch seemed to lose its boundary and direction near the fence extension. Ponding was observed near the area and berms were seen to control the runoff from the drainage ditch. Mr. Taylor indicated the area is prone to flooding during heavy rains as the area gets water from both the drainage ditch as well as overflow from the pond. Mr. Taylor shared a photograph taken during heavy rains in 2015 which showed the area under water due to runoff. Ms. Jones was concerned about the issue and noted that she did not observe such level of ponded water during previous site visits.

Slightly broken security fence in the north and growing tree limbs on the fence

- The padding around the well ALT-1 is buried under a sediment layer requiring maintenance.
- The chain link fence in the vicinity of well ALT-10 is damaged and needs to be repaired.

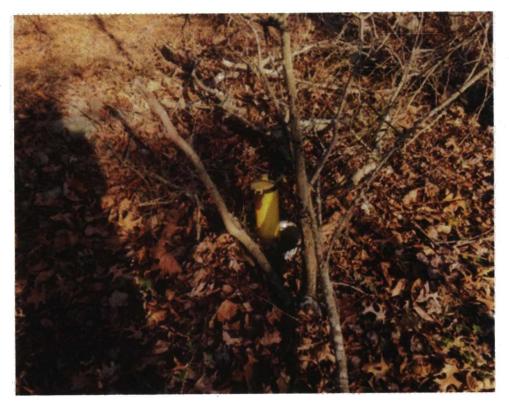
Padding on well ALT-1 buried under a soil layer

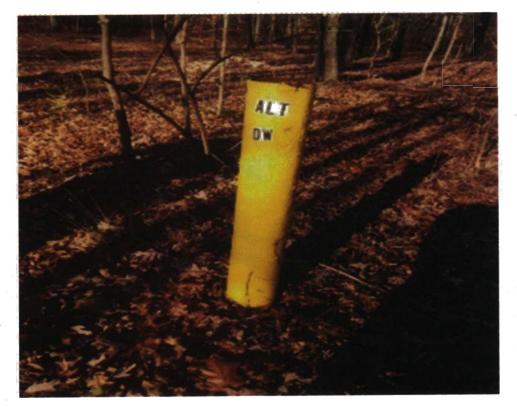
Unnamed pipe near well ALT-10, unlocked and not been properly abandoned

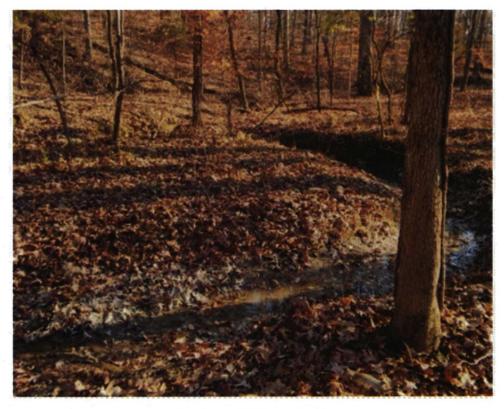
The drainage ditch was mostly clear of excessive vegetation except in the northern portion outside the cap, trees and shrubs had started to grow. All the groundwater monitoring wells were clearly marked and locked. Some of the locks were rusty and could not be opened. The padding around the wells was good except ALT-1 where the padding was buried under a soil layer. Casing had become loose on ALT-4. One of the wells had marks of being hit by a mower or a similar object. There was an unmarked pipe near ALT-10 and unlocked wells named ALT-DW along the northern portion of the Site which were not in use.

Unlocked well named ALT DW outside the fence area in the northern portion of the Site

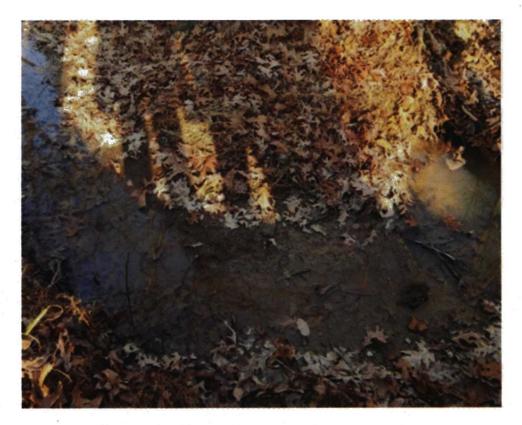
Portion of Wilson Creek

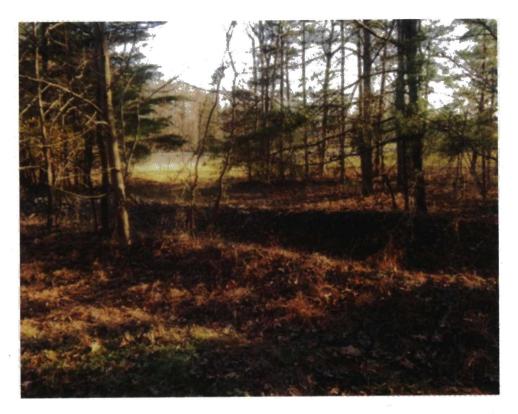
KDEP informed Ms. Jones that the paint waste and drum carcasses in Wilson creek were removed earlier in 2017. Ms. Jones wanted to confirm whether the paint waste removal was done satisfactorily or not. The creek was mostly clear and no waste was observed in the creek except at few places small remnants of paint waste were still noticeable.

OU(s): Sitewide	Issue Category: Monitoring Issue: The dried paint waste and drum carcasses along the banks of Wilson Creek were cleaned up in January 2017, but the sediment samples collected in December 2017 showed that PCBs continue to exist in the creek.				
	Recommendation: Investigate the source of PCB contamination in Wilson Creek.				
Affect Current Protectiveness	Affect Future Protectiveness	Party Responsible	Oversight Party	Milestone Date	
No	Yes	EPA/State	EPA/State	3/31/2020	
	l

Trace amount of paint sludge in Wilson Creek

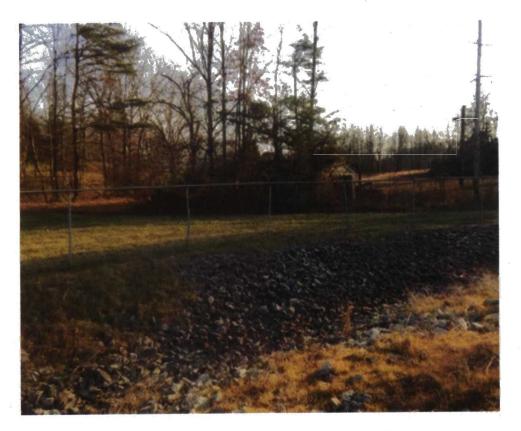
Trees and vegetation growing in the riprap of drainage ditch outside the fence on the north side
