Re: LCP Chemicals Superfund Site, Brunswick, GA
Civil Action No. 2:16-cv-00112
Pilot Study 6 Month Screening Summary

Thin Cover Pilot Study 6-Month Inspection Summary

September 2018

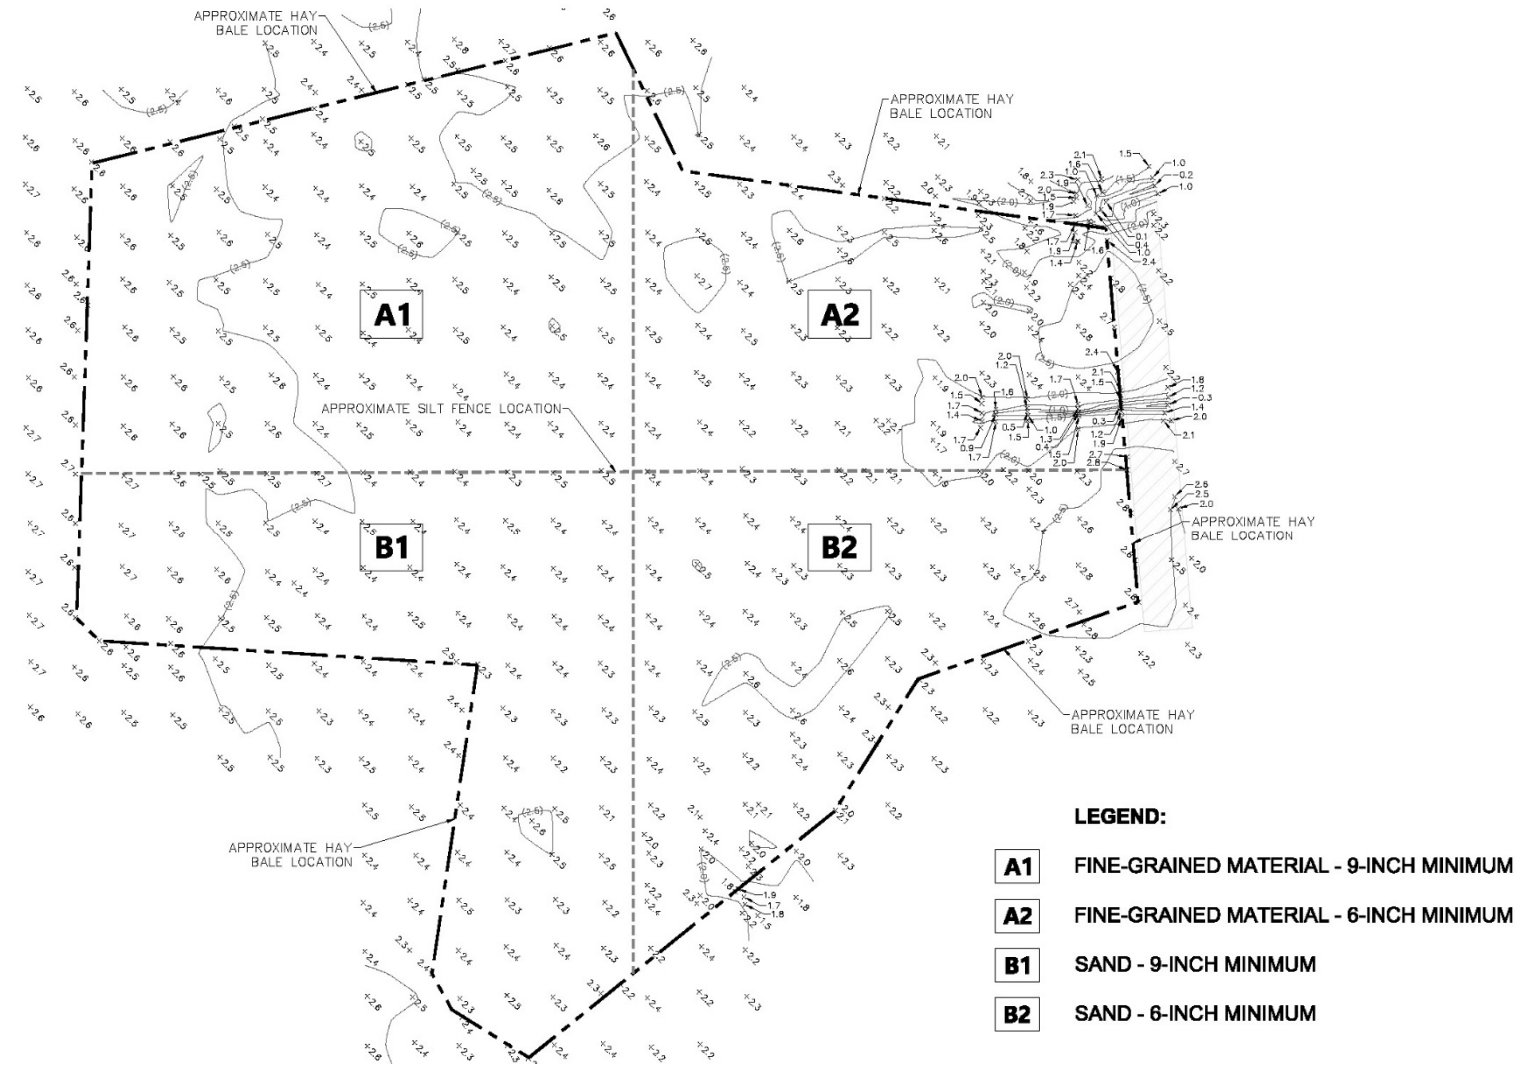
Thin Cover, Construction Plan

- Slide 3 – Elevations and contours shown are pre-construction conditions.
- Slide 4 – Imagery was collected prior to removal of tracer plot boards. Ponded water in the center of the area occurred as a result of localized compression due to equipment loading.

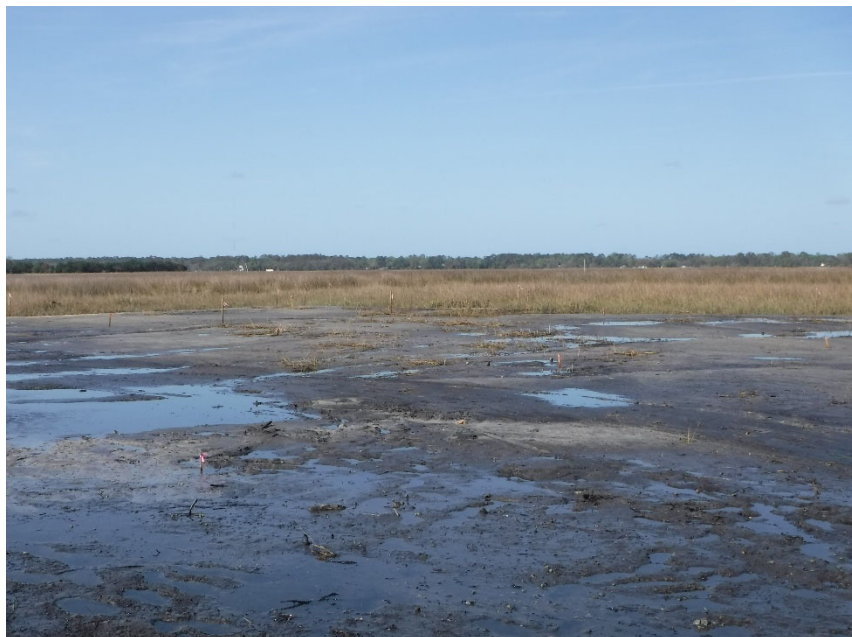
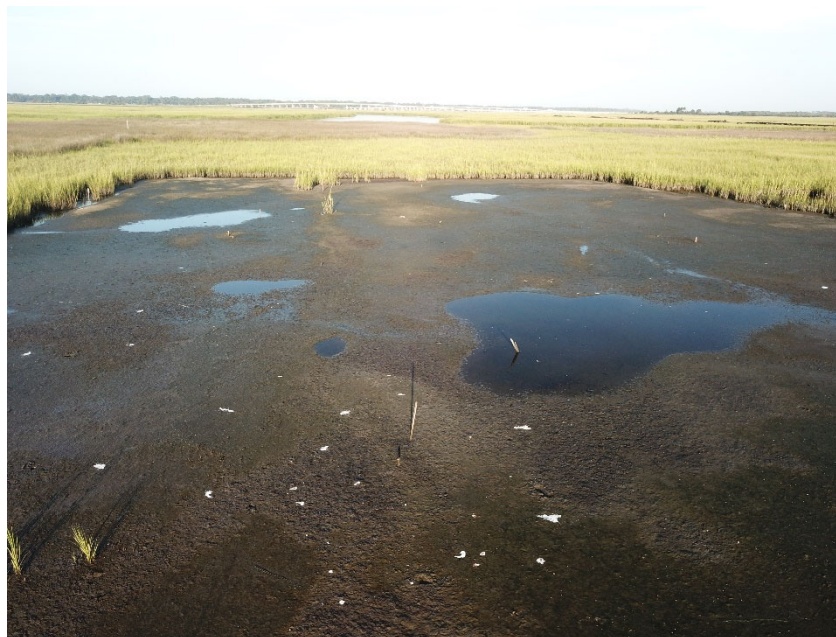
Quadrant A1 & B1

- Slide 6 – Depicts view looking west. The sand cover quadrant is to the left in images and fine-grained material to the right. Limited small patches of plant recovery are observable.

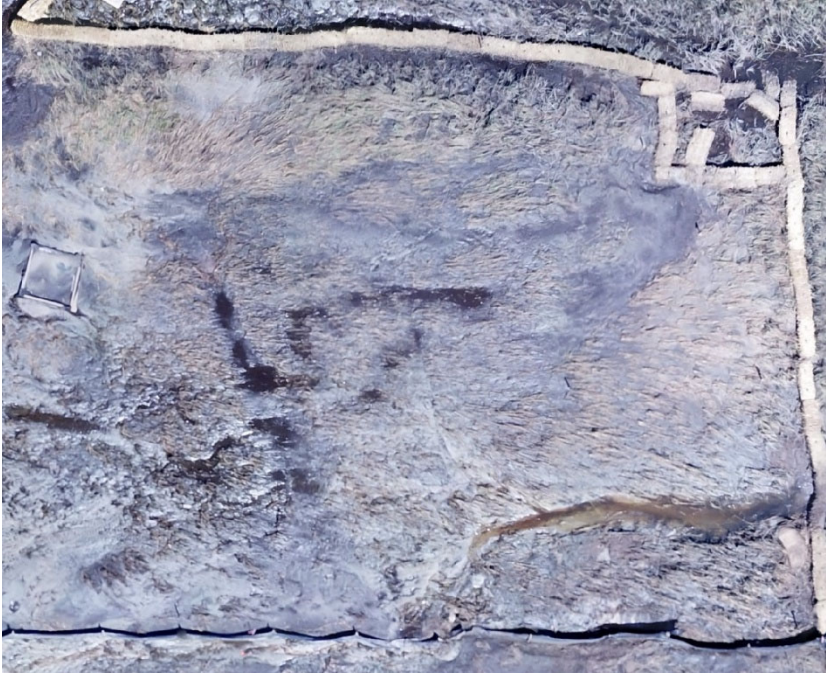
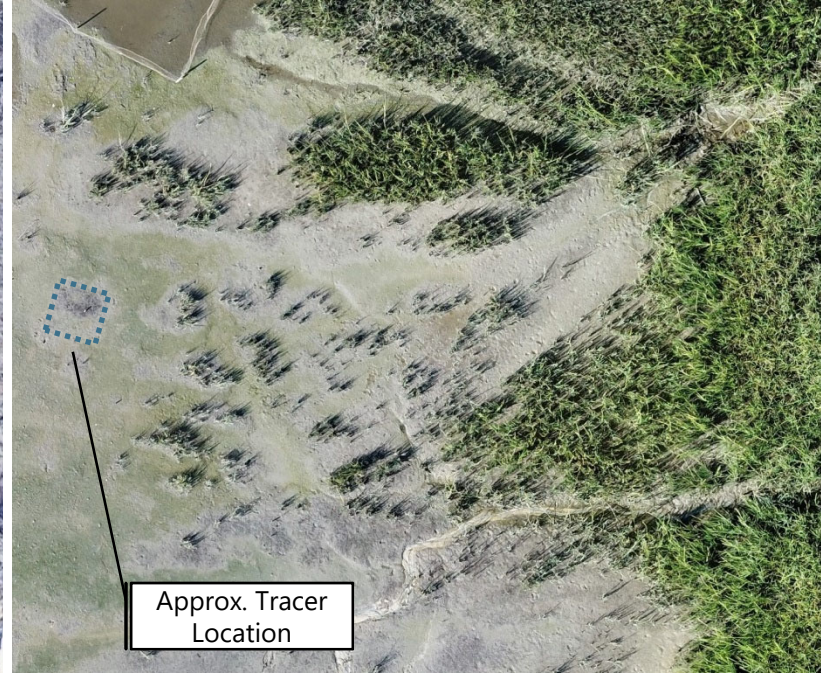
Quadrant A2

- Slide 8 – Approximate tracer plot location illustrated for comparison; no evidence of preferential scour or material loss observed. Reduced impact to vegetation during placement observable in the March 2018 imagery, resulting in stronger vegetation recovery by September 2018. Drainage channel in lower right corner re-established naturally following material placement.

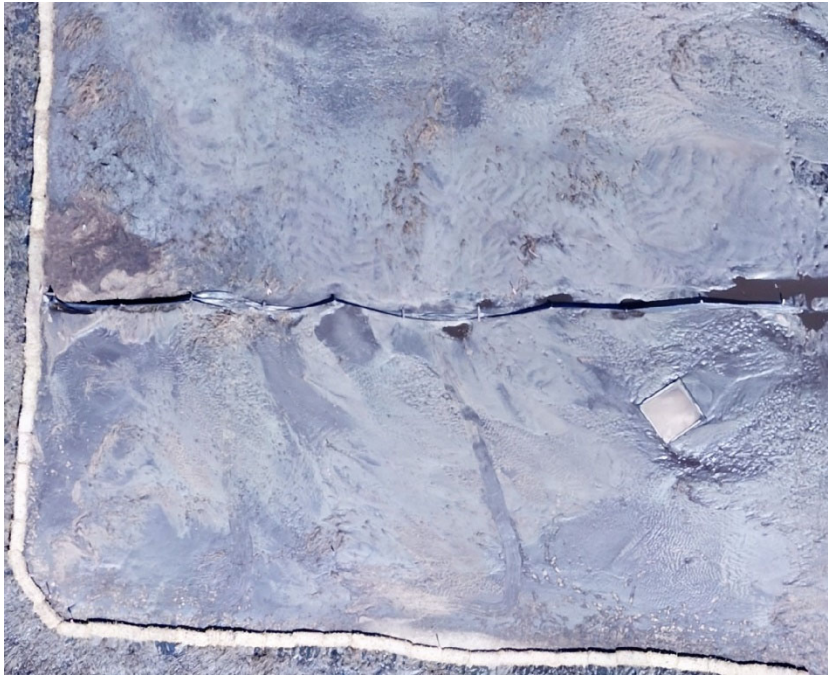
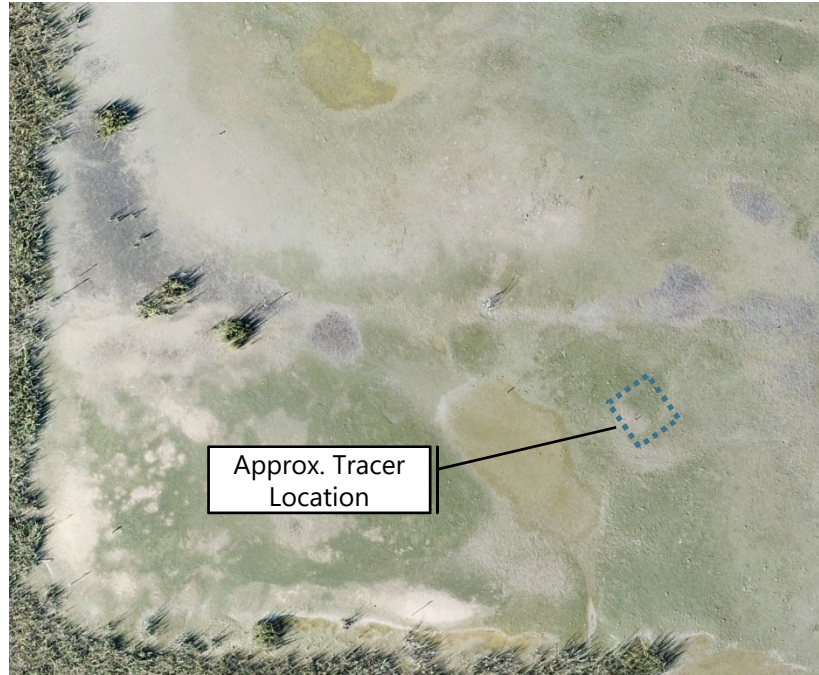
Quadrant B1

- Slide 9 – Orthogonal imagery comparison of similar area as Slide 6 oblique imagery; approximate tracer plot location illustrated for comparison.
- Slide 10 – Depicts view looking west along mat access road alignment. Compression from loading resulted in ponded water along the alignment; minimal vegetative recovery to-date, but warrants longer-term monitoring to assess trends.
