**FIVE-YEAR REVIEW  
FINAL  
FOR THE  
A.L. TAYLOR SITE  
BROOKS, KENTUCKY**

*(Contract No. 68-W9-0029)  
Work Assignment C04021B*

**U. S. ENVIRONMENTAL PROTECTION AGENCY  
REGION IV**

*June 30, 1992*

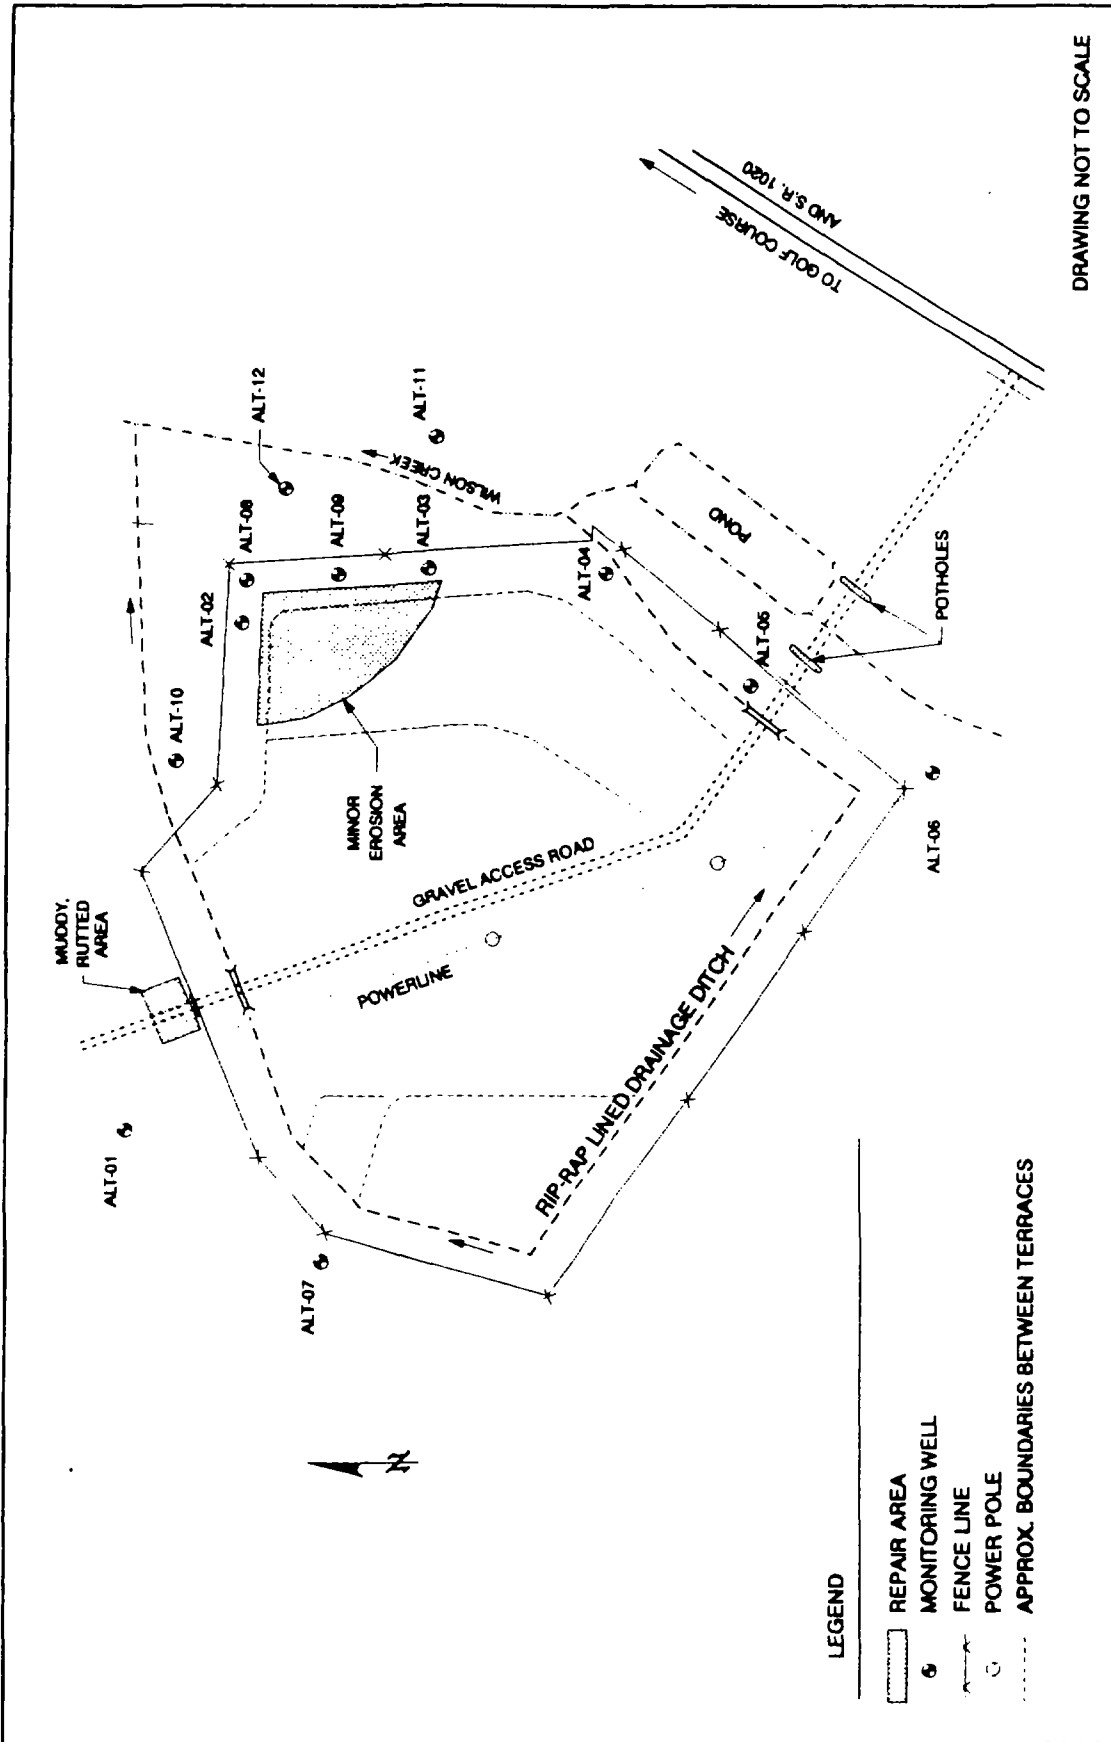
**FIGURE 2.1**  
**REPAIR AREAS**

Soil erosion is broken down into three erosional features in the O&M Plan: Swales greater than 1 ft. wide and 2 inches deep; cracks greater than 1/4 inch wide and 6 inches deep; and areas of erosional damage to grass. RAI noted erosional damage to grass in various places (See Figure 2.1). Areas of erosional damage around monitoring well ALT-08 consist of

The access road to the site consists of compacted dirt and gravel. Off-site conditions are generally good, with two exceptions. The first is a few minor potholes in the southeast portion of the road (See Figure 2.1). The second area of concern is at the rear gate. This area is extremely muddy, even in times of limited rainfall. The on-site access road is in good condition, allowing full access to the site.

While there is no current problem, the erosion areas around ALT-08 should be repaired to prevent growth of erosion channels. If channels go un-checked, the integrity of the clay cap could be jeopardized, and the potential for an exposure pathway from exposed waste would increase. Possible corrective actions could include one or more of the following: reseeding of eroded areas, hay bales, or filling the areas with rip-rap.

The access road leading to the front gate is in need of repair in certain areas (See Figure 2.1). There are three potholes along the drive that have contained ponded water during every visit to the site. One of them is actually part of Wilson Creek and should be left alone. It is suggested that the other two be filled and compacted with fill material and a layer of gravel put on top of the fill areas to prevent them from washing out. The area
