**Clayton Project No.: 35-01004.00**

**Subject: Report on the Oversight of Demolition Activities and Underground Storage Tank Closure Conducted at the Industrial Excess Landfill located in Uniontown, Ohio.**

Report on Oversight of On-site Activities  
Industrial Excess Landfill, Uniontown, Ohio  
Clayton Project Number: 35-01004.00

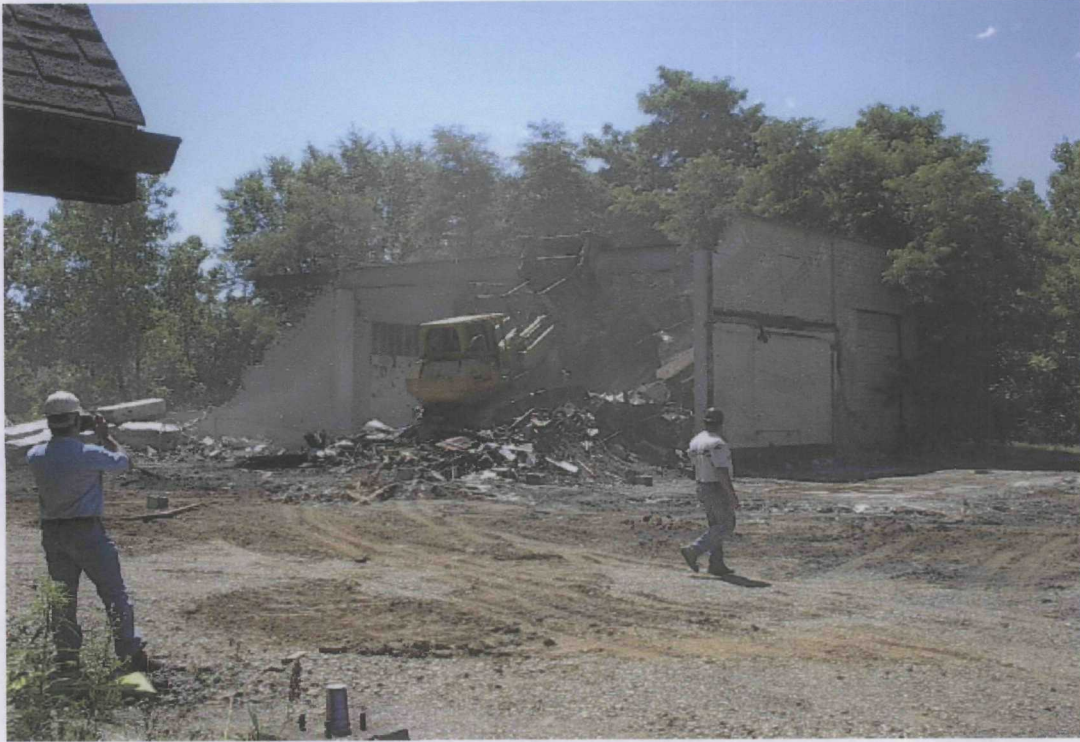
Demolition of the Uniontown Tire building took place July 9 through the 12. All building structures, including the foundation, were removed from the property. General construction debris from the site is transported to Eslich's East Canton, Ohio landfill. Aggregate materials such as masonry block and footers were taken to Eslich's crusher facility in Akron, Ohio for recycling.

Clayton Project No. 35-01004.00	<b>Description</b>	Demolition of Uniontown Tire Building.	<b>1</b>
	<b>Site Name</b>	Industrial Excess Landfill, Uniontown, Ohio	<b>Date</b> 07/9-15/01
	<b>Client</b>	Lake Township

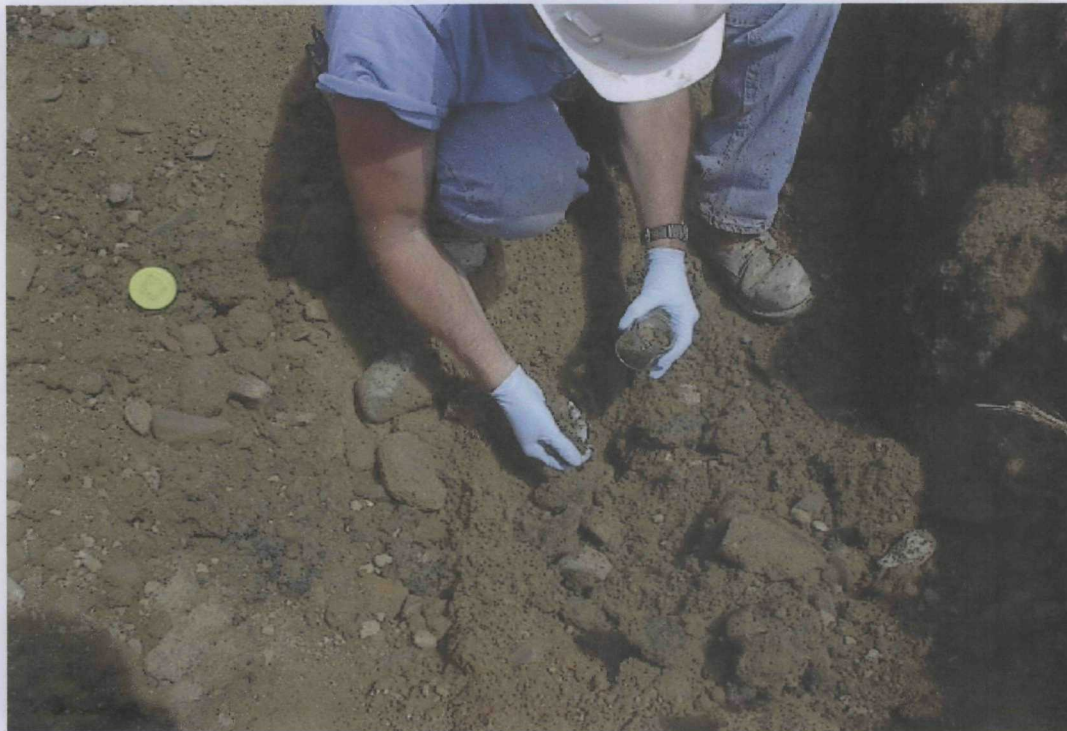
During excavation activities located in the south garage bay of the west portion of the building, an approximately two foot diameter, three foot deep catch basin filled with a black oil/water mixture was uncovered. It appeared this was located under a former drain in the garage area. A small amount of black oil stained soil was observed by Clayton around this catch basin. Eslich removed the impacted soil and catch basin from the site after mixing the material with other general construction debris from the site taken to Eslich's East Canton, Ohio landfill. At the time this activity took place, both representatives from Sharp and Clayton were briefly offsite for lunch. Mr. Zeke Secor, Senior Environmental Technician with Sharp, took one confirmatory sample from soil beneath the location of the former catch basin. The sample was placed on ice approximately twenty minutes after sampling and transported by Mr. Secor to Severn Trent Laboratory located in North Canton for analysis. The sample was analyzed for

Clayton Project No. 35-01004.00	<b>Description</b>	Collection of sample beneath former catch basin.	<b>2</b>
	<b>Site Name</b>	Industrial Excess Landfill, Uniontown, Ohio	<b>Date</b> 07/9-15/01
	<b>Client</b>	Lake Township

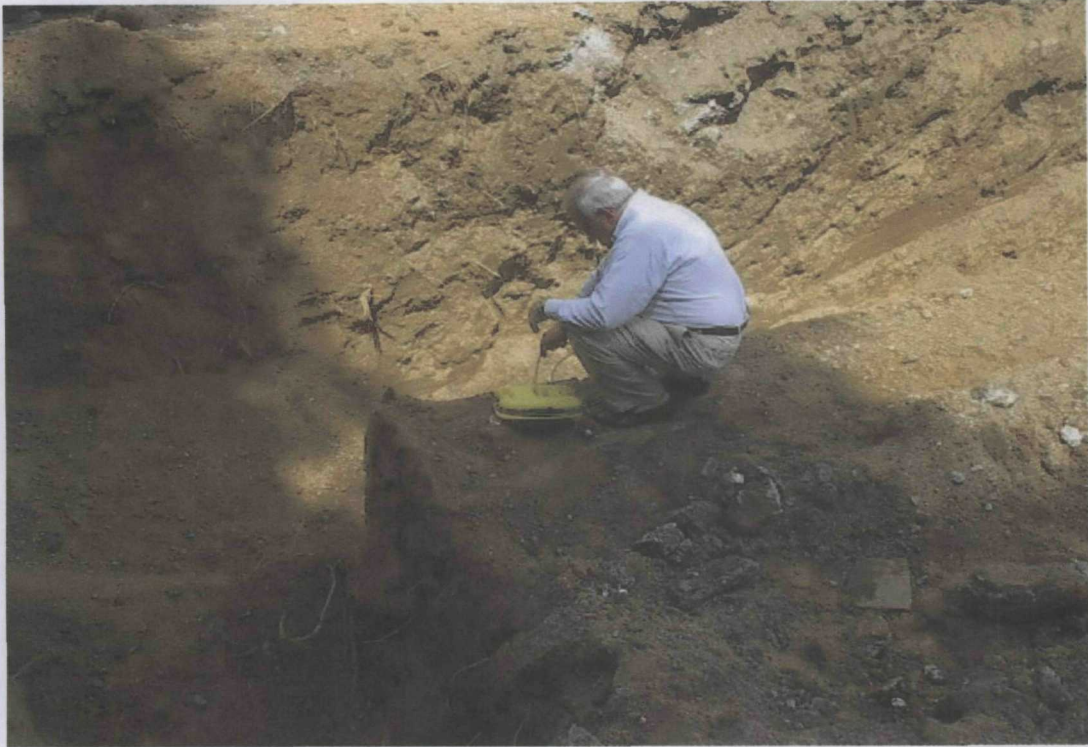
Mr. Floyd Fernandez, Environmental Assessment Specialist with Jeffries, arrived onsite at 11:30 am. Mr. Fernandez measured the lower explosive limit (LEL) inside the UST. Mr. Fernandez indicated the LEL was zero. Mr. Bill Jeffries, with Jeffries, and Mr. Phillips arrived at 12:00 p.m.

Clayton Project No. 35-01004.00	<b>Description</b>	Sampling of LEL in UST.	<b>3</b>
	<b>Site Name</b>	Industrial Excess Landfill, Uniontown, Ohio	<b>Date</b>
	<b>Client</b>	Lake Township	07/9-15/01

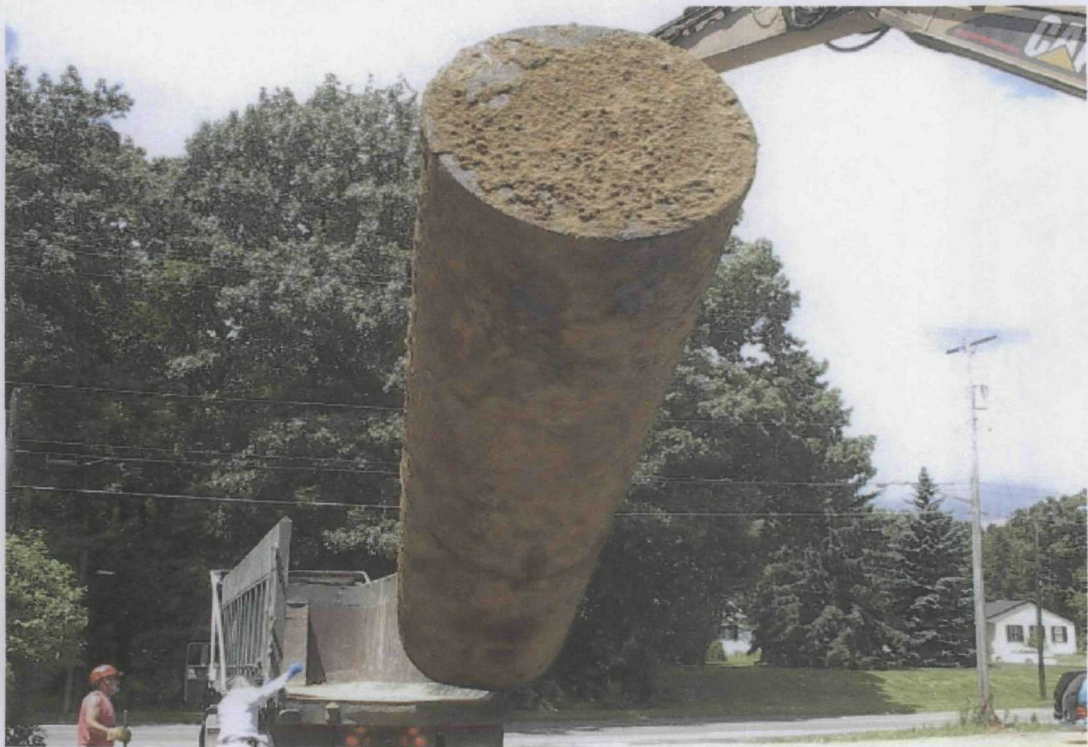
The UST was removed by Eslich from the cavity and placed in an Eslich dump truck. Eslich personnel indicated the tank would be taken to their maintenance shop, cut open, cleaned, and recycled. During the removal of the placement of the tank into the bed of the dump truck a one millimeter (mm) diameter hole was identified on the bottom of the tank. This hole was located on the former north end of the tank. A stream of black liquid with a kerosene odor was release from the hole into the bed of the dump truck. Eslich personnel used absorbent towels to catch the liquid and rotated the tank until the hole was no longer at the bottom.

The UST was in fair condition. Pitting was observed on the lower portions of the tank. One, one mm hole was observed on the bottom of the north side of the tank. This hole

appeared to be caused by removal activities. Additionally, a one-foot hole caused by excavation activities of the footer was located on the south side of the tank. It did not appear that contents in the tank were released from this large hole.

Clayton Project No. 35-01004.00	<b>Description</b>	Placement of UST in dump truck.	<b>4</b>
	<b>Site Name</b>	Industrial Excess Landfill, Uniontown, Ohio	<b>Date</b>
	<b>Client</b>	Lake Township	7/9-15/2001

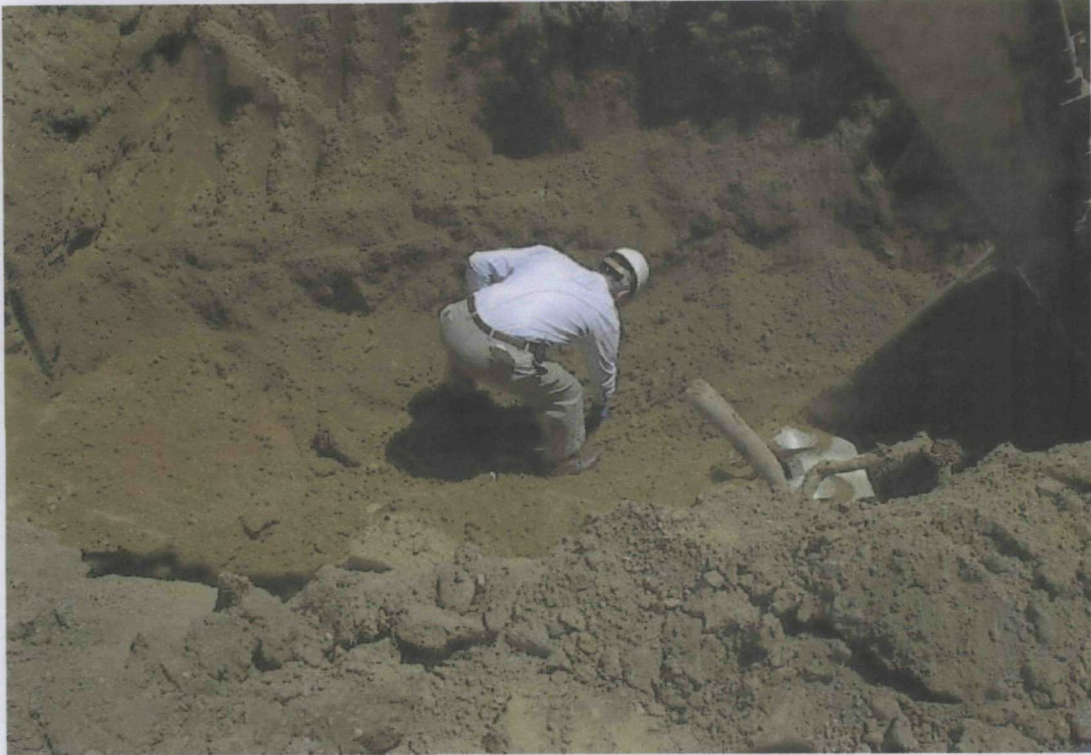
Three samples were collected from native soil beneath the UST. Samples were collected from the ends and middle of the tank. The samples were collected by lowering Mr. Jeffries into the cavity using the excavator bucket. Mr. Jeffries used a dedicated steel spade to collect the samples. These samples were placed in resealable bags for PID screening. Once screened, a sample selected from beneath the north end was placed in sample jars for laboratory analysis. Mr. Jeffries indicated all PID readings were zero. It was decided to submit the north end sample to confirm possible contamination in the discolored soil was completely removed.

Based on observations during the removal of the UST, it does not appear a significant release from the UST has occurred. However, Clayton is concerned with the integrity and validity of the VOC samples collected during removal activities. Because samples for VOCs were not collected directly into jars for laboratory analysis, it is possible volatilization of VOCs exceeding regulatory levels may have occurred. Mr. Jeffries indicated this would not be a problem due to the rapid PID screening and placement of the sample into jars. However, this offers the additional concern samples were not given enough time to volatilize prior to PID screening.

<b>Clayton Project No.</b> 35-01004.00	<b>Description</b>	Sampling beneath UST.	<b>5</b>
	<b>Site Name</b>	Industrial Excess Landfill, Uniontown, Ohio	<b>Date</b> 07/9-15/01
	<b>Client</b>	Lake Township

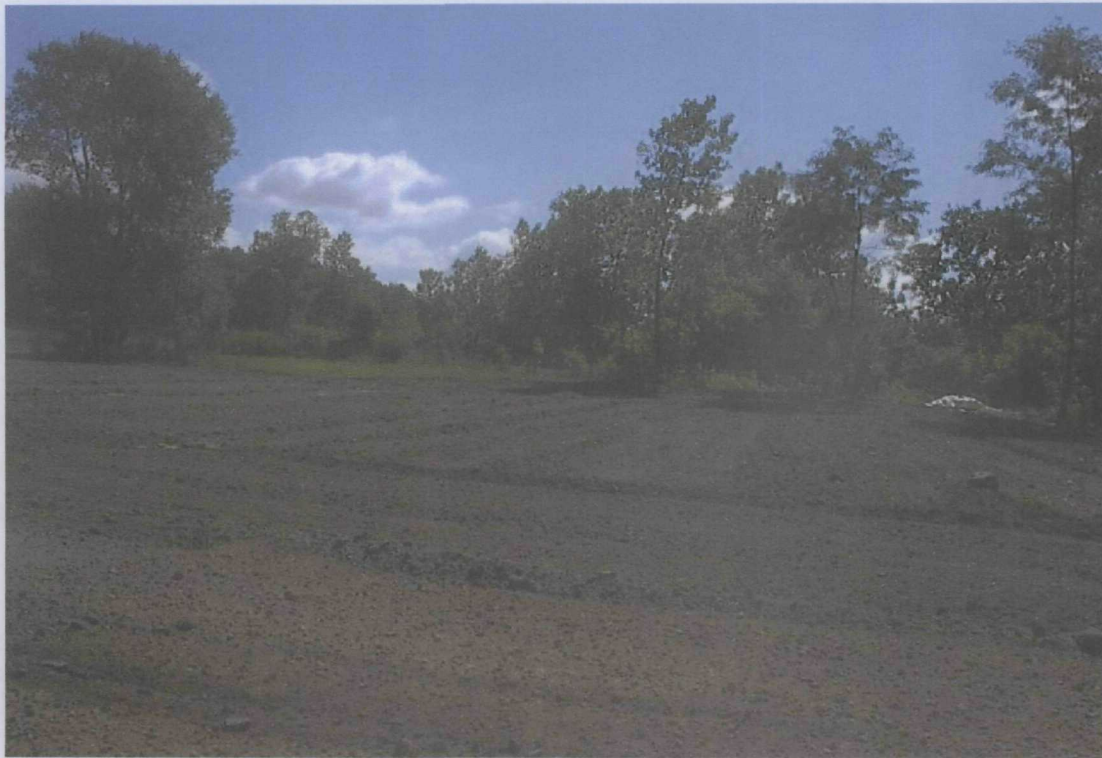
Once demolition of the buildings was complete, Eslich graded the property with topsoil. Topsoil was supplied from Eslich's Manchester Road facility. A sample of this topsoil was not analyzed by Sharp prior to use at the site. However, Clayton's visual inspection of the topsoil did not indicate the material was contaminated. Application of wild flower seeds was performed July 16, 2001.

<b>Clayton Project No.</b> 35-01004.00	<b>Description</b>	Completed demolition and grading activities.	<b>6</b>
	<b>Site Name</b>	Industrial Excess Landfill, Uniontown, Ohio	<b>Date</b> 07/9-15/01
	<b>Client</b>	Lake Township

USEPA Region 5 recommends that a barrier of some sort (temporary fence/concrete barricade, etc.) be installed along the eastern edge of Cleveland Avenue to prevent vehicles from trespassing on the newly seeded area, formerly occupied by the 3 remaining buildings and USTs. Lake Township concurs with this recommendation and suggests installation proceed as soon as practicable. Please inform this office if you decide to go along with this recommendation.
