INTEGRATED ASSESSMENT (IA) REPORT

BAKER WOOD CREOSOTING SITE

Marion, Marion County

March 5, 1998

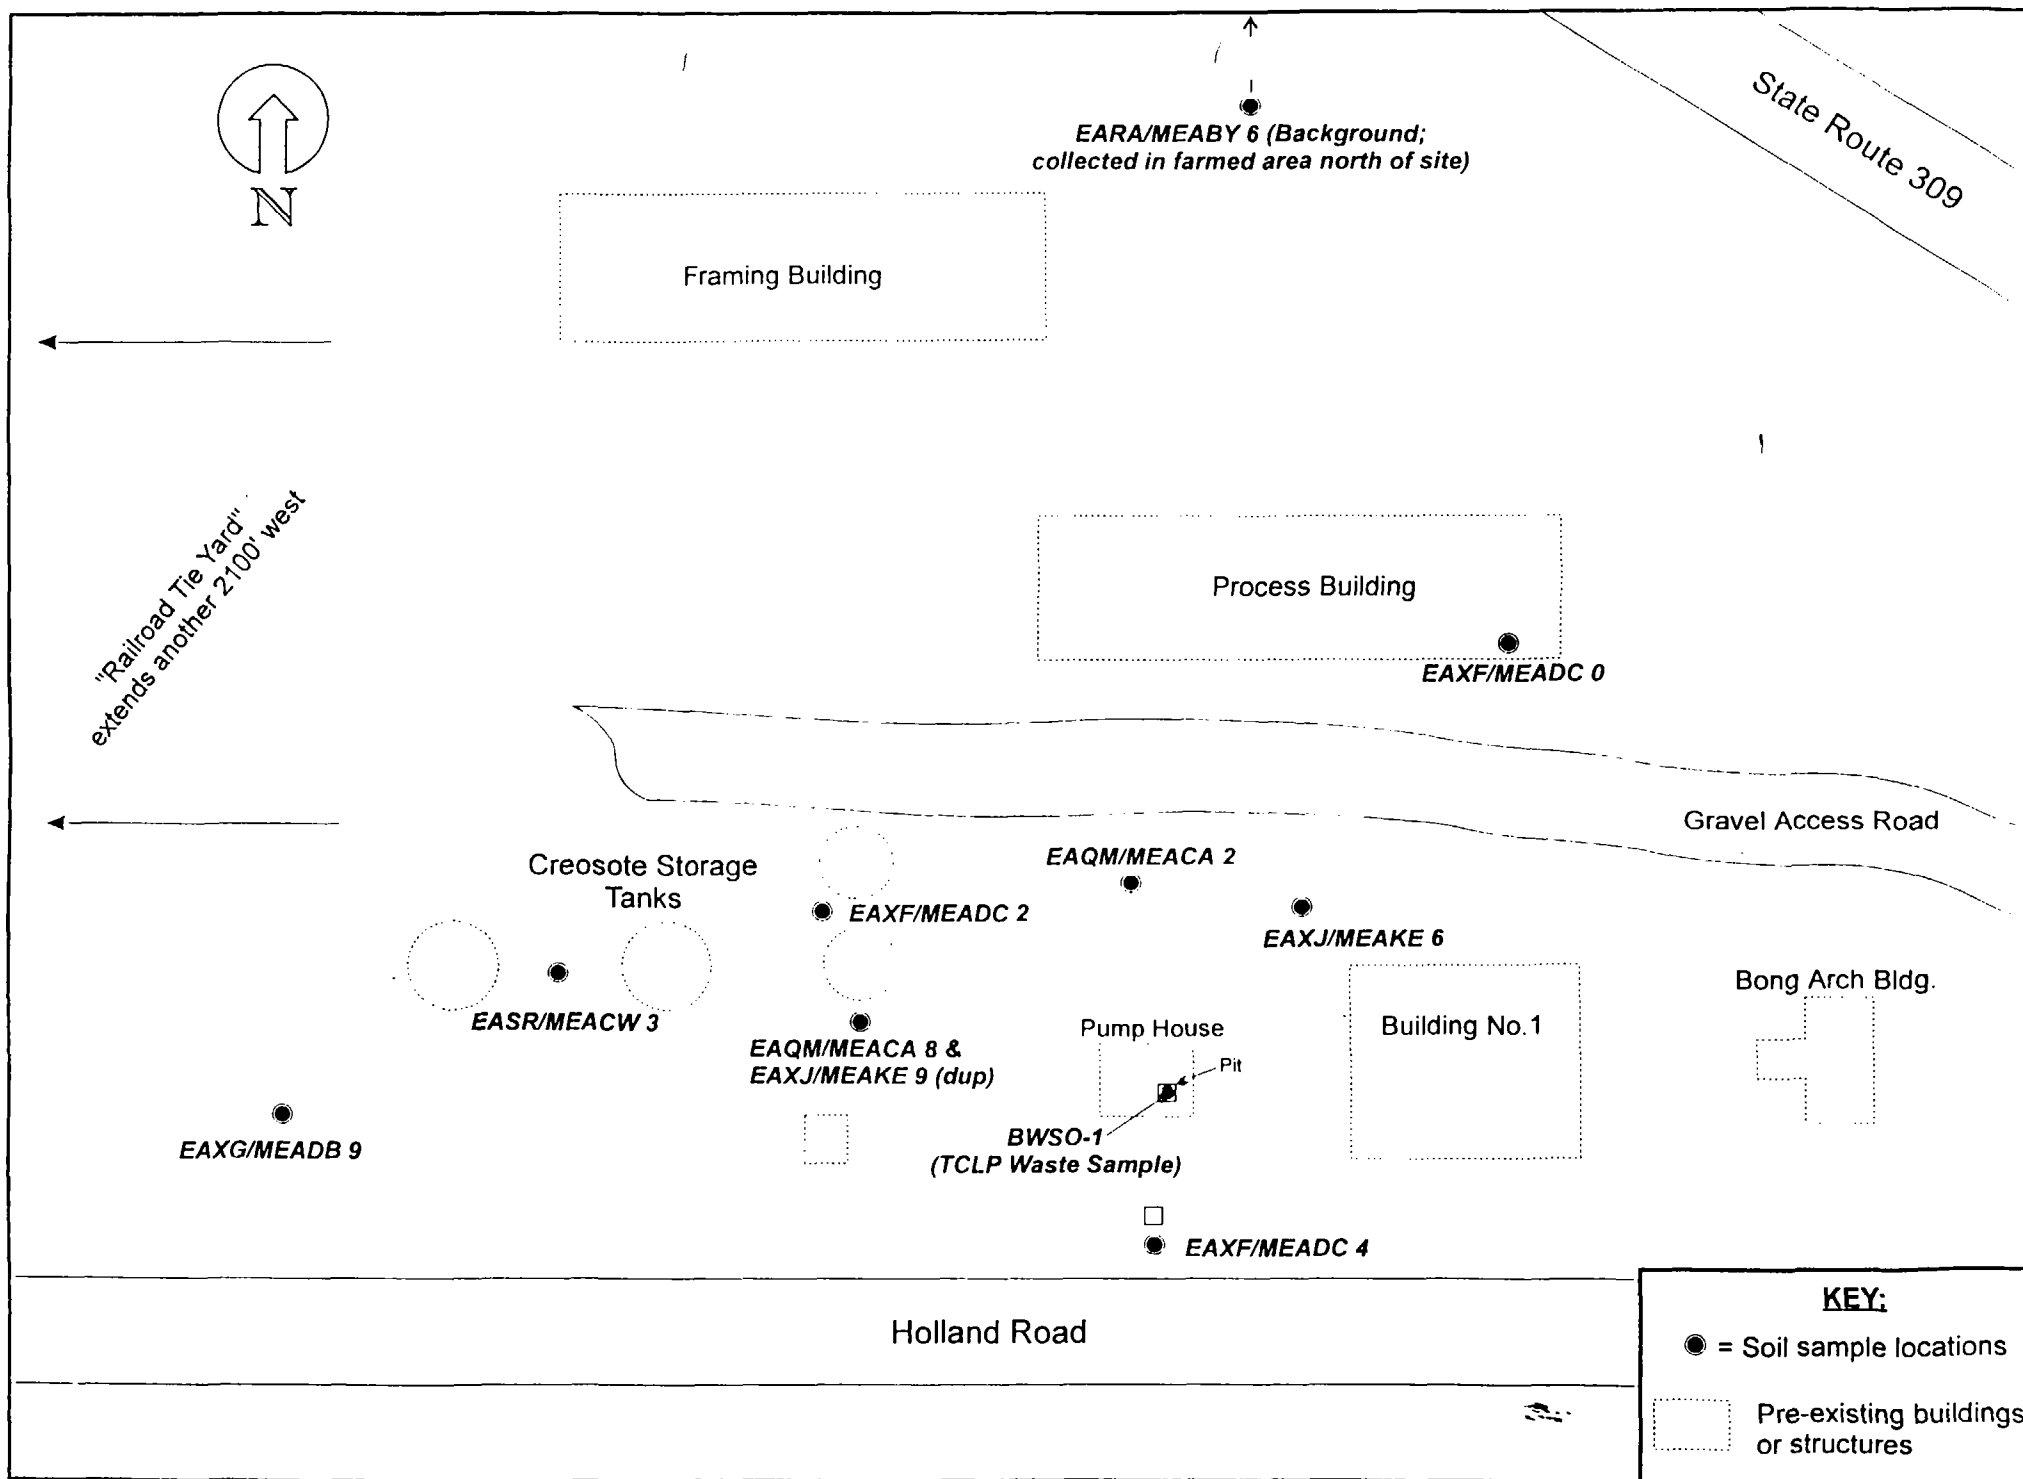
Figure 3: Baker Wood Creosoting Site - Soil Sample Location Map

With the exception of the background sample, all soil samples were collected between Holland Road and the site's gravel access road, in the vicinity of the old creosote storage tanks and the pre-existing pump house. Direct push techniques, utilizing a Geoprobe™, were employed to collect three of the soil samples at depths ranging from 6.5 to 12 feet below ground surface. All sample locations were chosen based on evaluation of historical records, aerial photographs, physical appearance of the potential source areas, or field screening results from portable air monitoring instrumentation (i.e., field photoionization detector).

pre-dominant semi-volatile compounds detected in the storage tank area soils within one foot from the surface: naphthalene, ranging from 2600 parts per billion (ppb) to 13,000,000 ppb; 2-methylnaphthalene, ranging from 1000 ppb to 7,700,000 ppb; acenaphthylene, as high as 27,000 ppb; acenaphthene, ranging from 460 ppb to 6,800,000 ppb; dibenzofuran, ranging from 940 ppb to 6,600,000 ppb; fluorene, ranging from 420 ppb to 10,000,000 ppb; phenanthrene, ranging from 1700 ppb to 20,000,000 ppb; anthracene, ranging from 1200 ppb to 33,000,000 ppb; carbazole, ranging from 740 ppb to 13,000,000 ppb; fluoranthene, ranging from 6700 ppb to 6,400,000 ppb; pyrene, ranging from 8000 ppb to 4,800,000 ppb; benzo(a)anthracene, ranging from 4700 ppb to 1,200,000 ppb; chrysene, ranging from 5000 ppb to 1,110,000 ppb; benzo(b)fluoranthene, as high as 780,000 ppb; benzo(k)fluoranthene, as high as 720,000 ppb; benzo(a)pyrene, ranging from 2900 ppb to 130,000 ppb; indeno(1,2,3-cd)pyrene, as high as 51,000 ppb; and benzo(g,h,i)perylene as high as 60,000 ppb.

Within the sampling limits of the investigation, the primary source of contamination at the Baker Wood Creosoting site are the soils saturated with creosote in the vicinity of the bulk storage tank area and pump house. This source area is approximately 250 feet by 375 feet, or approximately 93,750 square feet. It should be noted that during the sampling event, in what may have been the old pump house, a small pit or sump hole was observed to be filled with pure creosote product.

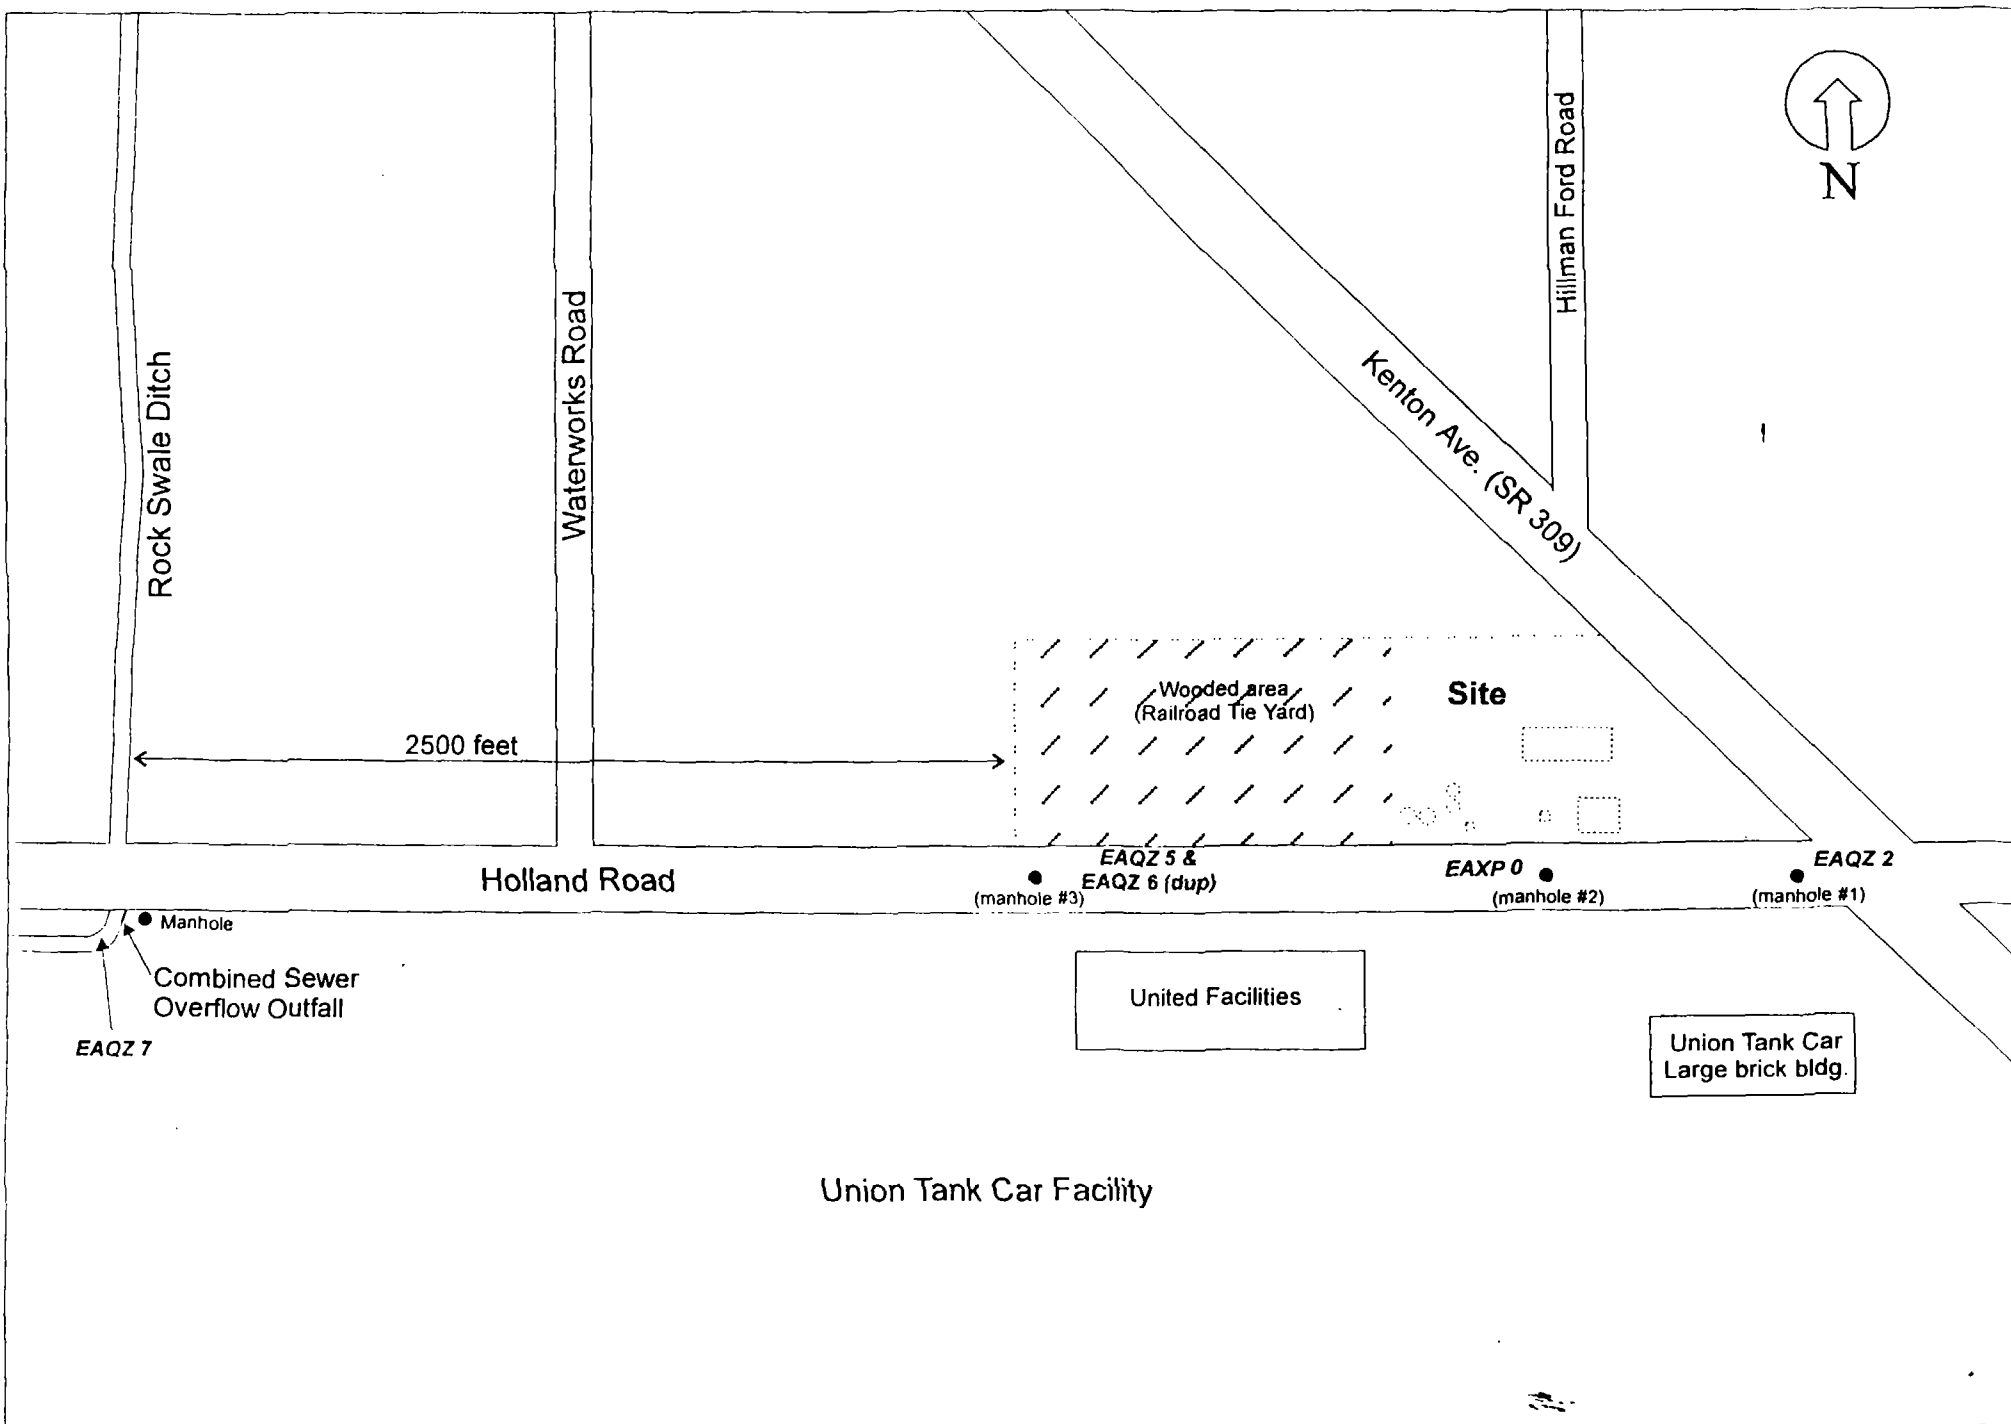
Figure 4: Baker Wood Creosoting Site - Sewer Manhole Map for Surface Water Samples (selected for TCL organics only)

Using bucket immersion techniques, water samples were collected from the sewer through manholes opened along Holland Road (Figure 4). Three sewer locations were sampled; one upstream of the site (manhole #1), one adjacent to the site (manhole #2), and one south of the site's western border (manhole #3). Additionally, the surface water in North Rockswale Ditch was sampled downstream of the sewer outfall, just south of Holland Road.

Five semi-volatile compounds, which were detected in on-site soils, were also detected in the water samples (EAQZ 5 & EAQZ 6) collected from manhole #3, located just west of the site on Holland Road, across from United Facilities.

An observed release to the surface water has been documented by both direct observation and analytical data. While sampling the sewer main, the water collected adjacent to and downstream from the site was observed to have an oily sheen. Chemical analysis confirmed the presence of five semi-volatile compounds which were also identified in on-site soils. The probable point of entry into North Rockswale Ditch is most likely the combined sanitary/storm sewer. Future work is planned in performing a sewer survey using a remote unit to identify any/all potential connections from the site and whether these connection are actively releasing to the sewer main.
