## FINAL 2006 CLEANUP STATUS REPORT VELSICOL CHEMICAL/PINE RIVER SITE

St. Louis, Michigan

Phase 2 Remedial Action

December 2006

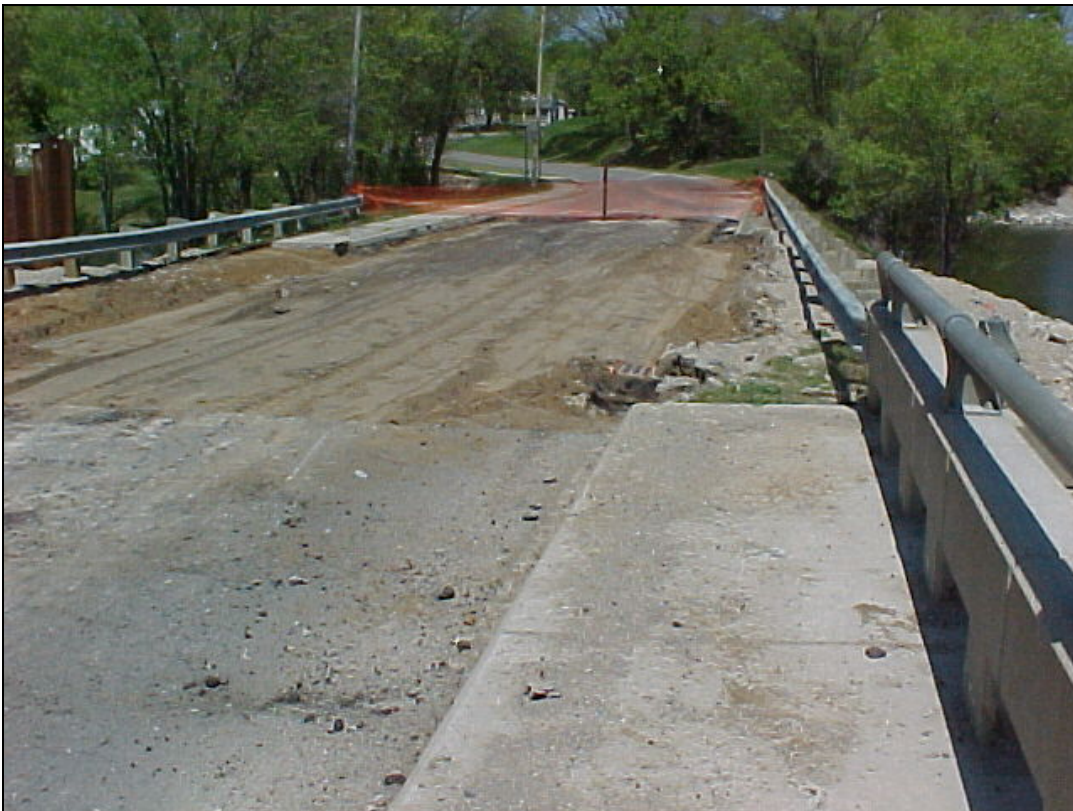
PHOTO 6—Damaged portion of Mill Street and adjoining sidewalk removed in May 2006.

On July 8, 2005, CH2M HILL had conducted a preclosure inspection of the Mill Street Bridge and nearby structures (that is, curb and gutter, sidewalks, etc.) that documented the preclosure condition. Removal of the temporary haul road over Mill Street in December 2005 exposed some surficial damage to the roadway, curbing, and sidewalks. A formal post construction inspection was performed by CH2M HILL on April 26, 2006, that documented the condition of the bridge and nearby structures. All significant damage that occurred between the two inspections was repaired by NES in May 2006.

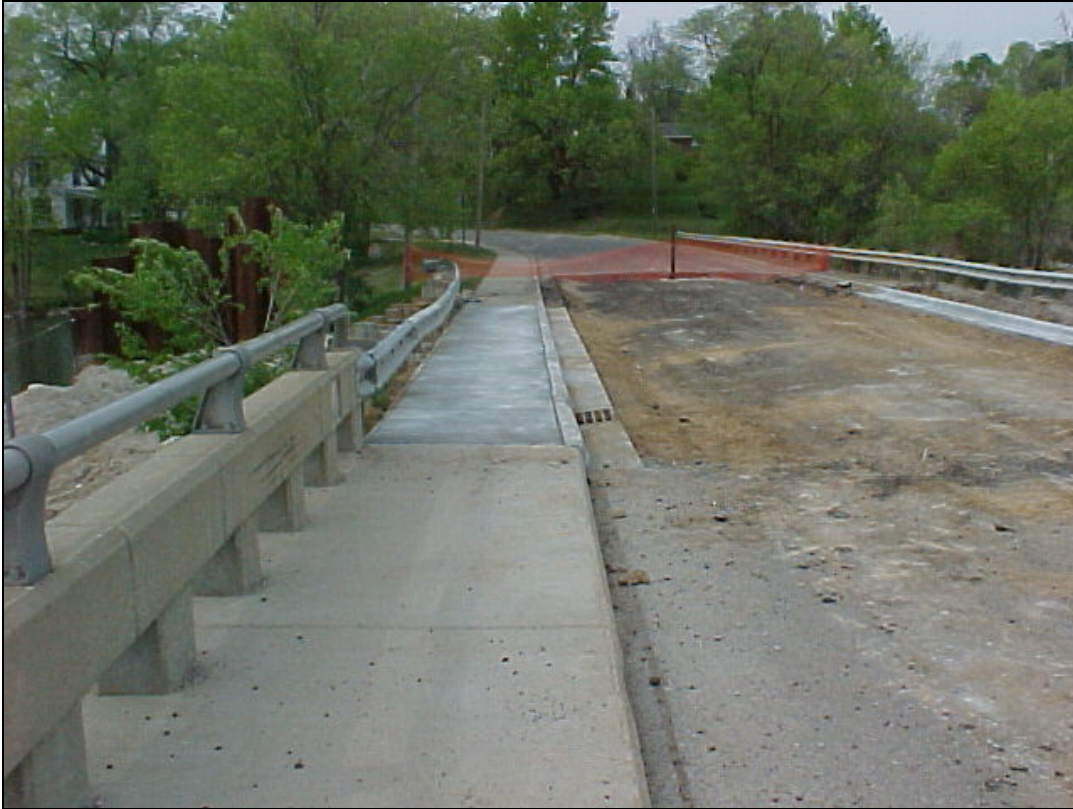
PHOTO 7—Previously damaged sidewalk after replacement in May 2006.

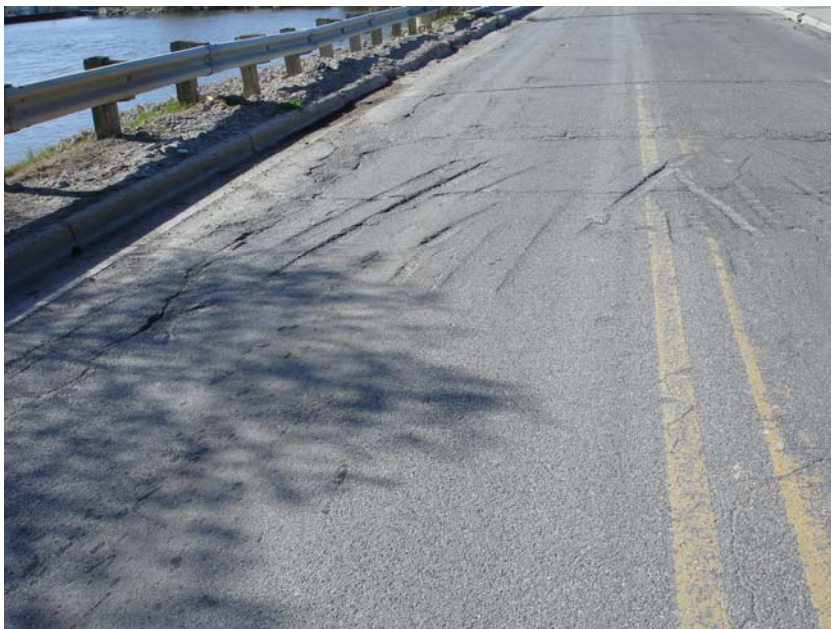
The north and south approach pavements are in poor condition. Most of the deterioration was documented during the July, 2005 inspection. Significant additional deterioration of the north approach was noted during the April 26, 2006 inspection. This has occurred where a haul road was constructed and includes deep ruts which are most likely a direct result of constructing and removing the haul road (Photograph 6). The roadway has settled in this area (Photograph 7). There are several locations where the patched asphalt has failed, resulting in holes through the top course.

*Photograph 6 - North approach pavement damage*

The bituminous wearing surface and south approach pavement are heavily cracked and may need to be repaired or replaced once the adjacent USEPA remedial activities are complete. The southwest quadrant will need to be monitored for settlement.

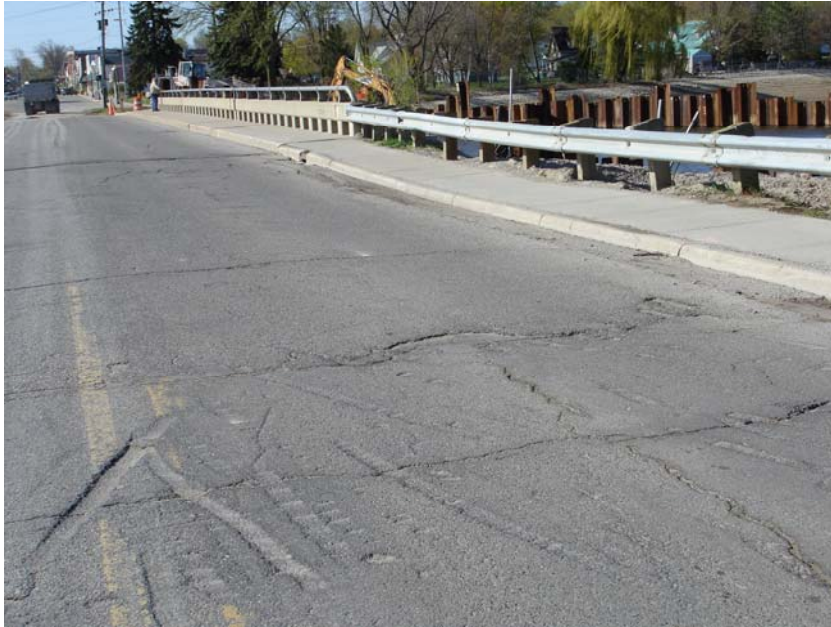
*Photograph 7 - North approach pavement damage*

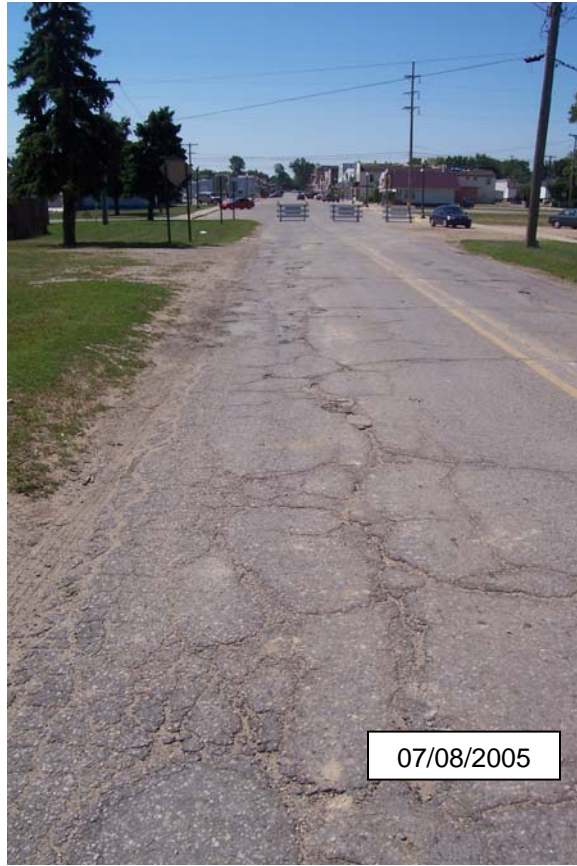
*Photograph 21 - Southeast approach shoulder deterioration*

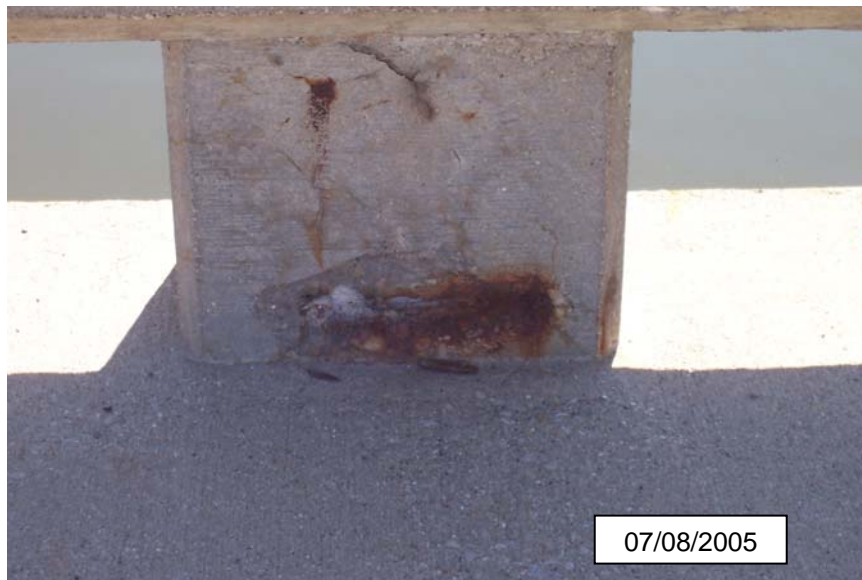
Overall, the changes in the bridge condition since the July, 2005 inspection were minimal. The asphalt wearing surface on the deck has more cracking and ruts than the previous inspection, but the minor damage is not substantial enough to change the condition rating of the deck. The open concrete parapet railings remain in fair condition.

*Photograph 22 - Representative parapet base spalling*

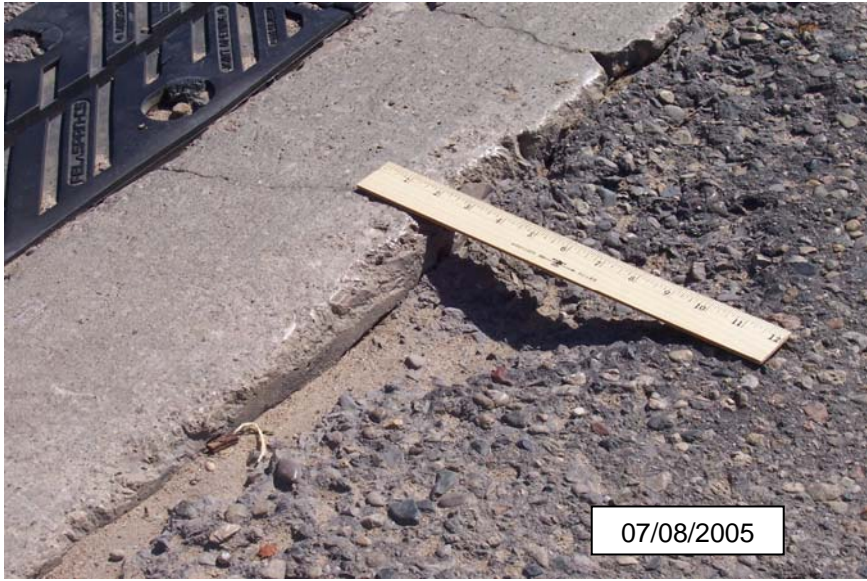
The expansion joint at pier 1 remains in fair to poor condition, and the expansion joint at pier 2 remains in good condition.

*Photograph 23 - Asphalt condition at Pier 2 Expansion Joint*

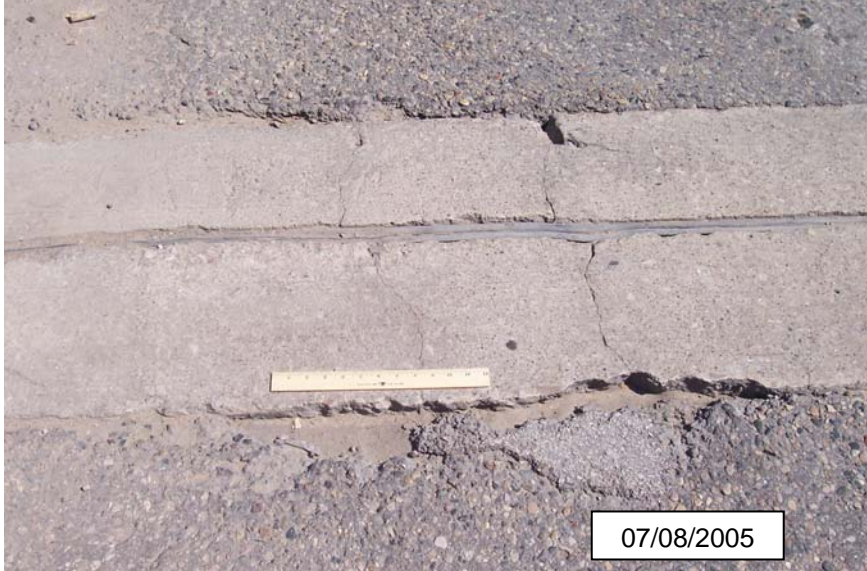
*Photograph 24 - Asphalt condition at Pier 1 Expansion Joint*

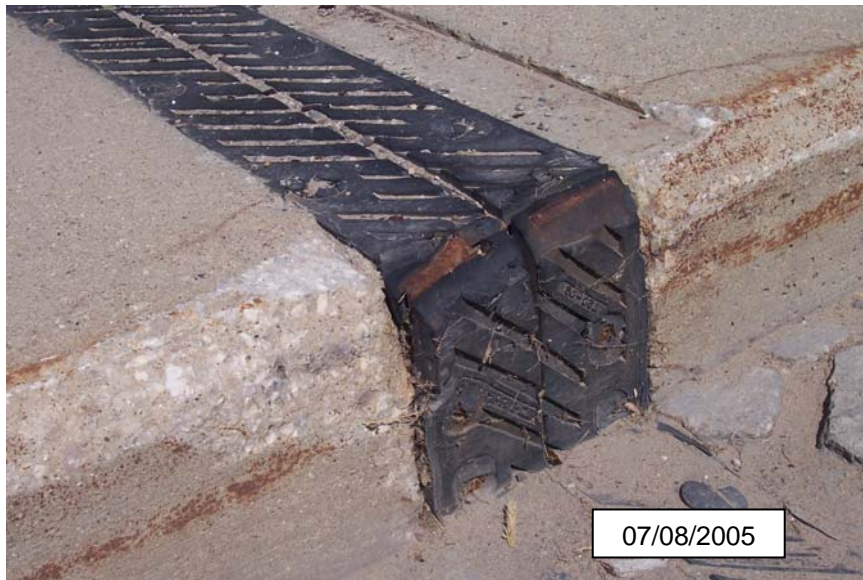
*Photograph 25 - Pier 2 expansion joint damage*

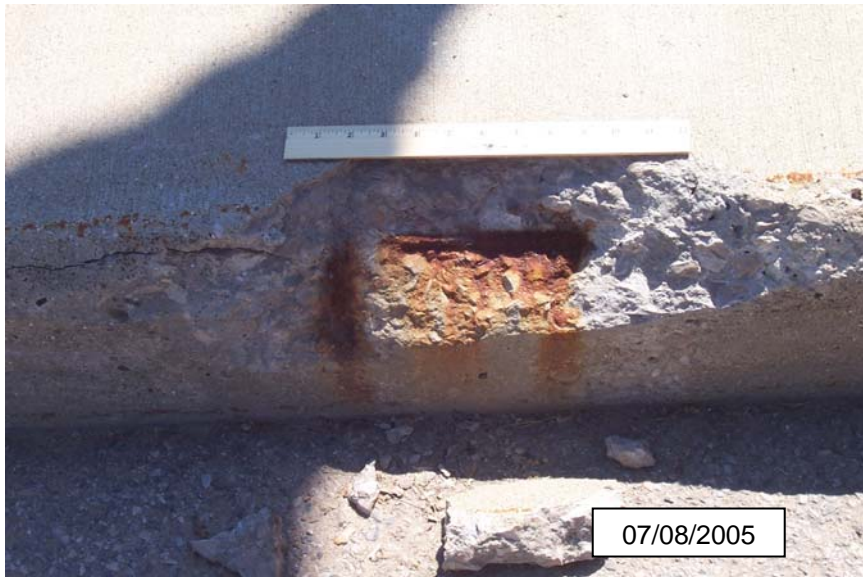
*Photograph 26 - Curb spall at southeast corner*

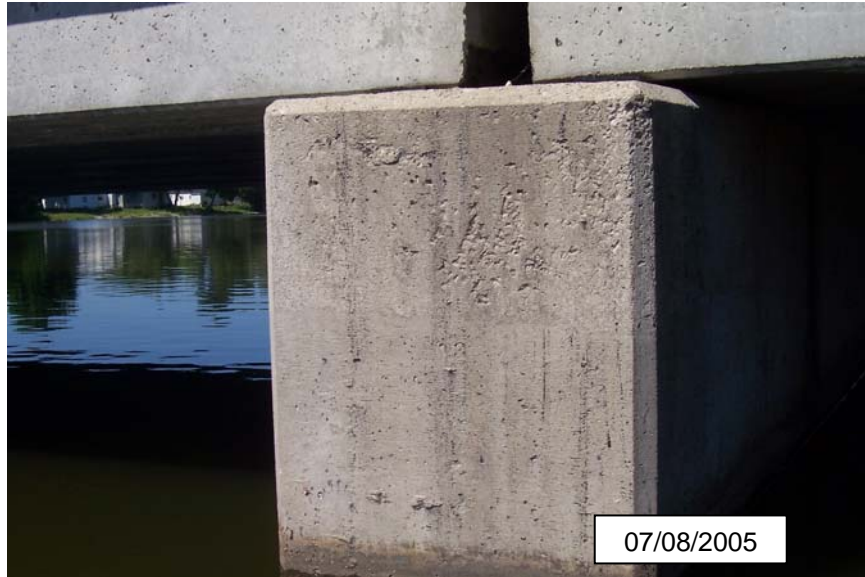
*Photograph 27 - East face of Pier 2 showing scaling*

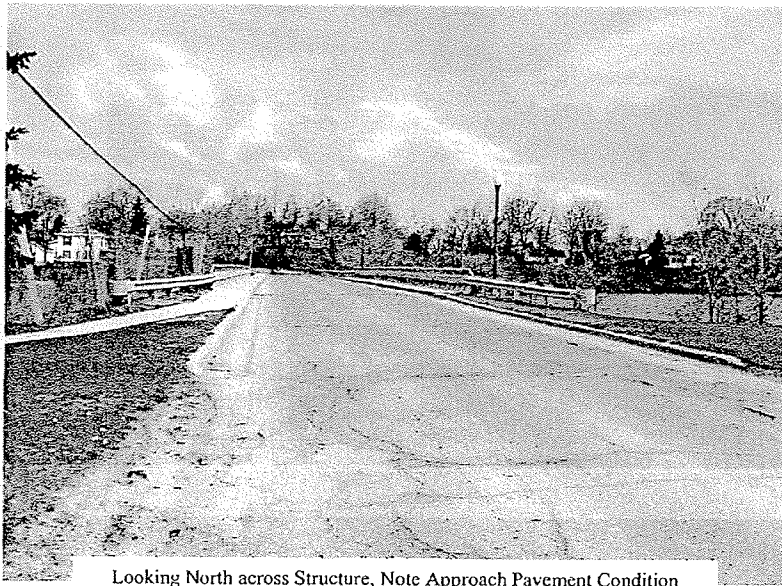
Looking North across Structure, Note Approach Pavement Condition
