### FOURTH FIVE-YEAR REVIEW REPORT FOR SOUTH POINT PLANT SUPERFUND SITE LAWRENCE COUNTY, OHIO

U.S. Environmental Protection Agency Region 5 Chicago, Illinois

4/9/2021

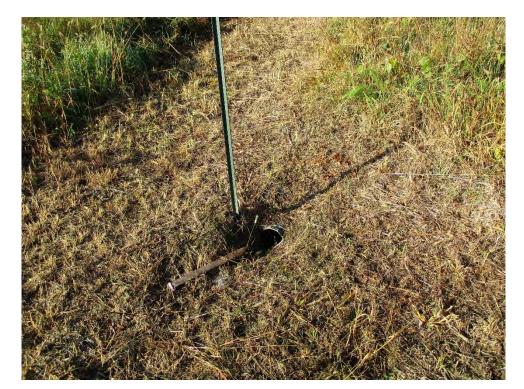
PHOTO 1:

Northwest Cap Drain (Flex)

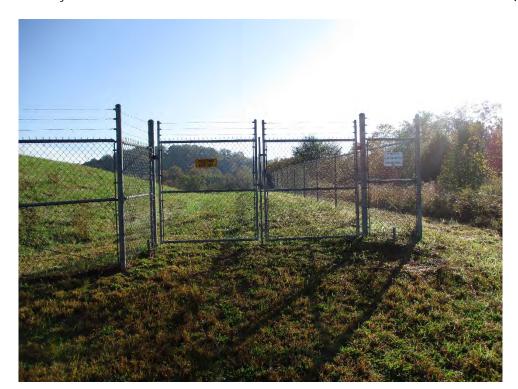
**PHOTO 3:**

Gate on South End of Cap looking West

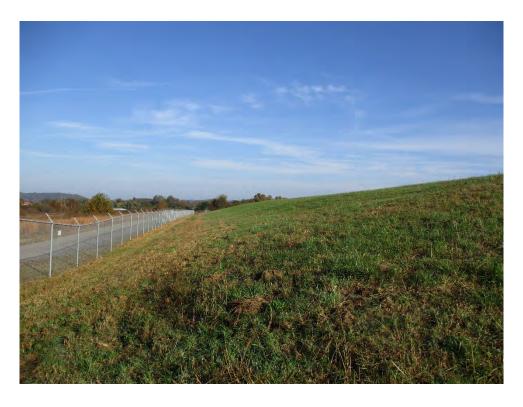
PHOTO 4:

South Side of Cap

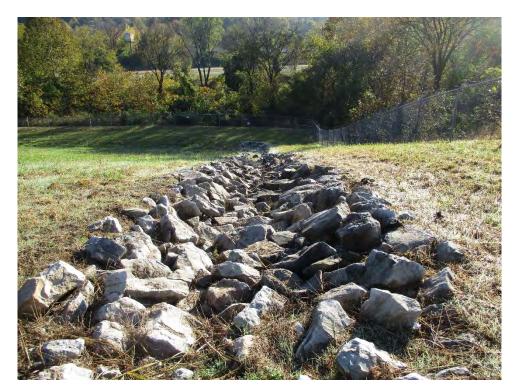
**PHOTO 5:**

Ditch Line on South Side of Cap

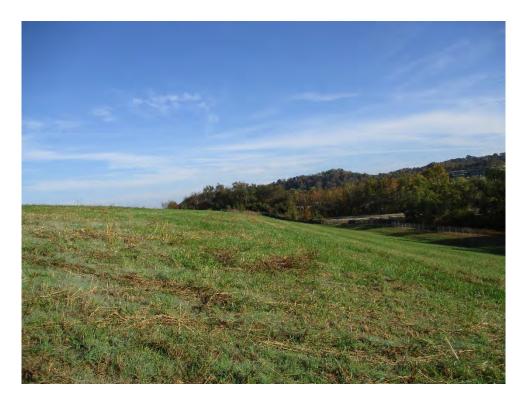
PHOTO 6:

North Side of Cap looking West

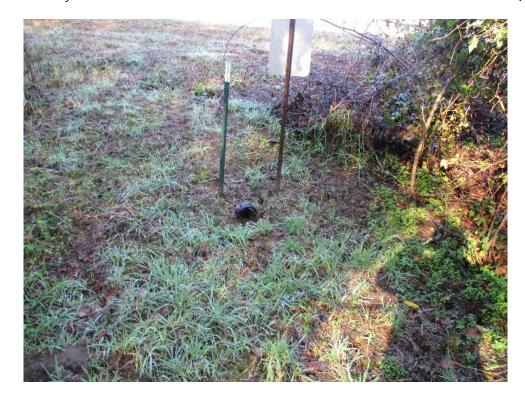
PHOTO 7:

Northeast Cap Drain (Flex)

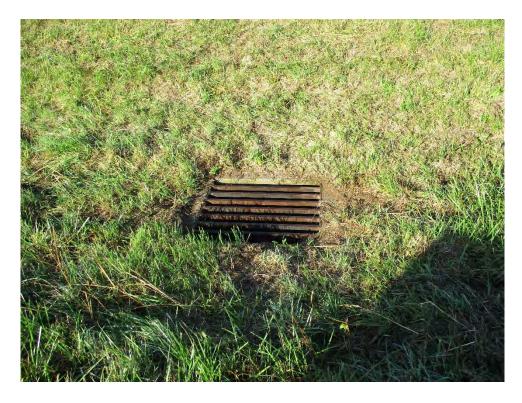
### **PHOTO 8:**

Cap Drain on North Side of Cap

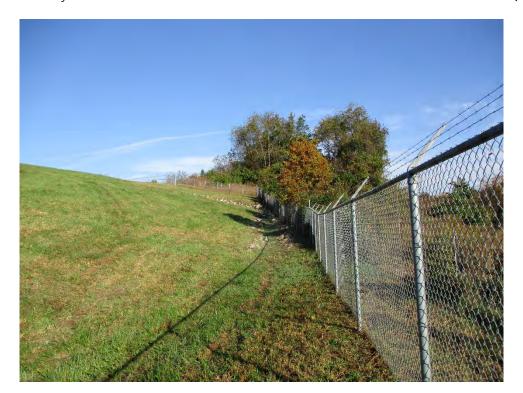
**PHOTO 9:**

Ditch Line on North Side looking Uphill

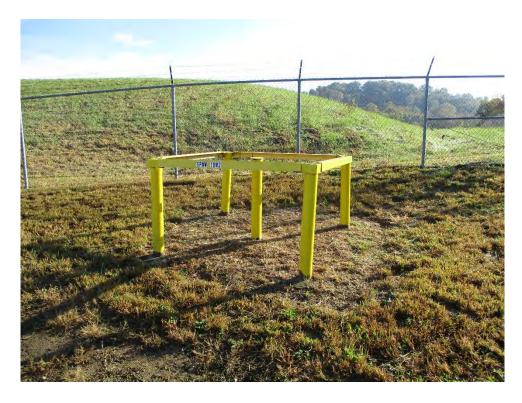
**PHOTO 10:**

SPMW-10R2

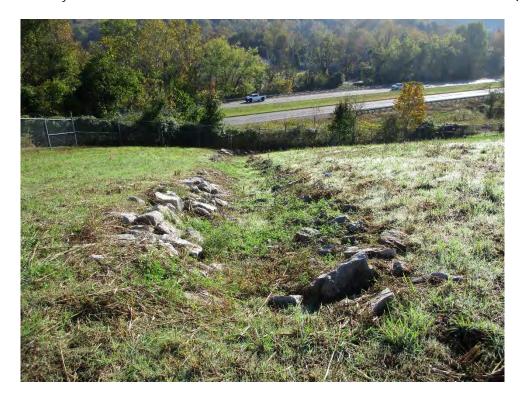
**PHOTO 11:**

Ditch Line on North Side looking Downhill

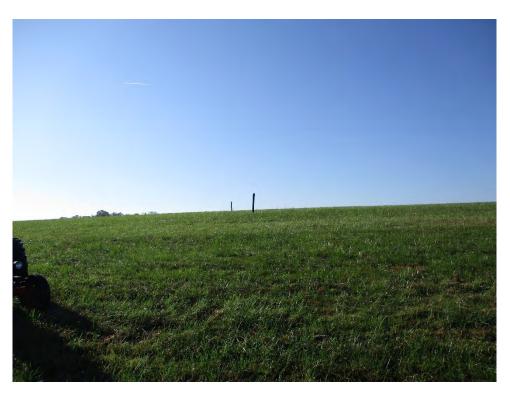
**PHOTO 12:**

Vents on Top of the Cap

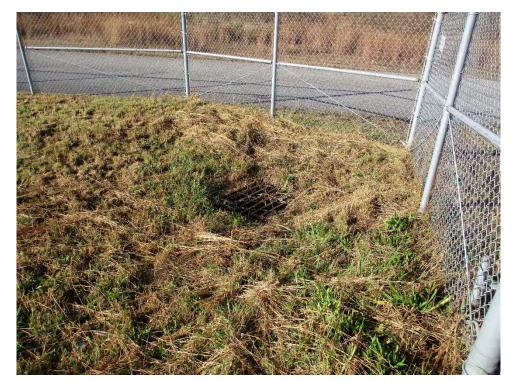
**PHOTO 13:**

Drain on North Side of the Cap

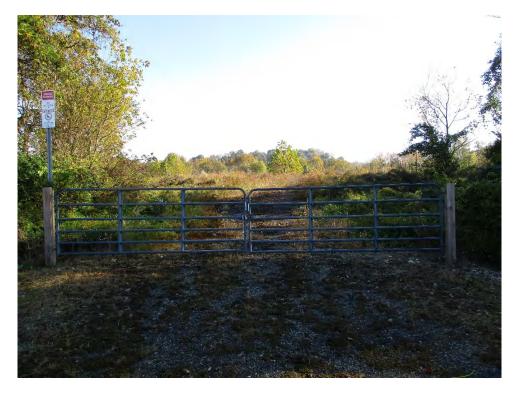
### **PHOTO 14:**

Fly Ash Pond Gate

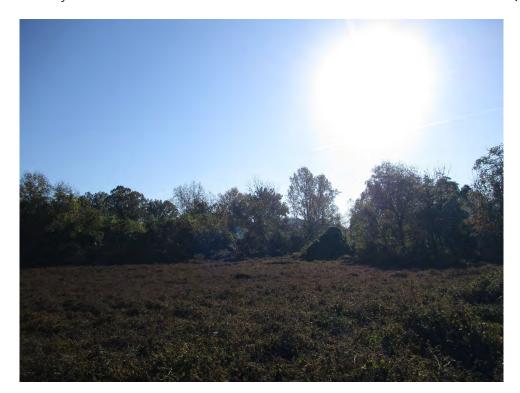
**PHOTO 15:**

Fly Ash Pond looking Southeast

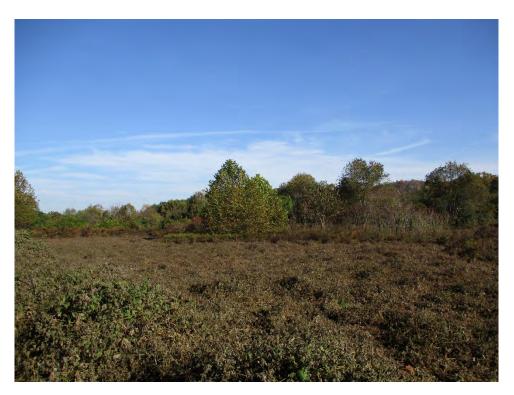
**PHOTO 16:**

Fly Ash Pond looking Northwest

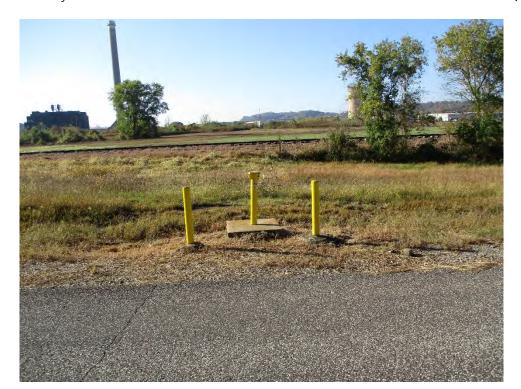
**PHOTO 17:**

OEPA's Site Inspection Email with accompanying photograph is included in Appendix C - Attachment 2. During the inspection, OEPA, Jacobs, and Wood discussed the re-stenciling of monitoring well SPMW-08. They also started a conversation about the future management of some woody vegetation observed on the cap. Currently, monitoring the growth and frequent mowing (approximately 3 times per year) appears to be sufficient management at this time. No other issues were encountered during the annual inspection.

SPMW-08

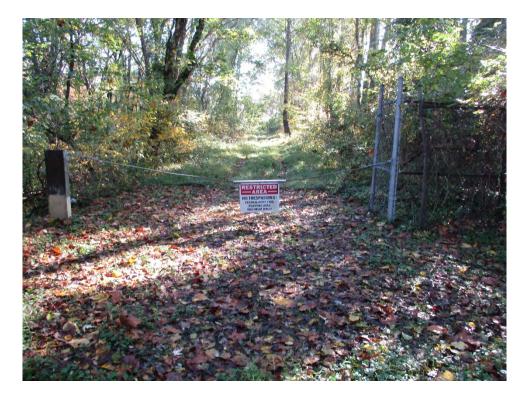
### **PHOTO 18:**

Chain Gate to SPMW-09

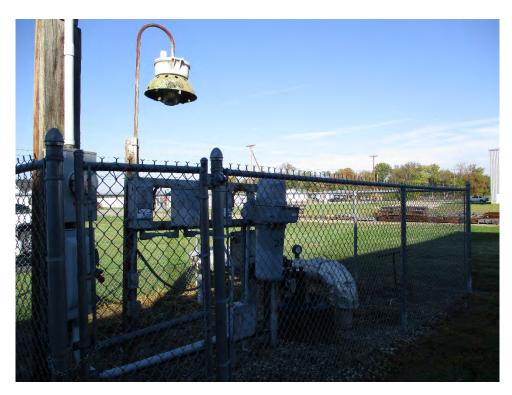
PHOTO 20:

SPIS-23

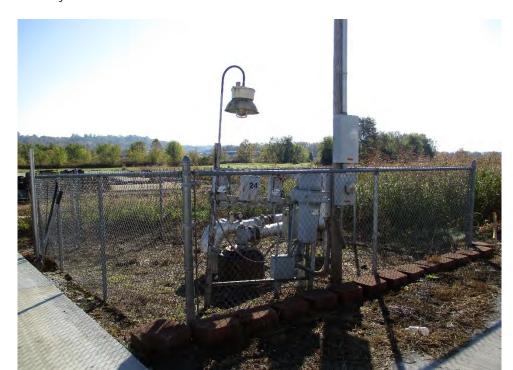
PHOTO 21:

SPIS-24

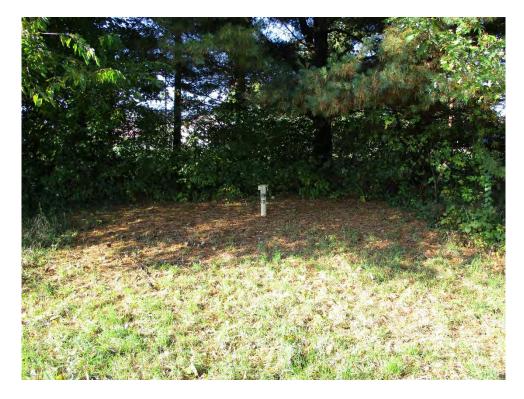
PHOTO 22:

SPMW-12

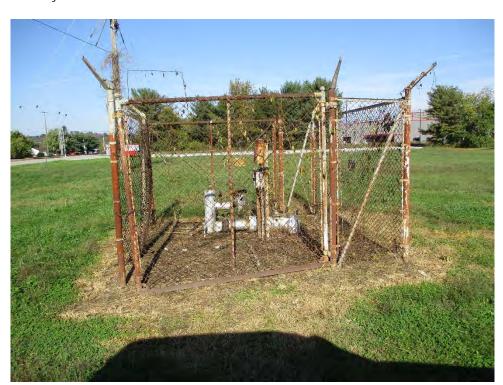
**PHOTO 25:**

SPIS-10
