Memorandum

Re: San Jacinto River Channel Slope Maintenance Completion Report

Re: Revised Plan for Armor Rock Placement Adjacent to the Time Critical Removal Action
Armored Cap, San Jacinto River Waste Pits Superfund Site, Channelview, Texas

July 2016 Quarterly Inspection Report

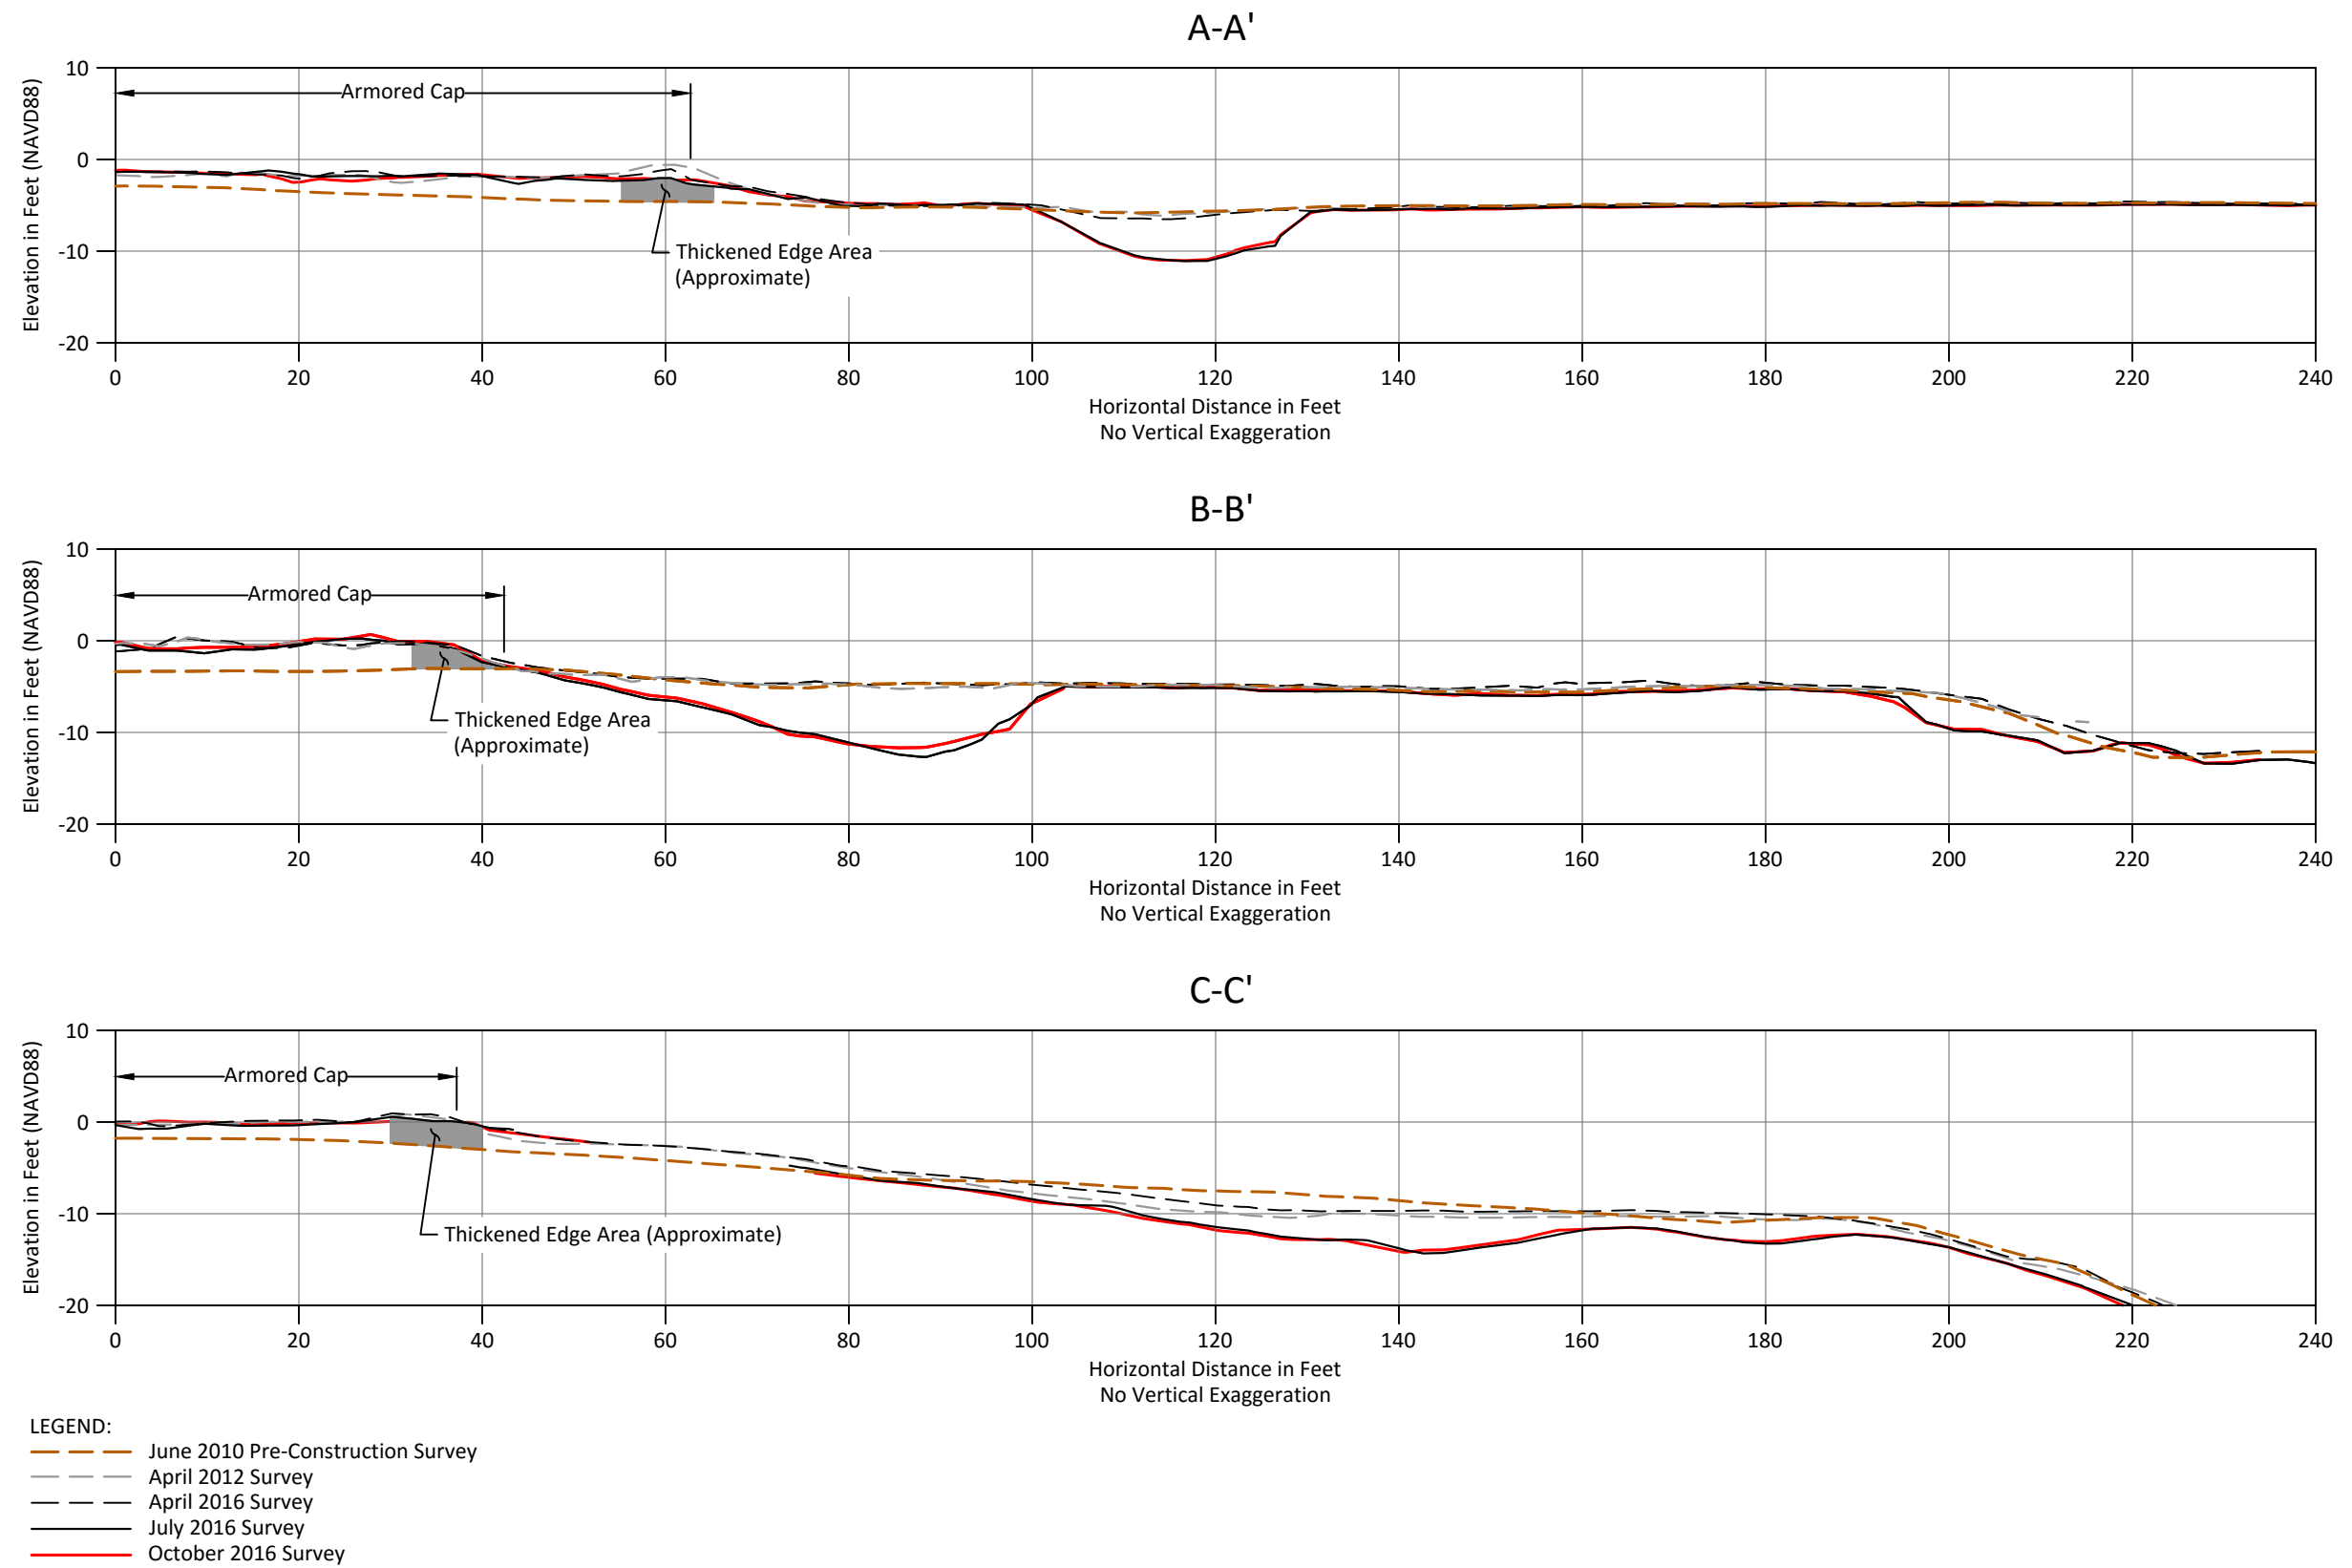
Localized deeper areas (Sections A, B, and C on Figures 1 and 2) were identified in the river channel when comparing quarterly bathymetric surveys conducted by Anchor QEA, LLC, in accordance with

the TCRA Operations, Monitoring, and Maintenance Plan (Anchor QEA 2011).¹ The deeper areas are likely the result of high flows during large storm events that occurred between April and June 2016. One storm, in May 2016, was between a 20- and a 50-year return interval storm based on river stage elevations measured at US-90. The Armored Cap was not damaged by this flood; however, this plan proposes to fortify the area shown in Cross Section B of Figure 2.

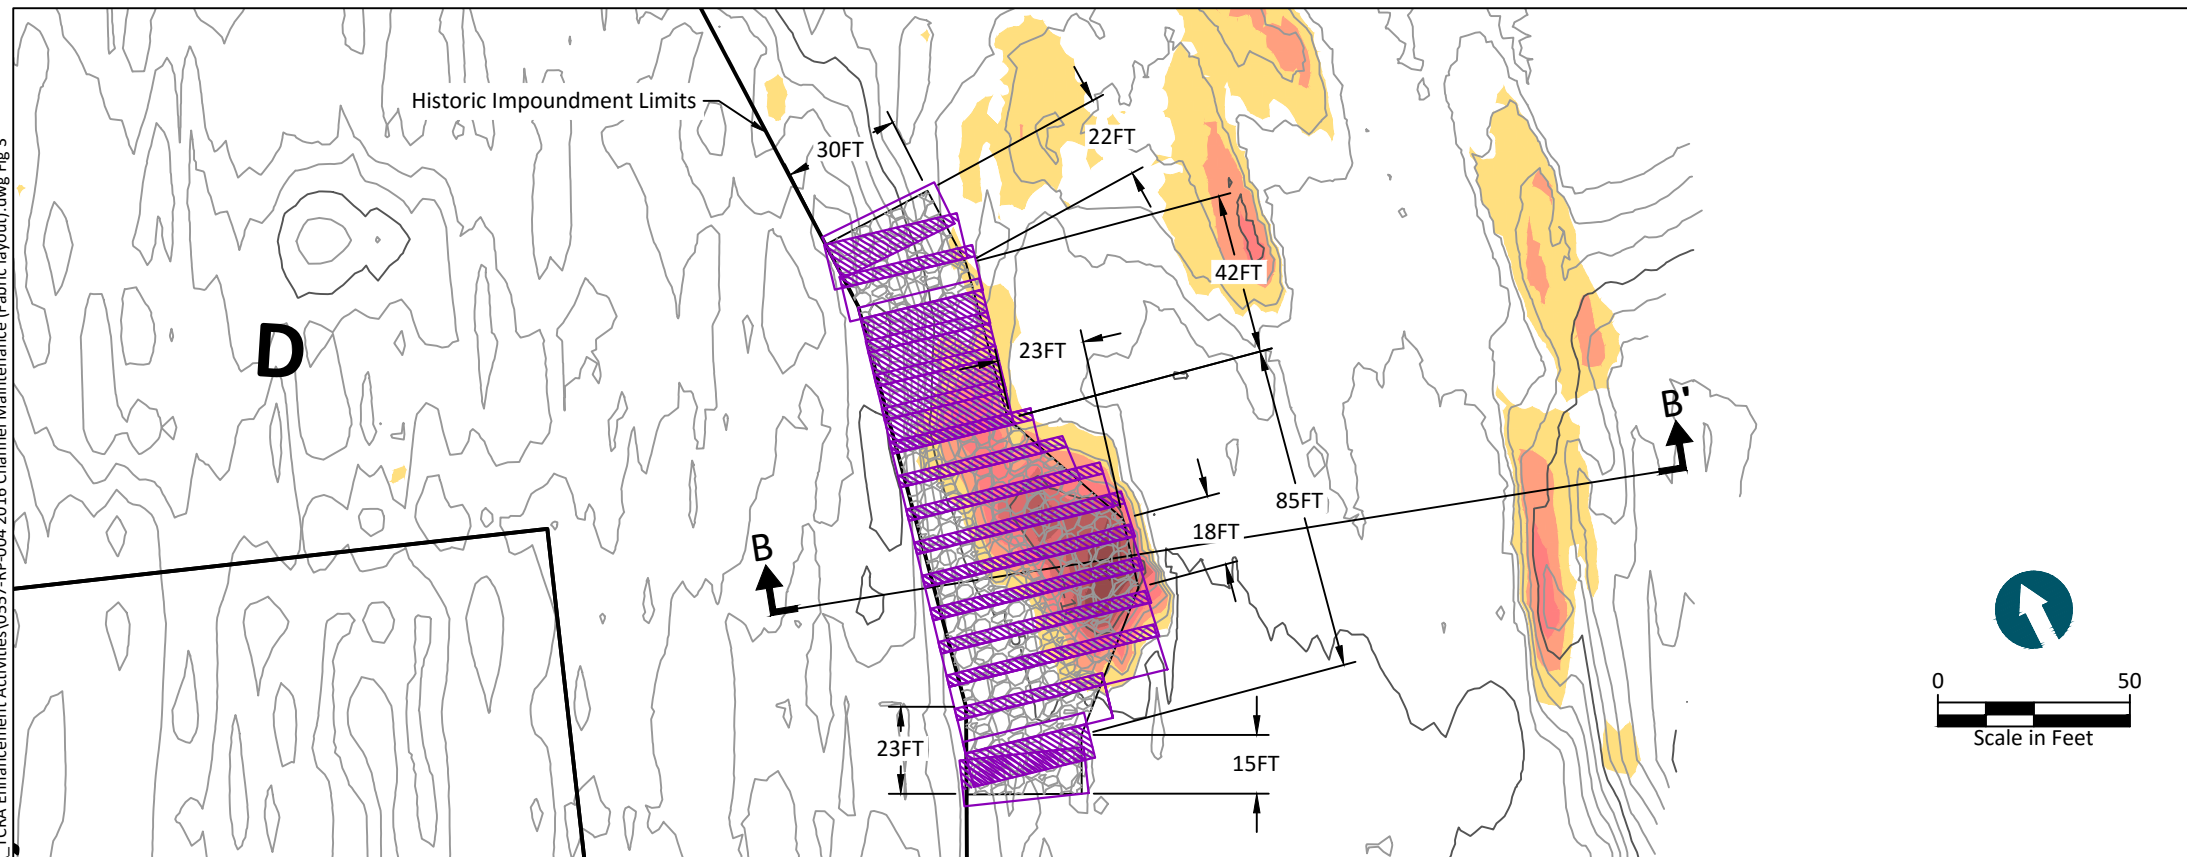
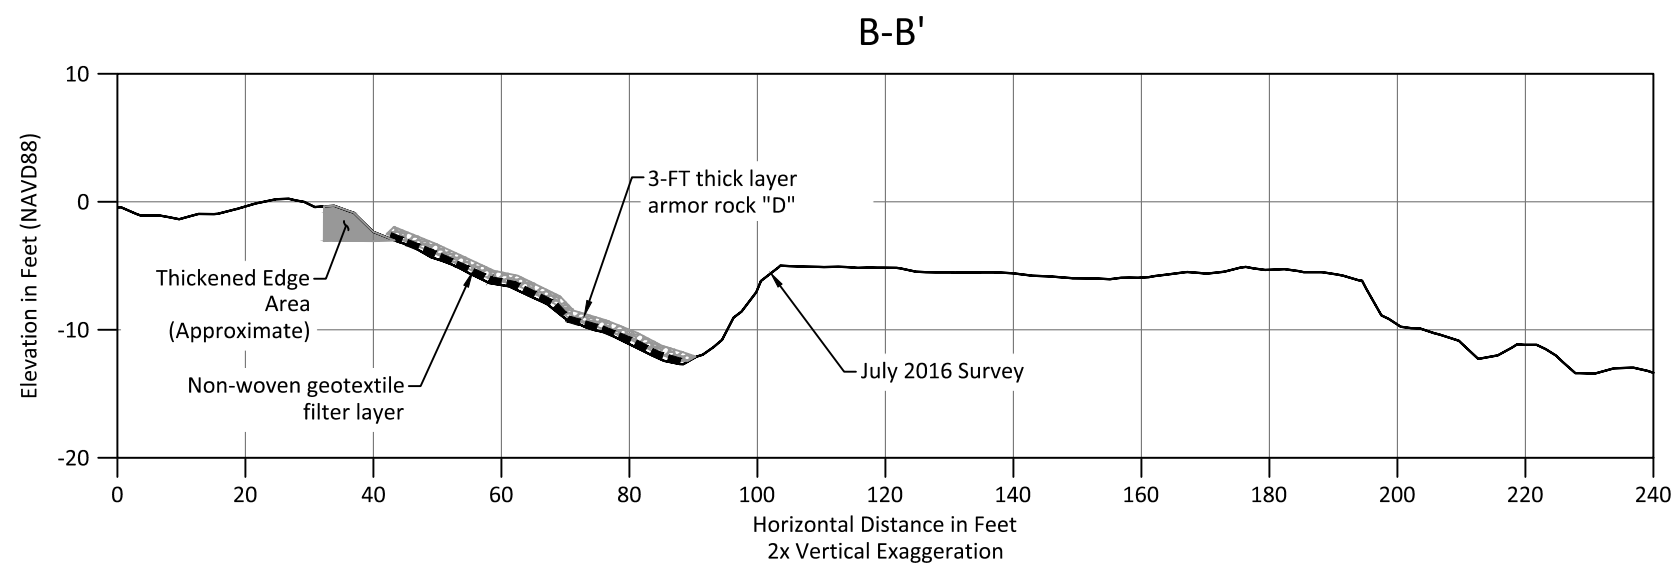
Figure 3 presents a focused plan view and detailed cross section of the proposed river erosion protection construction. Based on these criteria, a surface area of approximately 5,800 square feet will be included in this maintenance event, and an estimated 800 cubic yards of armor rock D will be placed.

geotextile panels, the contractor will place the required thickness of rock in the maintenance area (Figure 3).

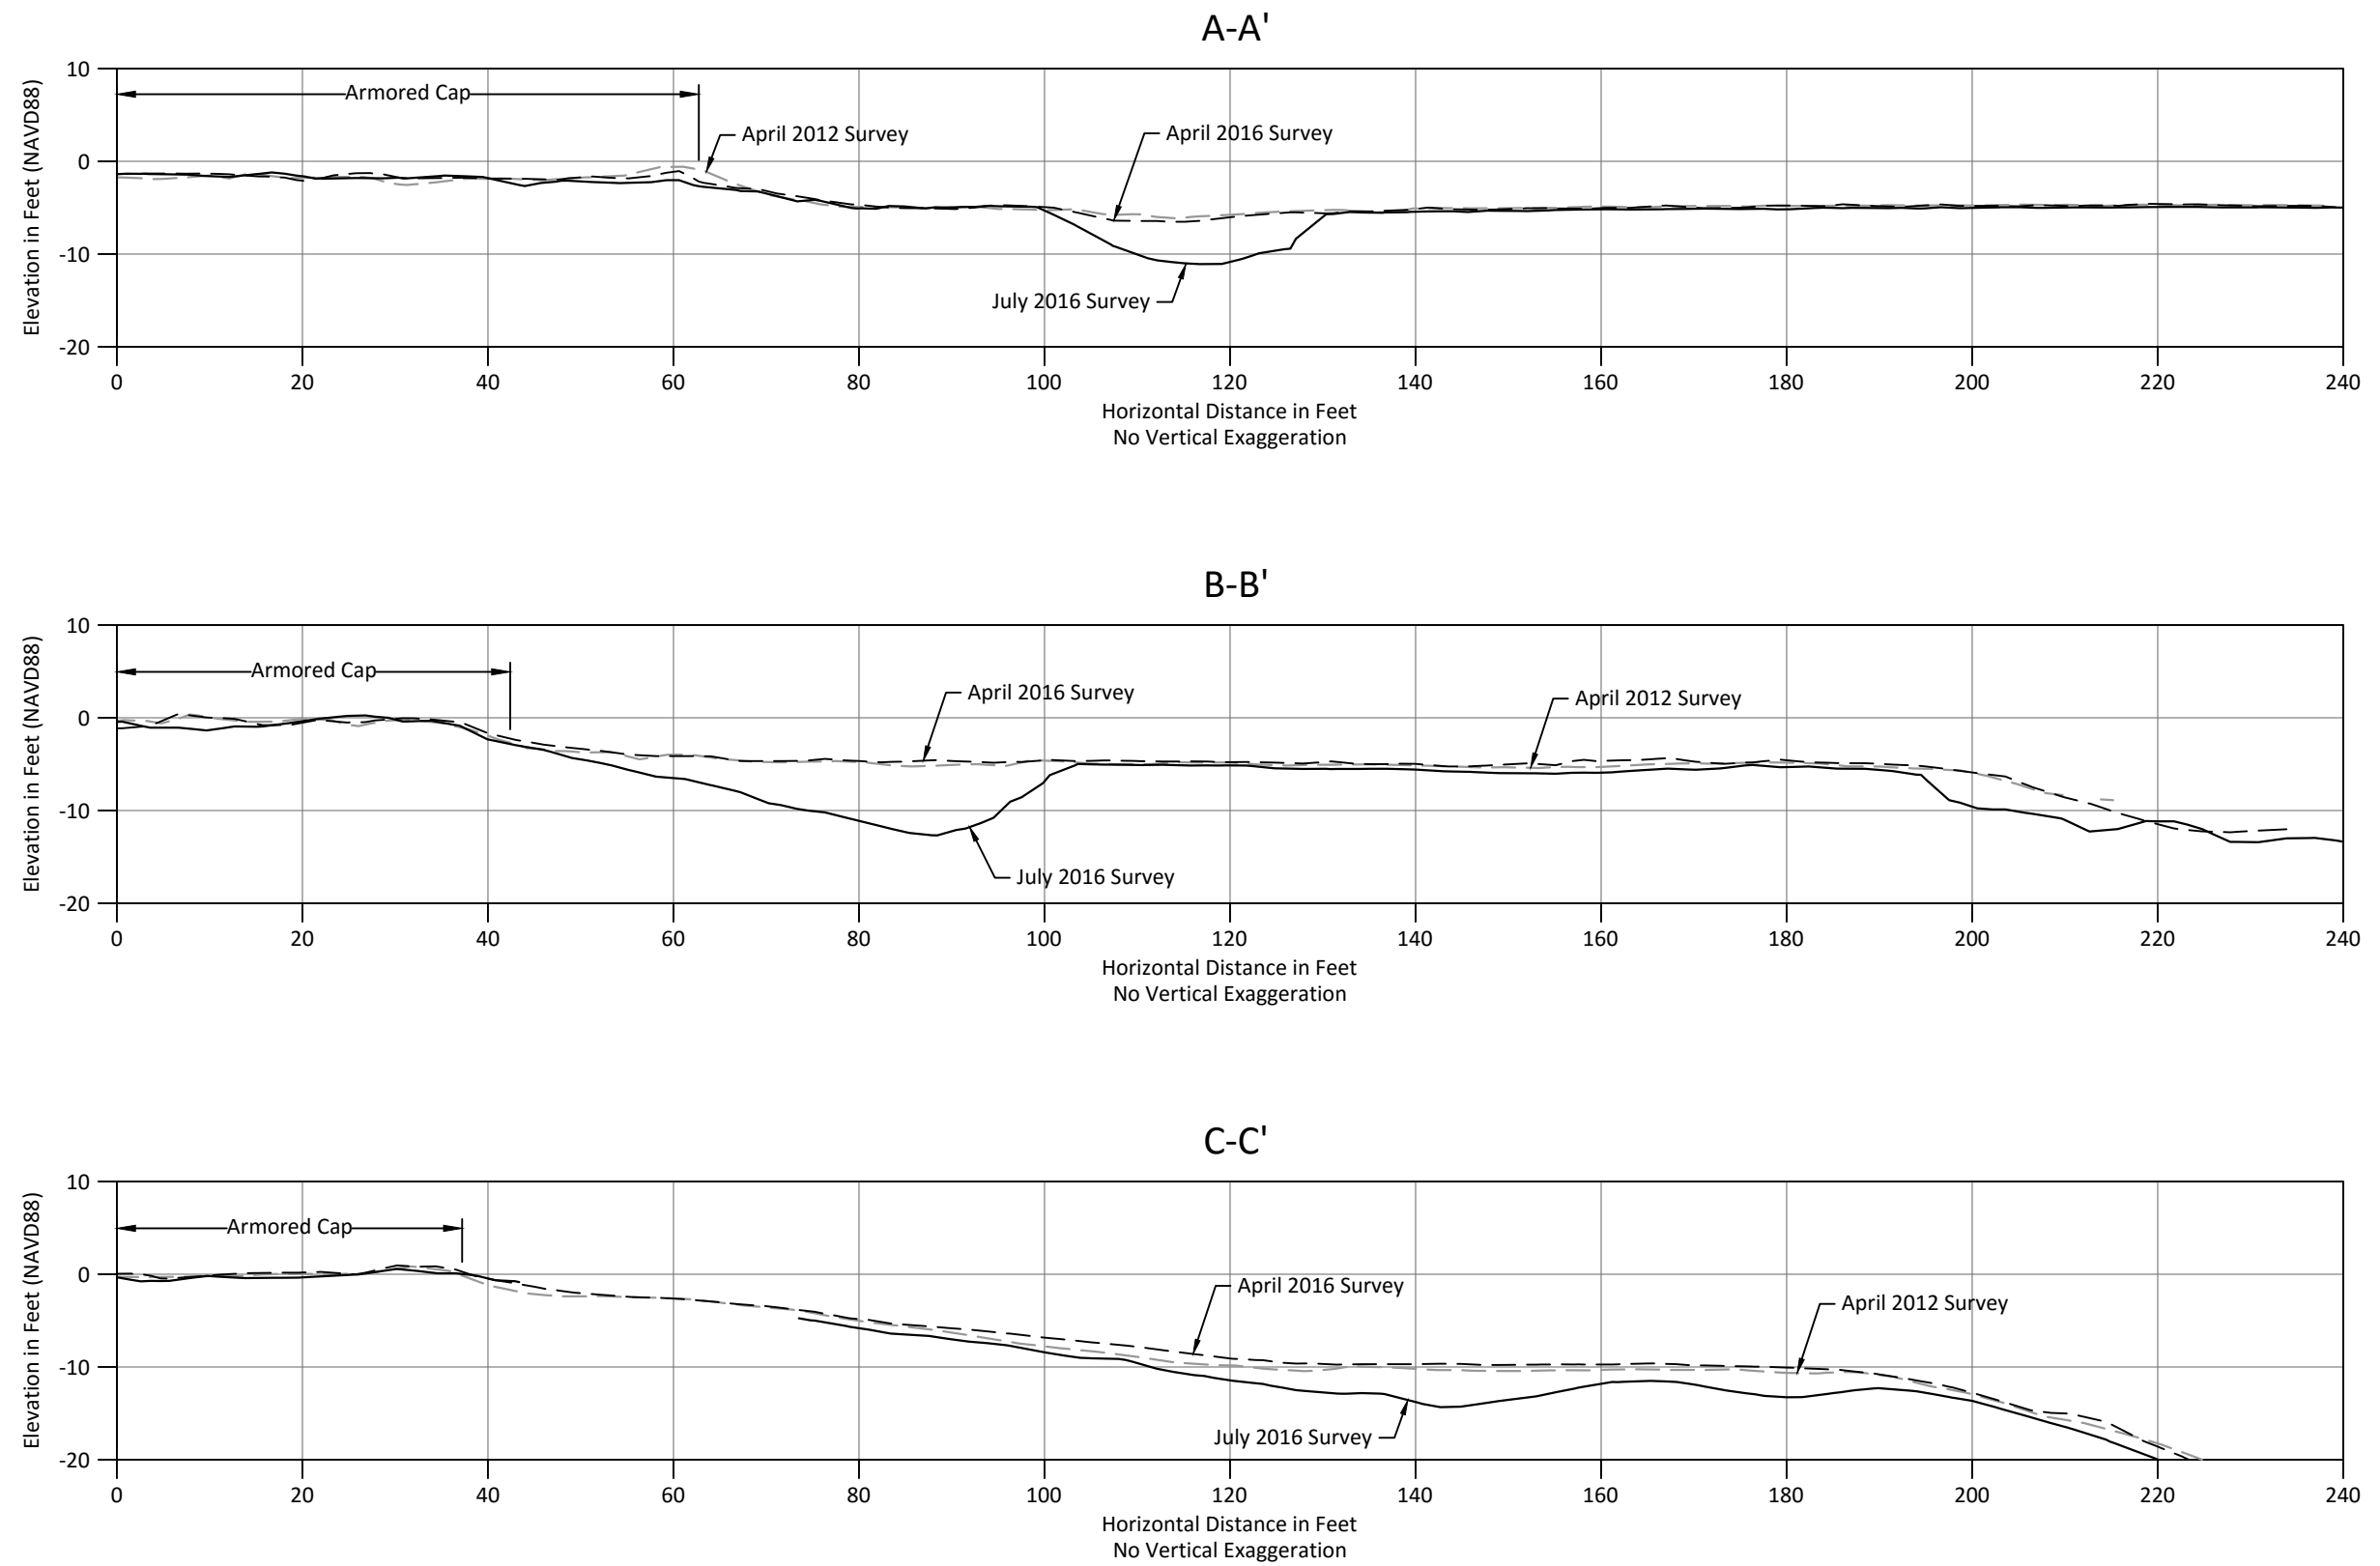
The survey data from the July 2016 inspection survey and the April 2016 survey were compared to evaluate the differences in the top of the armored cap elevation. These differences are shaded and shown on Figure 3. The survey results indicate the sediment had been scoured outside the perimeter of the Eastern Cell. Similar scouring was not observed on the armored cap itself.

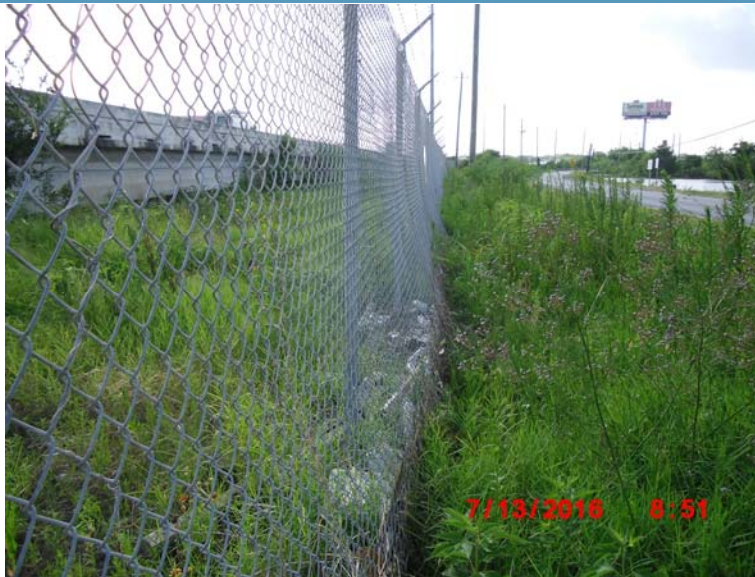
The perimeter fencing (Figure 2) on the west and east banks of the San Jacinto River was visually inspected for breaches or other signs of damage on July 13, 2016. The fencing on the west bank on the south side of I-10 was observed to be detached at the bottom and pushed away about 1 foot from the fence posts. Based on the debris build up on the ground, the damage was likely caused by high river levels during recent flood events in June 2016. Repairs of the fencing began on July 27, 2016 and were completed on July 29, 2016. The repairs to the fencing included pulling the fence back into place, replacement of the lower tension wires, and replacement of the couplings holding the fabric to the fence in the affected area. Photographs 17 and 20 in Appendix A show the damaged and repaired fence. No other breaches or signs of fence damage were observed during the inspection of the perimeter fencing on either the east bank south of I-10 or west bank north of I-10. For examples, see Photographs 14 through 16 in Appendix A.

Photograph 17: Perimeter fence located south of I-10 on west bank that was damaged during recent floods (view east)

No deficiencies were noted in the signage, security camera system, or perimeter buoys. The inspection identified damage to the perimeter fence on the west bank on the south side of I-10 that was repaired on July 27, 2016. The final bathymetric survey dataset did not identify any areas in need of maintenance under the approved OMM Plan; however, Respondents proactively chose to perform manual inspections of ten areas (significantly smaller than the 30 feet by 30 feet areas specified by the OMM Plan) identified by the survey results as having changed in elevation by more than 6 inches as compared to the prior survey. Two small areas required maintenance (although geotextile and armor rock were present) to assure that the design armor rock thickness was achieved, and maintenance was completed on August 26, 2016.

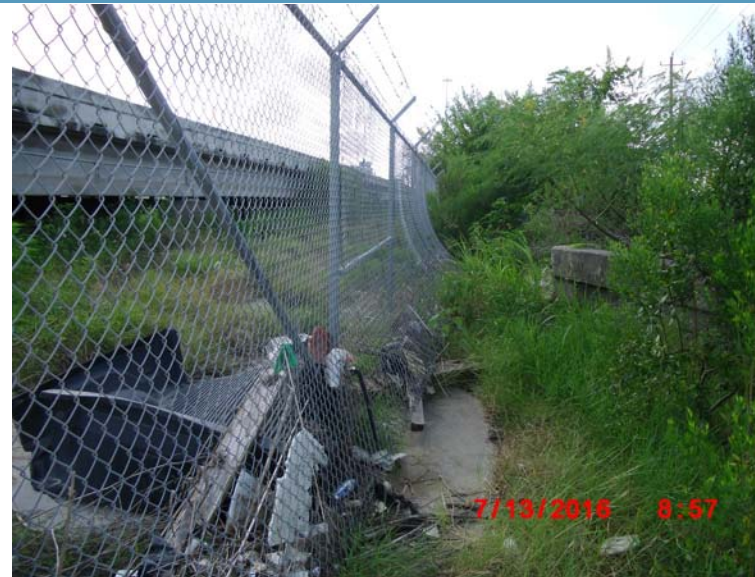
Photograph 18: Perimeter fence located south of I-10 on west bank that was damaged during recent floods (view east)

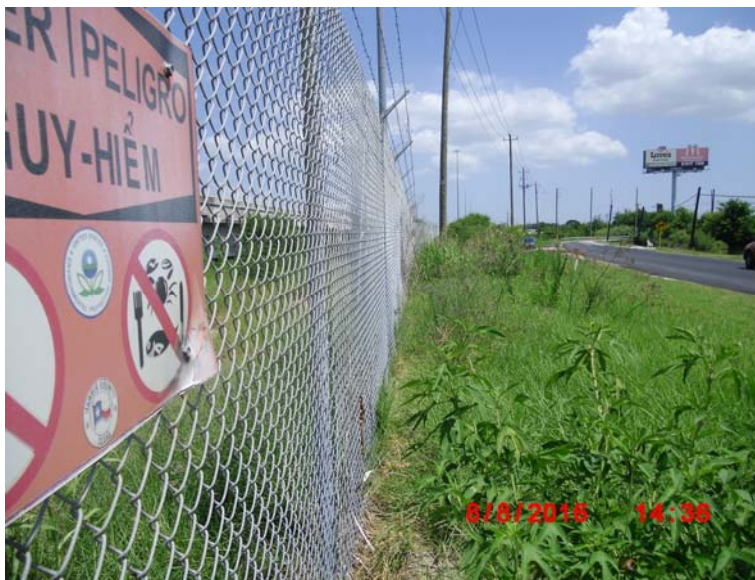
Photograph 19: Repaired perimeter fence located south of I-10 on west bank (view east)

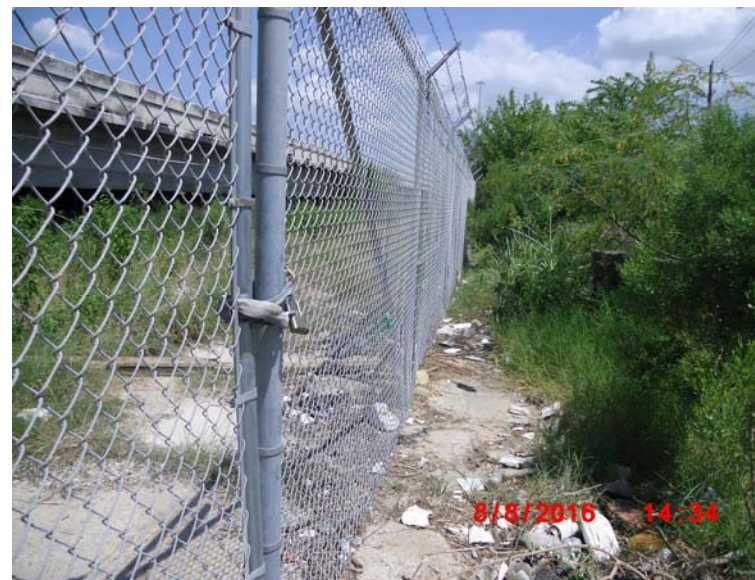
Photograph 20: Repaired perimeter fence located south of I-10 on west bank (view east)

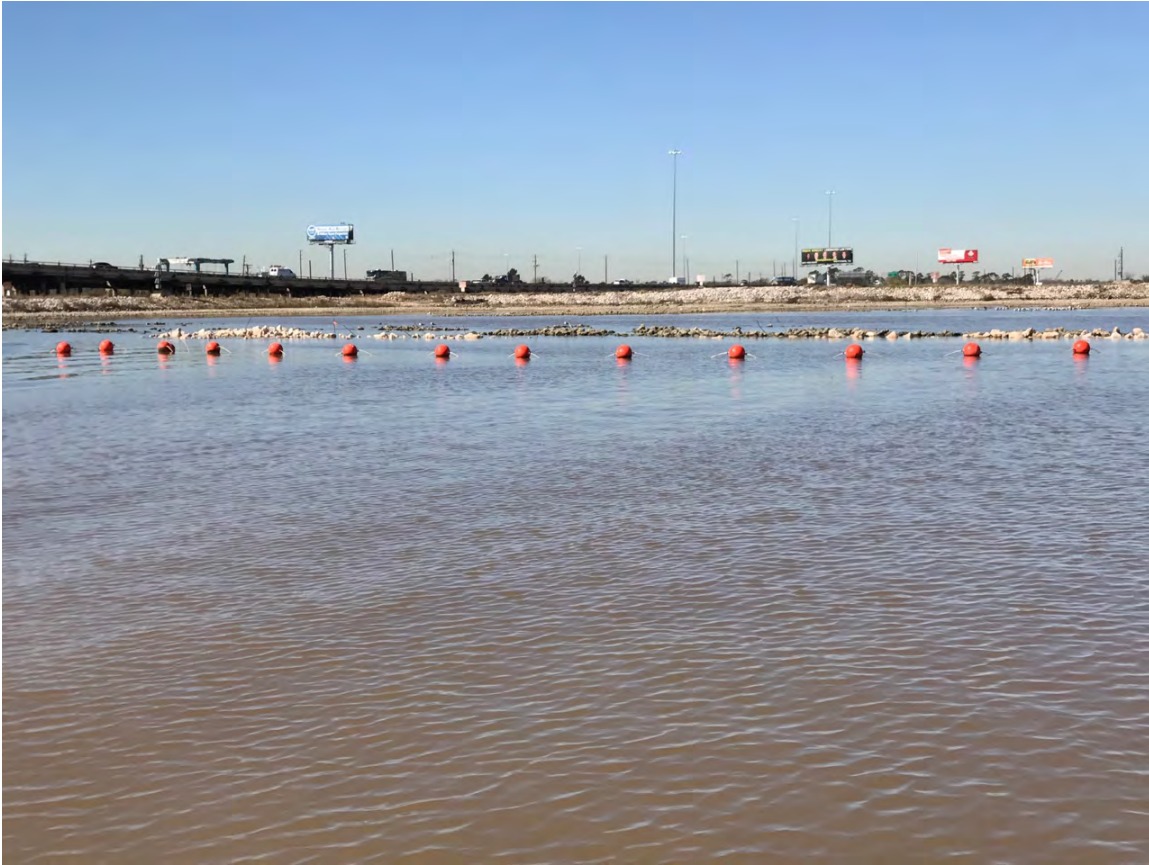
Photo 1: Perimeter buoys replaced around the channel maintenance area and all equipment and personnel demobilized from site.
