INVESTIGATION OF SHALLOW SUBSURFACE
CONDITIONS AT 2001 CAVALCADE STREET
HOUSTON, TEXAS

Prepared for
Great Southern Life Insurance Company
Houston, Texas

By
William F. Guyton Associates, Inc.
Consulting Ground-Water Hydrologists
Austin - Houston, Texas

January 1984

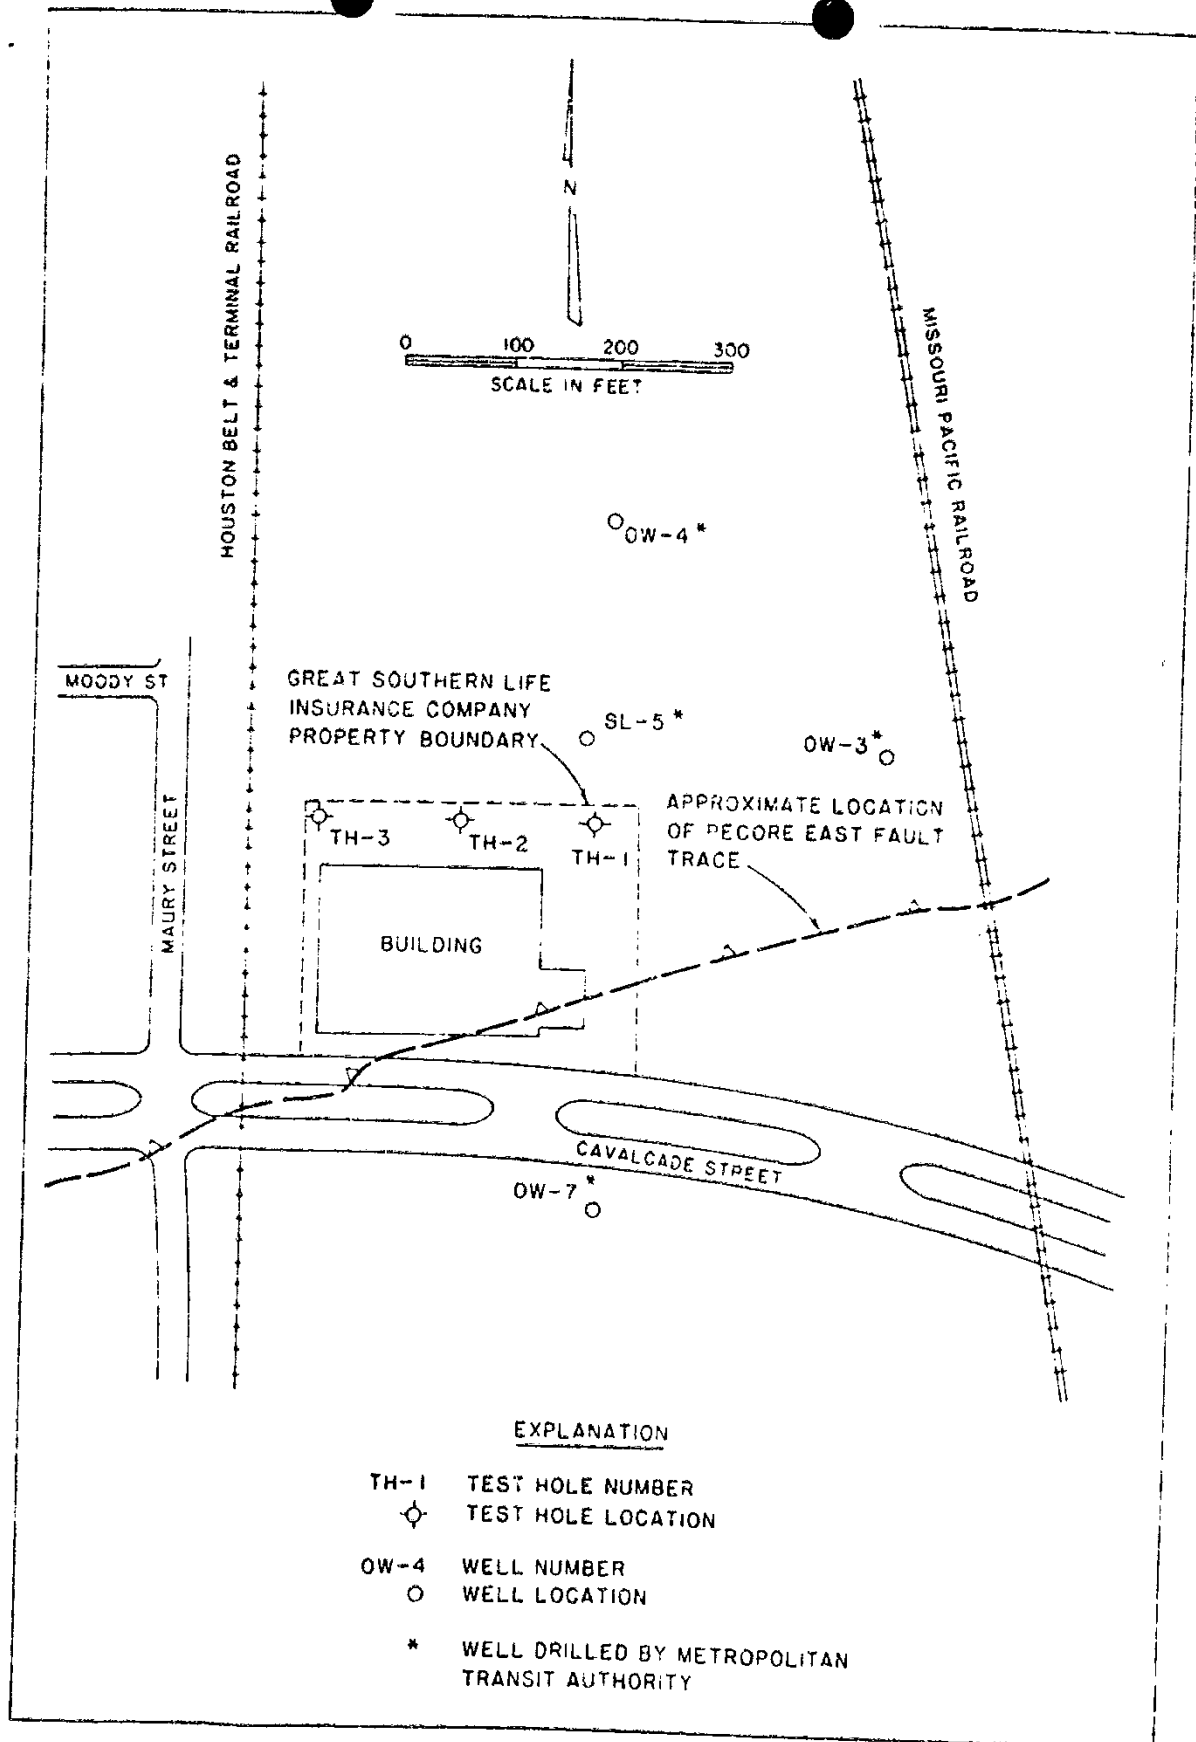
Figure 1

Data presented in the report prepared by McClelland Engineers, Inc. for MTA show that creosote contaminants are present in varying concentrations in some of the formation samples and water samples collected from monitor wells located north and northeast of the property. Therefore, three test holes ranging in depth from 13.5 to 21.5 feet were drilled on the property to determine if any shallow creosote contamination existed and if it resulted from past wood-treating activities on the property. Deep test holes were not drilled because had contamination occurred as a result of past wood-treating operations on the property now owned by Great Southern Life Insurance Company, it would still be detectable in the shallow materials. Locations of the three test holes, designated TH-1, TH-2, and TH-3, and locations of nearby monitor wells for which data from the McClelland Engineers report are presented or discussed in this report are shown on Figure 1.

LOCATIONS OF TEST HOLES AND MONITOR WELLS

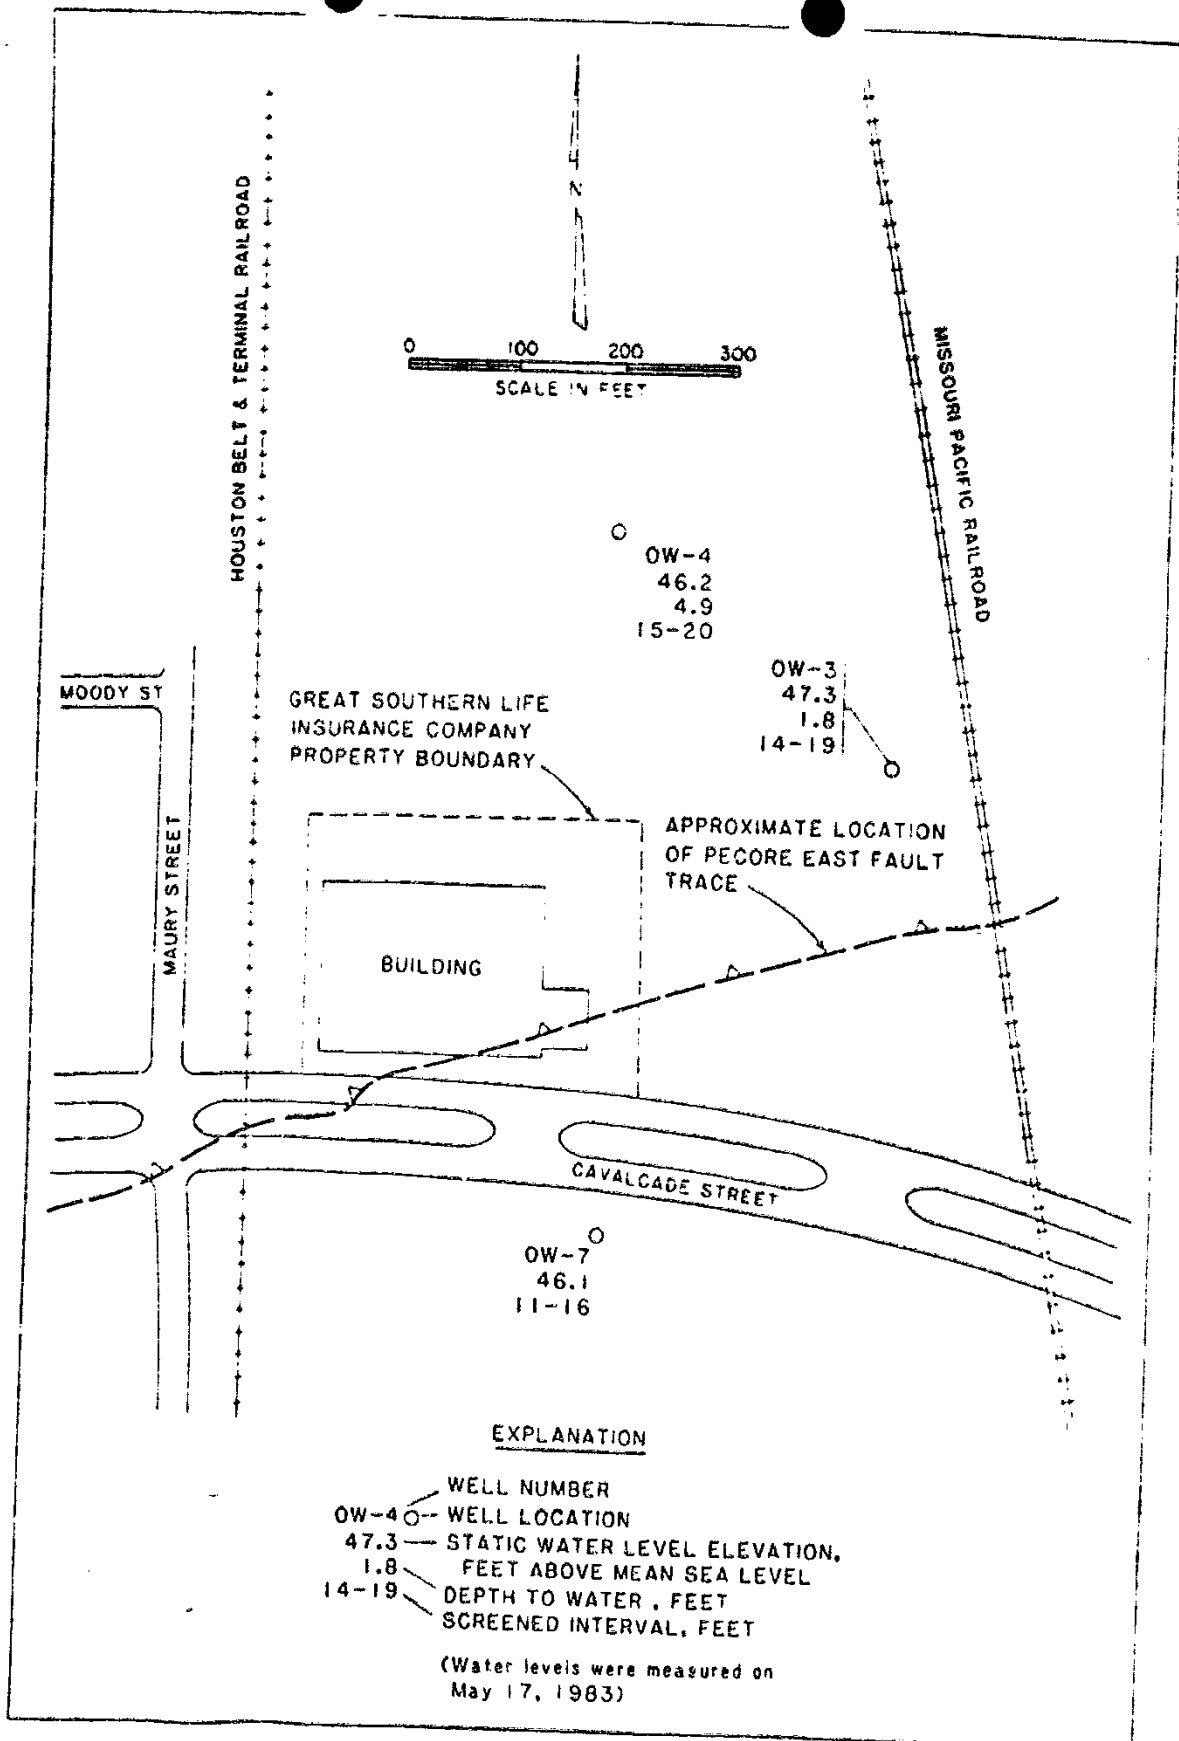
Data from the three test holes drilled during this investigation and water-level data presented in the McClelland Engineers, Inc. report show that the shallow sand or silty and clayey sand that is present in the area is saturated with water. While fluid levels in the open holes at Test Holes 1 and 3 were five feet or less below land surface, accurate fluid levels could not be obtained because of the large amount of sand, silt, and clay that was mixed with ground water during augering. An accurate fluid level could not be obtained at Test Hole 2 because water was used to drill the lower part of the test hole. Three monitor wells (OW-3, OW-4, and OW-7) that McClelland Engineers drilled for MTA in the vicinity of the property screen the shallow sand. No water-level or completion information was given for Well SL-5 in the McClelland report. Screened intervals, depths to water, and water-level elevations for the three shallow monitor wells are shown on Figure 2. The water levels shown on Figure 2 were reported to be measured on May 17, 1983.

Based on the information presented on Figure 2, it appears that the hydraulic gradient slopes downward generally to the west. Thus, the direction of ground-water flow also is generally to the west.

the surface, and its approximate location is shown on Figures 1 and 2. Displacement along the fault is not known, but the water-level data and stratigraphic correlation of data for monitor wells and test holes in the area indicate that the fault has little, if any, effect on shallow ground-water or geologic conditions.

WATER LEVEL DATA
