FOURTH FIVE-YEAR REVIEW REPORT FOR HOMESTAKE MINING COMPANY SUPERFUND SITE CIBOLA COUNTY, NEW MEXICO

SEPTEMBER 2016

U.S. Environmental Protection Agency Region 6 Dallas, Texas

FOURTH FIVE-YEAR REVIEW REPORT HOMESTAKE MINING COMPANY SUPERFUND SITE EPA ID#: NMD007860935 CIBOLA COUNTY, NEW MEXICO

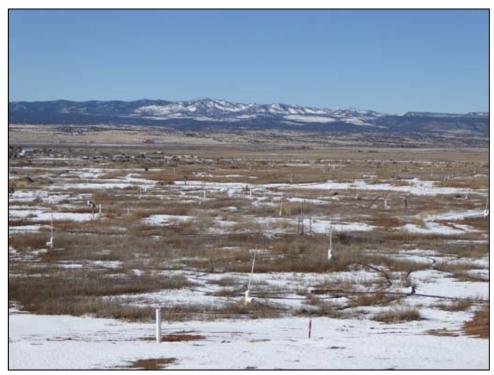
Top of the LTP

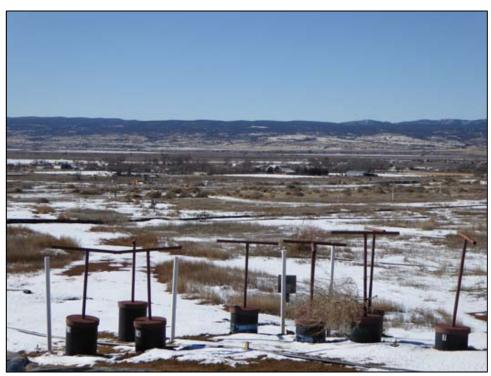
Wells on top of the LTP

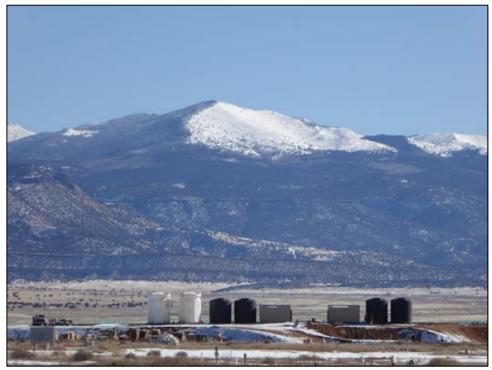
Full-scale zeolite treatment facility on top of the LTP

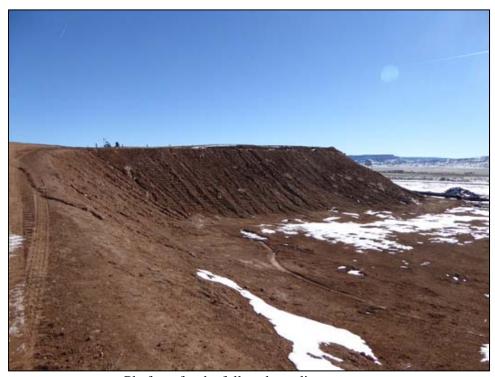
Platform for the full-scale zeolite treatment

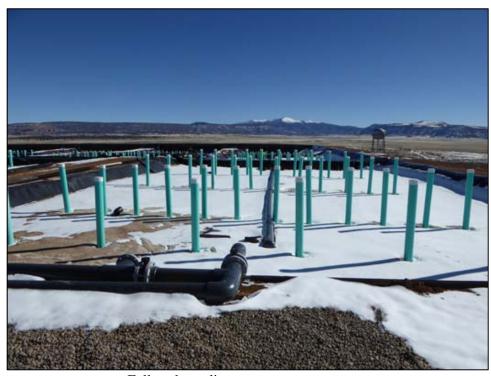
Full-scale zeolite treatment system vents

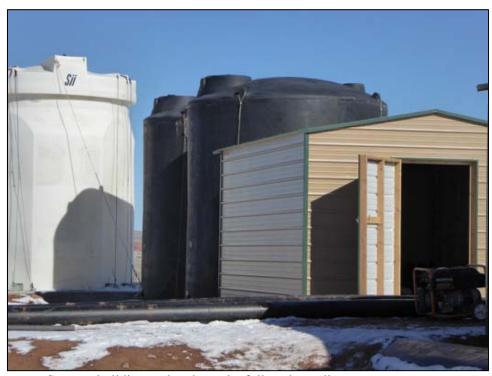
Support building and tanks at the full-scale zeolite treatment system

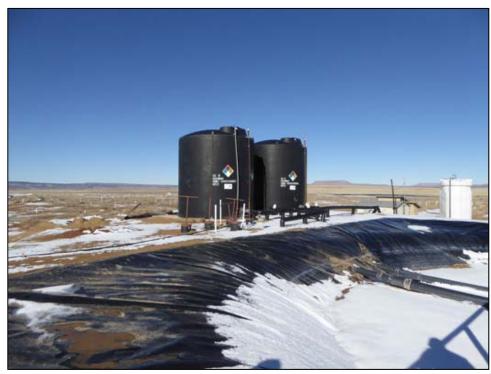
Pilot zeolite treatment system tanks

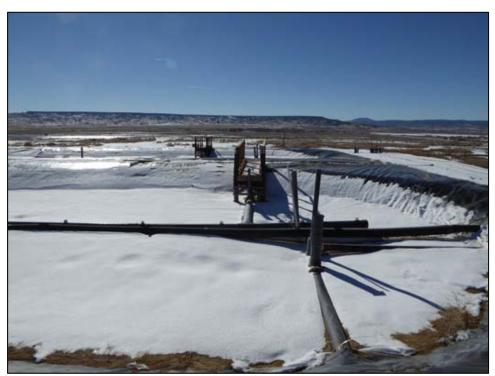
Pits and piping for the pilot zeolite treatment system

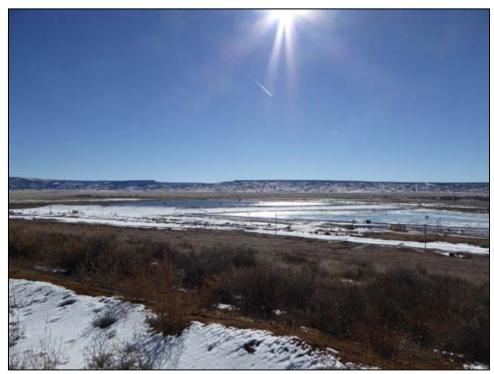
View of evaporation ponds 1 and 2 on top of the STP

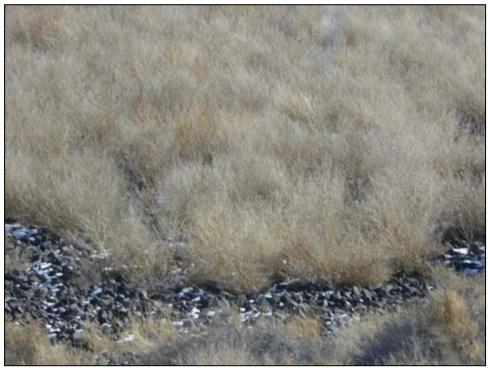
Rock and radon cover for the LTP

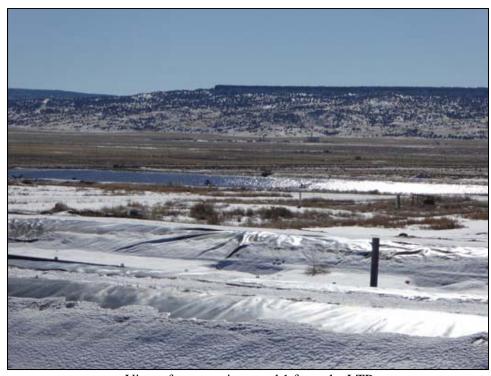
respective facility designs. A slump was observed in the fill under the pond liner of evaporation pond 1, along about 200 feet of the south inslope of the pond from the southeast corner westward. The slump at evaporation pond 1 should be protected against further displacement to protect the liner. During 2014, leaks in the liners for evaporation ponds 2 and 3 were also repaired.

View of evaporation pond 1 from the LTP

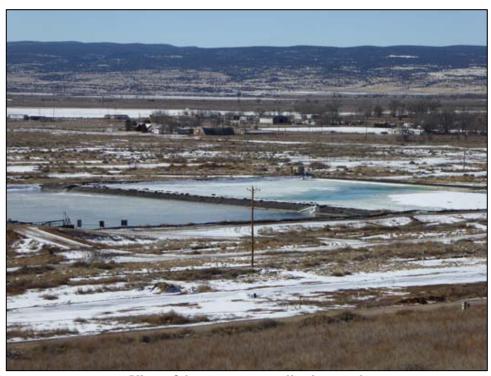
View of the wastewater collection ponds

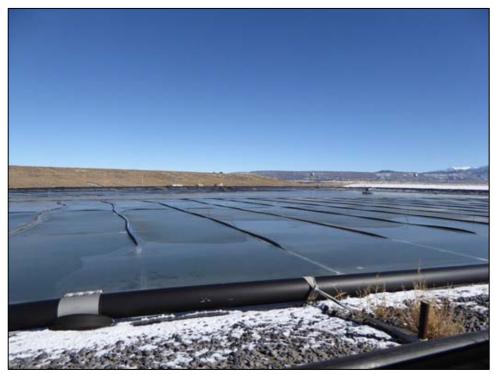
Evaporation pond 2

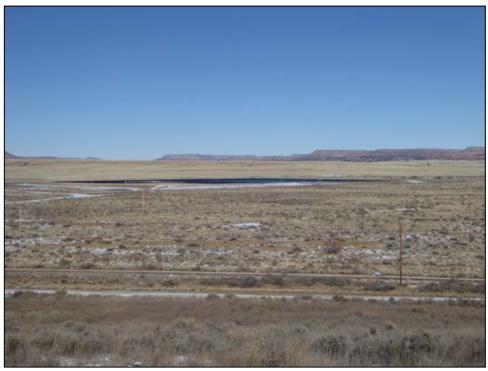
Evaporation pond 3

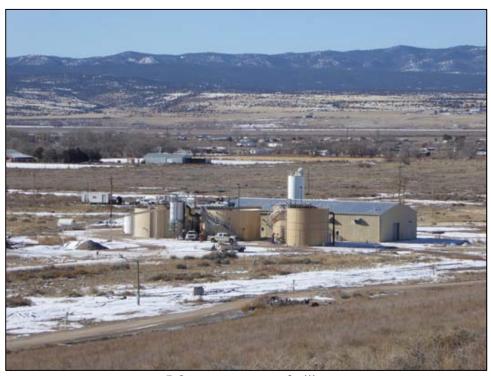
RO water treatment facility

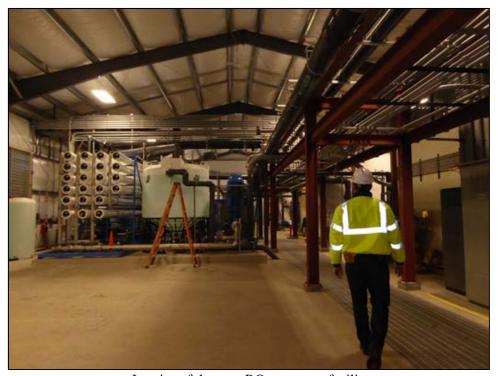
Interior of the new RO treatment facility

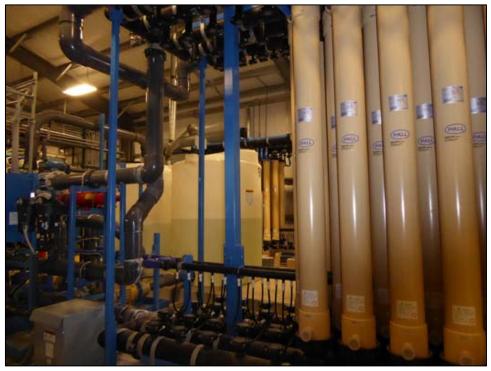
New microfiltration units within the RO treatment system facility

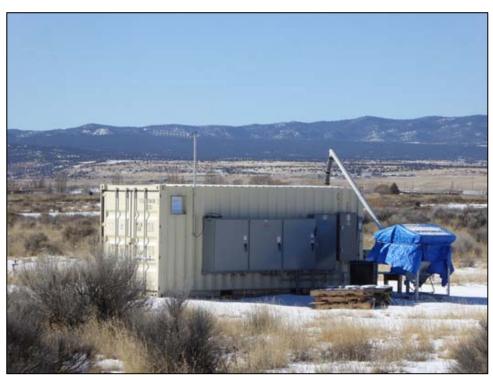
TPP pilot test support building

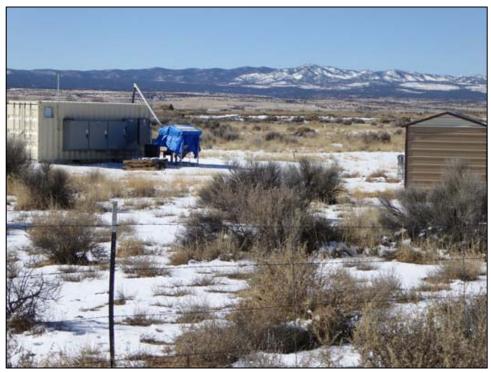
TPP pilot test area
