**FOURTH FIVE-YEAR REVIEW REPORT FOR  
KOPPERS CO., INC. (TEXARKANA PLANT) SUPERFUND SITE  
BOWIE COUNTY, TEXAS**

**SEPTEMBER 2016**

**U.S. Environmental Protection Agency  
Region 6  
Dallas, Texas**

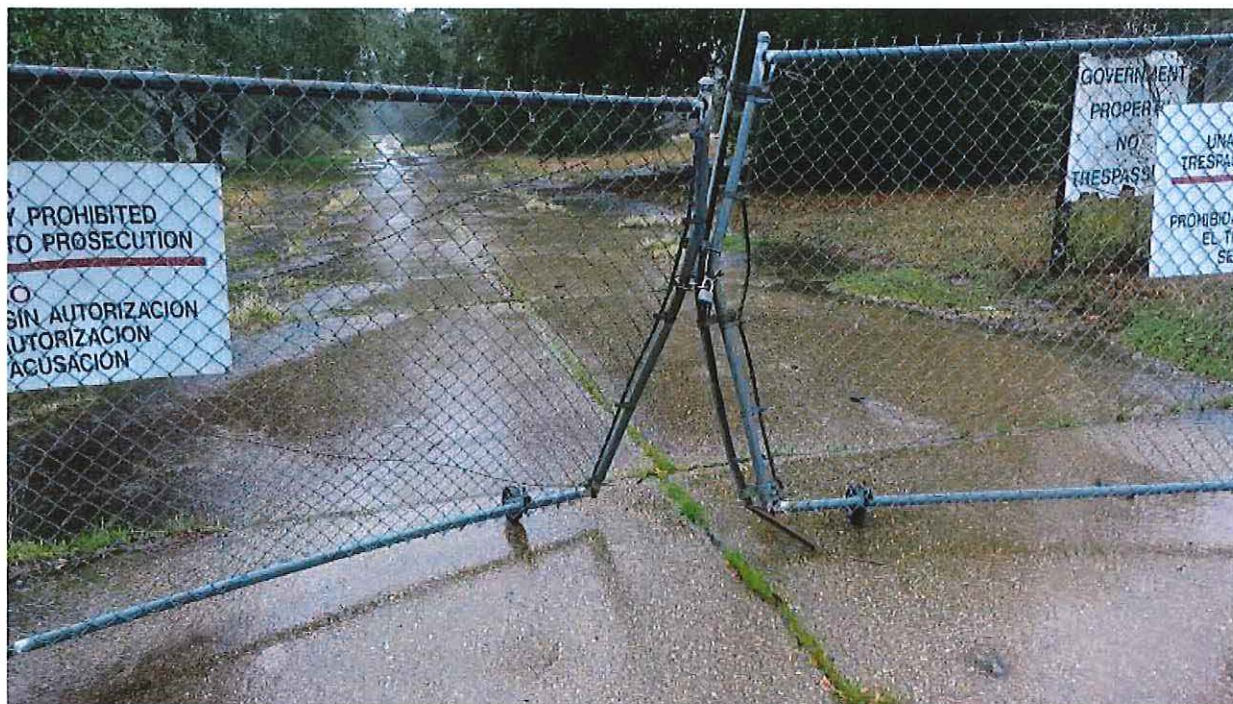
| | <b>Issue:</b> The Site's main gate is damaged and can allow unauthorized access to the Site. | | | |

Main entrance to the Site

| | <b>Recommendation:</b> Repair the main gate to avoid unauthorized access to the Site. | | | |

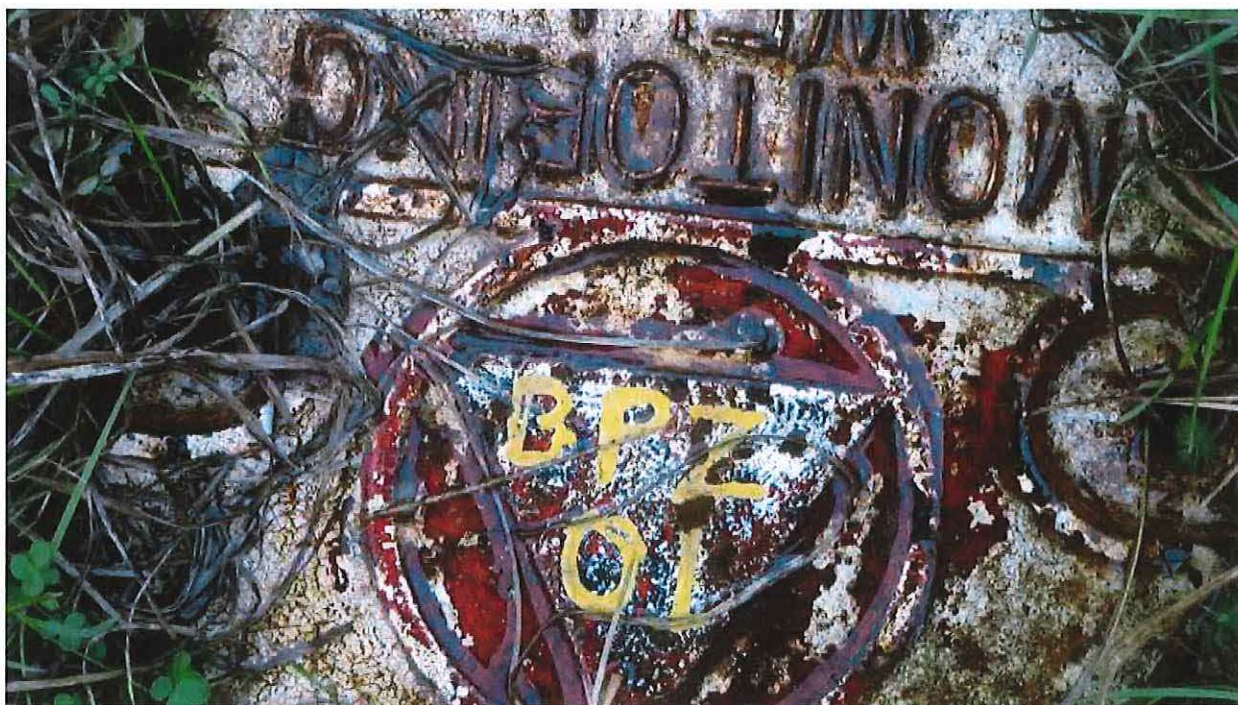
DNAPL recovery system piezometer BPZ 01, unlocked

- A few wells have missing locks and unsecured caps. Secure all piezometers and monitoring wells.
- Include updated site documents, including FYRs, in the site repository.

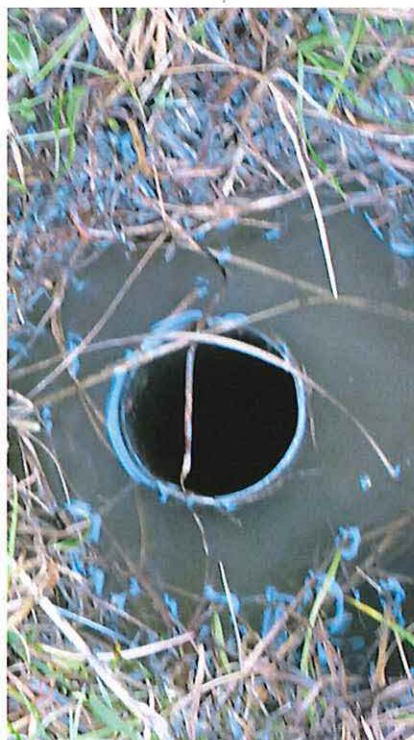
DNAPL recovery system piezometer BPZ 01, without cover and missing cap

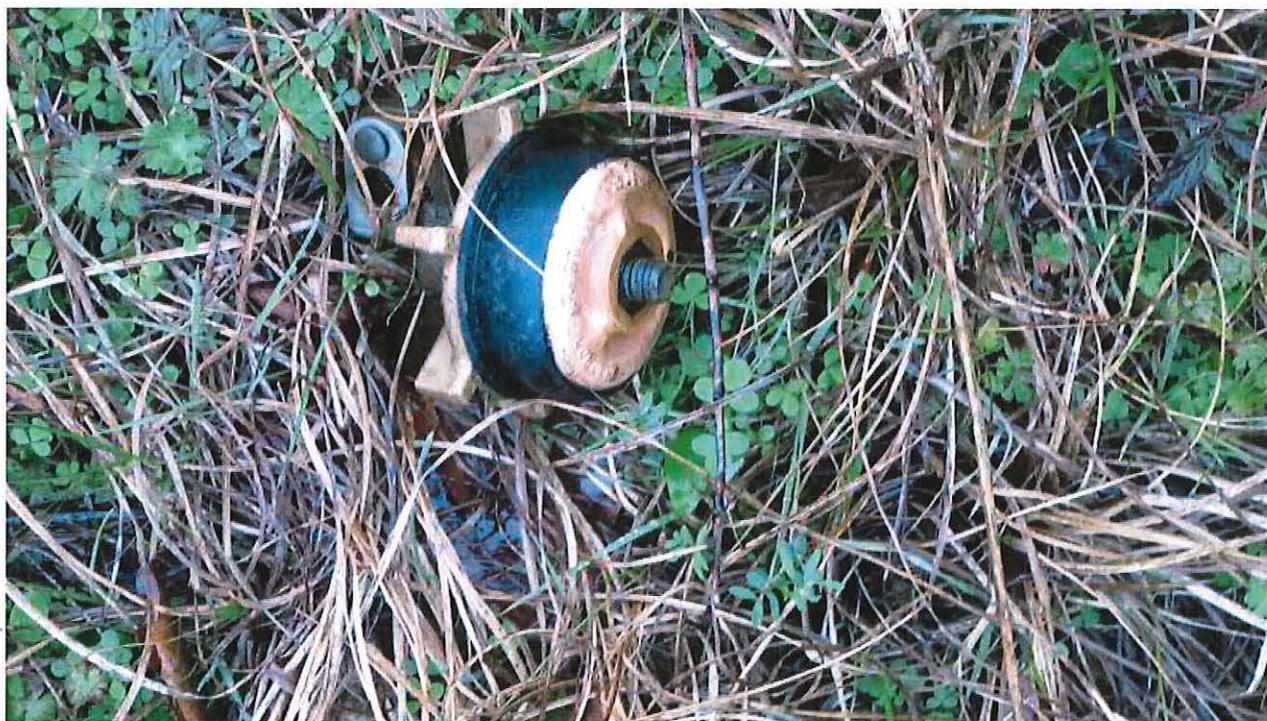
Well cap located near DNAPL recovery system piezometer BPZ 01

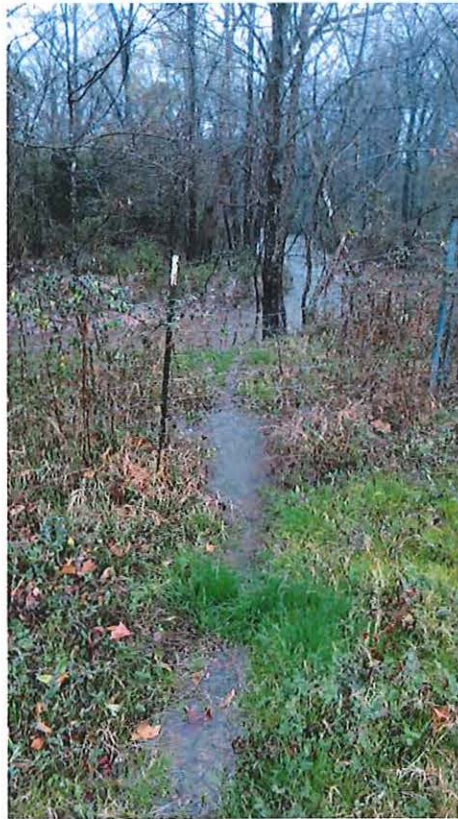
Runoff during a heavy rain event leading from the Site to Wagner Creek

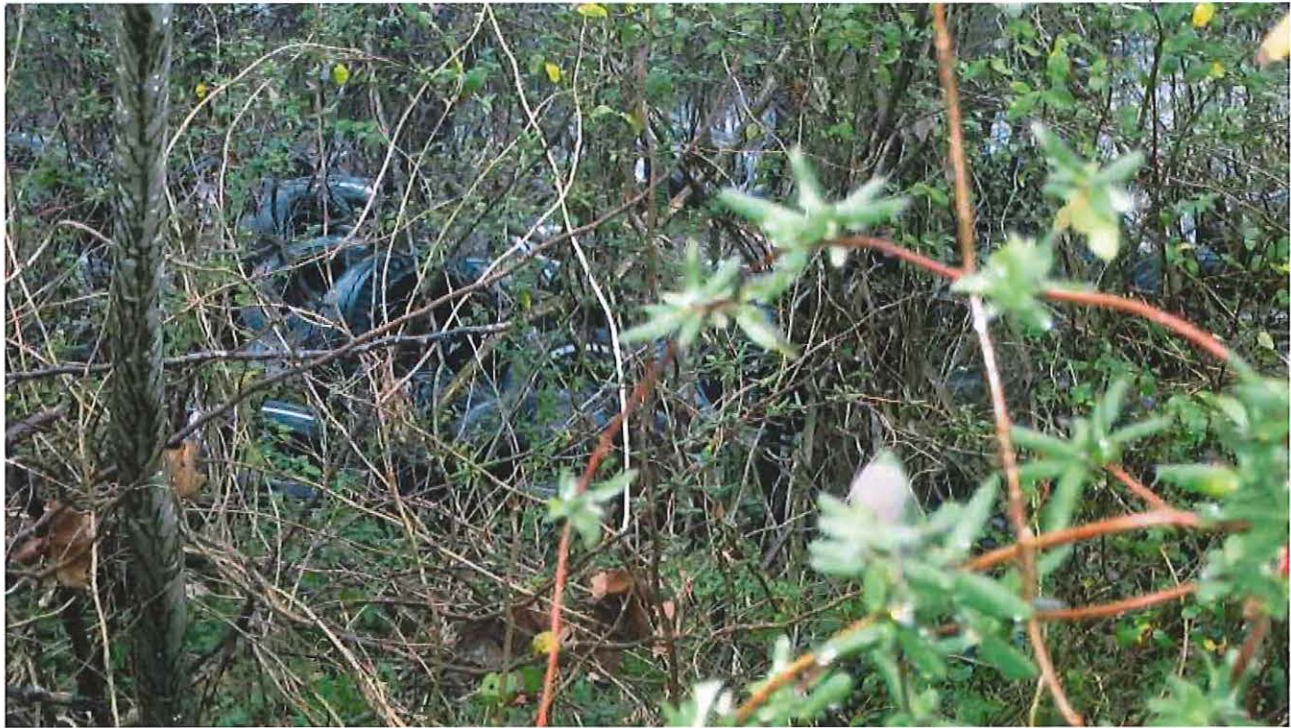
On-site tire pile, west of the gravel pond area

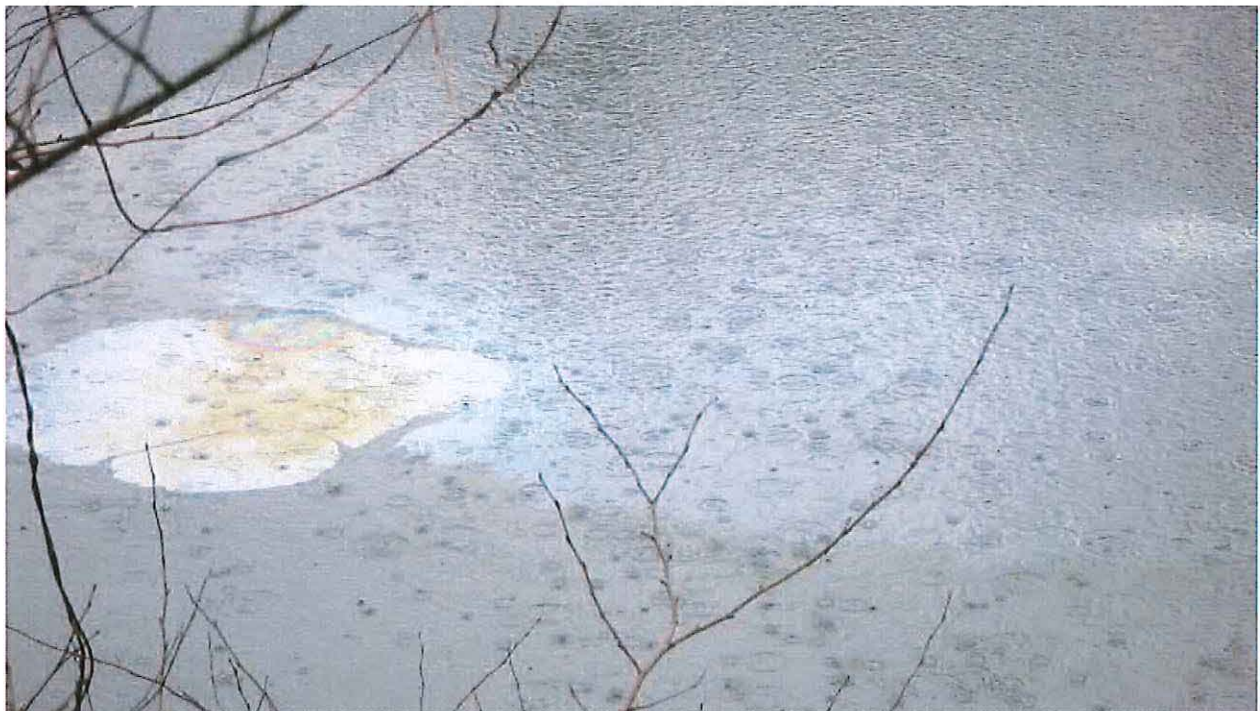
| | <b>Issue:</b> Water quality and the cause of the oily sheens in the submerged gravel pits are unknown. | | | |

Oily sheen on the eastern side of the gravel pond

| | <b>Recommendation:</b> Investigate water quality of the gravel pit water and the cause of the oily sheen within the pit water. Determine if DNAPL is accumulating in low points within the base of the gravel pit. | | | |

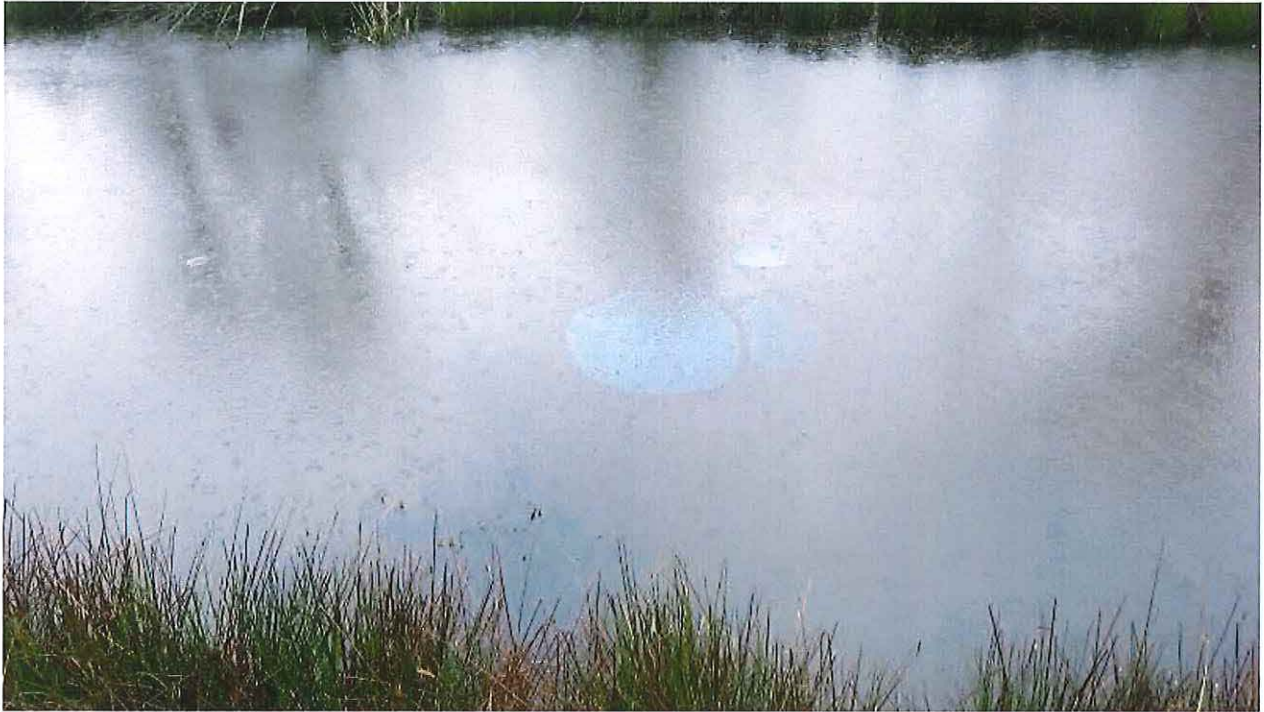
Additional oily sheens on the eastern side of the gravel pond
