Third Five-Year Review Report

**Homestake Mining Company Superfund Site
(EPA ID: NMD007860935)
Cibola County, New Mexico**

September 2011

**Region 6
United States Environmental Protection Agency
Dallas, Texas**

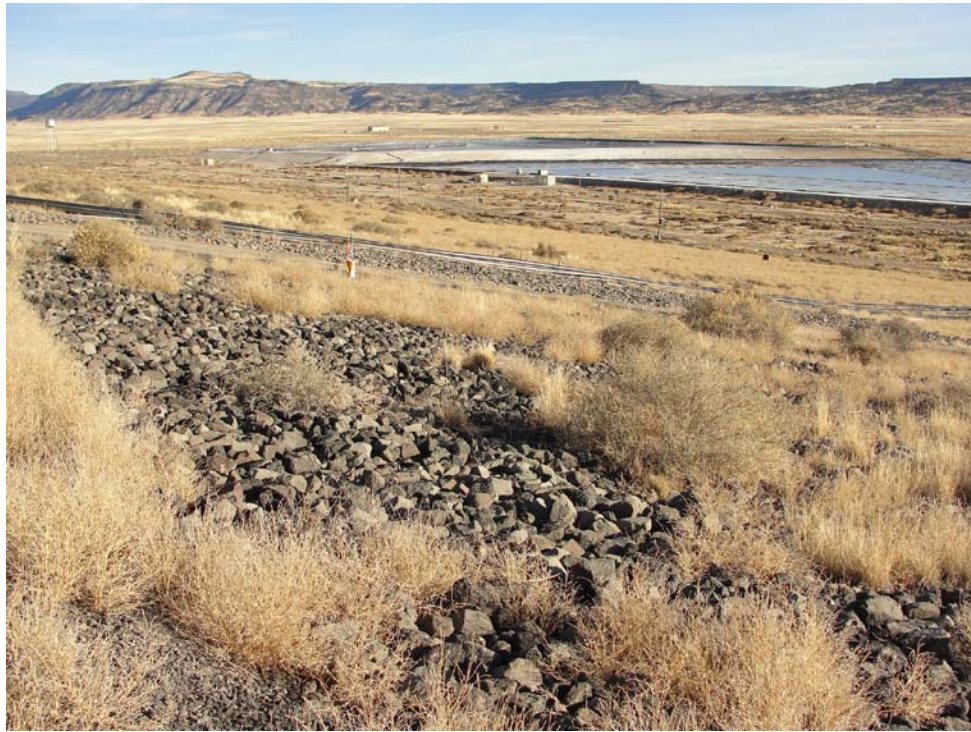
Photo 1: View of Evaporation Pond 1 (far left) and Evaporation Pond 2 from on top of the large tailings pile. Note the cobbles in the foreground used as a part of the erosion-protection cover on the large tailings pile. View looking southeast.

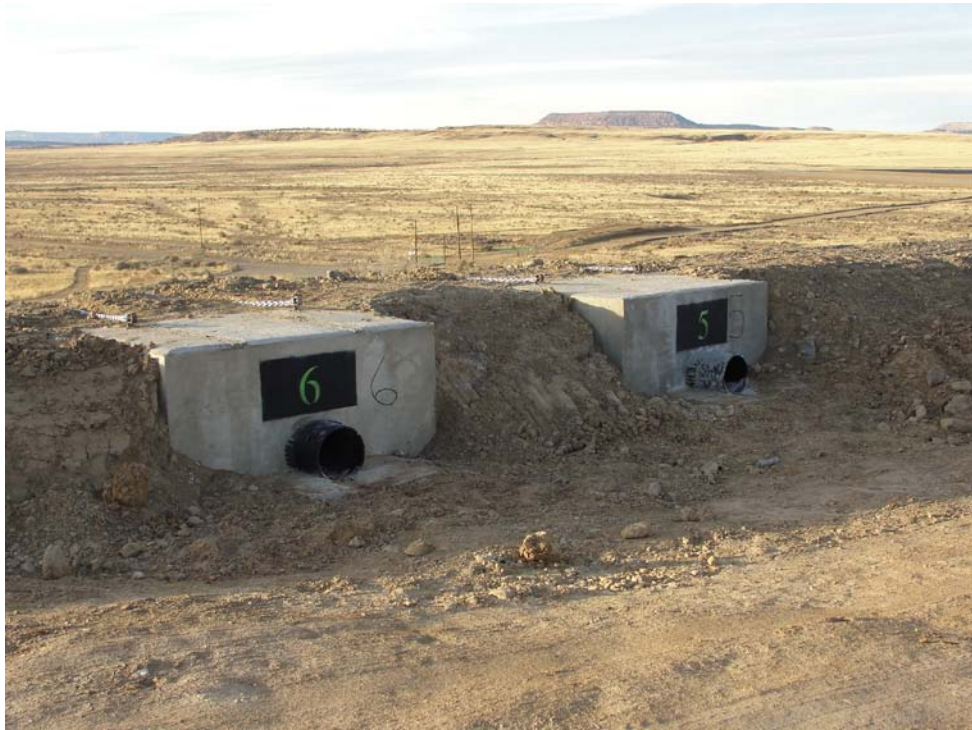
The team then drove on top of the large tailings pile to the west end where they observed two concrete discharge structures used to convey surface water off of the top of the large tailings pile (**Photo 9**). A total of 14 such discharge structures are situated on top of the large tailings pile. Areas of ponded water resulting from snow melt were noted on top of the large tailings pile, however, this does not affect the protectiveness of the remedy. The team concluded the first day of the site inspection by returning to the HMC office.

Photo 9: Two of 14 discharge structures used to convey surface water off of the top of the large tailings pile. View looking northwest.

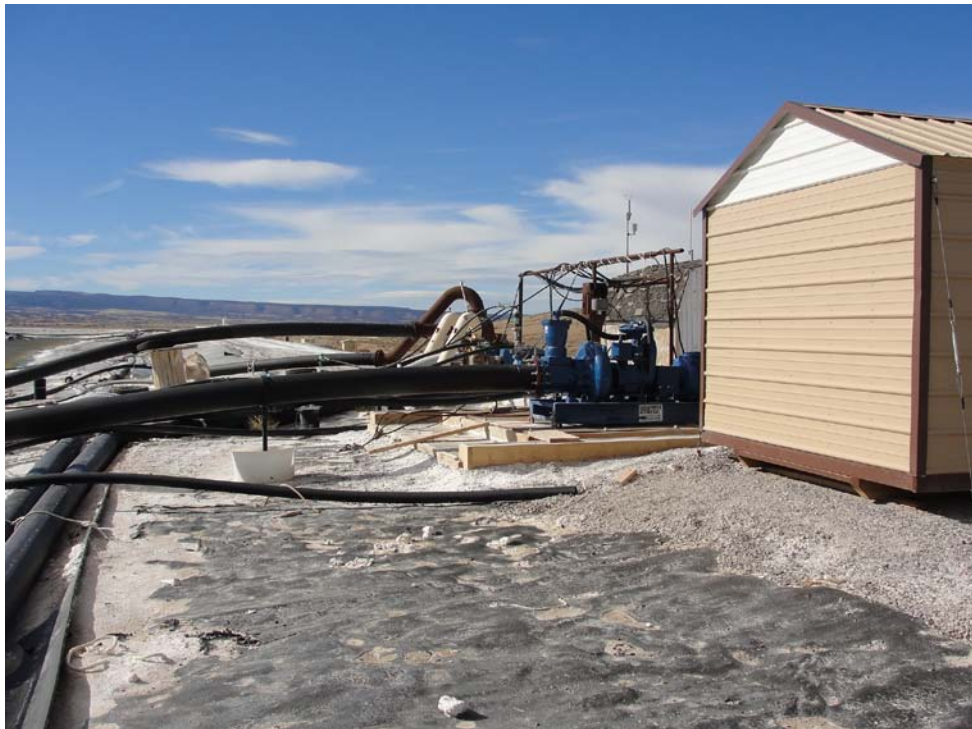
Photo 10: Pump, pump house, and piping at Evaporation Pond 1. Equipment is used to convey extracted groundwater from the large tailings pile (to the right out of the photo) to the evaporation pond. The black surface is an asphalt-emulsion liner that forms the base for the pond. View looking west.

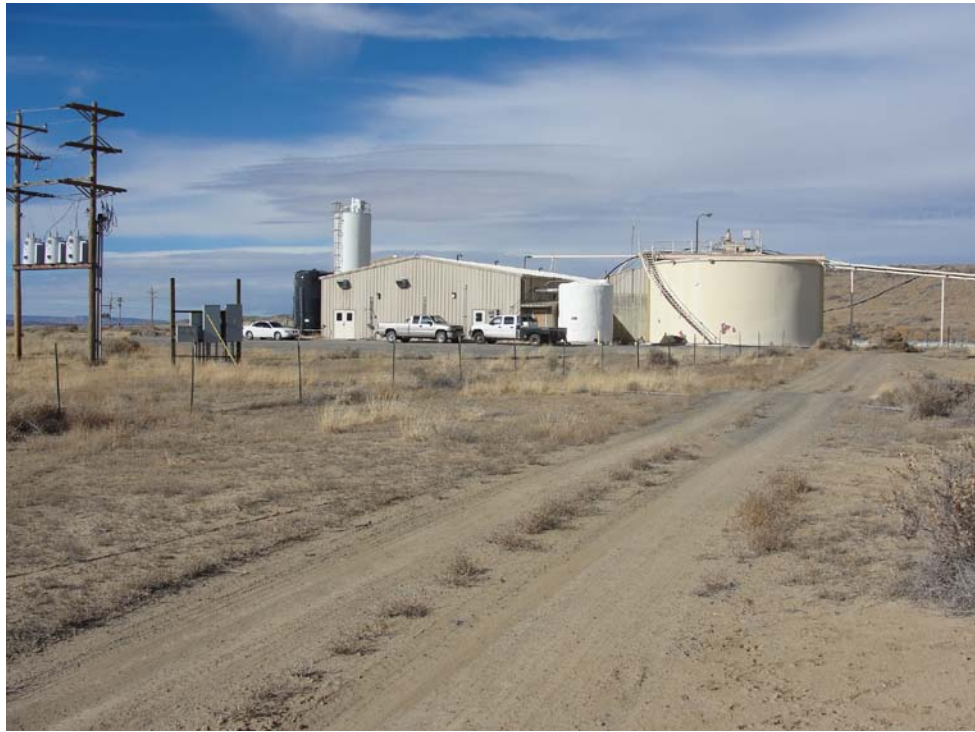
The team observed POC Well X at the toe of the small tailings pile (**Photo 13**) and POC Well D1 near the RO treatment plant (**Photo 14**). The team then proceeded to the RO treatment plant (**Photo 15**). The plant was undergoing renovation at the time of the inspection but the team was able to view the computers and ancillary equipment that control the flow of water into and out of the system, and the membrane filtration system (**Photo 16**).

Photo 15: RO treatment plant. View looking west.

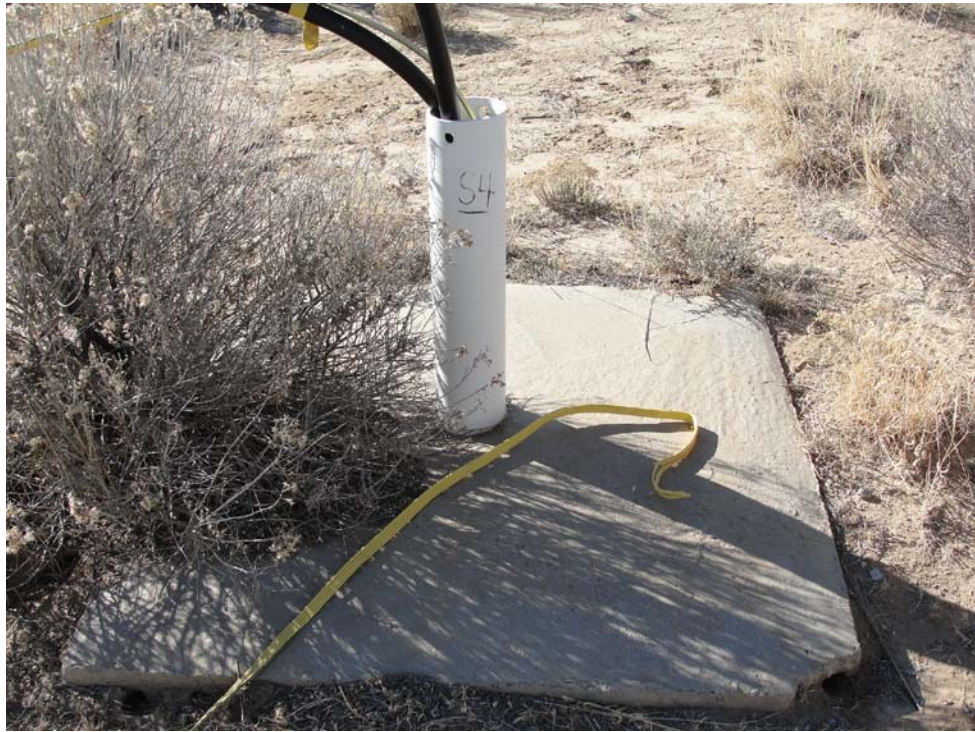
The team drove to POC Well S4 on the west side of the large tailings pile (**Photo 17**). Two corners of the concrete well pad for Well S4 were broken off; however, the integrity of the well was not compromised. The team concluded the second day of the site inspection by returning to the HMC office.

Photo 17: POC Well S4 on the west side of the large tailings pile.
