Environmental Services Inc.  
Environmental Scientists and Engineers

December 16, 2009

Subject: Vent Installation  
Leon Valley Veterinary Clinic  
6701 Bandera Road  
Leon Valley, Texas

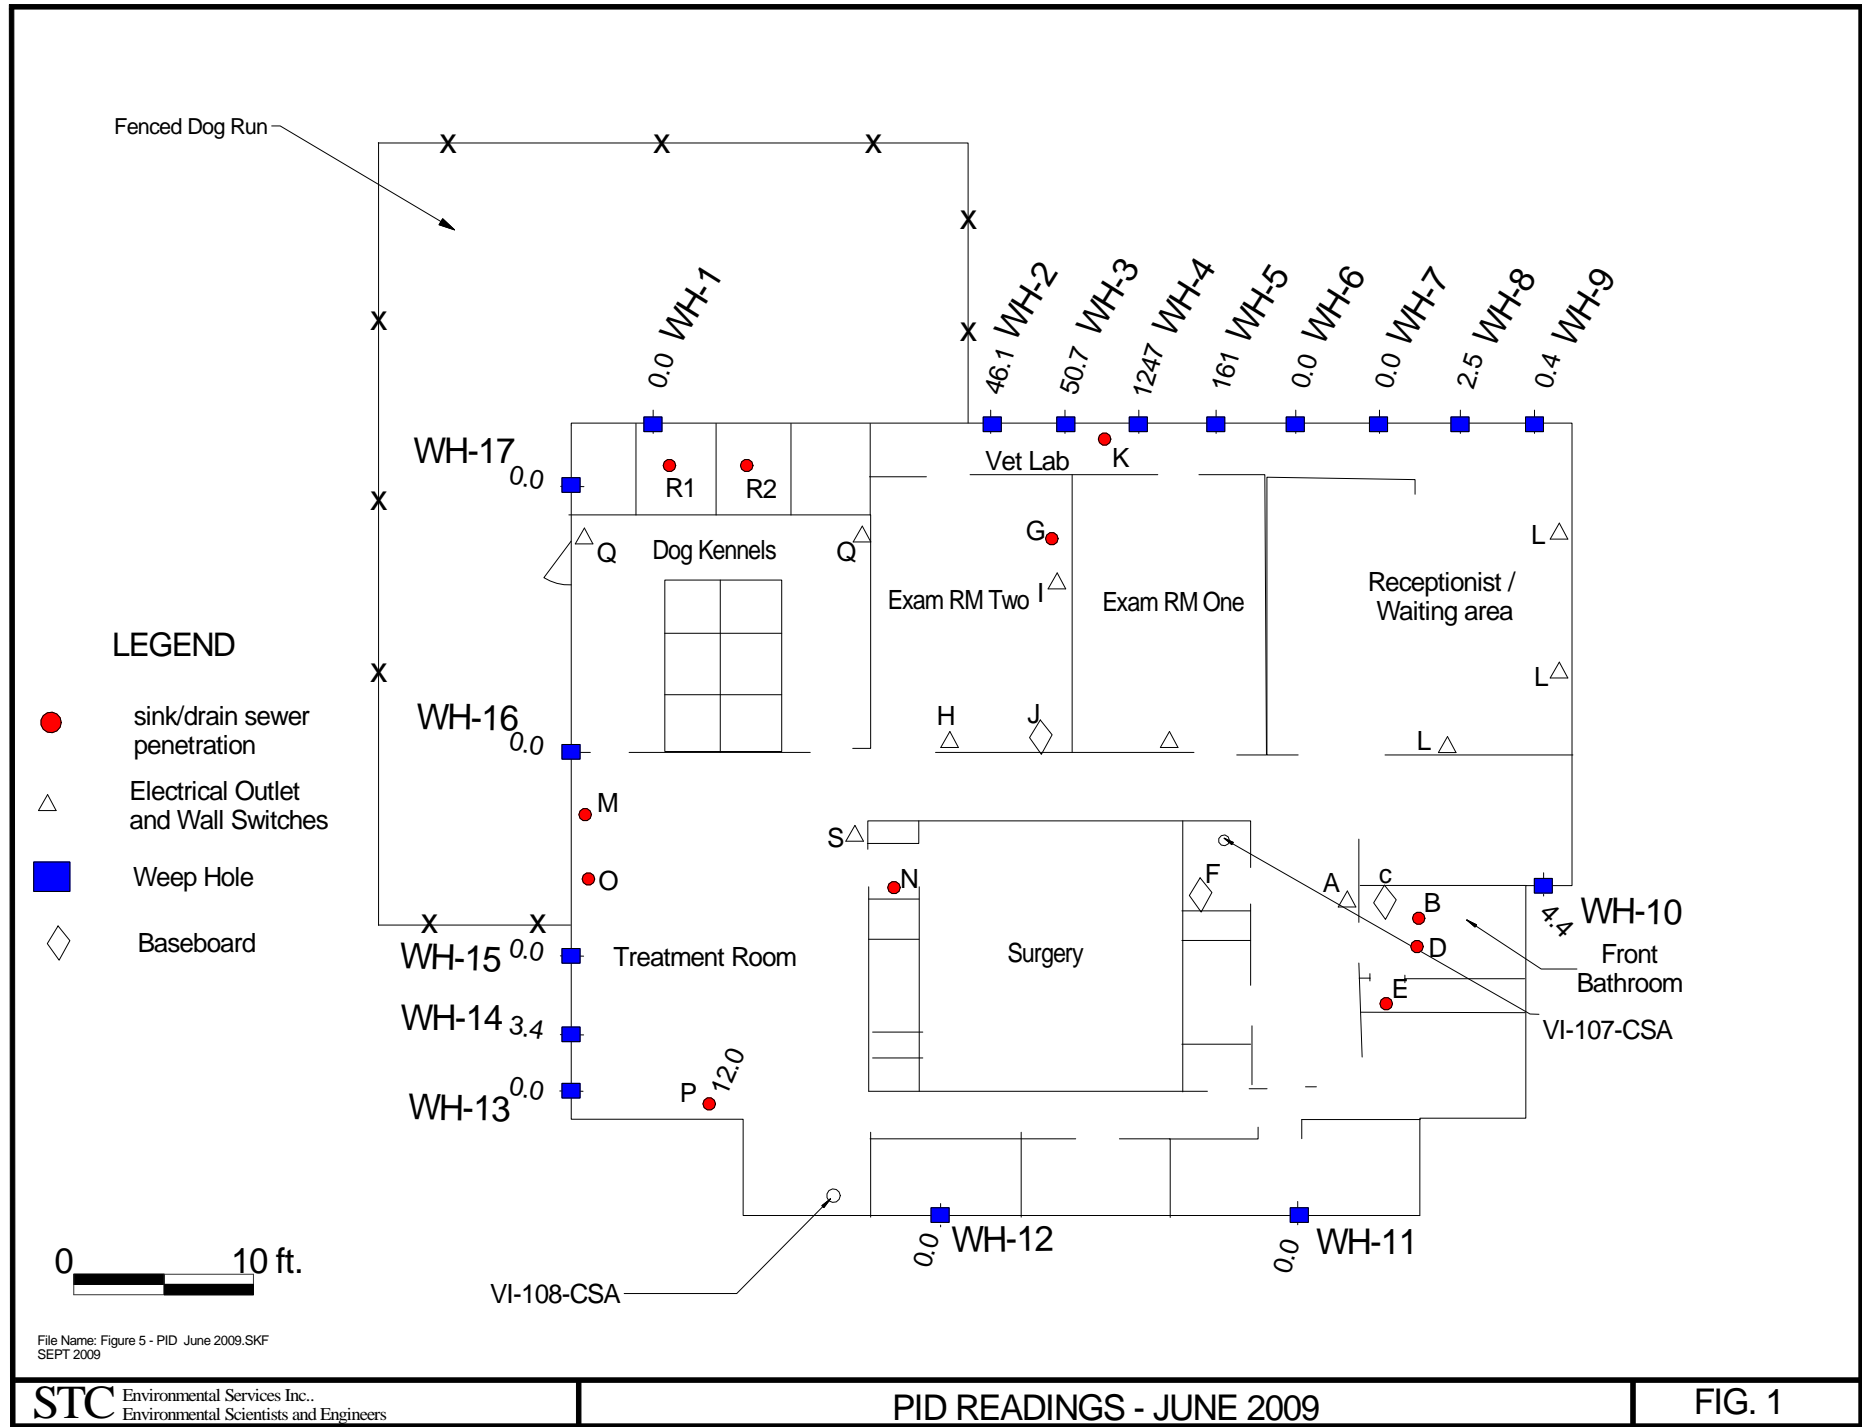
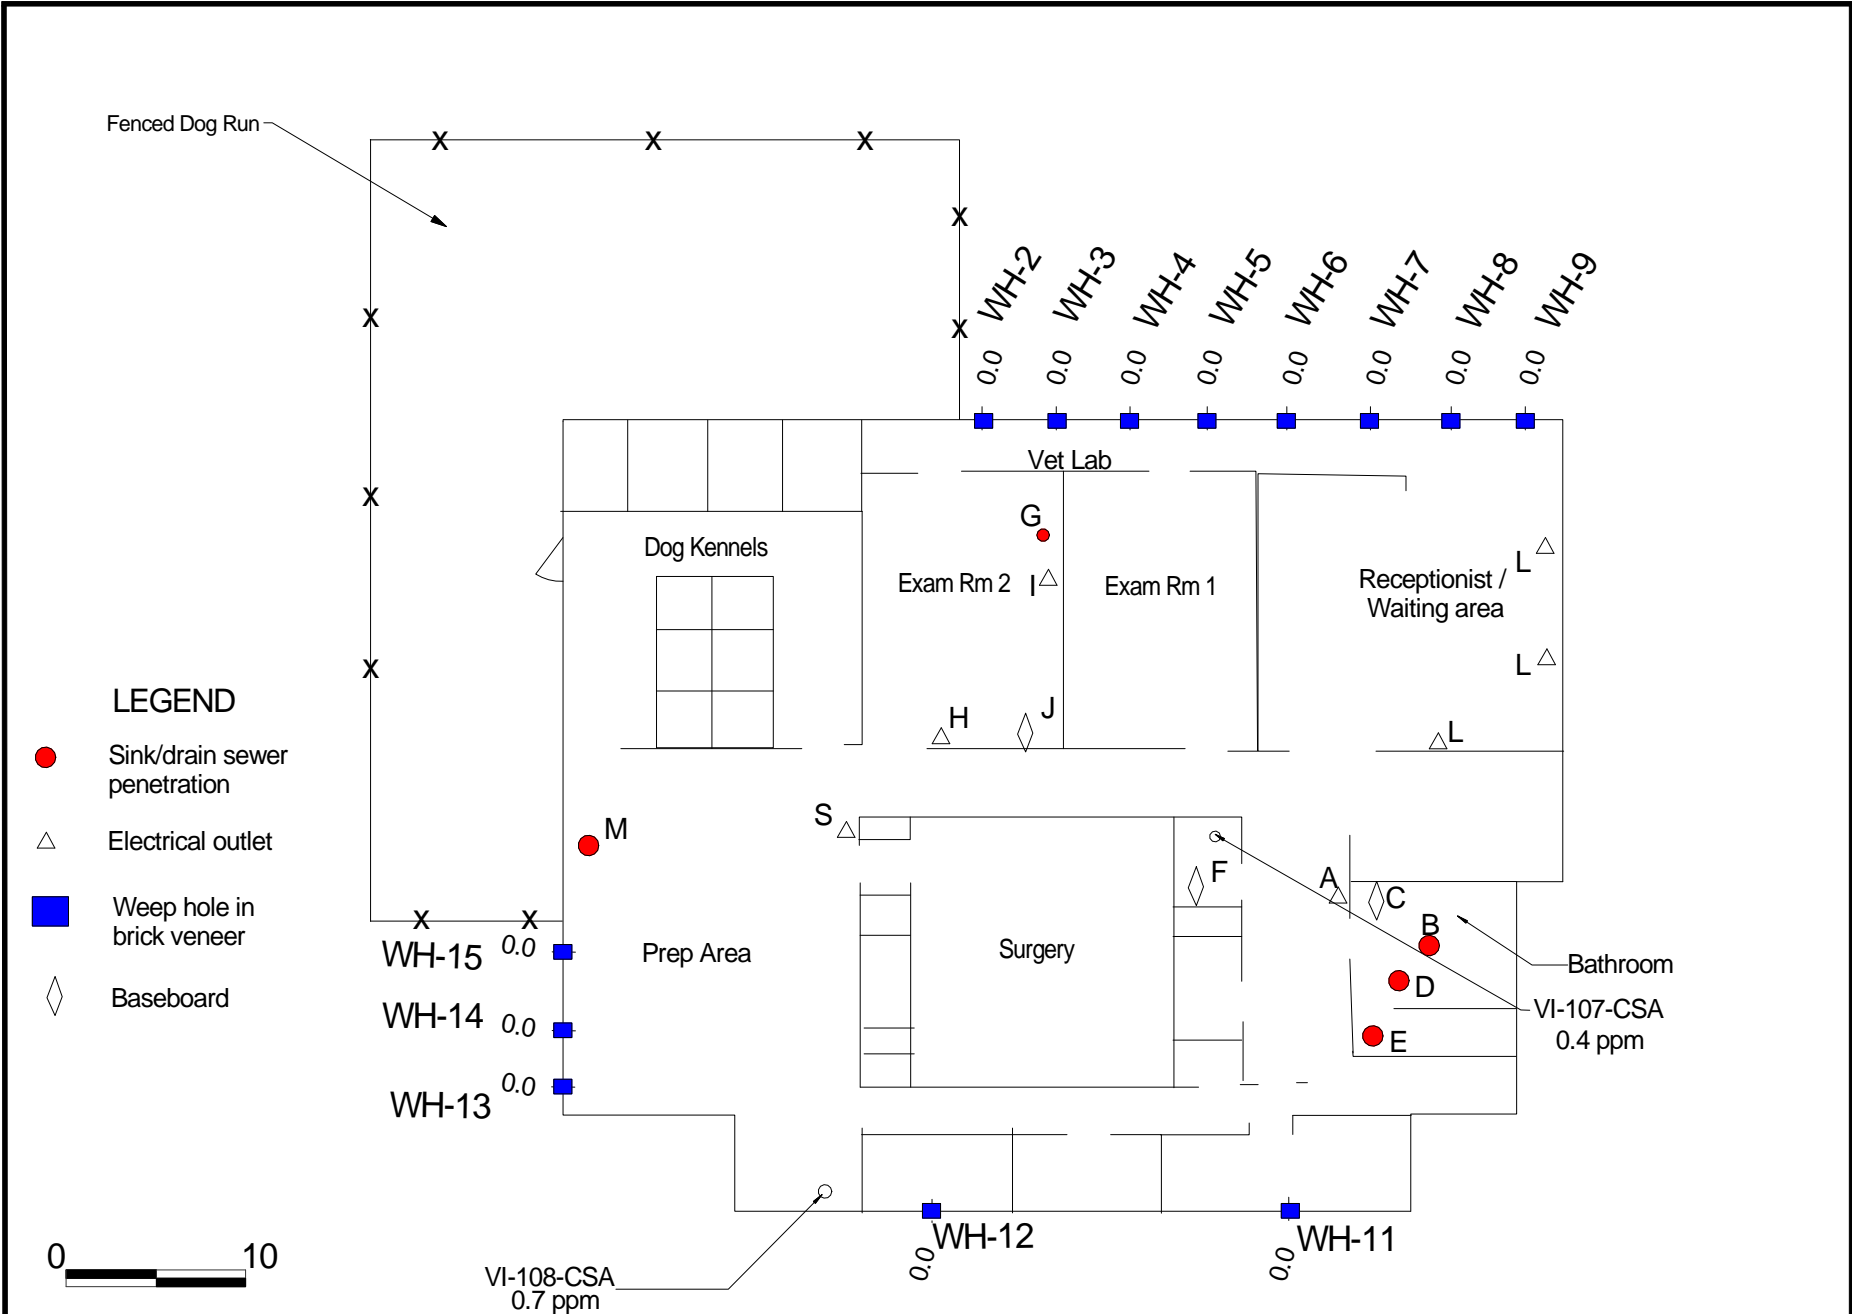
4. The PID was calibrated on 6/4/09 and 7/21/09 with Isobutylene. Additional details are presented on the attached calibration sheets.
5. All accessible weep holes were sampled during the June event. The July event did not include weep holes inside the fenced area which showed no detectable levels during the June event. Sampling locations for the two surveys are shown on Figures 1 and 2.

Section 1 of the EPA Comment letter also requests weep hole numbers also be presented on the corresponding figures. These revisions are shown on Figures 1 and 2.

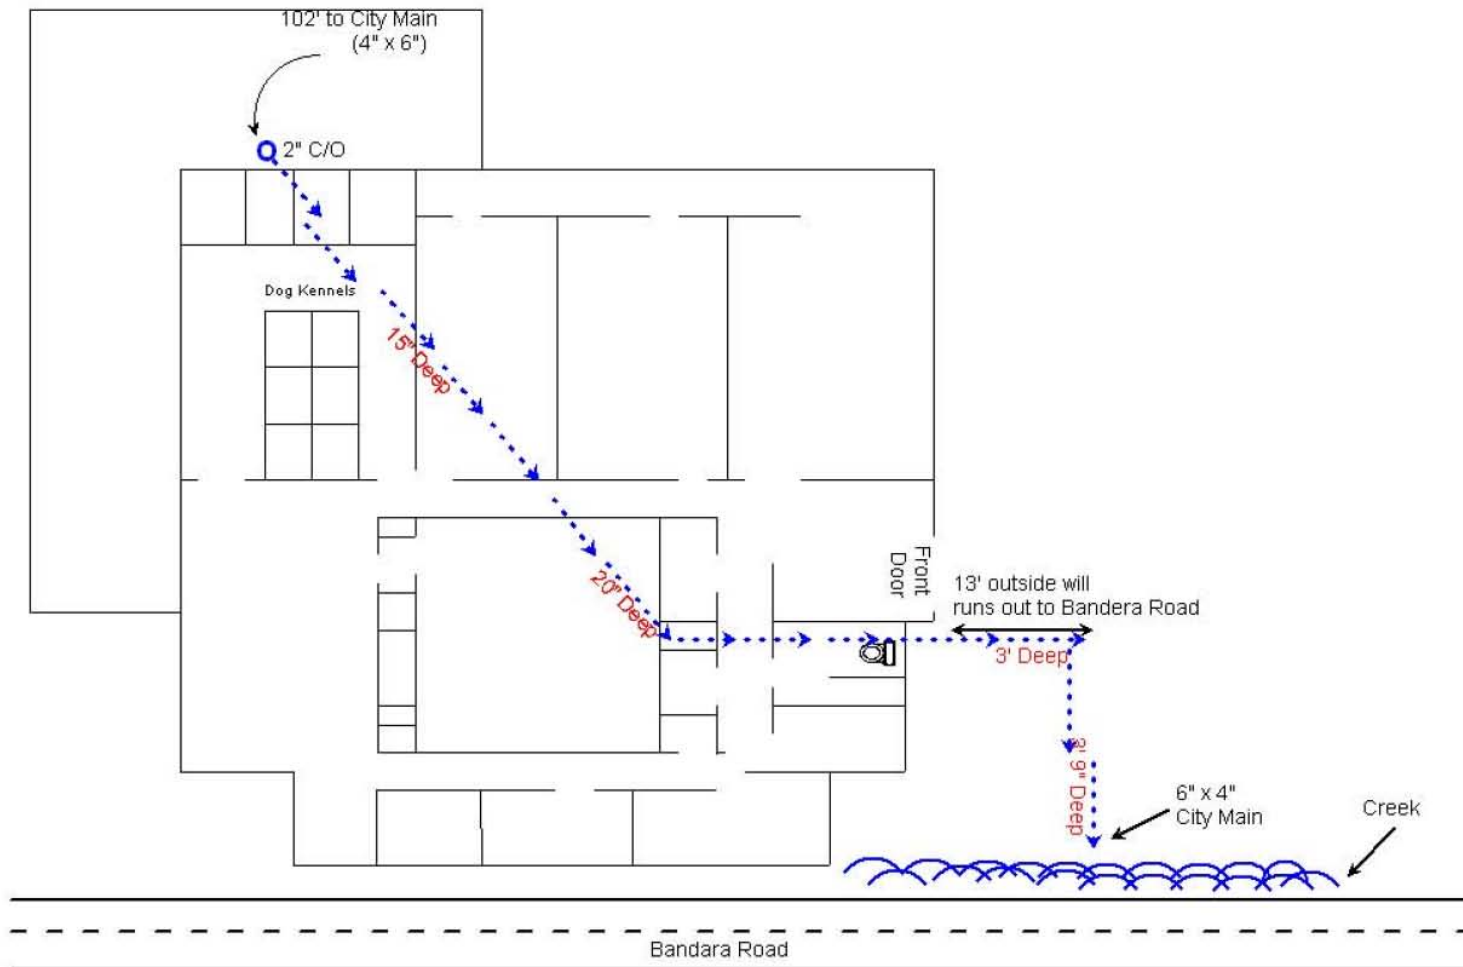
**FIG. 3**

E.L. Smith Plumbing of San Antonio performed a camera inspection of the sewer lines at the Vet Clinic on November 20, 2009. This camera inspection revealed a sanitary sewer line exits the building at a point near the front entrance to the building on the southeast side of the structure.

The work by E.L. Smith also located the larger lines under the slab of the Vet Clinic. This work revealed the larger main line under the slab extends to the northwest portion of the building where a cleanout is located on the exterior wall on the kennel area. These main lines are shown on Figure 3. Smaller lines for several sinks and other plumbing fixtures were not identified. However, estimated locations of these secondary lines are shown on Figure 4.

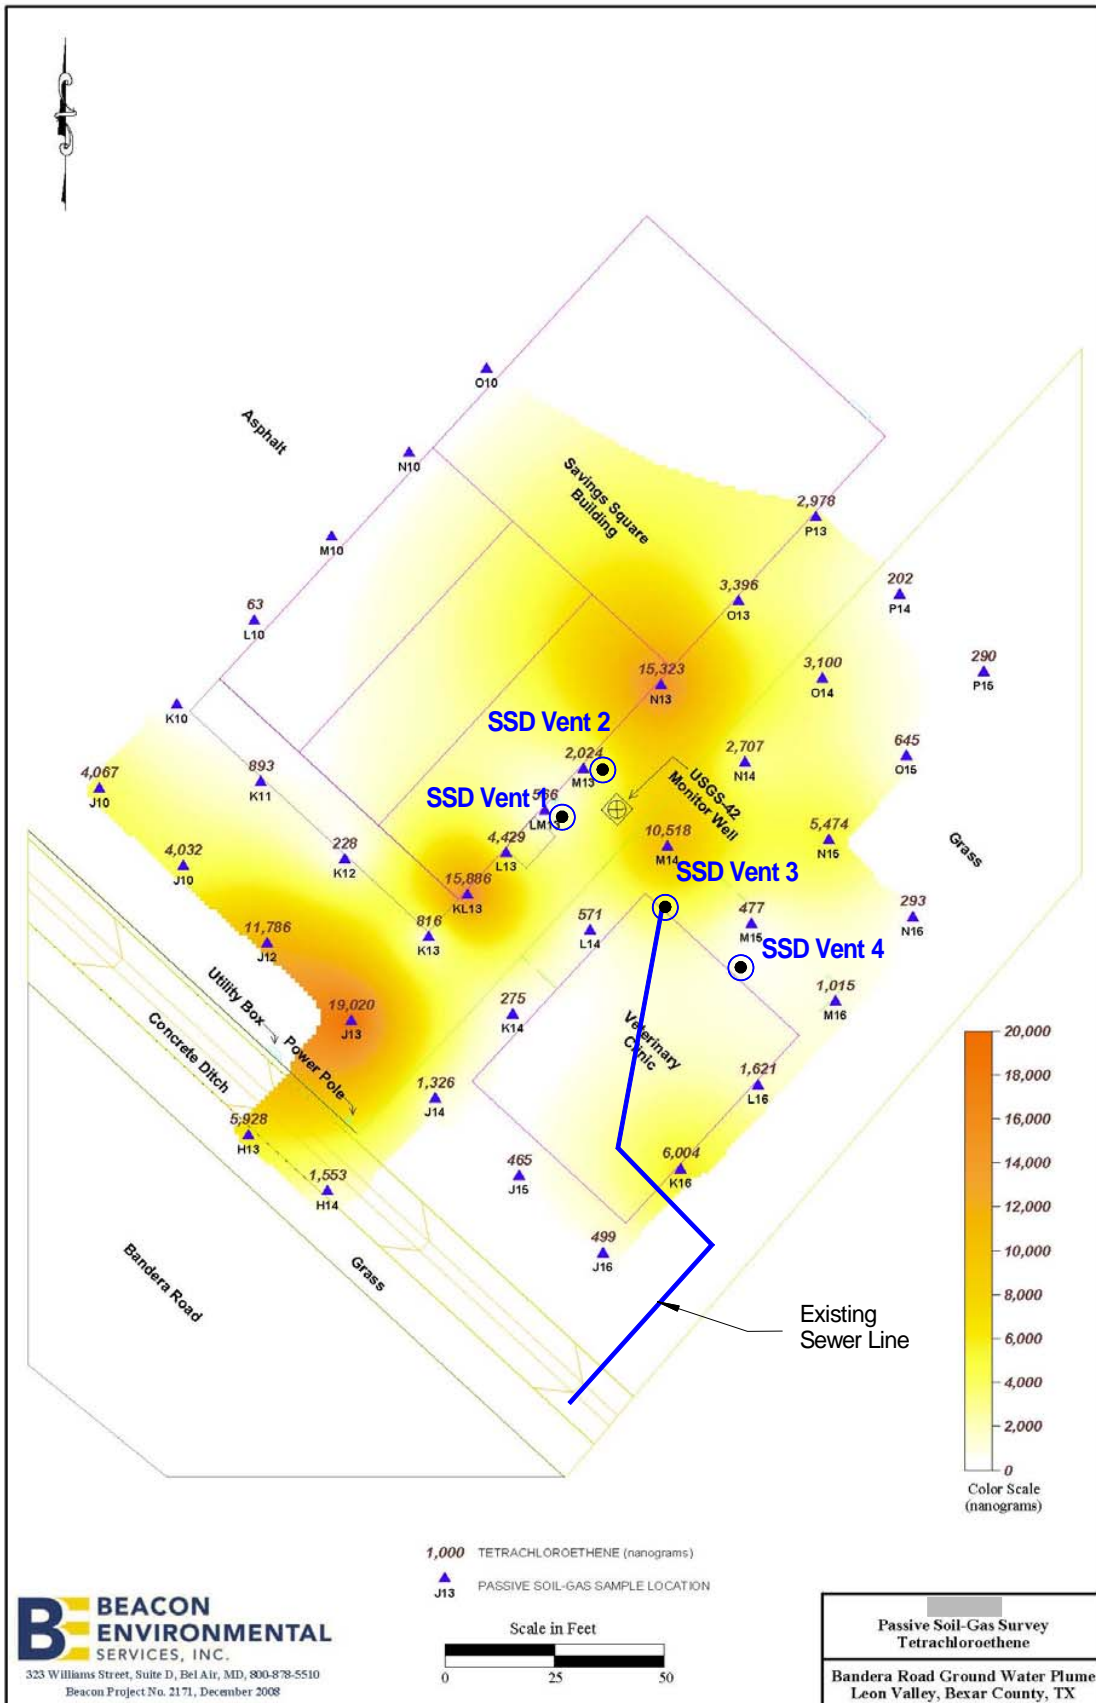
FIG. 5

1. Both vents are located relatively close to Beacon Probe location M14 (See Figure 5). This location showed one of the highest levels of vapor during the study. Therefore, it is possible that both vents may reduce vapors in this area.
2. Beacon sample K16 also showed an elevated level of vapor. This area is located near the point where the sewer line exits the building. This location was also considered for vent installation. However, no vapors were found in weep holes near K-16, which is located near the main entrance to the facility. Installation of a vent in this area is therefore also an atheistic concern. Based on these conditions, placing a vent near the other end of the main sewer line was considered a more optimal location.

It is proposed that two sub-slab depressurization vents will be installed at the northwest corner of the building near the kennel area (SSD-3) and near the crack in the northern building wall (SSD-4). The location of SSD-3 has been changed slightly to reflect the results of the camera survey. All other conditions and specifications noted in the September 24, 2009 work plan remain unchanged. The location of the vents is shown on Figure 4.
