**Five-Year Review
South Cavalcade Street Superfund Site
Houston, Harris County, Texas**

September 2002

FIVE-YEAR REVIEW
South Cavalcade Street Site
EPA ID# TXD980810386
Houston, Harris County, Texas

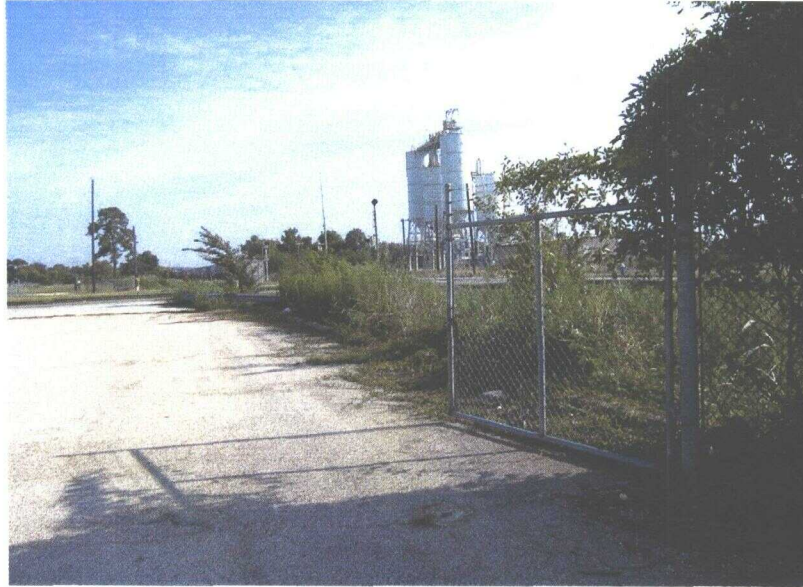
Perimeter fencing from the northeast corner south about 70 yards is partially down and overgrown (Attachment 4). This part of the fence separates the Nations Way property from the rail right-of-way bounding the Site on the east. [The January 2, 2002 annual O&M report for the cap noted that Sullivan Transfer had purchased the former Nations Way property. Property ownership should be verified.] Under the Access agreement, property owners are responsible for maintaining their sites, and will be contacted for repairs. There is very effective 24-hour security for the Site, but repairs to the perimeter fence along this section would further secure the ground water wells and treatment system. The southwest cap is outside the perimeter fence, but is being used as a parking lot for American Warehouse. The cap is an effective barrier to surface soils and is considered protective without the additional fencing.

View looking north from access gate on eastern boundary of South Cavalcade Site to South Cavalcade Street. Note that fencing along eastern boundary is down; beyond this area is the railroad right-of-way.

EPA recommends perimeter fence repairs (NE corner) to further secure the site. This does not impact protectiveness of the remedy.

- EPA recommends perimeter fence repairs (NE corner) to further secure the site.

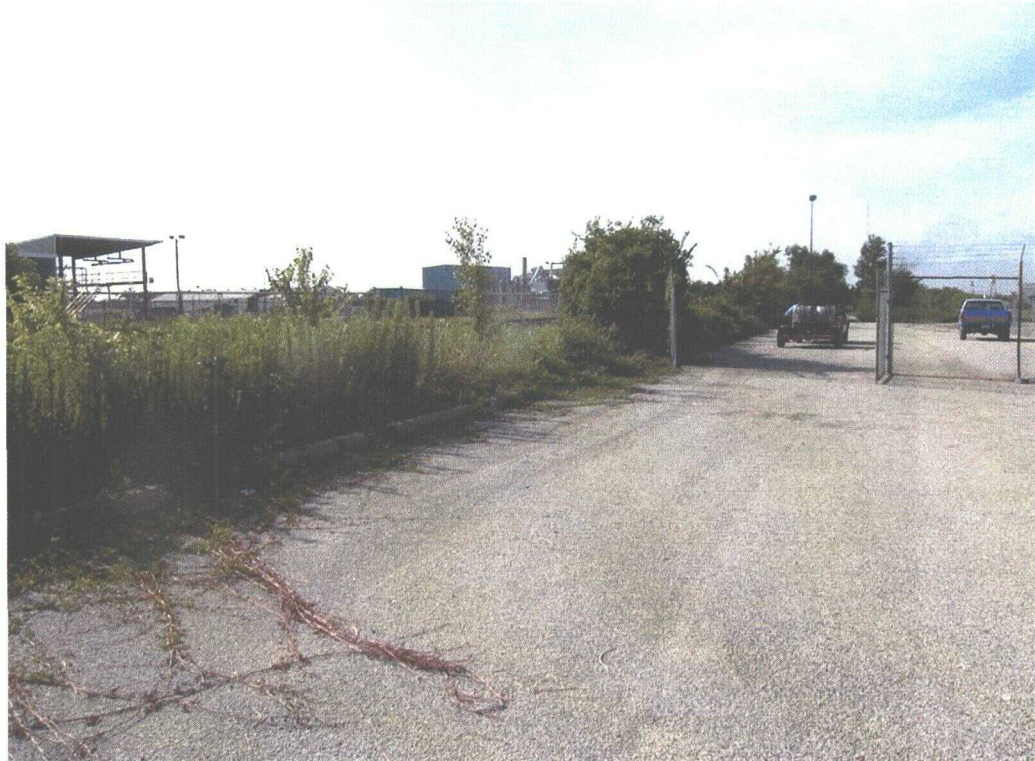
1. **Fencing damaged** Location shown on site map Gates secured N/A
 Remarks: Perimeter fence from NE corner south about 70 yds. is partially down and overgrown.
 Recommend that property owner be notified for repairs. Site security is not obviously compromised as 24-hour security patrol is very effective.

This view is taken from South Cavalcade Street looking south down the eastern boundary of the Site. Note the eastern fence line is completely or partially down. The fence is partially down beyond the gate as well; access is somewhat limited as the fence line is very overgrown. The rail right-of-way is directly to the left of the fence line.

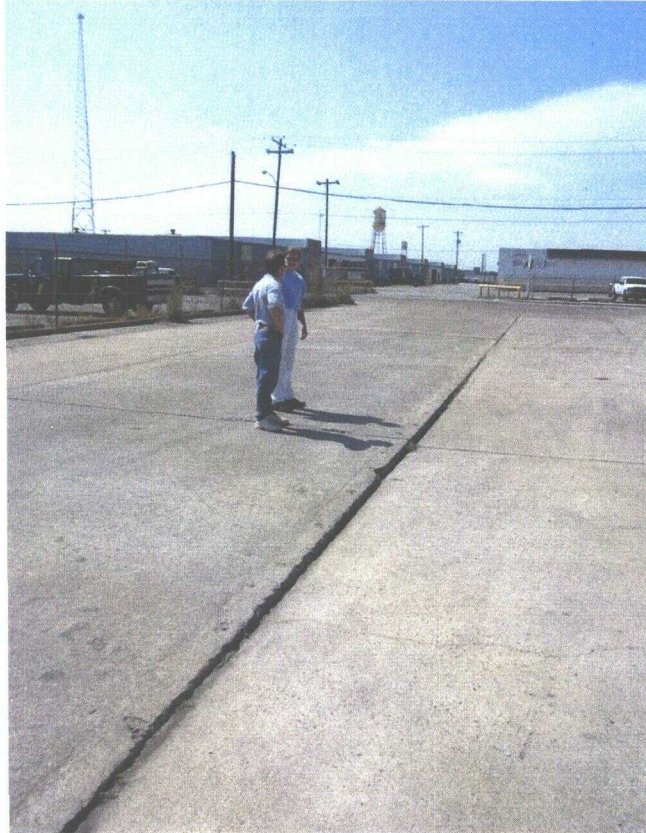
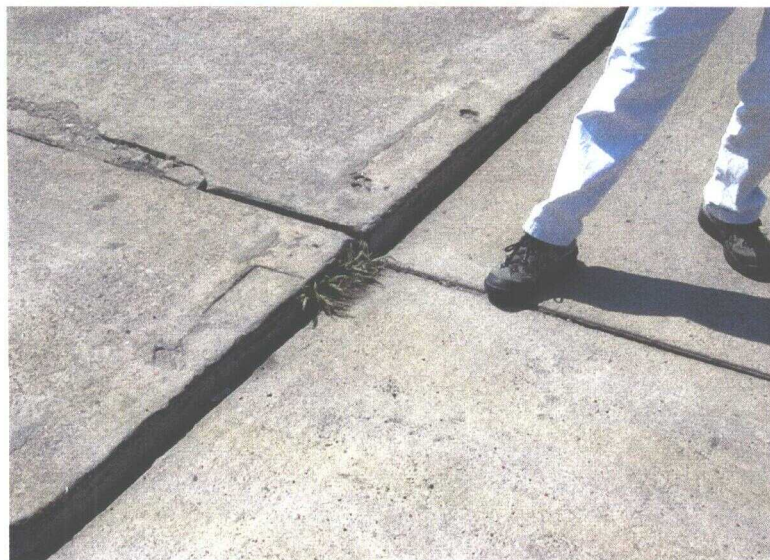
The August 2002 inspection team noted that the driveway just to the east of the southwest cap had a vertical offset at the joint (Attachment 4). Beazer indicated that there had been a water break in this area just after the cap was completed and that the offset was likely due to a soil wash-out along the pipe. There was no discernible impact to the cap, or indications of settlement, however this should be followed in the annual inspections and any significant changes noted.

1.	Settlement (Low spots) Areal extent _____	<input type="checkbox"/> Location shown on site map Depth _____	x Settlement not evident
2.	Cracks Lengths _____ Widths _____ Depths _____	<input type="checkbox"/> Location shown on site map	<input type="checkbox"/> Cracking not evident
Remarks: Cracking not significant; a few minor surficial cracks associated with curing. Condition will be monitored on PRP annual inspections. *A vertical off-set in a driveway joint adjacent to the east boundary of the southwest cap was noted during the site inspection and is most likely related to a break in a water piper, and washout, after the cap was completed. Off-set was approximately 3 vertical inches at the maximum point.

The top orienting view is taken at the eastern edge of the southwest capped area, looking south towards Collingsworth Street (running parallel to the first utility line). The concrete offset is along a joint in a driveway on the American Warehouse property. The offset is related to an earlier water main break and wash-out and does not appear to impact the cap integrity. The cap edge runs parallel to the off-set and is at the right edge of this photo. See detail below for offset comparison.

- Monitor the eastern edge of the southwest cap for impacts from a historical water line break.
- Monitor the surficial cracks (from curing) in the caps for any significant changes over time.
- Verify property ownership of the Nations Way tract.
- Contact the property owner for perimeter fence repairs.
