Project: 090557-01

Re: Post-TCRA Quarterly Inspection Report - January 2013 Inspection

This document reports the results of the January 2013 quarterly inspection of the armored cap cover, fencing, and signage installed for the Time Critical Removal Action (TCRA) at the San Jacinto River Waste Pits Superfund Site (TCRA Site).

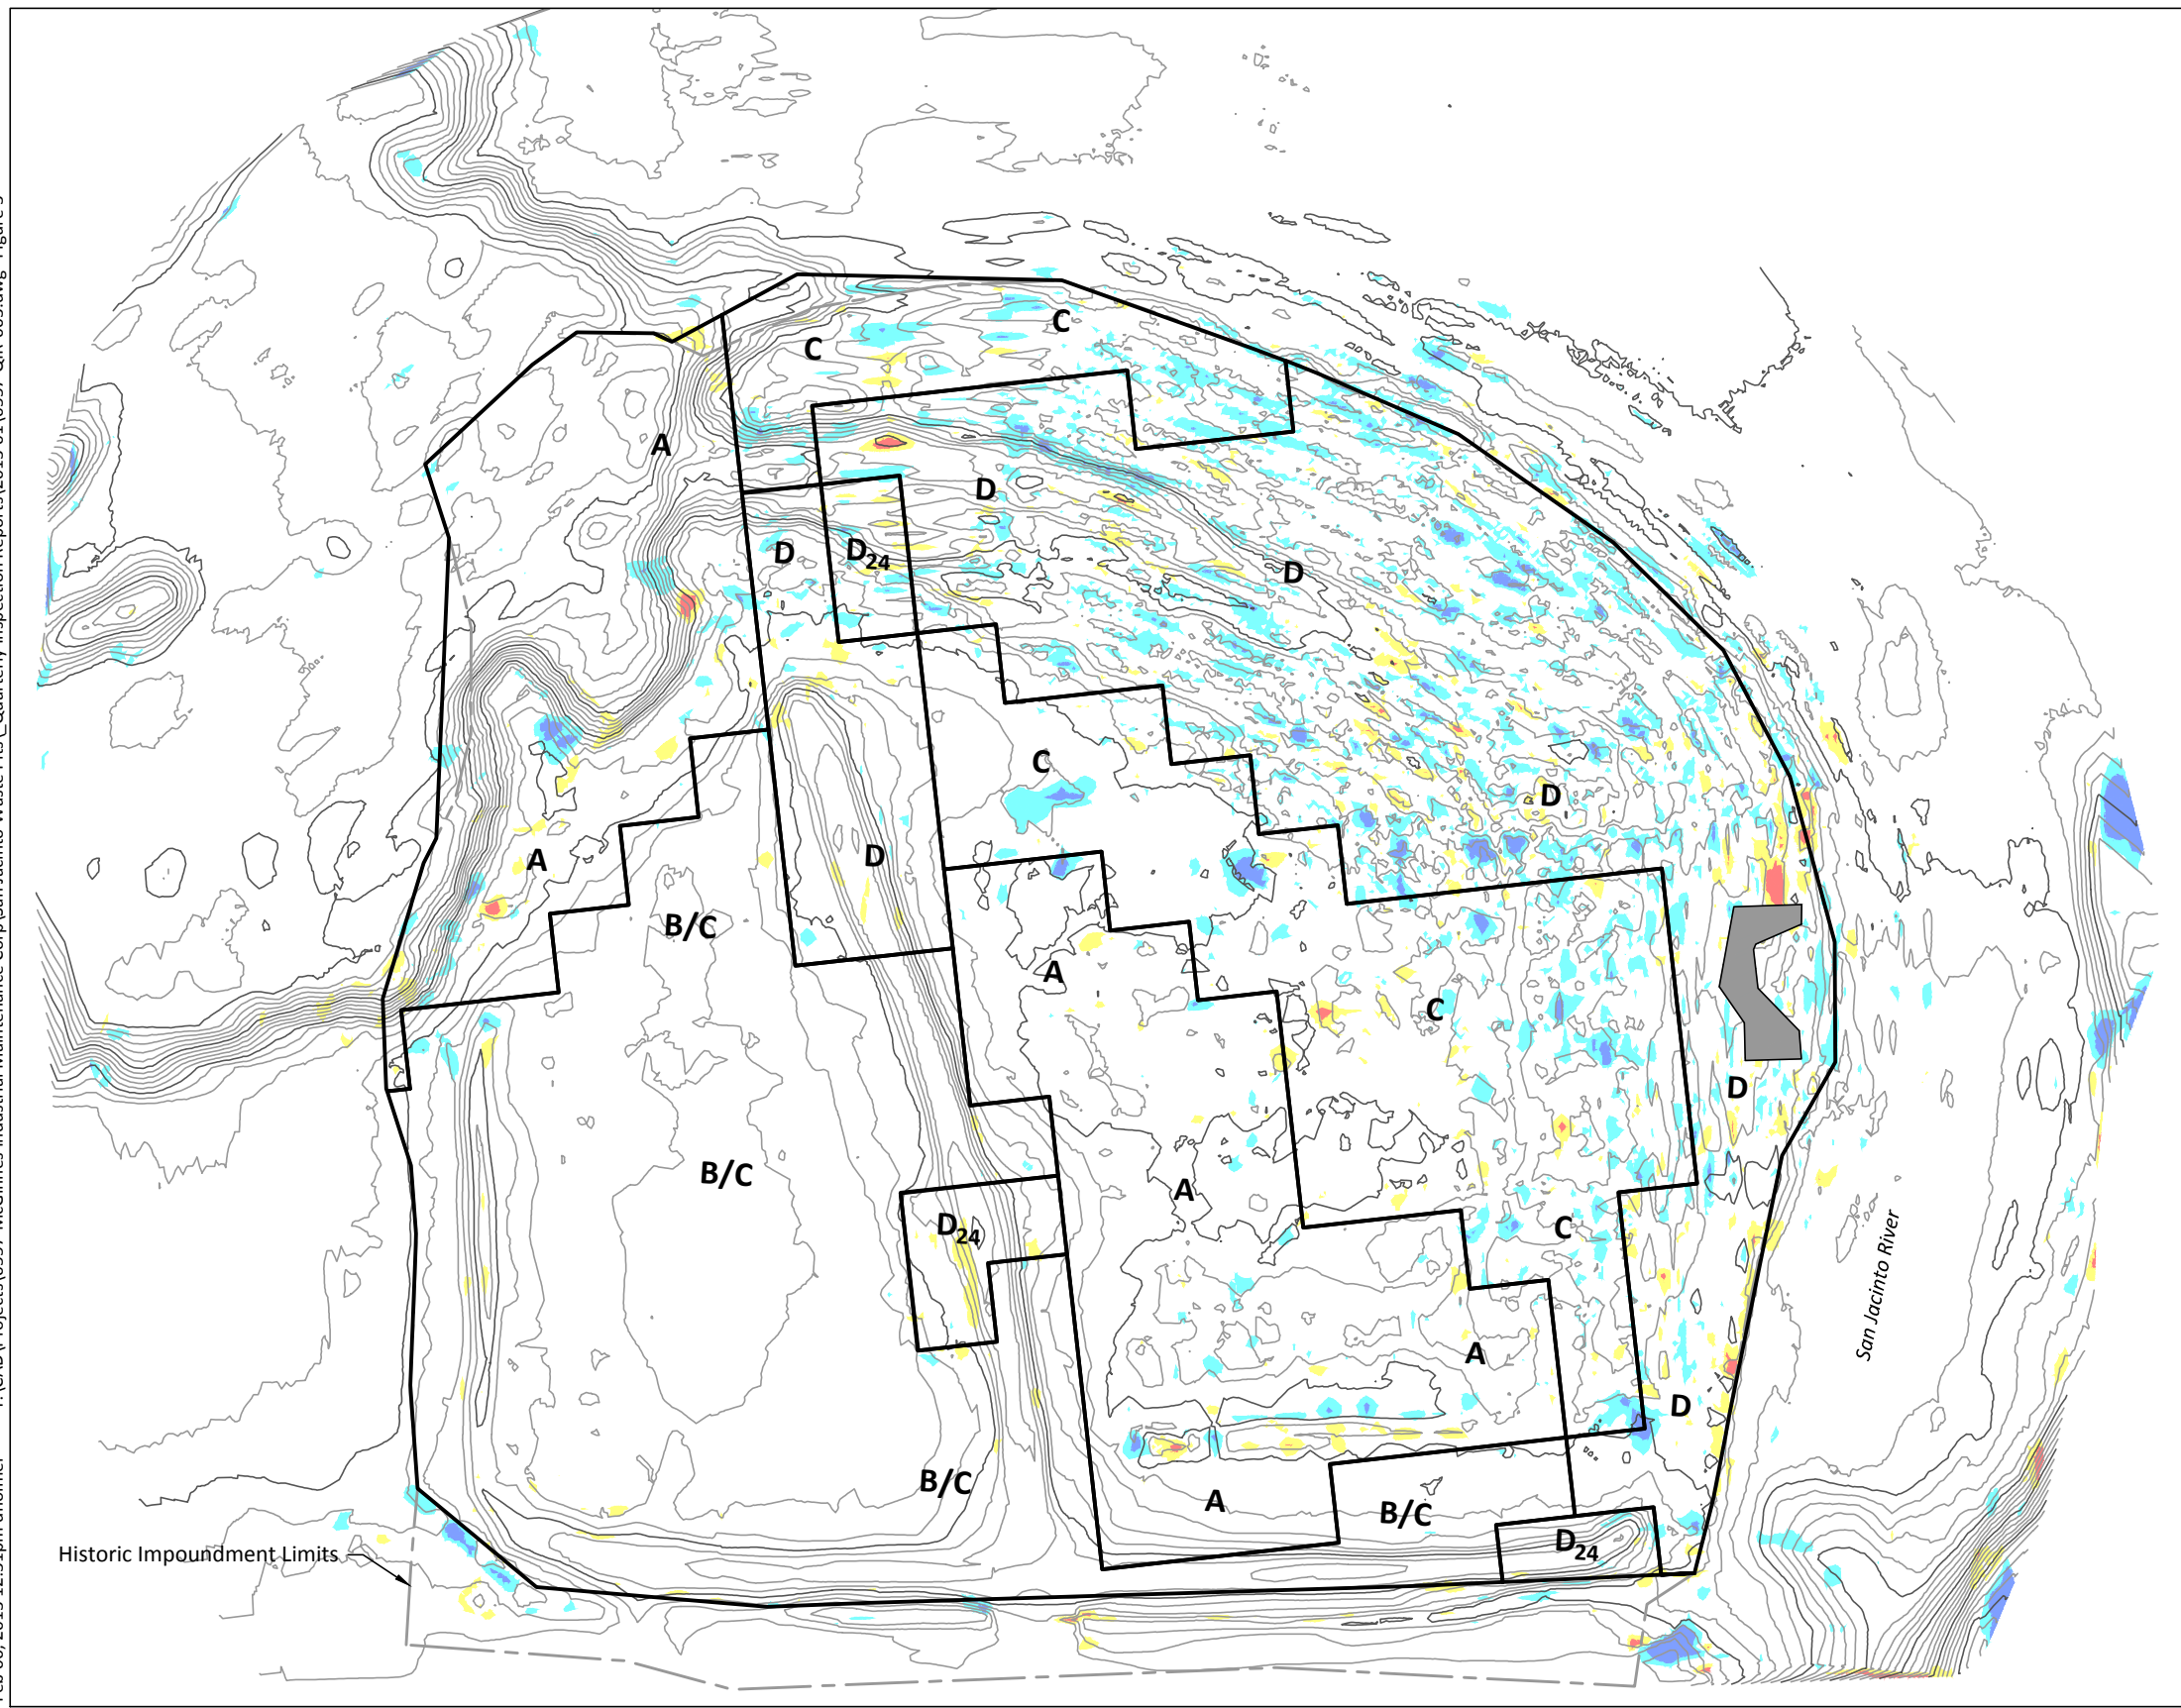
Figure 3
 January 2013 Quarterly Inspection Survey
 Post TCRA Quarterly Inspection (January 2013)
 San Jacinto River Waste Pits Superfund Site

A small area in the intertidal zone was not safely accessible by either topographic or bathymetric methods (Figure 3). Seasonally low tides with north winds during the month of January prevented safe access by boat to the areas identified on Figure 3. Algal and crustacean growths in these small areas were hazardous for the surveyor to access by foot. Visual inspection in this area indicates that no movement of the armored cap has occurred in these areas.

The survey for this quarterly inspection event was conducted by Hydrographic Consultants, Ltd. Hydrographic survey data were collected from January 22, 2013 to January 28, 2013; upland topographic data were collected from January 3, 2013 to January 30, 2013. The topographic survey required additional days to complete in order to accommodate the maintenance event, and the hydrographic survey was offset as a result of the consistently low tide conditions at the TCRA Site during the month of January 2013. Figure 3 displays the results of the completed survey.

No deficiencies were identified by the topographic or bathymetric surveys.

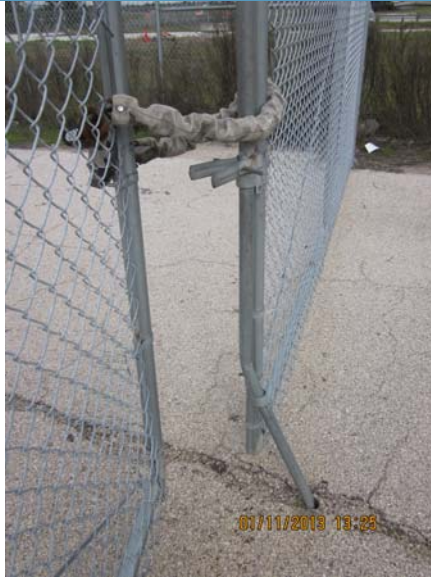
The visual inspection event on January 11, 2013 did not identify damaged or otherwise deficient areas in the perimeter fence or signage. Incidental damage to the fence center post at the eastern gate was noted, but did not require action, as it was not identified as a breach in the fencing. However, additional inspections of the TCRA Site fencing during the armored cap survey and maintenance event identified two breaches in the perimeter fence. These two areas were repaired by the Respondents' Fence Contractor; all repair activities were completed by February 6, 2013. Details regarding the TCRA Site fencing repairs are provided in the attached Maintenance Completion Report; see photographs 26 through 28 of Appendix A for examples of the fencing repairs.

Photo 05: Bent center post of east access gate (view east)

During the work day on January 30, 2013 a NFC representative examined the breaches in the perimeter fencing to develop plans for maintenance of the fence. Subsequently, two panels were repaired and three additional panels were reinforced. The east access gate center post was also replaced due to minor damage.

1000 – 1330 – Completed barb wire installation. Installed new gate center post, east bank access. Took photographs repairs and departed Site.

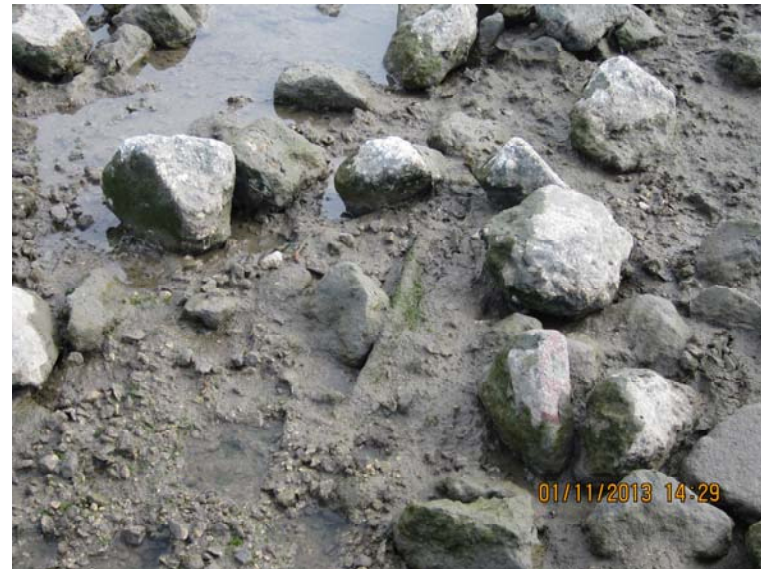
There was a low tide during the January 11, 2013 visual inspection because of northerly winds. This low tide exposed two localized areas of the TCRA armored cap cover with less than 12 inches of stone cover thickness. The underlying geotextile layer in those areas was intact and there was no evidence that any of the underlying materials were or had been exposed. The USEPA was notified of this condition through a phone conversation and submission of a notification letter on Tuesday, January 15, 2013. The Respondents conducted a field investigation during a low-tide event on Thursday, January 17, 2013 collecting topographic and probing data that identified three additional areas that had less than 12 inches of stone cover thickness and would require maintenance. One of the three additional areas also required geotextile placement over an approximate 2 foot by 2 foot area. Further phone communications with the USEPA took place on Thursday, January 17, 2013, and an additional written notification was submitted to USEPA on January 18, 2013. The Respondents continued to evaluate the TCRA cap during the low tide conditions that existed on January 17 and January 18, 2013. The low tide event on Friday, January 18, 2013 was the lowest of any of the inspection days, and was at -2 foot mean sea level (MSL)³.

Photo 12: Thin armor cap area identified during visual inspection (view north)

During the visual inspection and subsequent thickness probing surveys of the armored cap, five localized deficiencies were noted for the stone cover in the Eastern Cell; these deficiencies have been repaired as described in the Maintenance Completion Report (Appendix B). During maintenance activities, the on-site team was notified of a potential maintenance area near the northwest corner of the Western Cell. This area was identified as a location for preventative maintenance and has been repaired as described in the Maintenance Completion Report (Appendix B).

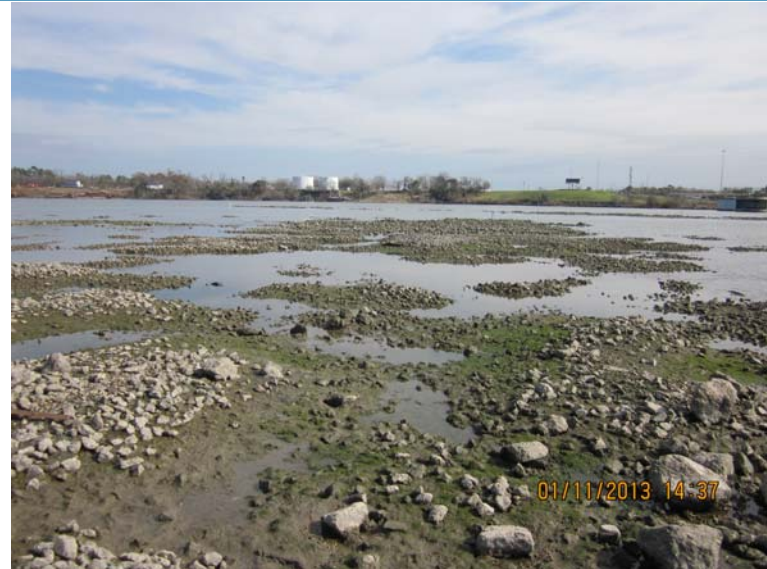
Photo 14: Low tide conditions in the Eastern Cell; note sedimentation and biological growth (view east)

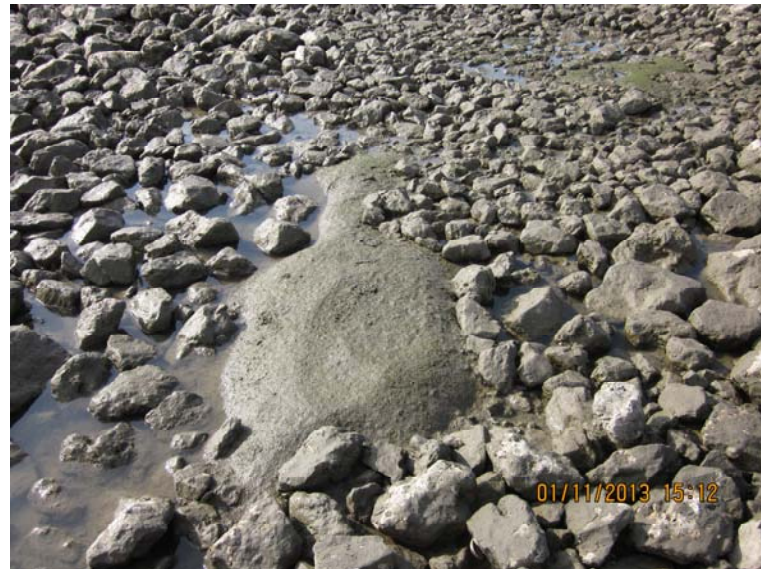
Photo 16: Areas (foreground and background) of thin armor cap area and exposed geotextile identified during visual inspection (view northwest)

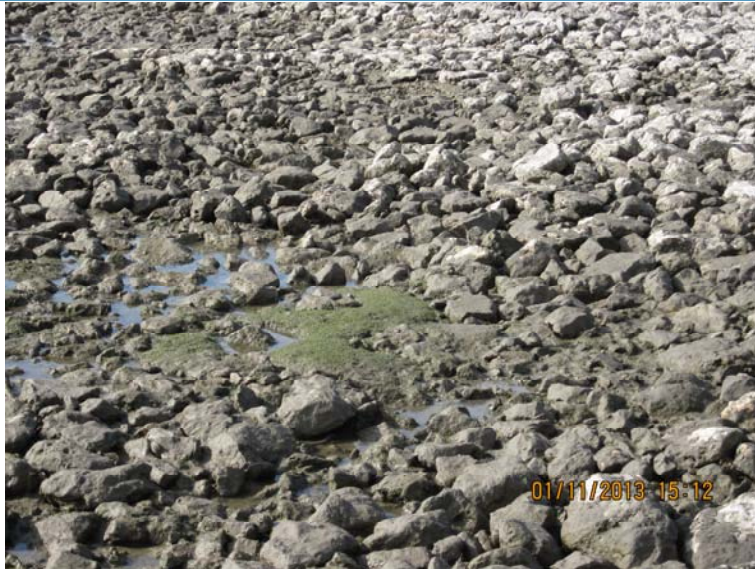
Photo 17: Background location from Photo 16 of thin armor cap area and exposed geotextile identified during visual inspection (view southwest)

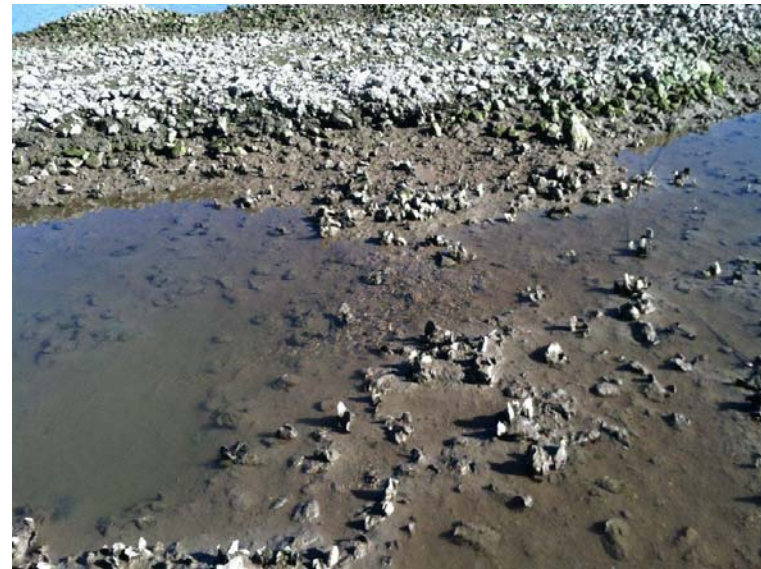
Photo 24: Area of Eastern Cell showing biologic growth and sediment deposition (view northeast)

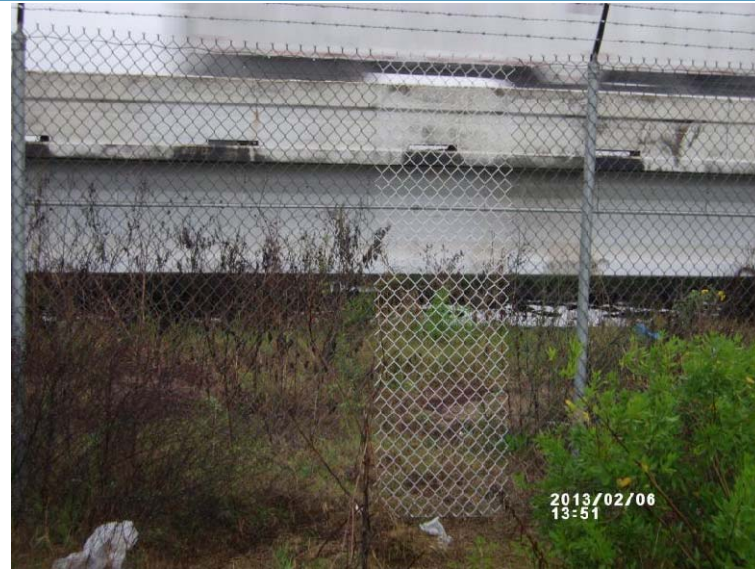
Photo 26: Repaired fence fabric, south alignment, west bank of the San Jacinto River I-10 crossing (view north)

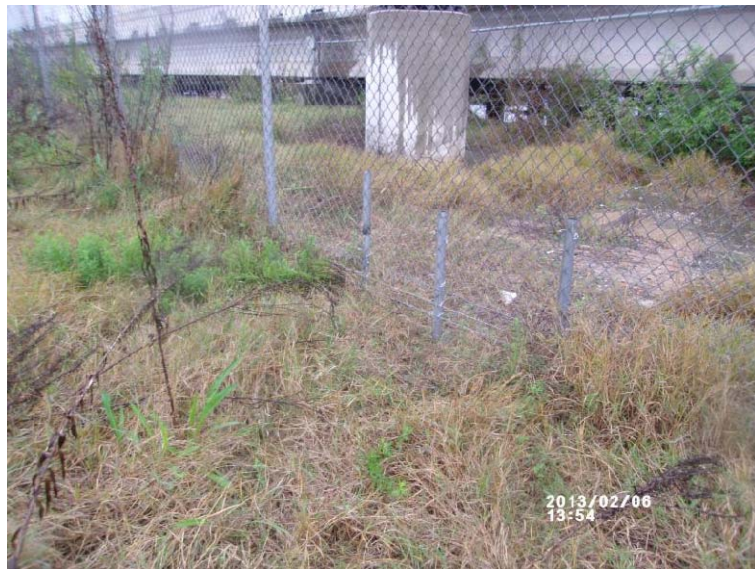
Photo 27: Added lower supports on adjacent panels to secure fence fabric and barb wire (view northwest)

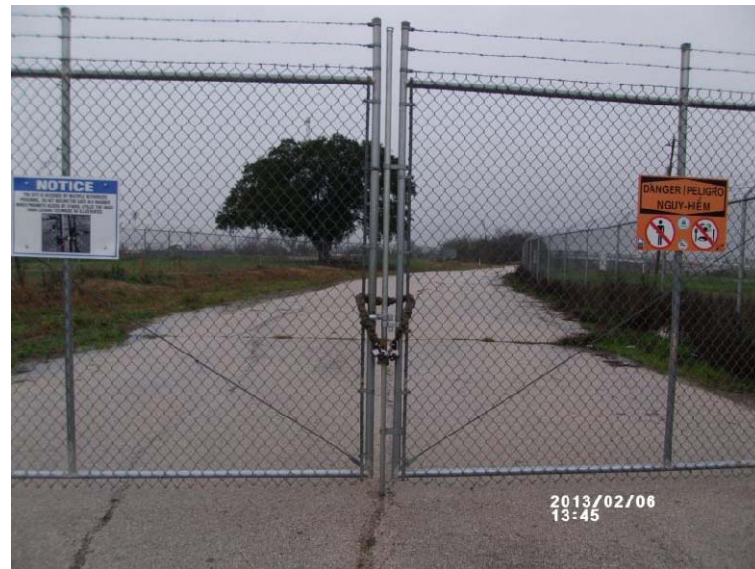
Photo 28: New gate center post installation, east bank (view north)

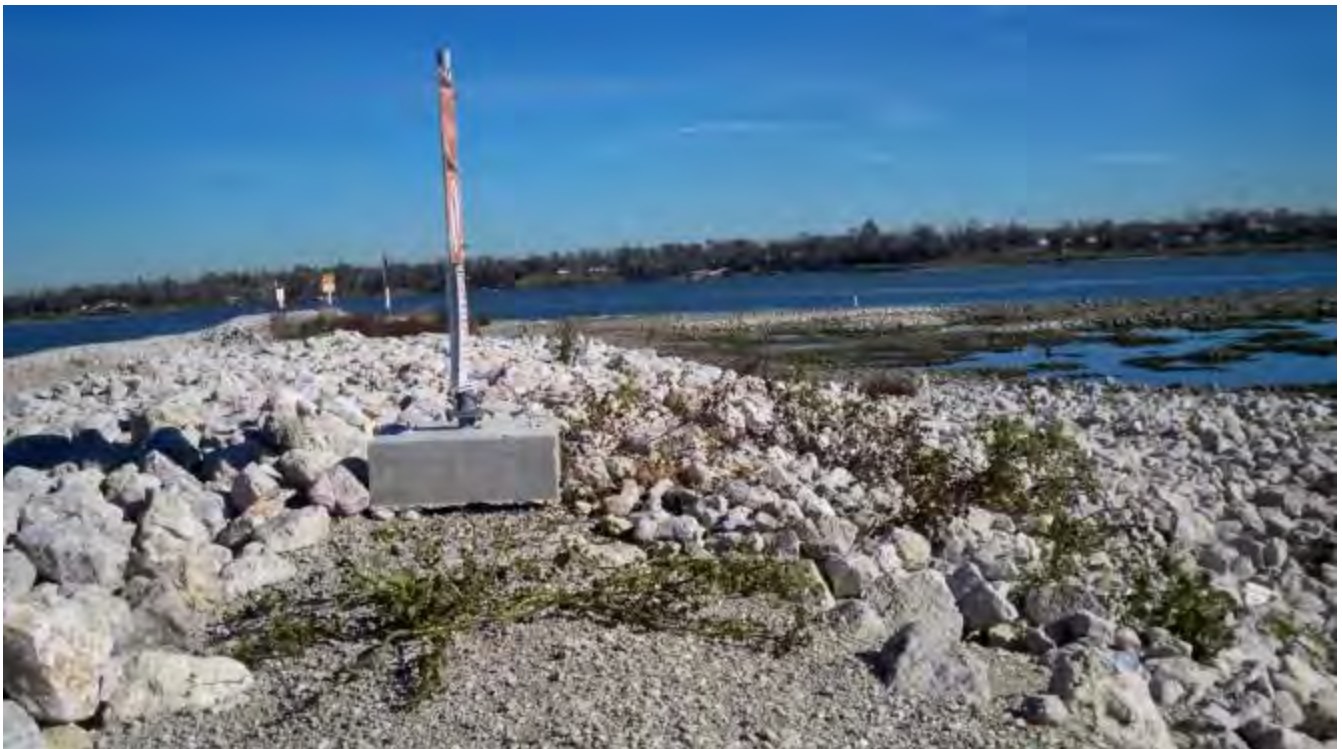
Photograph 3 – Woody stem vegetation cleared from signage on central berm.

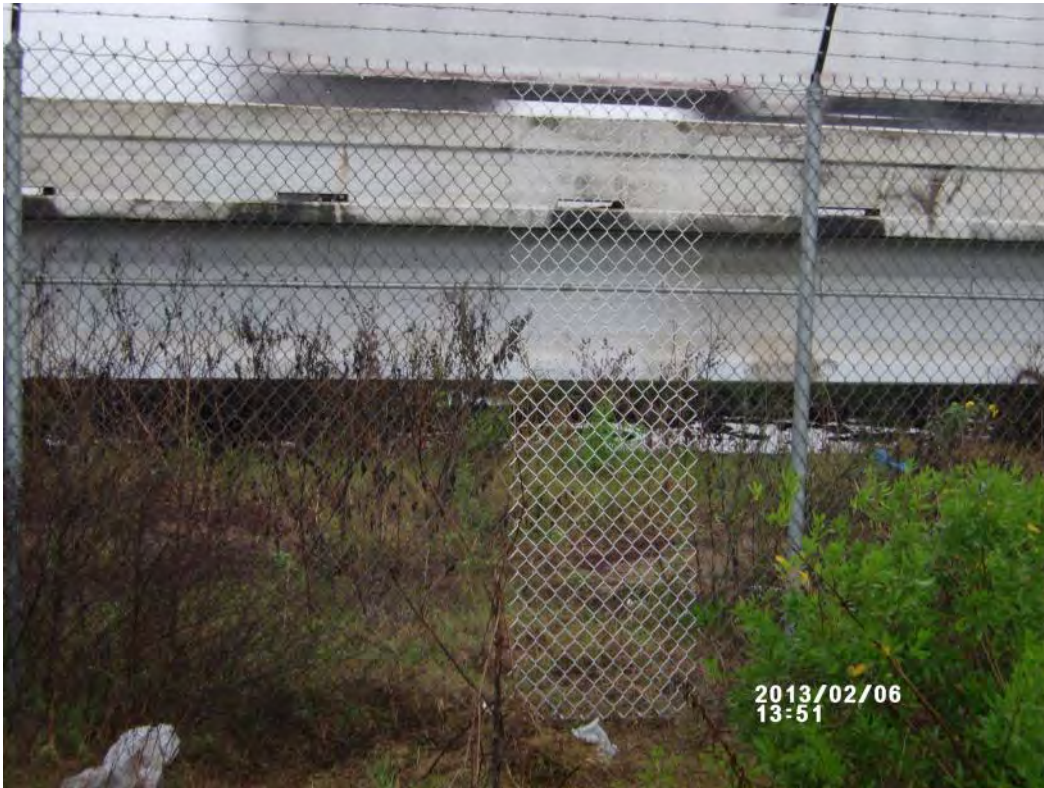
Photograph 1 – Repaired fence fabric, south alignment, west bank of the San Jacinto River I-10 crossing

- Repaired cut fence fabric
- Installed additional mid panel posts and barb wire
- Replaced damaged gate center post
- All maintenance items complete

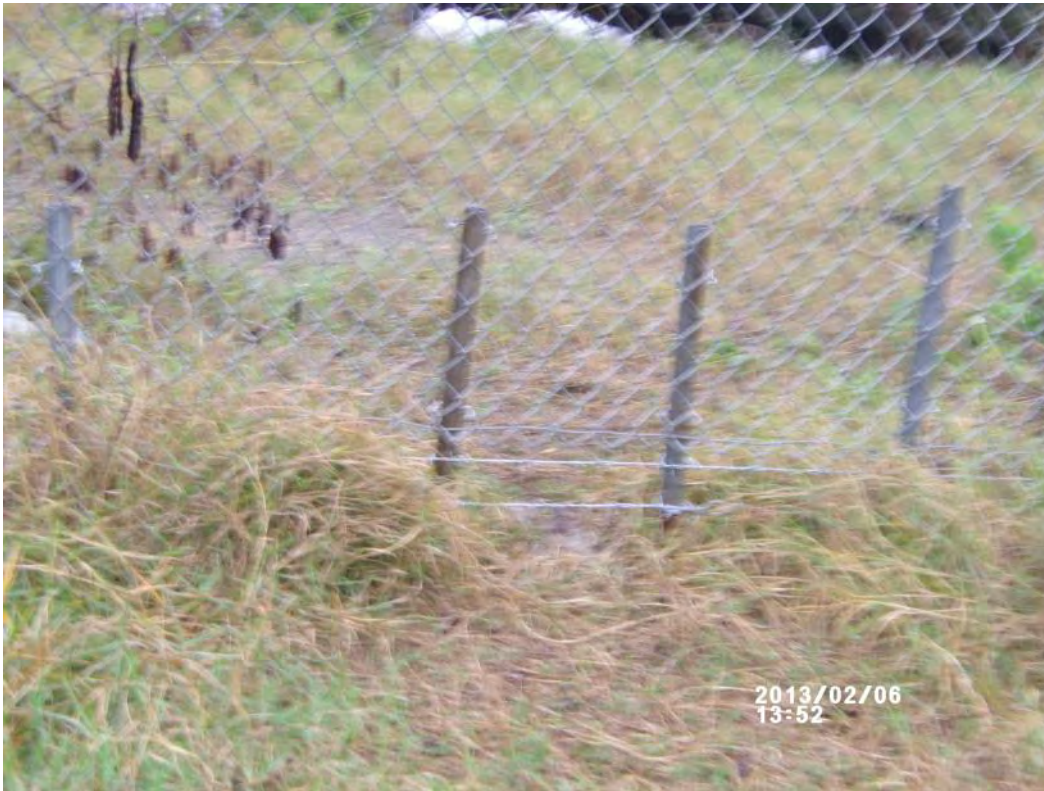
Photograph 2 – Added posts and barb wire closures, south fence alignment, west bank.

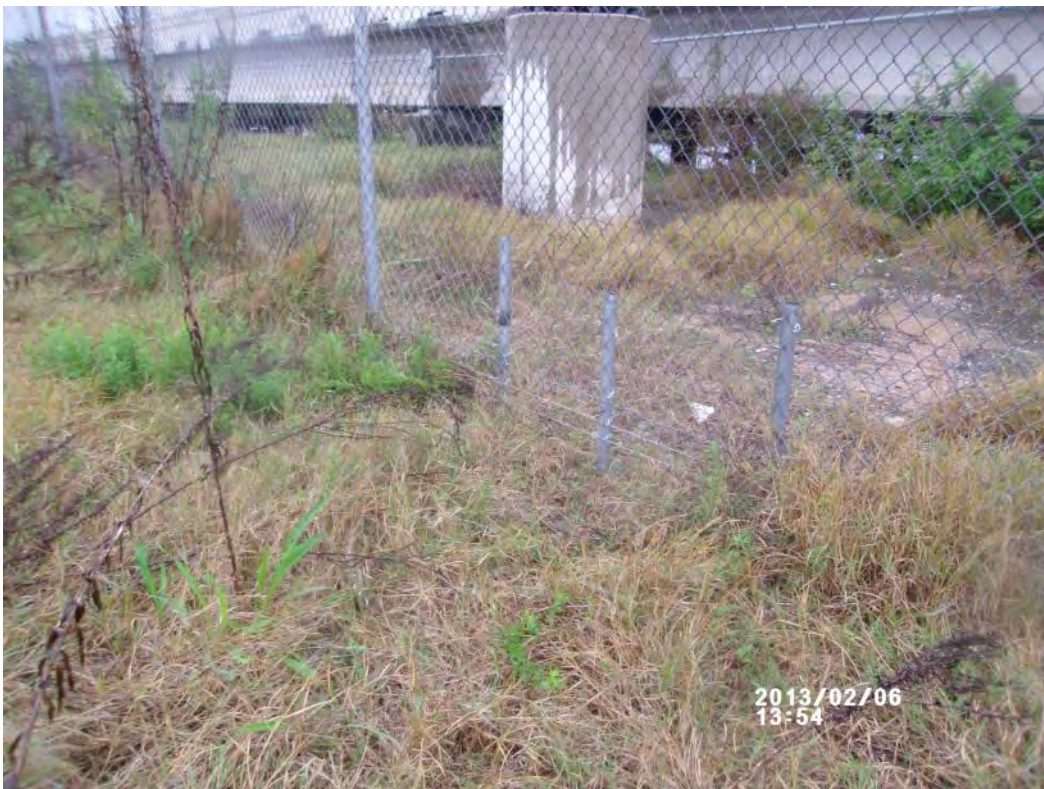
Photograph 3 – Added barb wire and fence supports to prevent access, south fence line, west bank.

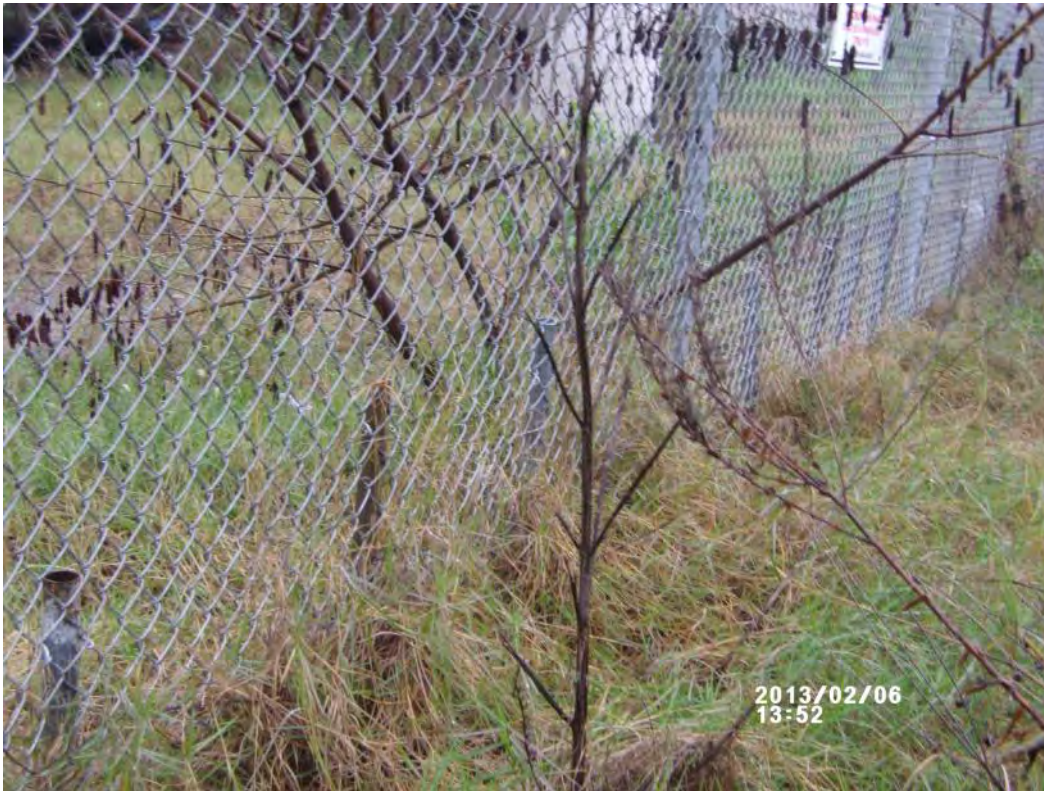
Photograph 4 – Added lower supports on adjacent panels to secure fence fabric and barb wire.

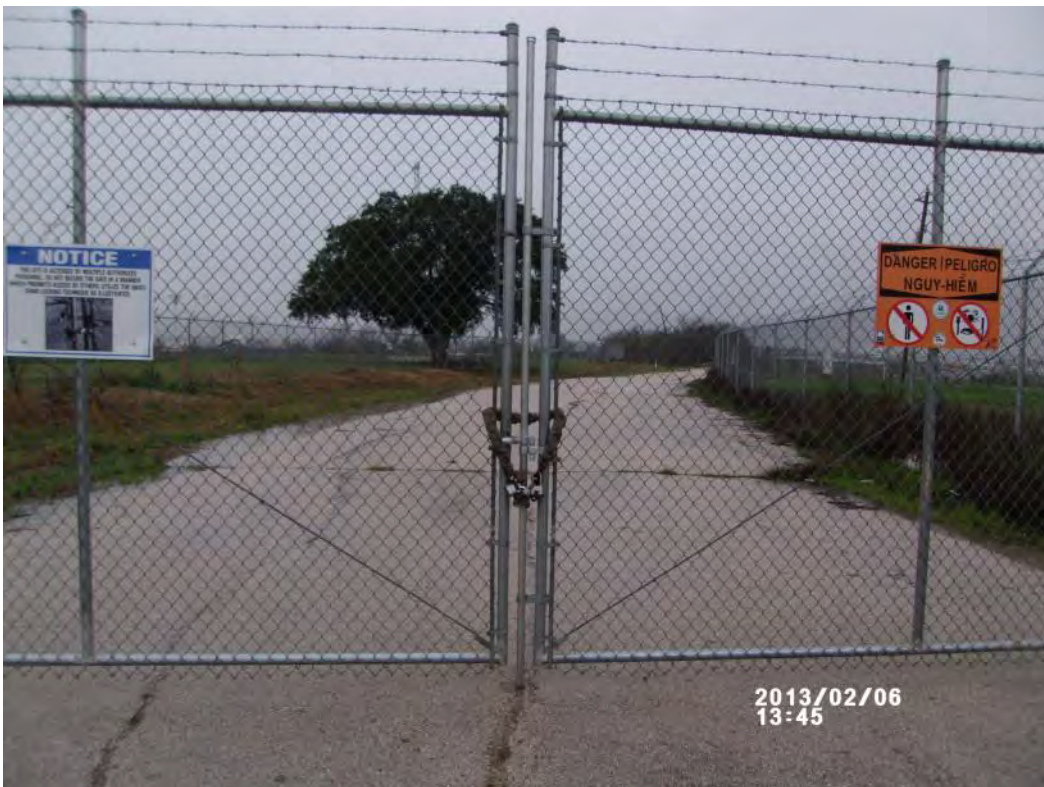
Photograph 5 – New gate center post installation, east bank. All fence maintenance actions complete.
