SUBJ: Results of Well Water Sampling Along South Bellingham Road

April 20, 1993

Re: Results of Well Water Sampling Along South Bellingham Street

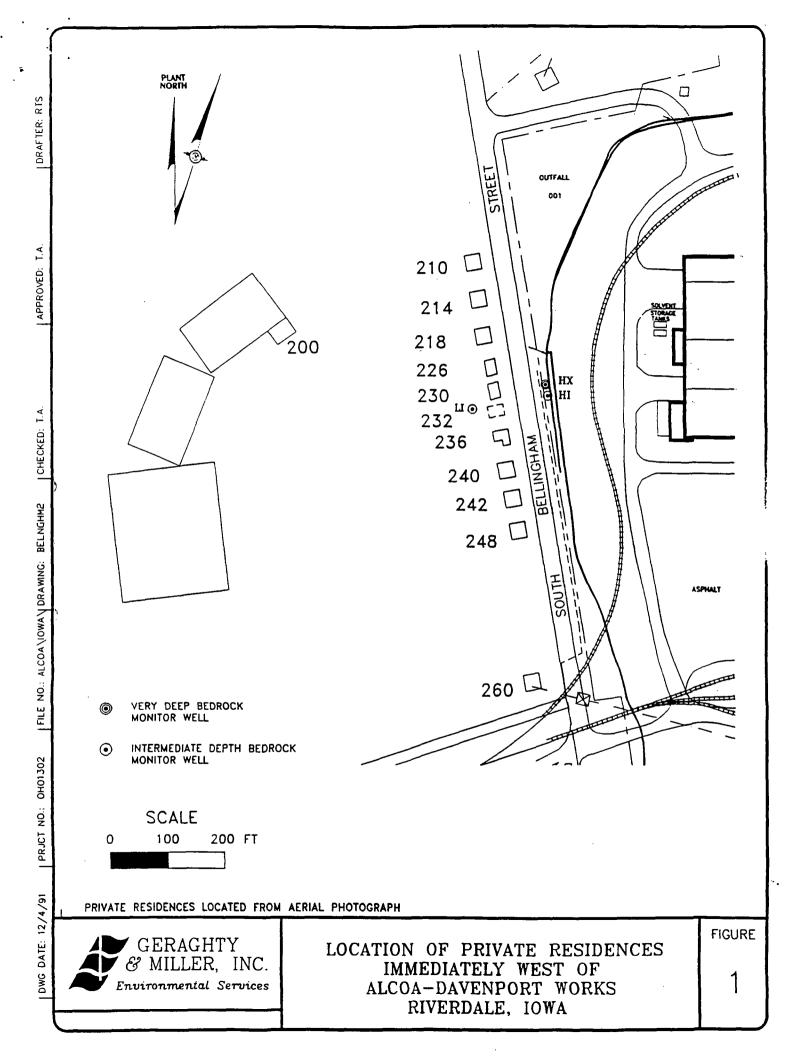
Monitor well LI was installed in the fall of 1991. The location of monitor well LI is illustrated on Figure 1. Trichloroethene was first detected in monitor well LI in a sample collected October 13, 1992. No contamination was detected in LI during two previous sampling events during October 1991 and May 1992. Because of the proximity of this monitor well to residential well water users along South Bellingham Street, a well survey and sampling event was conducted in conjunction with EPA Region VII personnel to determine whether residential wells have been affected.
