MEMORANDUM

SUBJECT: Trip Report: Emory Plating Co., 3929 E. 14th Street,
Des Moines, Iowa.
TDD#: T07-9206-044
PAN#: EIA0317SAA
EPA/OSC: Wood Ramsey

INTRODUCTION

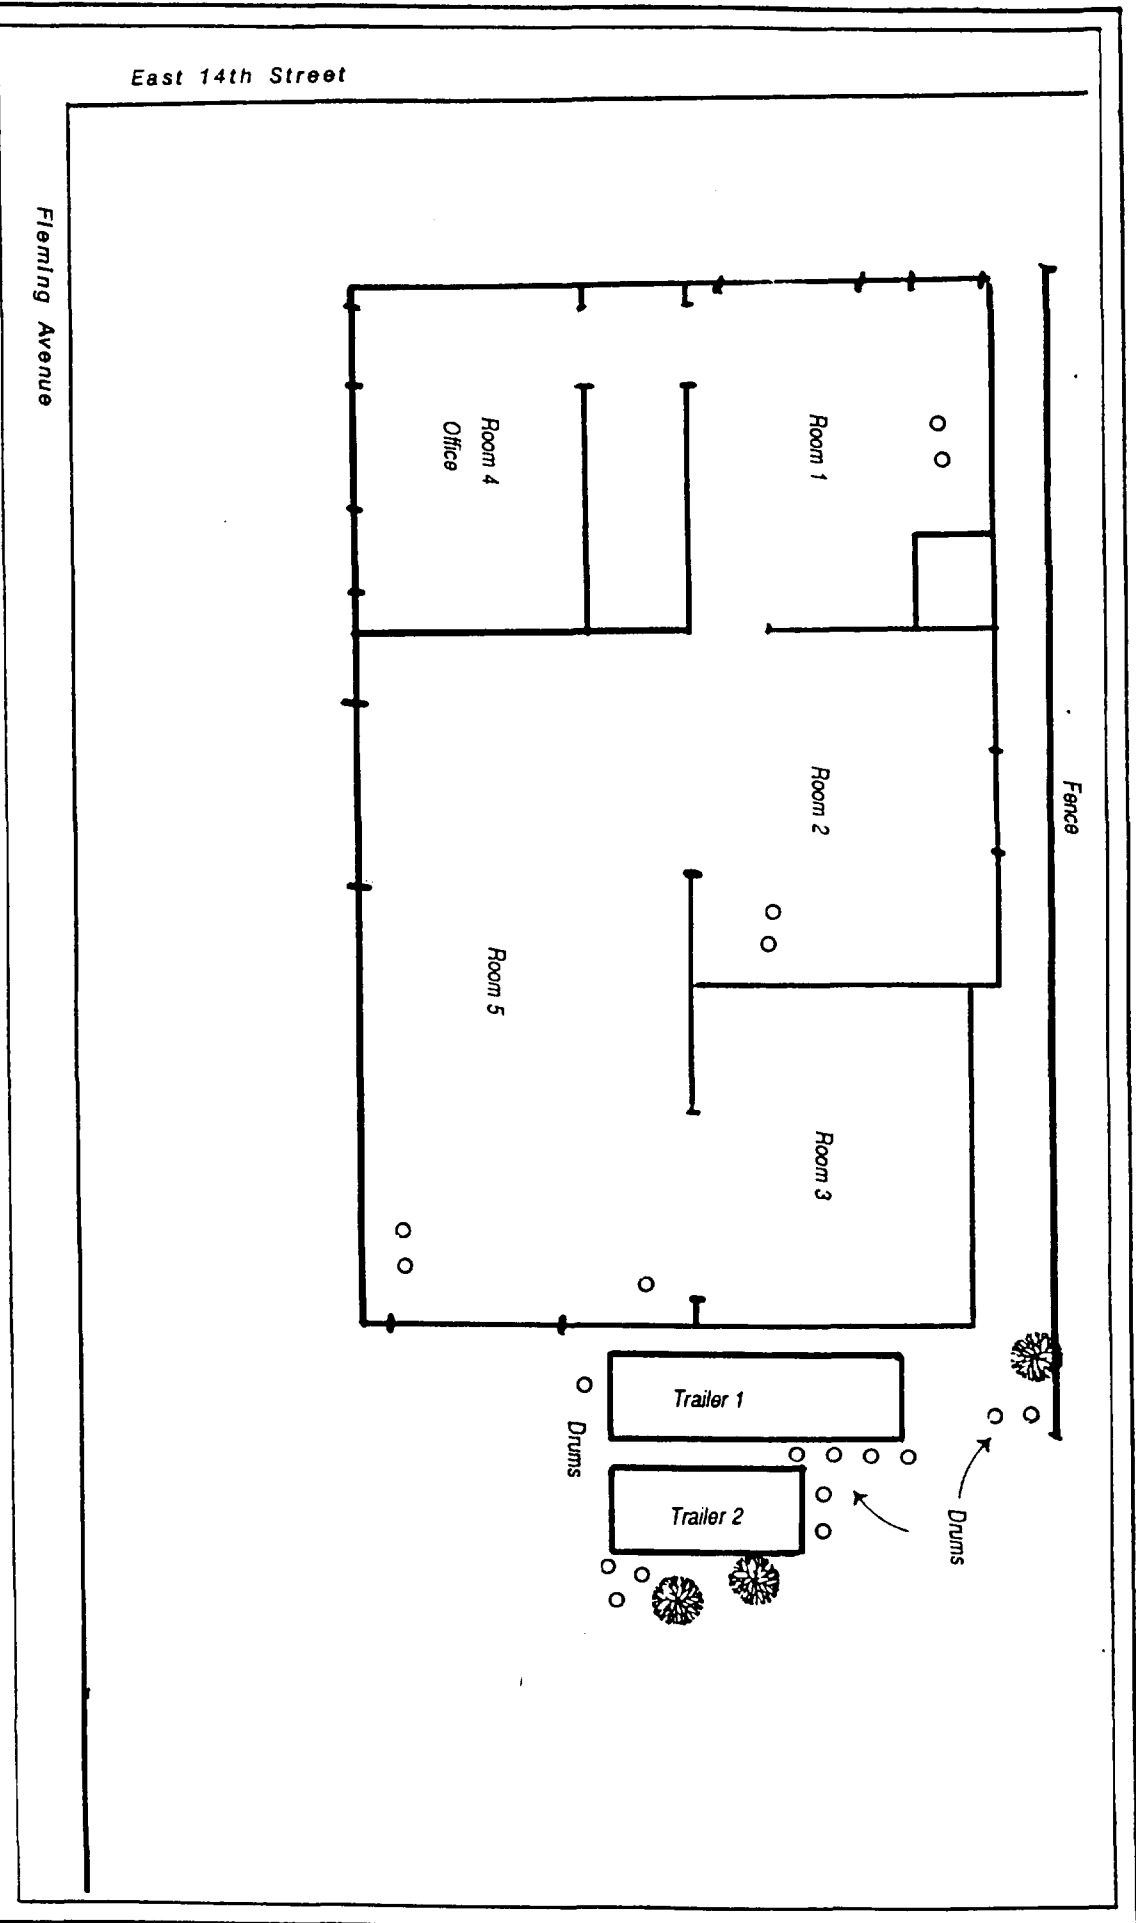
Figure 2: Site Map

The site perimeter was inspected for any visual evidence of potentially hazardous substances. A pile of sand thought to be used as polishing abrasives was located outside the east garage door (Figure 2: Site Map). One drum labeled Rust Veto, a combustible liquid, (Table 1) was found east of trailer 1 (Site Map). Five unlabeled drums of unknown contents (Table 1) and several empty drums were located east of the building, in and around the two trailers left on site. At least two of the unknown drums were deteriorated and leaking. The trailers were approximately 20 feet long and 10 feet long. Both trailers were filled with empty drums and debris.

Five 55-gallon drums of unknown materials were located east of trailer 1 (Site Map) along with an additional drum labeled as Rust Veto, a combustible liquid.
