DAILY FIELD RECORD

Project and Task Number: 350.0065.004		Date: 4/10/23	
Project Name: Frenchtown Mill		Field Activity: CFR Berm Observations	
Location: Missoula County		Weather: Sunny 70°F	
USGS Station 12353000 (Below Missoula):		3280 cfs (1.94 ft)	
Observer(s):	Company	Time in	Time Out
Dan Hoffman	NewFields	1400	1630
Heath Geil-Haggerty	NewFields	1400	1630
Wil George	MTDEQ	1400	1630
PERSONAL SAFETY CHECKLIST:			
<input type="checkbox"/>	<input type="checkbox"/>	Steel-toed boots	<input checked="" type="checkbox"/> X
<input type="checkbox"/>	<input type="checkbox"/>	Gloves	<input type="checkbox"/>
<input type="checkbox"/>	<input type="checkbox"/>	Hard Hat	<input checked="" type="checkbox"/> X
<input type="checkbox"/>	<input type="checkbox"/>	Safety Goggles	<input type="checkbox"/>
<input type="checkbox"/>	<input type="checkbox"/>	Traffic Vest	<input type="checkbox"/>
<input type="checkbox"/>	<input type="checkbox"/>	Waders	<input type="checkbox"/>

PURPOSE:			
<p>Perform Clark Fork River (CFR) berm monitoring in accordance with the Former Smurfit-Stone/Frenchtown Mill - Clark Fork River Berm Surveillance & Contingency Plan, Version 3, May 22, 2019. Berm monitoring is conducted to

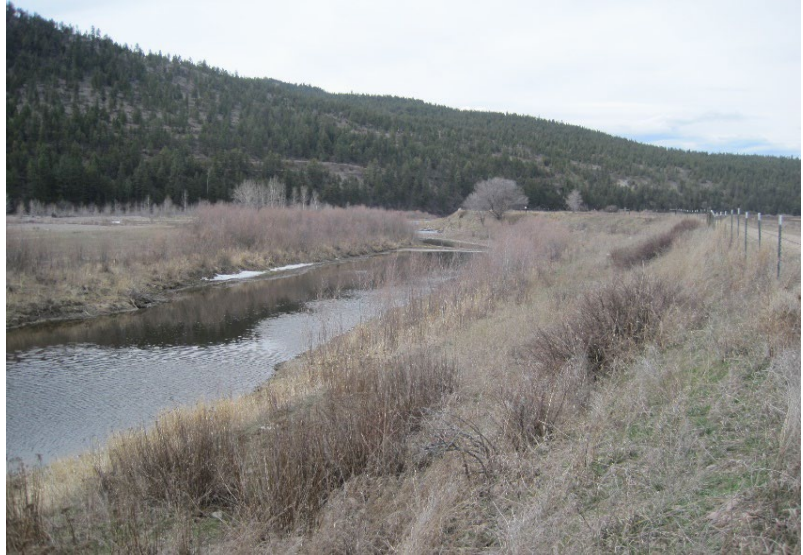
Photo 1**Site: Photo Point 1****Date/Time:** 4/10/23 1449**Staff Gage (ft):** N/A**Location:**

Looking northwest. Southwest corner of HP2.

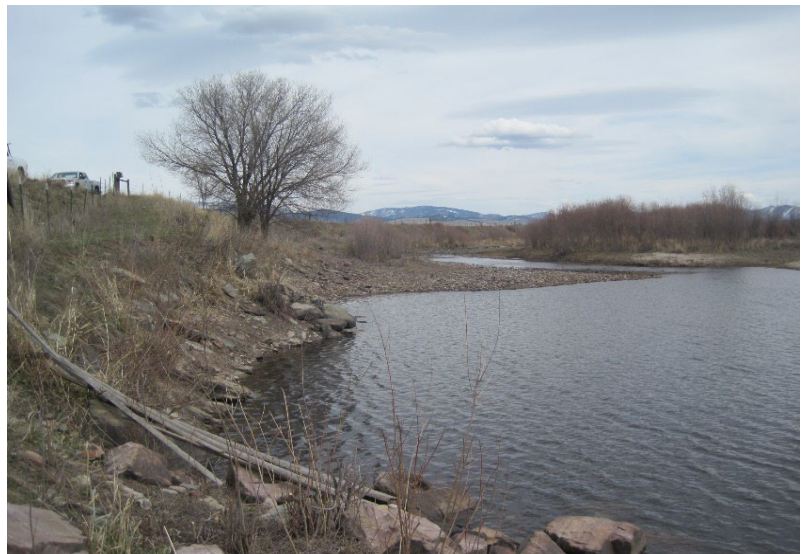
**Photo 2****Site: Photo Point 2****Date/Time:** 4/10/23 1455**Staff Gage (ft):** N/A**Location:**

Looking east.

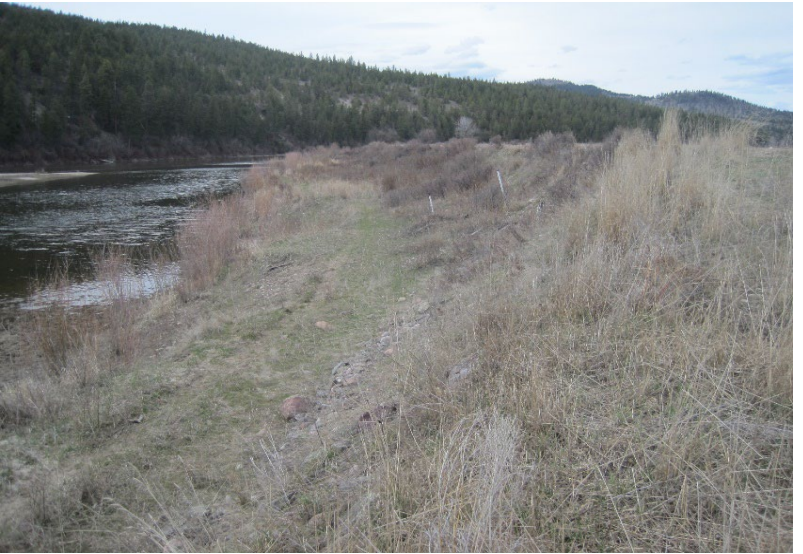
Photo 3	
Site: Photo Point 3	
Date/Time: 4/10/23 1459	
Staff Gage (ft): Below gage	
Location:	
N 46.95146	
W 114.21378	
Comments:	
Looking northwest. West side of HP2.

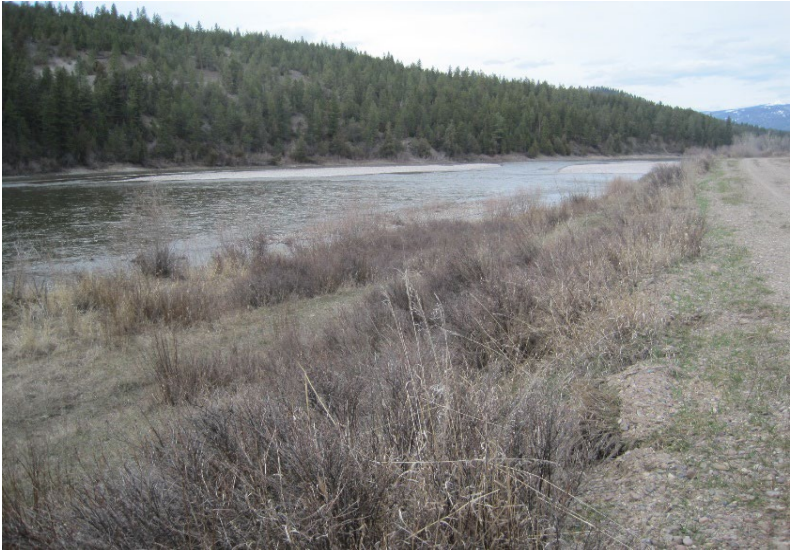
Photo 4	
Site: Photo Point 4	
Date/Time: 4/10/23 1502	
Staff Gage (ft): N/A	
Location:	
N 46.95341	
W 114.21720	
Comments:	
Looking north. West side of HP2.

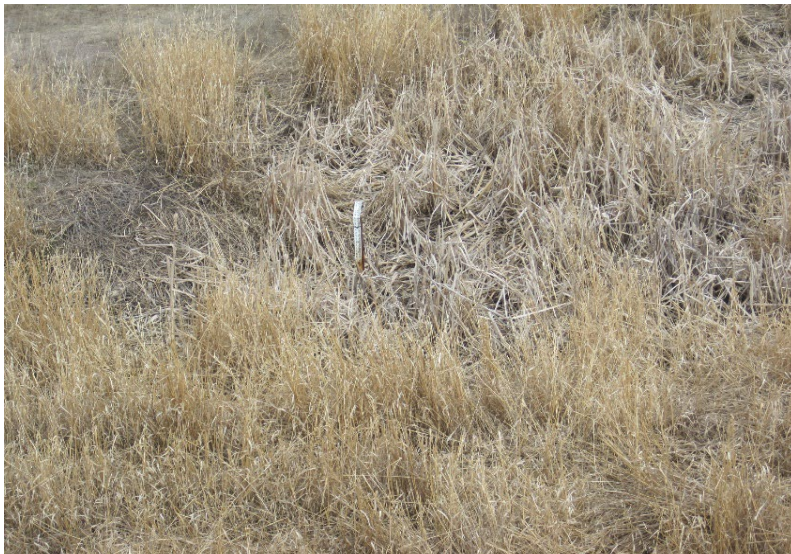
Photo 5

HP2 gage.

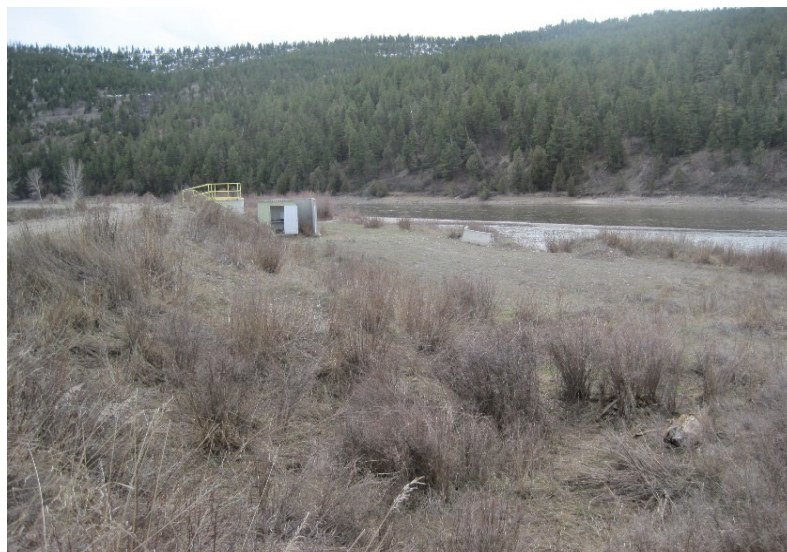
Photo 6

Looking south. Southwest side of HP11.

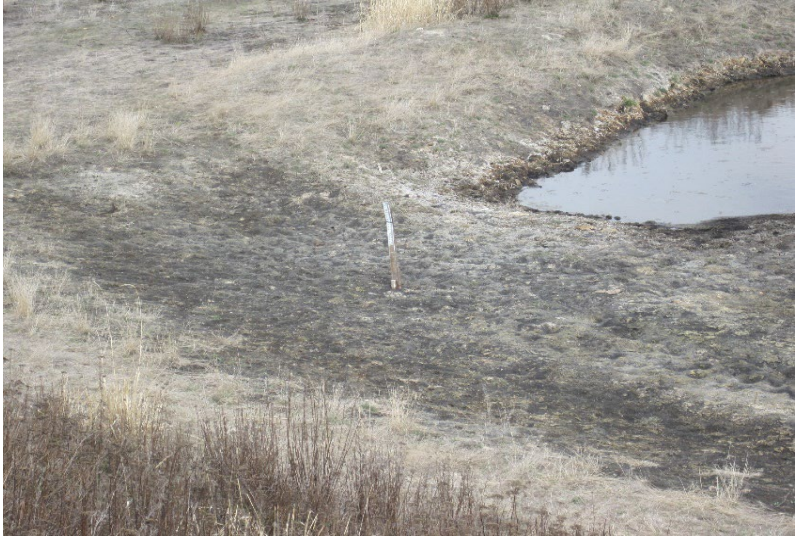
Photo 7

Site: HP7 gage	
Date/Time: 4/10/23 1531	
Staff Gage (ft): Below gage	
Location:	
N 46.95975	
W 114.21866	
Comments:

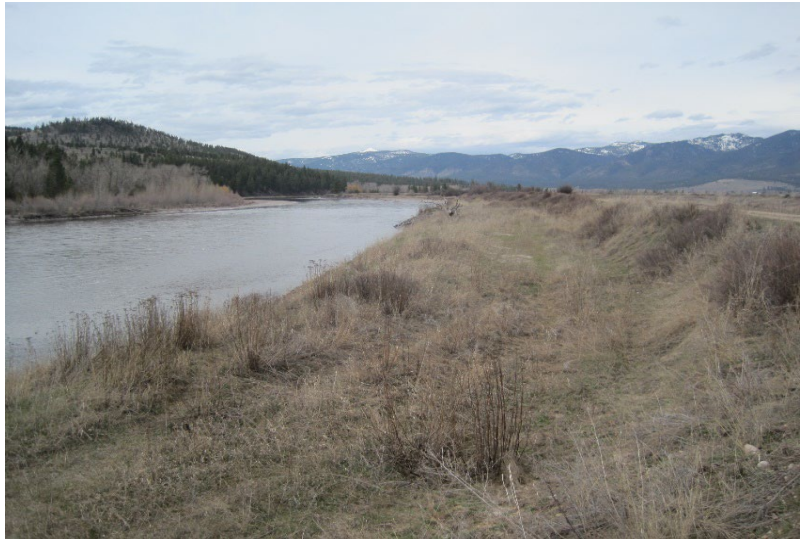
HP7 gage.	
Photo 8	
Site: Photo Point 6	
Date/Time: 4/10/23 1533	
Staff Gage (ft): N/A	
Location:	
N 46.96022	
W 114.21975	
Comments:	
Looking north. Southwest side of HP11.

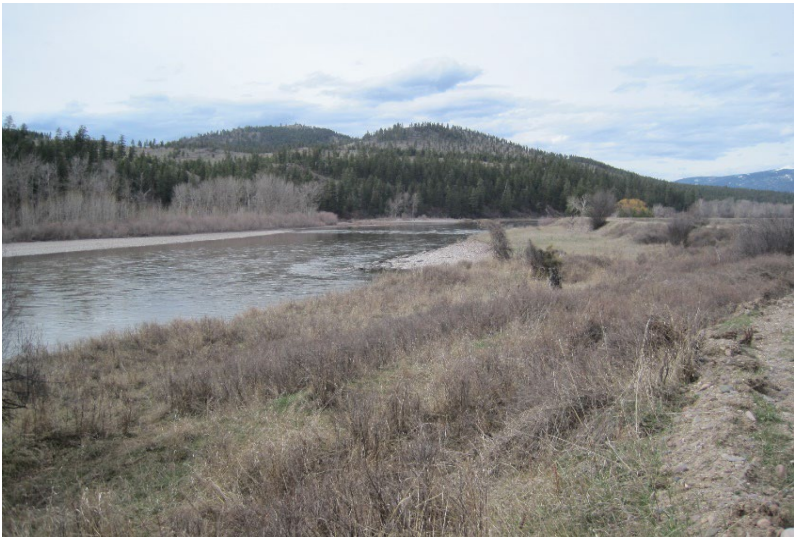
Photo 9

Site: Photo Point 7	
Date/Time: 4/10/23 1538	
Staff Gage (ft): N/A	
Location:	
N 46.97682	
W 114.22689	
Comments:	
Looking north. West side of HP11.	
Photo 10

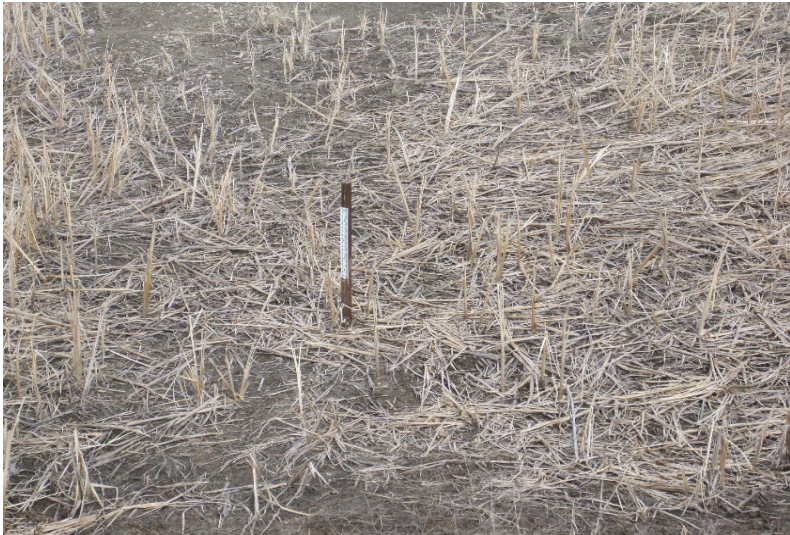
Site: HP11 gage	
Date/Time: 4/10/23 1541	
Staff Gage (ft): Below gage	
Location:	
N 46.96666	
W 114.22391	
Comments:	
HP11 gage.

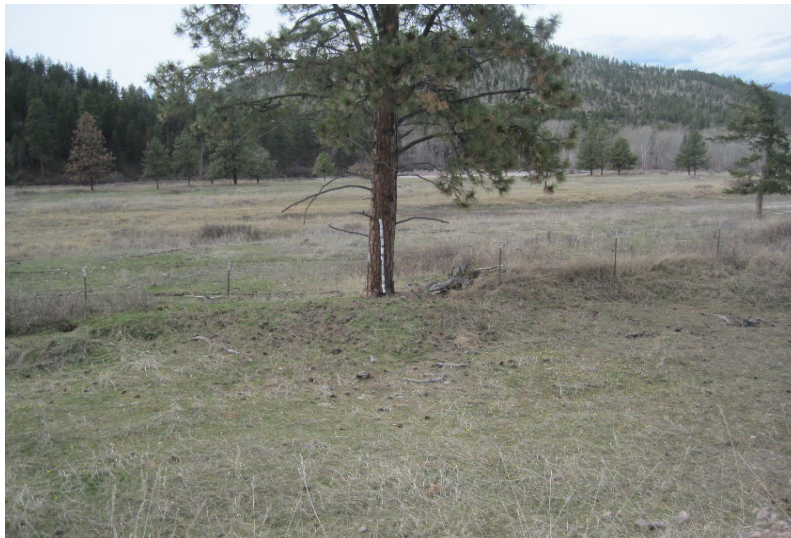
Photo 11**Site:** Photo Point 8**Date/Time:** 4/10/23 1546**Staff Gage (ft):** Below gage**Location:**

Looking north. West side of HP12.

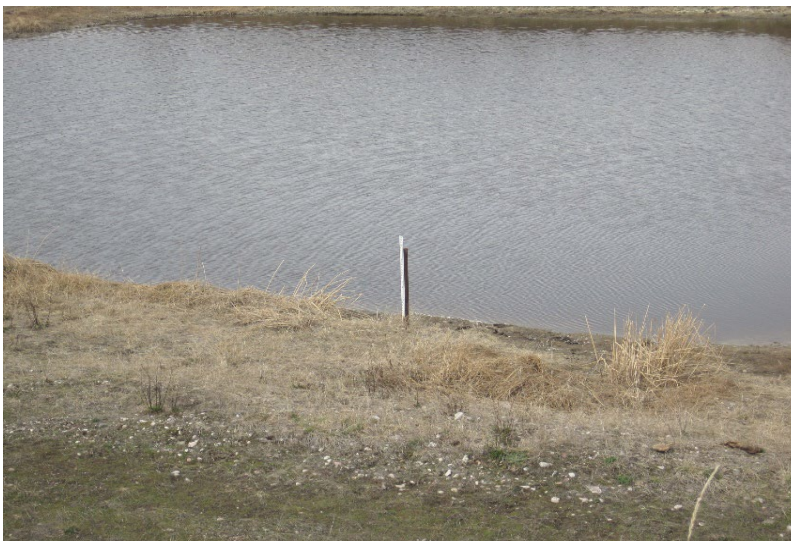
**Photo 12****Site:** HP13a gage**Date/Time:** 4/10/23 1552**Staff Gage (ft):** Below gage**Location:**

HP13a gage.

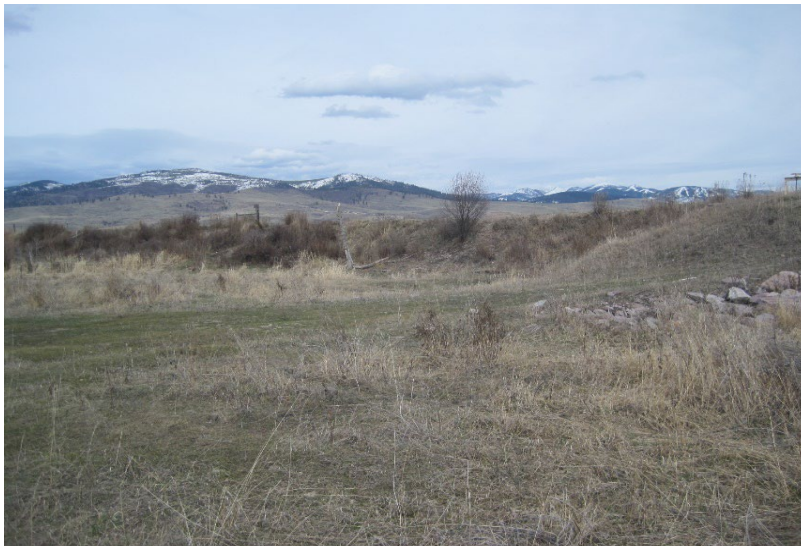
Photo 13
Site: Photo Point 9
Date/Time: 4/10/23 1555
Staff Gage (ft): N/A
Location:
N 46.97682
W 114.22689
Comments:
Looking north. West side of HP13a.
