FIVE-YEAR REVIEW REPORT

SECOND FIVE-YEAR REVIEW REPORT
FOR
THE FORMER DEFENSE DEPOT OGDEN
OGDEN, UTAH

MARCH 2001

PREPARED BY:
DEFENSE DISTRIBUTION DEPOT HILL UTAH
OGDEN SITE

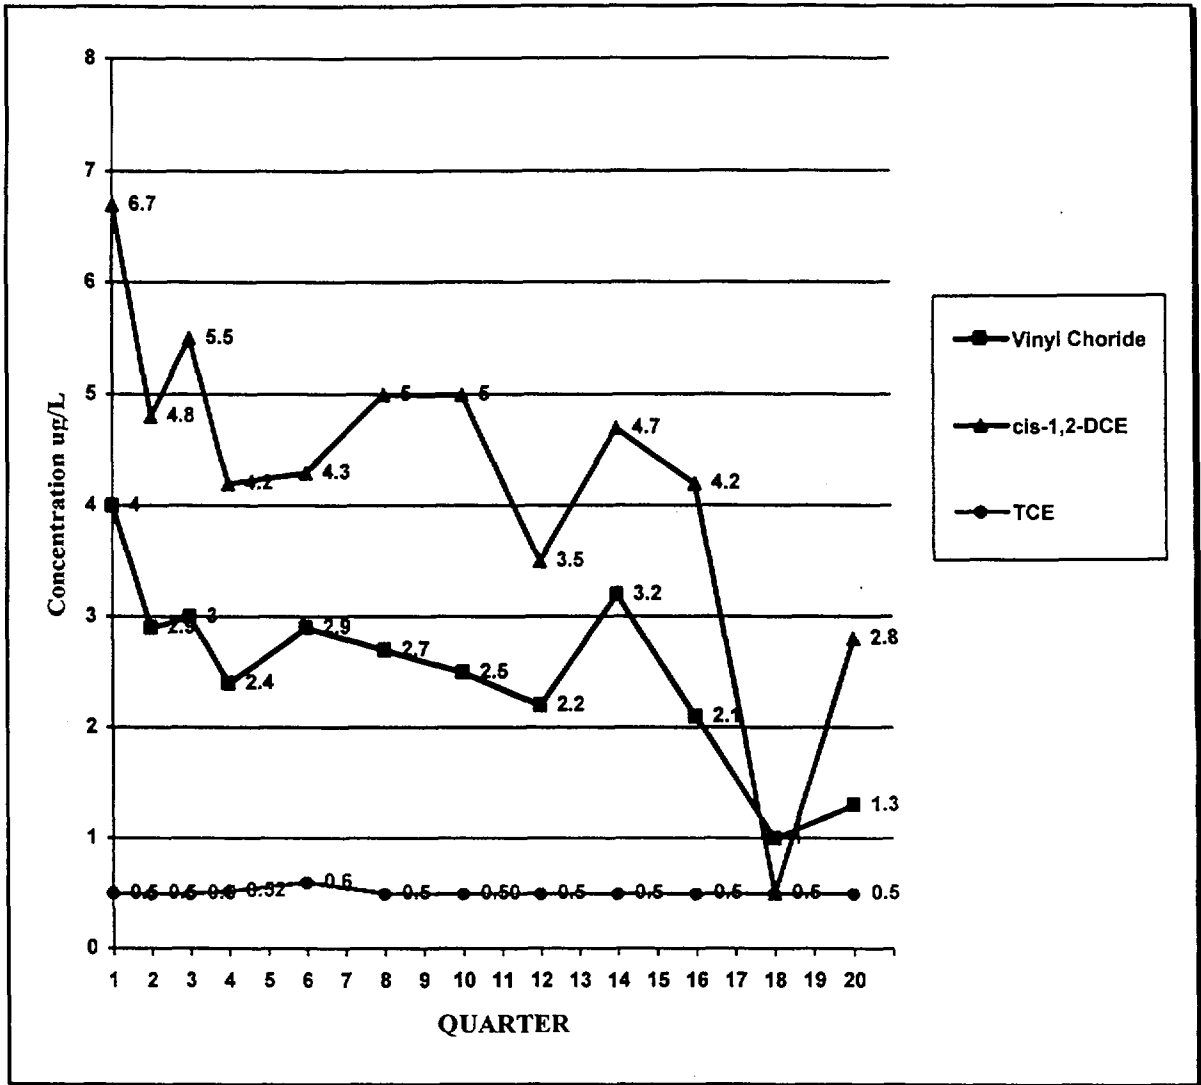
Treatment Plant Influent
Contaminant Versus Time
Operable Unit -1
Defense Depot, Hill, Utah
July 1999

Figure 6. Plot of VOC concentration versus time for plant influent.
