FIVE-YEAR REVIEW
UMETCO MINERALS CORPORATION
URAVAN SUPERFUND SITE
URAVAN, COLORADO

U.S. Environmental Protection Agency, Region VIII
999 18th Street
Denver, Colorado 80202

Frontier Environmental Services, Inc.
5171 Ward Road, Unit 1
Wheat Ridge, Colorado 80033

Date: 9/28/05

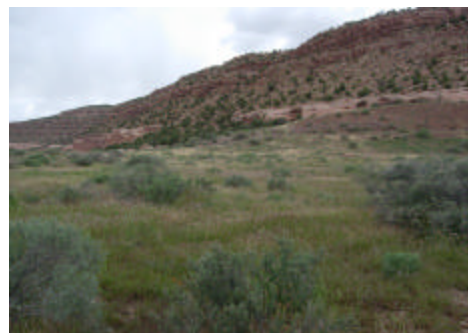
The on-site visit of May 11, 2005 found Atkinson Creek Disposal Area to be visually restored and well vegetated as compared to the surrounding areas not included in the Atkinson Creek Disposal Area. Crystals, discoloration, or other signs of contamination were not observed in this area. Visible signs of severe erosion were also not observed. Vegetation had re-established itself and visually appeared to be very healthy. The site is equipped with a well maintained fence, which aids in keeping grazing animals off the site.

Reclaimed and vegetated Atkinson Creek Disposal Area, May 2005

This EPA Five-Year Review makes no recommendations for the Atkinson Creek Disposal Area.

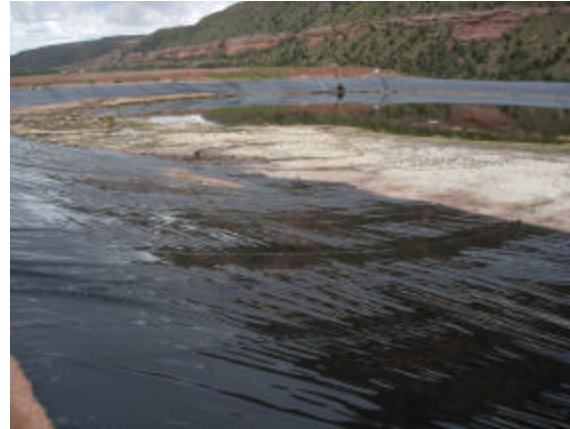
The inspection of May 11, 2005 indicated that Club Ranch Pond CRP #4 had suffered significant liner failure due to excessive liner tension forces imposed during a period in which the pond was left empty and allowed to go through a series of temperature extremes. The temperature extremes created a condition that allowed CRP #4 liner to "trampoline" or otherwise become stretched beyond the support of its sub-grade. When the stressed CRP #4 was filled during the winter/spring period of 2004/2005, the stress liner failed in at least eight locations. Liner failure occurred in parent material, fusion welds and extruded welds. The majority of the liner failures were on the crest or outside of CRP #4 containment bowl. Two of the eight liner failures were within CRP #4 containment bowl, but were located approximately two-feet above pond water line. Inspection of CRP#4 leak detection sump indicated presence of liquids, but not in quantities or volumes that would trigger Liner Failure Contingency Plan. Club Ranch Evaporation Pond CRP #4 has been taken out of service, drained and scheduled for excavation and removal with disposal of its liner and any contaminated materials to an approved on-site Club Mesa Repository (B-Plant Repository). Reference Umetco UraVan Club Ranch Ponds Synthetic Liner Inspection Report, dated May 20, 2005.

CRP #4 Interior Liner Trampoline Effect

It is recommended that the Club Ranch Pond CRP #4 be removed from service immediately (This action was implemented as of May 20, 2005) and be excavated and removed during the 2005 remediation season with disposal in an on-site approved repository (B-Plant Repository). Club Ranch Ponds CRP #1 and CRP #8 should be repaired at the earliest time achievable. Club Ranch Ponds CRP #1 and CRP #8 should be inspected daily for Iner deterioration and failure and their leak detection systems inspected and evaluated on a weekly basis until removed from operation.

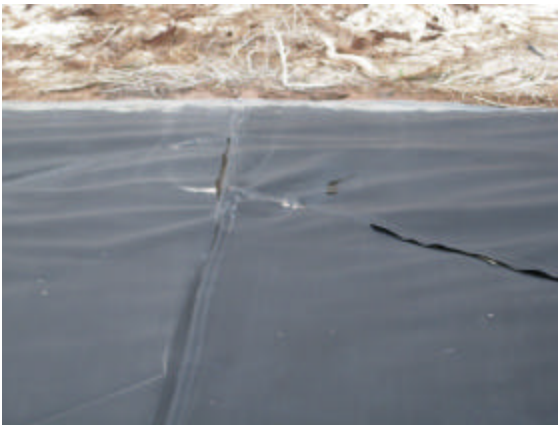
Club Ranch Pond CRP #4 Interior Liner Failure

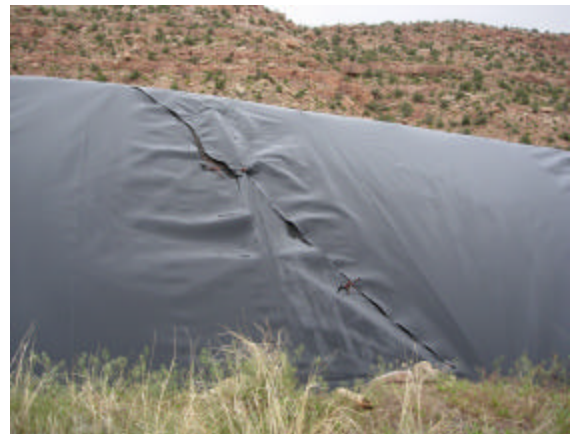
Club Ranch Pond CRP #4 Exterior Liner Failure

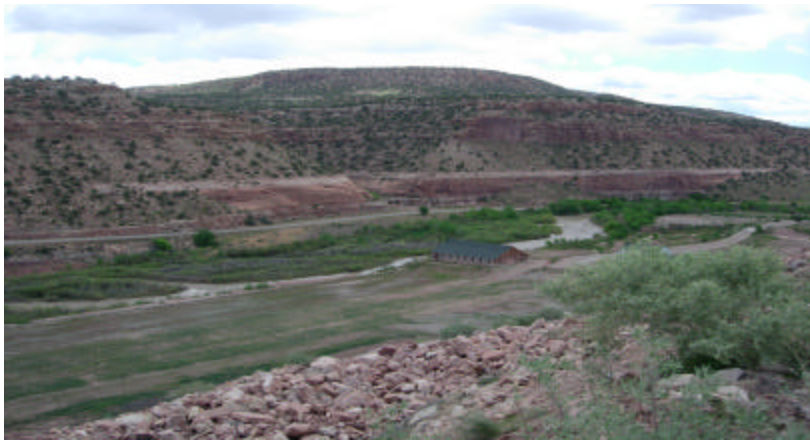
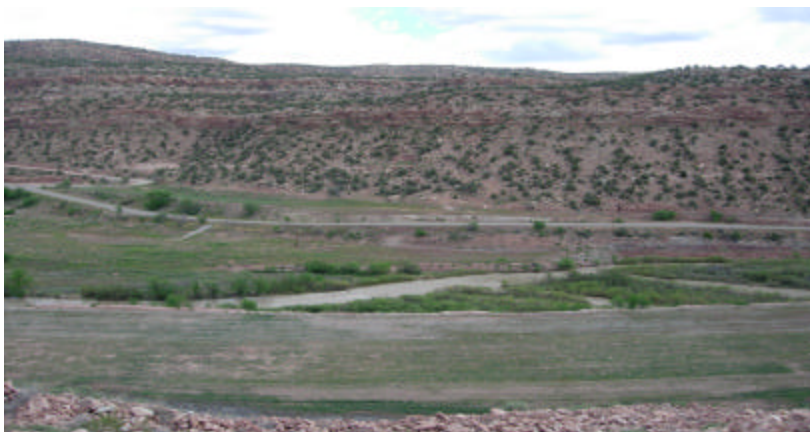
Visual observations during the site visit of May 11, 2005 found the River Ponds Area to be restored to a condition comparable to surrounding areas not included in the River Ponds Area. The San Miguel river has incorporated the River Ponds Area into its course. Vegetation has re-established itself and visually appeared to be healthy. Tailings, discoloration, or other signs of vegetation stress and/or contamination were not observed.

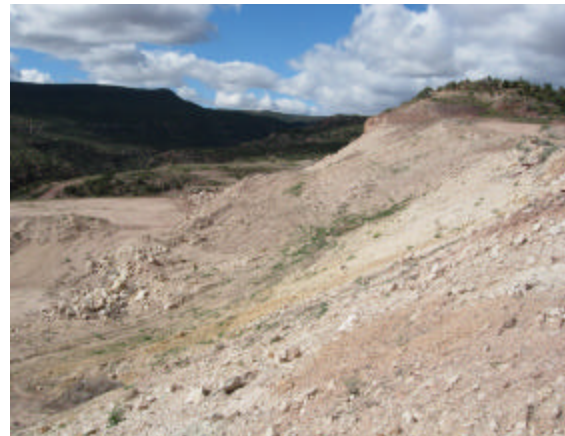
The joint separation on Tailings Pile 3 noted in the 1999/2000 Five-Year Review has been mitigated. Joint separation was due to overlooking and adjoining bedrock displacement and not movement of the tailings pile. Inspection of Tailings Pile 3 indicated a stable and well drained cap system.

Photo 1 of 4 of Tailings Pile 3 Repair
of Suspected Joint Separation

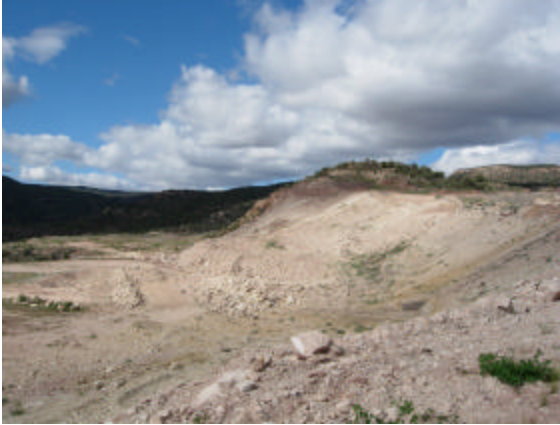
Photo 2 of 4 of Tailings Pile 3 Repair of Suspected Joint Separation

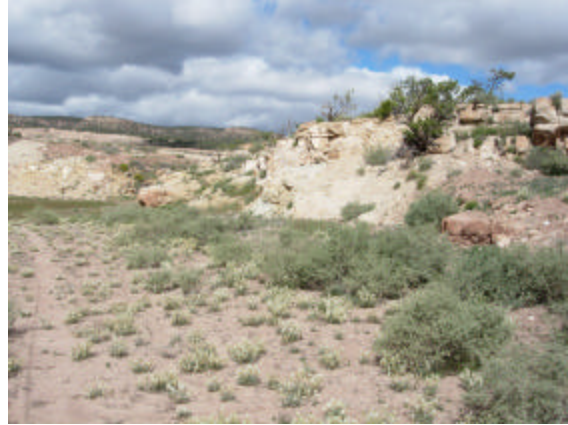
Photo 3 of 4 of Tailings Pile 3 Repair of Suspected Joint Separation

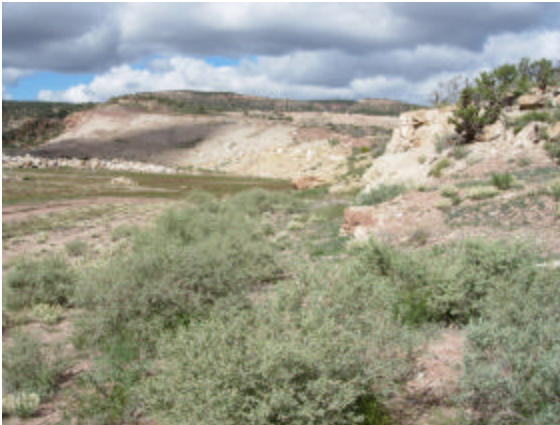
Photo of Tailings Pile 3 Repair of Suspected Joint Separation

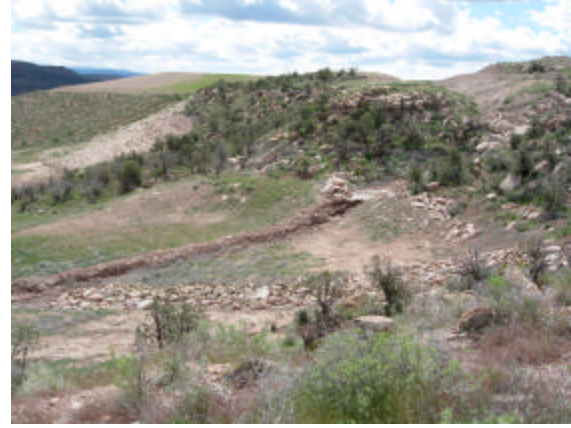
A storm water erosion feature of some significance was noted coming off the northeast face of Tailings Piles 1 & 2 adjoining the Club Mesa Area. This erosion feature should be inspected and repaired as needed.

Club Mesa Storm Water Run-Off Erosion/Washout Feature

Club Mesa Tailings Piles 1 and 2 and Club Mesa Area north facing storm water erosion features require inspection, maintenance and repair.

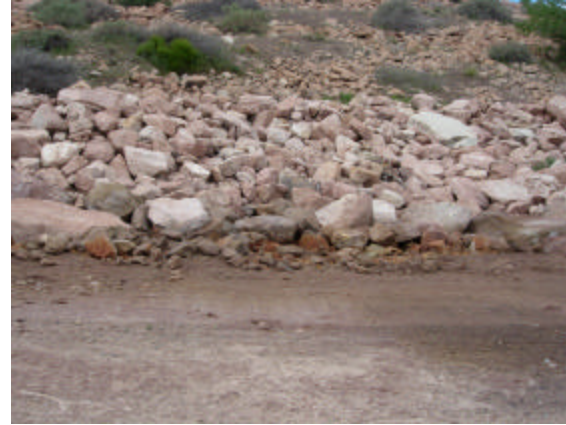
Seeps from Tailings Piles 1, 2 and 3 noted in the 1999/2000 Five-Year Review have been mitigated to an extent. However, as observed during the May 2005 site visit, collection of possible tailings piles seeps with meteoric water was present in Sump #1. Prior to the de-commissioning of the scheduled Sump #1 in FY2005; Umetco needs to confirm mitigation methods and performance on measures implemented to stop seeps from the Club Mesa Tailings Piles have been achieved.

Example of Club Mesa Tailings
Piles 1 &2 Seepage Staining

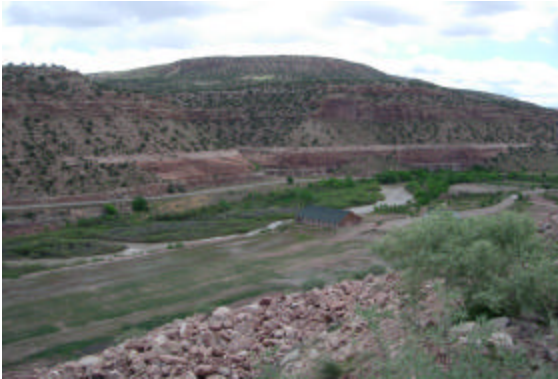
The site visit of May 11, 2005 visually found the Town of Uravan and the Adjacent Areas fully remediated, except for the portion of Colorado Highway 141 and the Windblown Areas. No visible signs of remaining contamination, e.g. buildings; drums; equipment; discolored soil; tailings; etc. were observed in these areas during the site visit. Grading and site reclamation and revegetation of the Town of Uravan and Adjacent Areas appeared to have been completed, and healthy-looking vegetation has been reestablished in these areas.

In the distance, Un-remediated Colorado Highway 141
