**FIFTH FIVE-YEAR REVIEW REPORT FOR  
COAST WOOD PRESERVING SUPERFUND SITE  
MENDOCINO COUNTY, CALIFORNIA**

USACE, Seattle District

**U.S. Environmental Protection Agency  
Region IX**

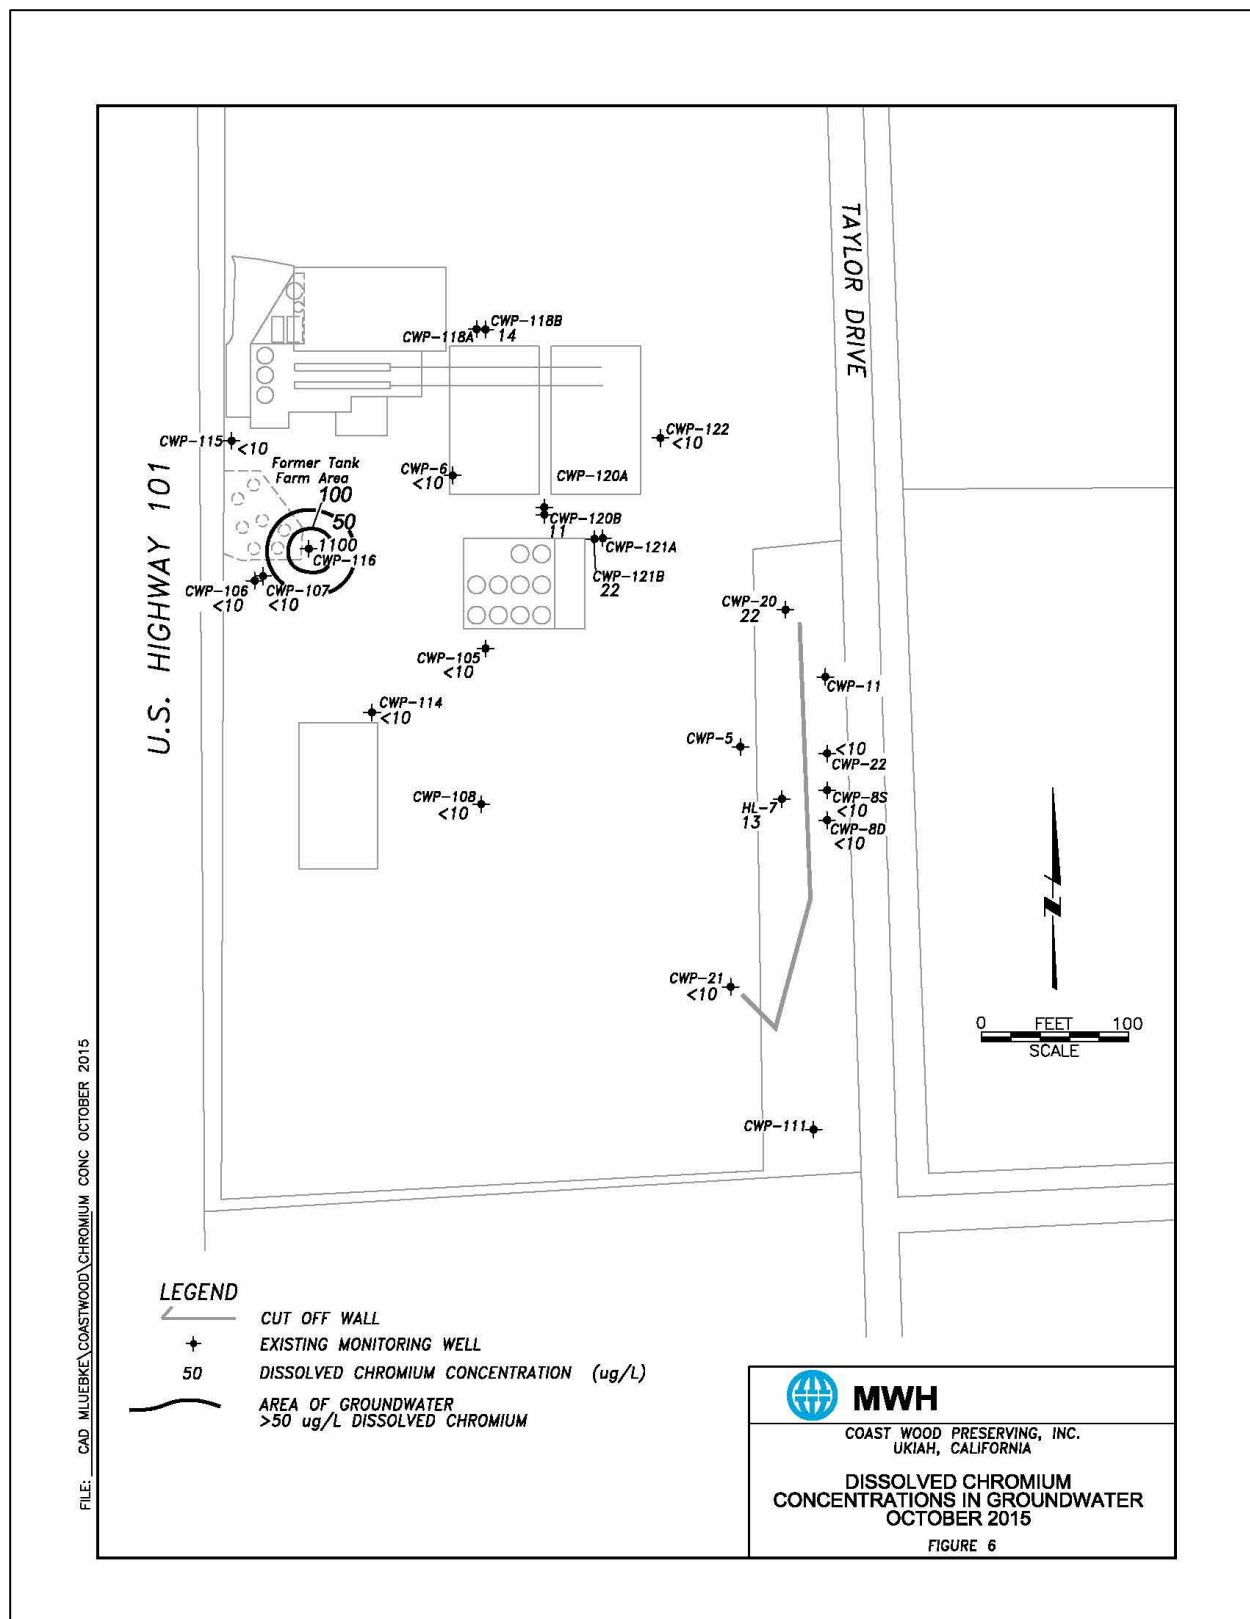
Figure 3 : Total Chromium Plume Map from October 2015

Hexavalent chromium and total chromium concentrations in groundwater currently remain above their respective clean up levels in a few isolated areas, and have fluctuated in concentration during this review period, possibly due to seasonal variation in groundwater levels. Only two wells have had arsenic concentrations exceeding cleanup levels during this review period. These wells are located near the most recent injection which occurred in 2010, and are expected to decline and not migrate off site as arsenic re-precipitates. Concentrations of contaminants are expected to decline over time as arsenic precipitates and as total chromium and hexavalent chromium continue to reduce from past injections.

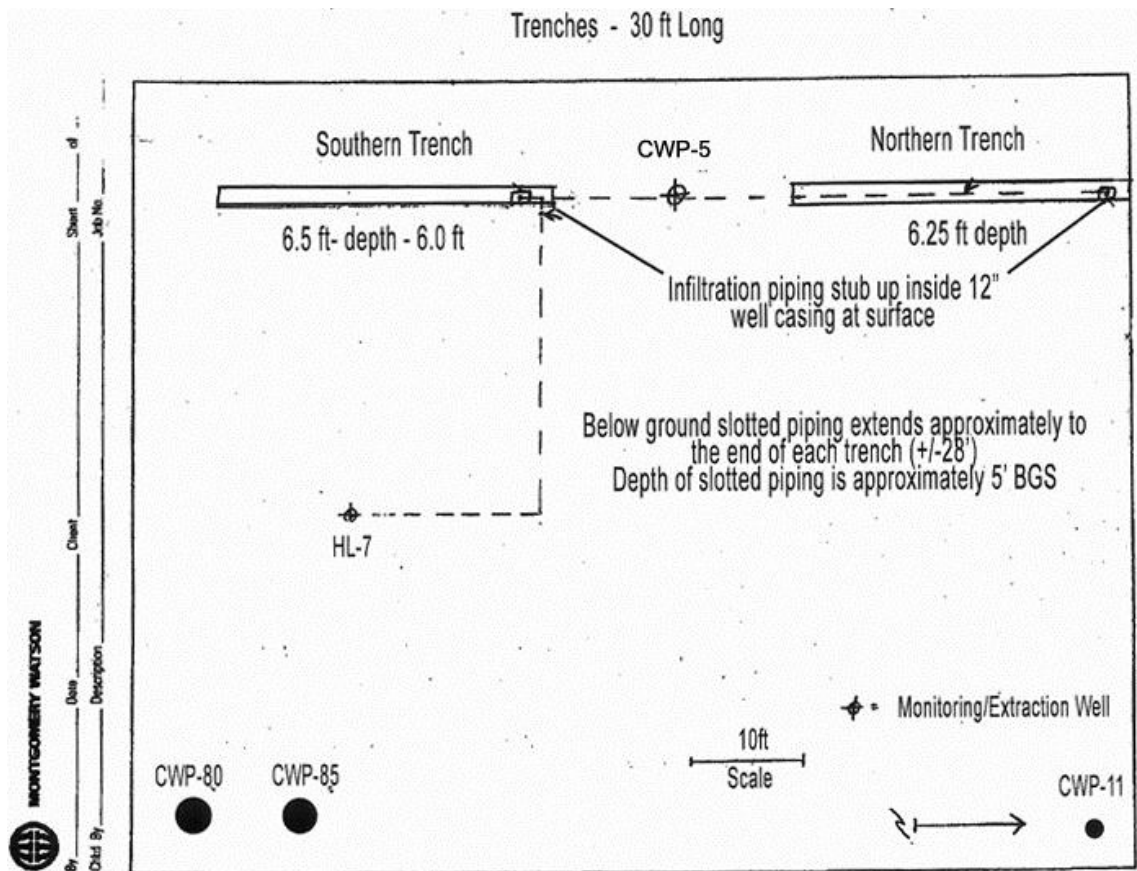
**Figure B-2: Location of Infiltration Trenches Used in January 2015**

In January 2015, due to the pulse of untreated hexavalent chromium, infiltration of the reductant solution was conducted using the infiltration trenches located in the Infiltration Trench Area upgradient of HL-7 (Figure B-2). The 2015 *Annual Groundwater Monitoring Report* (MWH, 2016) noted that the reductant solution injected into the infiltration trench upgradient of HL-7 was effective at reducing hexavalent chromium in HL-7, but concentrations increased during the 1 year time span between sampling events. Additional infiltration began on February 2, 2016, while water levels remain elevated from winter rainfall. In the future, sampling of the wells will be positioned around the cutoff wall to evaluate the presence or absence of potential leakage under or around the cutoff wall. Data generated from such sampling will be presented in the next annual report in 2017.

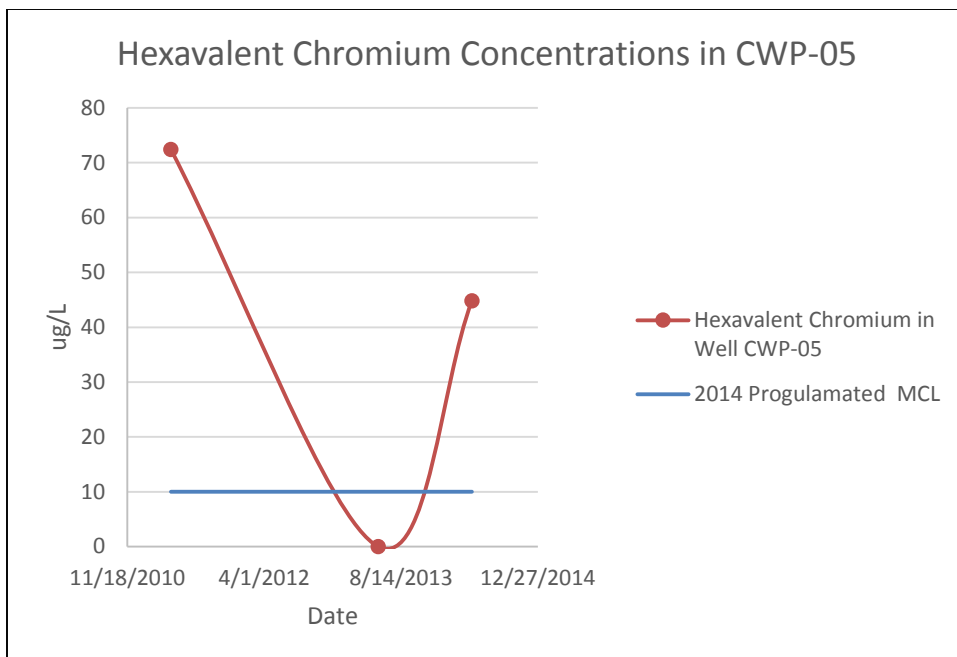
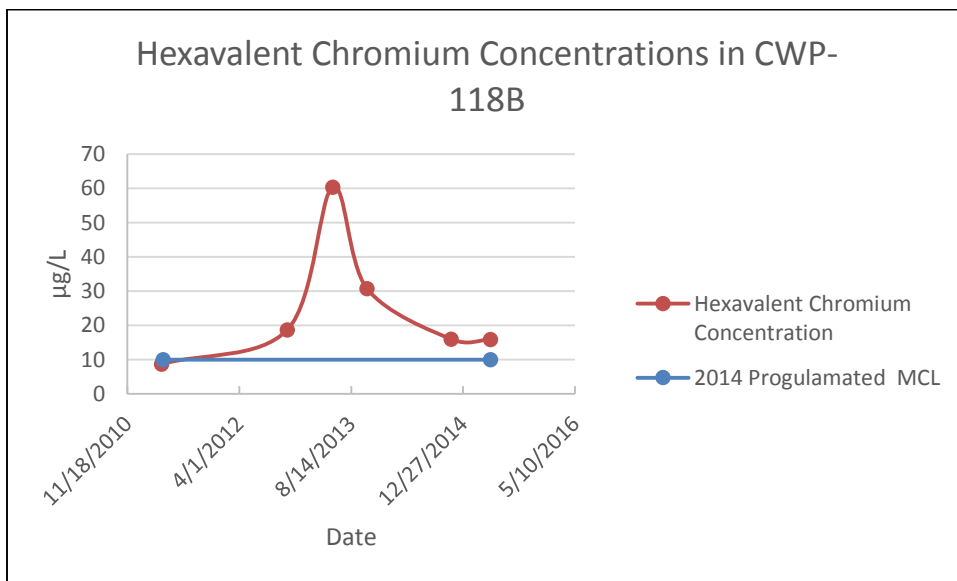
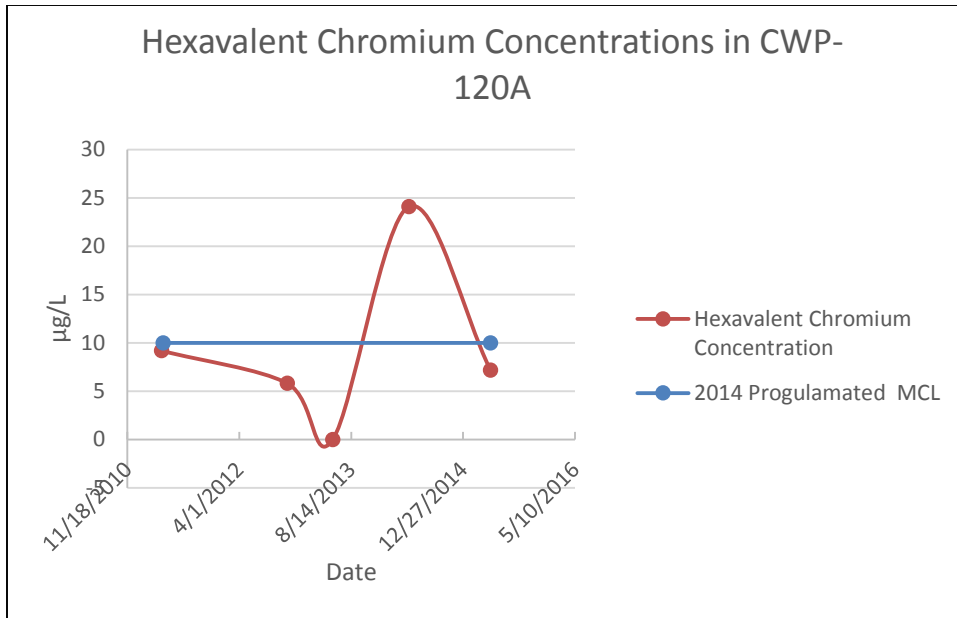
Though not enough data was available to conduct a trends analysis on hexavalent chromium, graphs of concentrations over time were generated (Figure B-6 through Figure B-9). Note that no data of hexavalent chromium exists for CWP prior to 2011. These graphs were generated for wells where sampling results showed hexavalent chromium concentrations above MCLs. The graphs indicate a possible pulse of untreated hexavalent chromium resulting from seasonal precipitation and higher groundwater levels in April of 2014. The concentrations then dip in 2015 due to the infiltration of reductant at the infiltration

In regard to hexavalent chromium, it is recommended that all non-decommissioned wells in the Perimeter Wells Area and the wells that have shown consistent concentrations of hexavalent chromium above MCLs, have an increased monitoring frequency for this COC. Increased monitoring will provide data to conduct a trends analysis on this COC in upcoming FYRs. Additional samples and analysis of hexavalent or total chromium should also occur in well CWP-11 to fill the data gap in the Perimeter Wells Area, as suggested in the 2015 *Annual Groundwater Monitoring Report*.

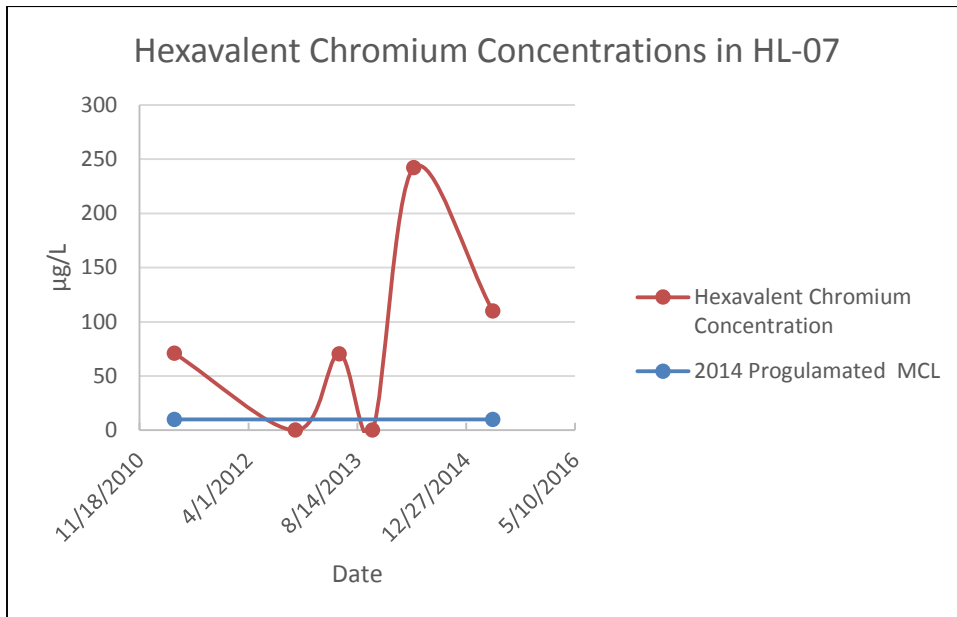
**Figure B-9: Hexavalent Chromium Concentrations at HL-7 during the Review Period**  
(Note: HL-07 = HL-7)

In April 2014, samples collected from trench HL-7 contained a concentration of 242 µg/L hexavalent chromium believed to be related to seasonally high groundwater contacting contaminated soils in the vadose zone and prompting the recommendation in the February 2014 annual groundwater monitoring report for an additional round of reductant infiltration. As was the case for prior infiltration activities, the purpose of the January 2015 infiltration event was to deliver a dilute solution of calcium polysulfide reductant into both the vadose and saturated zones into the trenches upgradient of HL-7, with groundwater extraction from HL-7 and re-infiltration of the extracted groundwater into the upgradient trenches. Immediate results after the infiltration and recirculation of the reductant indicated that dissolved chromium and arsenic were below levels of detection.
