# SIXTH FIVE-YEAR REVIEW REPORT FOR COAST WOOD PRESERVING SUPERFUND SITE MENDOCINO COUNTY, CALIFORNIA

U.S. Army Corps of Engineers

**U.S. Environmental Protection Agency**

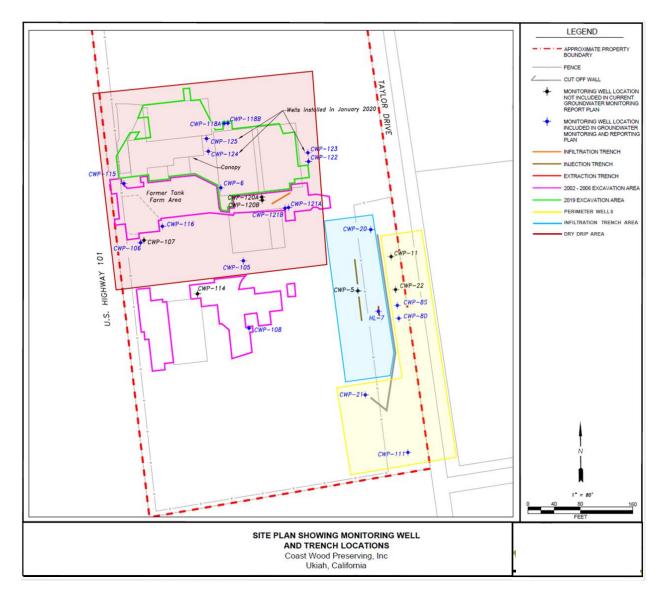
Figure 3. Site Plan Showing Monitoring Wells and Trench Locations

The three additional groundwater monitoring wells CWP-123, CWP-124, and CWP-125 (Figure 3) were installed within and downgradient of the former production area and area of the final soil remediation activity. Well CWP-123 was paired with well CWP-122. Well CWP-122 is screened from 11.5 to 16.5 ft bgs and monitors groundwater conditions in Zone 1, while CWP-123 is screened from 20 to 25 ft bgs and monitors groundwater conditions in Zone 2. Wells CWP-124 and CWP-125 are paired together beneath the canopied area in close proximity to the former retorts. CWP-124 is screened from 5 to 10 ft bgs and monitors groundwater conditions in Zone 1. Well CWP-125 is screened from 15 to 20 ft bgs, and the lack of recharge during bailing of the well suggests that the screened interval lies within a low permeability zone suspected to be Zone 3. The newly installed wells have been included in the updated groundwater monitoring and reporting program, which currently consists of 19 sampled wells. Beginning in 2021 the groundwater monitoring and reporting program will move to annual sampling during the second quarter.

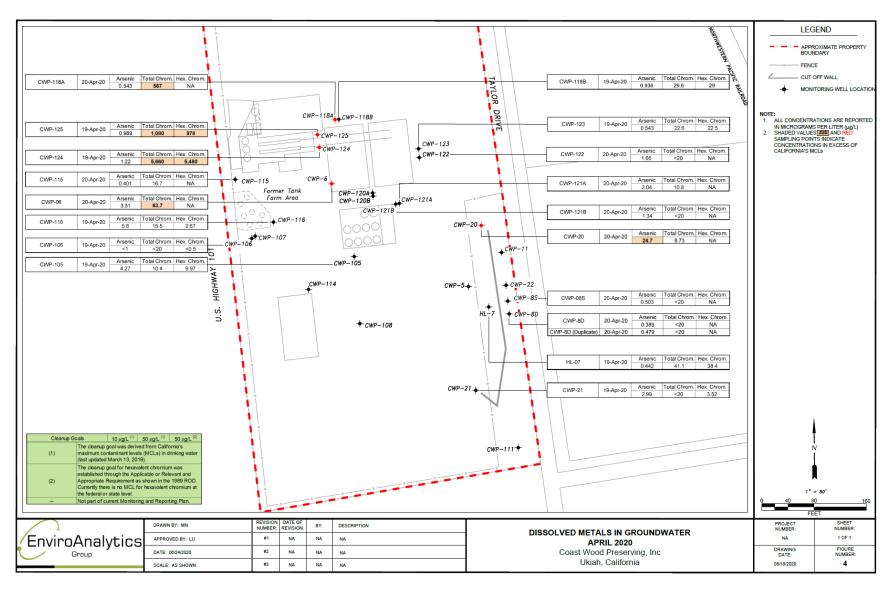
Figure 4. Dissolved Metals in Groundwater (April 2020).

Out of the 19 sampled wells, five wells had exceedances of cleanup levels for total chromium, three for hexavalent chromium, and three for arsenic. Wells that have been sampled less than four times were not statistically evaluated due to either insufficient sampling results above the detection limits or because all detected concentrations were below the cleanup goal. The wells selected and the results of the analysis are shown in Table 5.

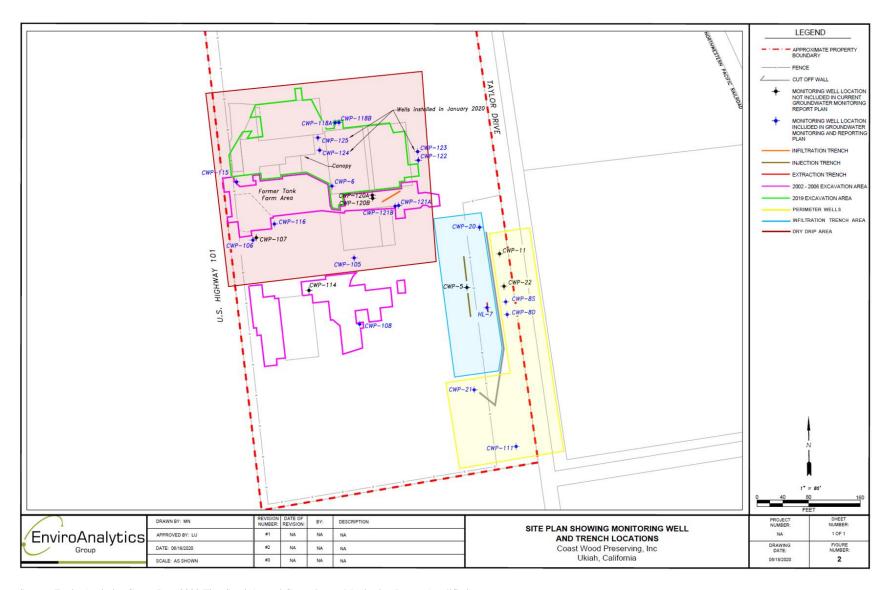
Figure C-1: Well location map.

In February 2020, three groundwater monitoring wells CWP-123, CWP-124, and CWP-125 (Figure C-1) were installed at the Site in order to monitor concentrations of hexavalent chromium and arsenic within and downgradient of the former production area and the area of the final soil remediation activity. Well CWP-123 was paired with existing well CWP-122 which monitors groundwater conditions in Zone 1, while CWP-123 monitors groundwater conditions in Zone 2. Wells CWP-124 and CWP-125 are paired together beneath the canopied area near the former retorts and monitor groundwater conditions in Zone 1 and Zone 3, respectively. The newly installed wells have been included in the updated groundwater monitoring program. The current groundwater monitoring and reporting program consists of 19 sampled wells. Beginning in 2021 the groundwater monitoring and reporting program will move to annual sampling during the 2nd quarter.

Groundwater monitoring well locations can be viewed in Figure C-1. The wells at the Site are divided into one of three categories by area: the Dry Drip Area, the Infiltration Trench Area, and the Perimeter Wells Area.

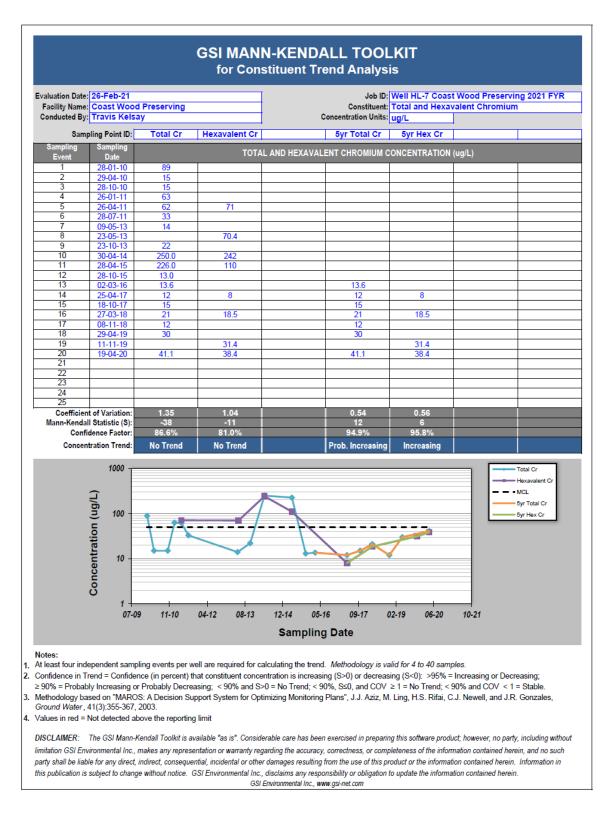
Figure C-7: Mann-Kendall Statistics for well HL-7 Chromium concentrations.

HL-7, located in the Infiltration Trench Area directly upgradient of the slurry wall (Figure C-1), has exceeded the total chromium and hexavalent chromium cleanup level in past sampling events (last exceedance for both was April 28, 2015) and shows a probably increasing for total chromium and increasing trend for hexavalent chromium, over the last five years. Therefore, the well was analyzed using Mann-Kendall Statistics to compare the trend between the last 5 and 10 years (Figure C-7). HL-7 does not show an increasing trend in total chromium and hexavalent chromium concentrations over the last 10 years.+ It is important to note that these measurements were only observed in one of the current sampling wells in the Infiltration Trench Area and are not valid for drawing conclusions over the entire Site.

Looking at the 10 year data, the graph in Figure C-7 indicates a pulse of untreated total chromium and hexavalent chromium resulting from seasonally high groundwater contacting contaminated soils in the vadose zone and prompting the recommendation in the February 2014 annual groundwater monitoring report for an additional round of reductant infiltration. As was the case for prior infiltration activities, the

purpose of the January 2015 infiltration event was to deliver a dilute solution of calcium polysulfide reductant into both the vadose and saturated zones into the trenches upgradient of HL-7, with groundwater extraction from HL-7 and re-infiltration of the extracted groundwater into the upgradient trenches. Immediate results after the infiltration and recirculation of the reductant indicated that dissolved chromium and arsenic were below levels of detection. In February 2016, additional infiltration of reductant occurred, while water levels remain elevated from winter rainfall.

Considering the trend observed at HL-7 during this review period, it is recommended that well HL-7 continue to be monitored for total chromium and hexavalent chromium on a semi-annual basis, instead of the annual (2<sup>nd</sup> quarter of the year) monitoring scheduled to start in 2021, to more closely monitor concentration trends in the Infiltration Trench Area and allow for adjustment in remedial actions, should the chromium levels increase above the cleanup levels.
