**THIRD FIVE-YEAR REVIEW REPORT FOR
INDIAN BEND WASH SUPERFUND SITE
MARICOPA COUNTY, ARIZONA**

U.S. Army Corps of Engineers

U.S. Environmental Protection Agency

Indian Bend Wash 3rd Five Year Review -- Errata page

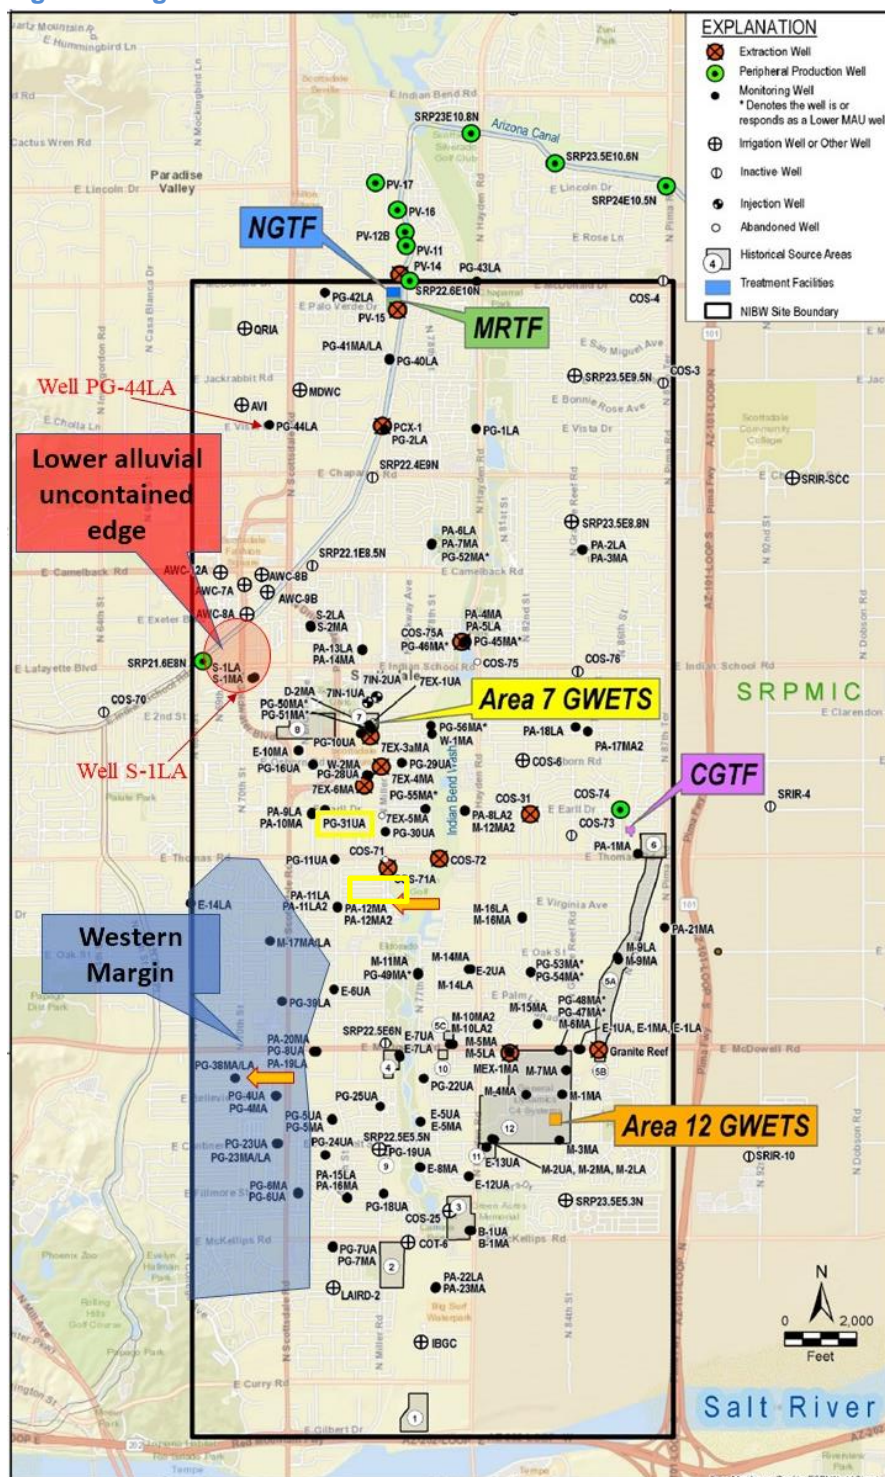
Figure 7.Regions of Possible Lack of Plume Containment at North Indian Bend Wash

The areas where concentrations are increasing are either in the Western Margin region of the Site or the western edge of the lower alluvial unit. During this five-year reporting period, the US Army Corps of Engineers performed Mann-Kendall trend analyses for several select monitoring wells (See Appendix D). The trend analyses identified increasing PCE concentrations at wells PA-10MA, PG-38MA, and S-1LA, although PA-10MA and PG-38MA are still below EPA drinking water standards. All of these wells are located within the Western Margin. PG38-MA is located near PG-4-UA where there is another PCB source unrelated to the North Indian Bend Wash plume. PA-10MA is outside of the currently reduced Area 7 capture zone, where PCE from this location may migrate to the western margin. Monitoring well S-1LA has increasing PCE concentrations ranging from 21 to 48 µg/L and is also located on the western margin of the plume near groundwater production wells for the Salt River Project and Arcadia Water Company, which are being used for irrigation. Monitoring well S-2LA is to the northeast and downgradient of S-1LA and also has increasing TCE concentrations. The western edge of the lower alluvial unit does not appear to be fully contained by the currently operating extraction well network. Groundwater in this area is poorly defined due inadequate monitoring well network along the periphery of the Western Margin, as shown in Figure 7. Additional characterization is warranted given the proximity of the production wells. Groundwater iso-concentration maps have demonstrated a gradual westward shift over time, as shown on Figure 8.

Note: Regions of possible lack of plume containment in the North Indian Bend Wash (red and blue areas). Modified map from 2020 NBIW groundwater report. Orange arrows indicate increasing wells in the middle alluvial unit.

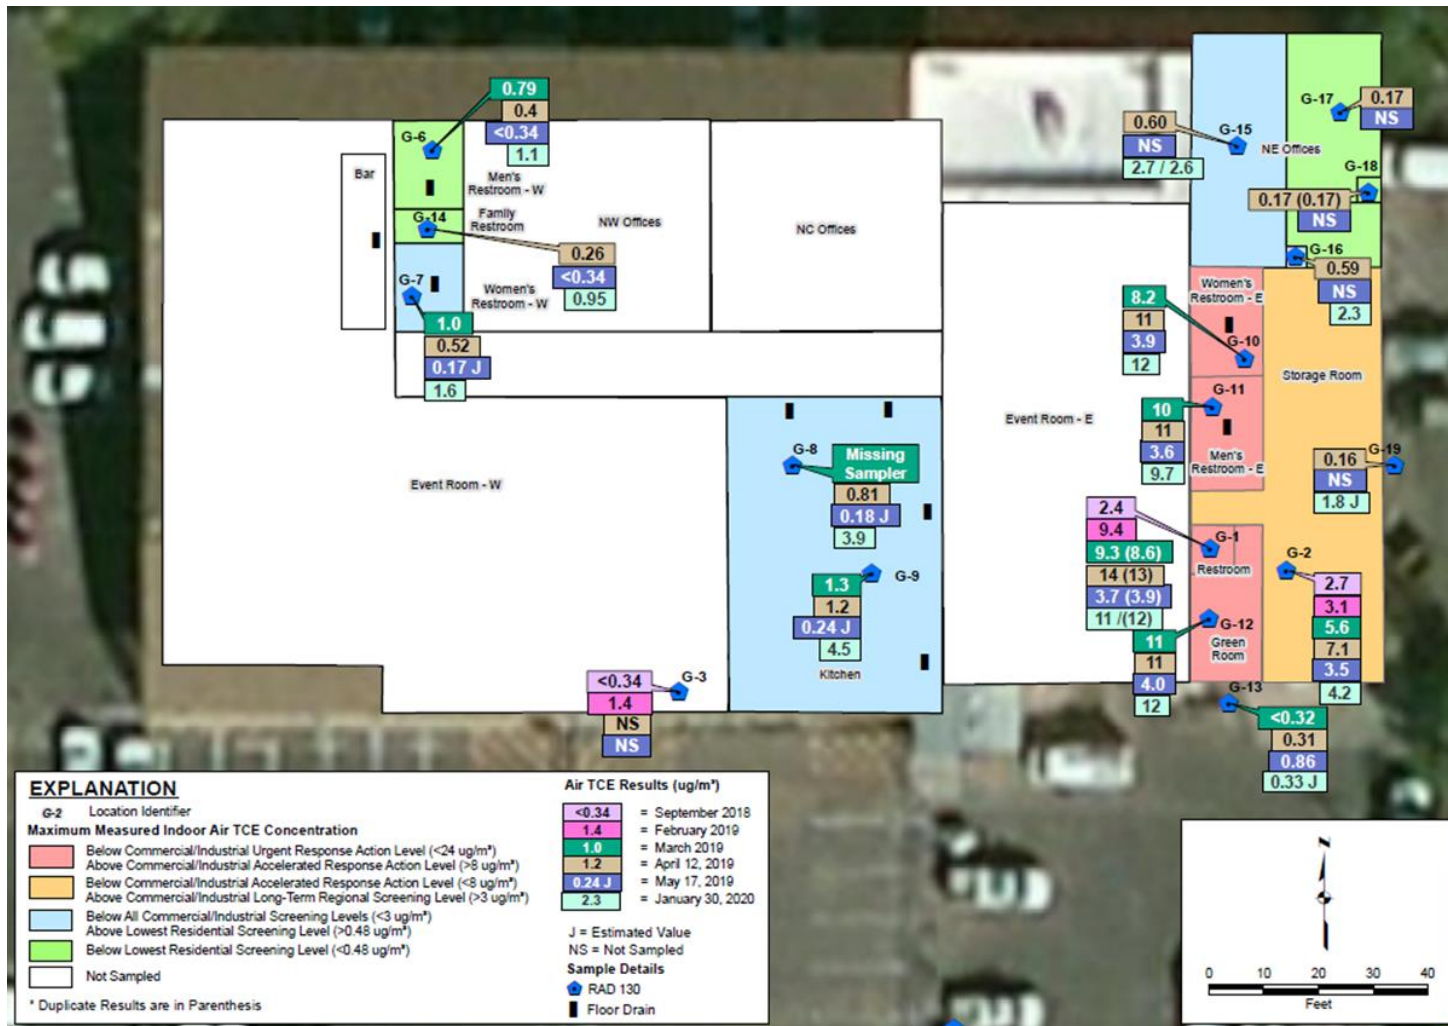
Figure 9. Indoor Air Concentrations in Events Center

In August 2021, EPA contacted the event center owner who told EPA that center is now open but has had very few events. The green room generally is not being used, and events often take place with the rollup doors open. Otherwise, the owner runs the HVAC fans all the time during events. EPA provided information on sub-slab depressurization systems and will work with him to install appropriate long-term mitigation measures.

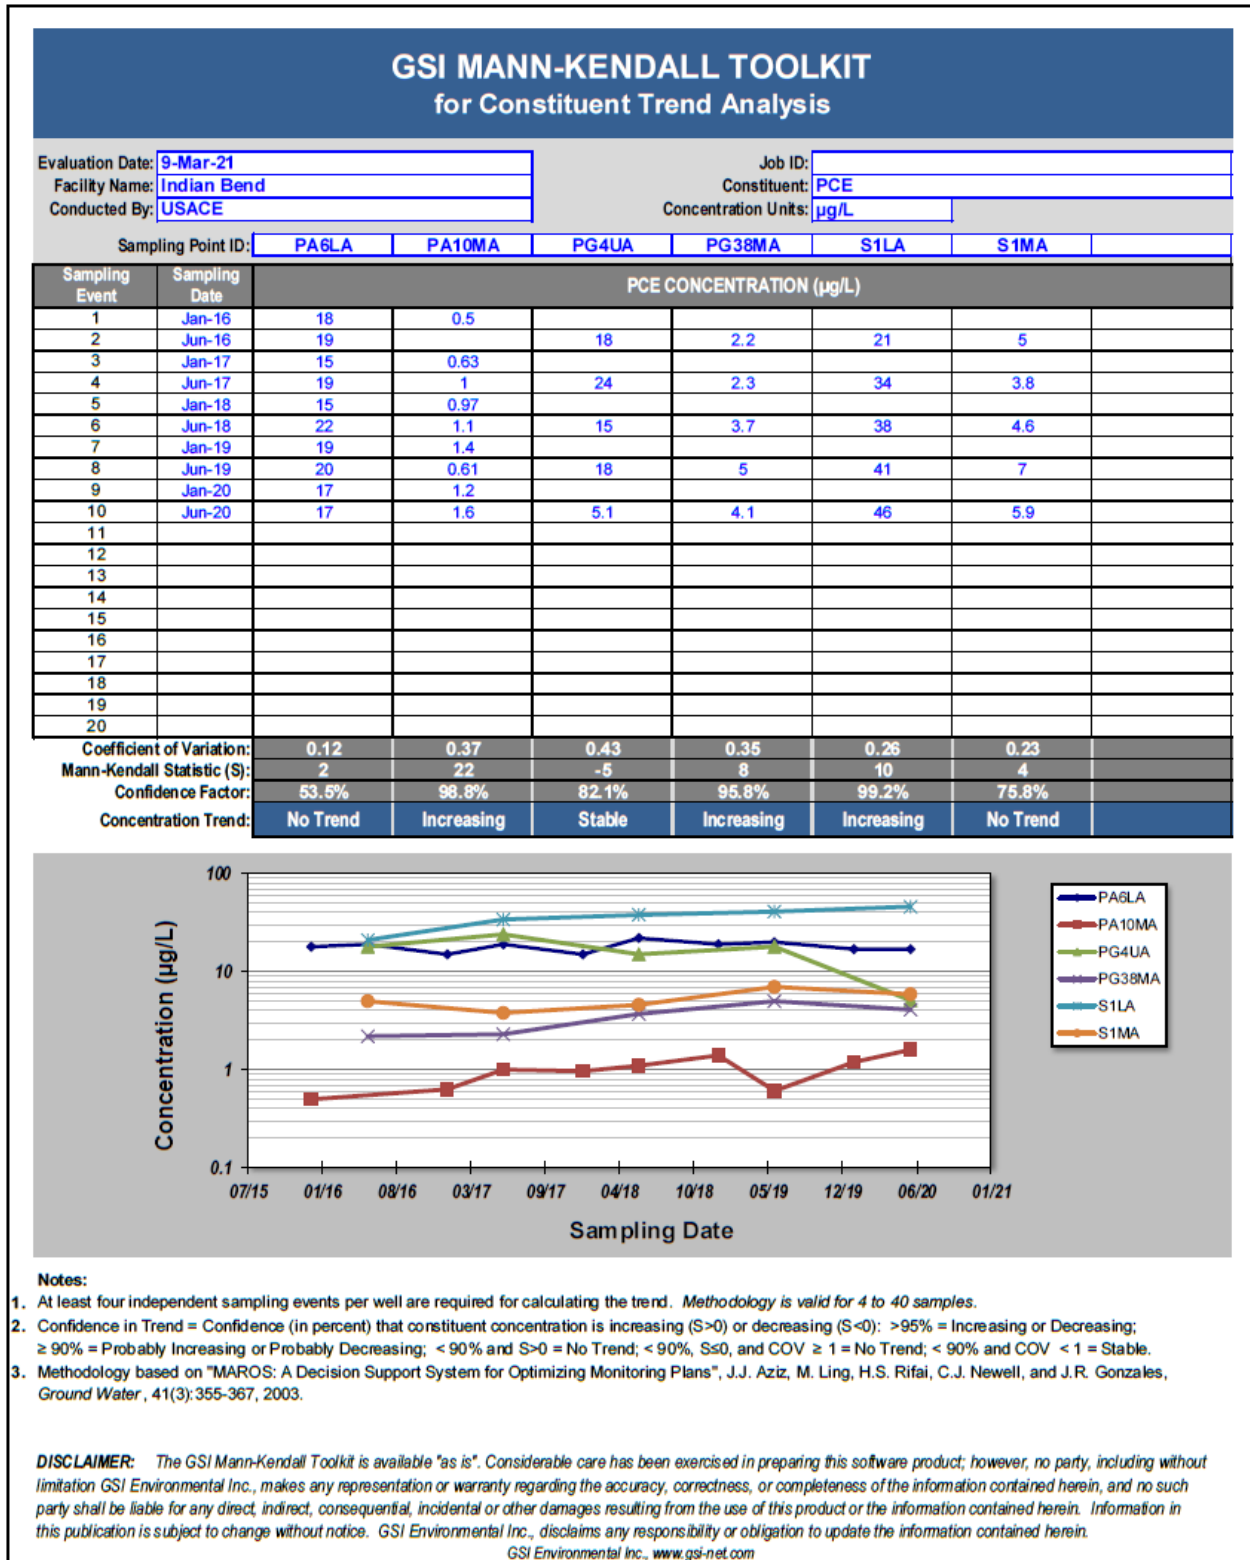
During this five-year reporting period, Mann-Kendall trend analyses show PCE concentrations increasing at three of six monitoring wells shown in Figure D-3, below. These six monitoring wells are aligned north-south along the western portion of the sites. Two of the six monitoring wells with increasing trends, PA-10MA and PG-38MA were at or below the EPA drinking water Maximum Contaminant Level (MCL) for

PCE of 5 µg/L. As shown on Figure D-2, PG38-MA is located on the far Western Margin, and although PCE concentrations are below MCLs (Figure D-3) this well is located near vicinity of PG-4UA. PG-4UA is located within a PCE source area unrelated to the Superfund site. PA-10MA may not be captured by the reduced CGTF Area 7 capture zone following removal of 7EX-4MA and COS-71A from the extraction program and PCE contamination from this well migrates towards the Western Margin. Monitoring well S-1LA is located on the northwest edge of the plume near groundwater production wells for the Salt River Project and Arcadia Water Company. Northeast and down gradient of S-1LA is monitoring well S-2LA with increasing TCE concentrations (see TCE discussion below).

Figure D-3. PCE concentration trend plot since the previous five-year review of middle and lower alluvial wells. Three wells are increasing in PCE concentrations, with S1LA as one of the wells that may indicate the plume is not bounded in the west. The Federal drinking water standard for PCE is 5µg/L.

Recommendation: Complete the review of the groundwater model and Remedy Optimization Study.			
Affect Current Protectiveness	Affect Future Protectiveness	Party Responsible	Oversight Party	Milestone Date
No	Yes	EPA	EPA	5/31/2022
OU(s): North Indian Bend Wash	Issue Category: Remedy Performance			
	Issue: Although the remedy has been in operation for several years, the timeframe to achieve remedial action objectives is unknown, which complicates evaluation of remedy effectiveness or effectiveness of optimization enhancements.			
	Recommendation: Integrate a contaminant fate and transport model into the existing groundwater flow model and estimate remedial timeframes.			
Affect Current Protectiveness	Affect Future Protectiveness	Party Responsible	Oversight Party	Milestone Date
No	Yes	PRP	EPA/State	9/30/2023

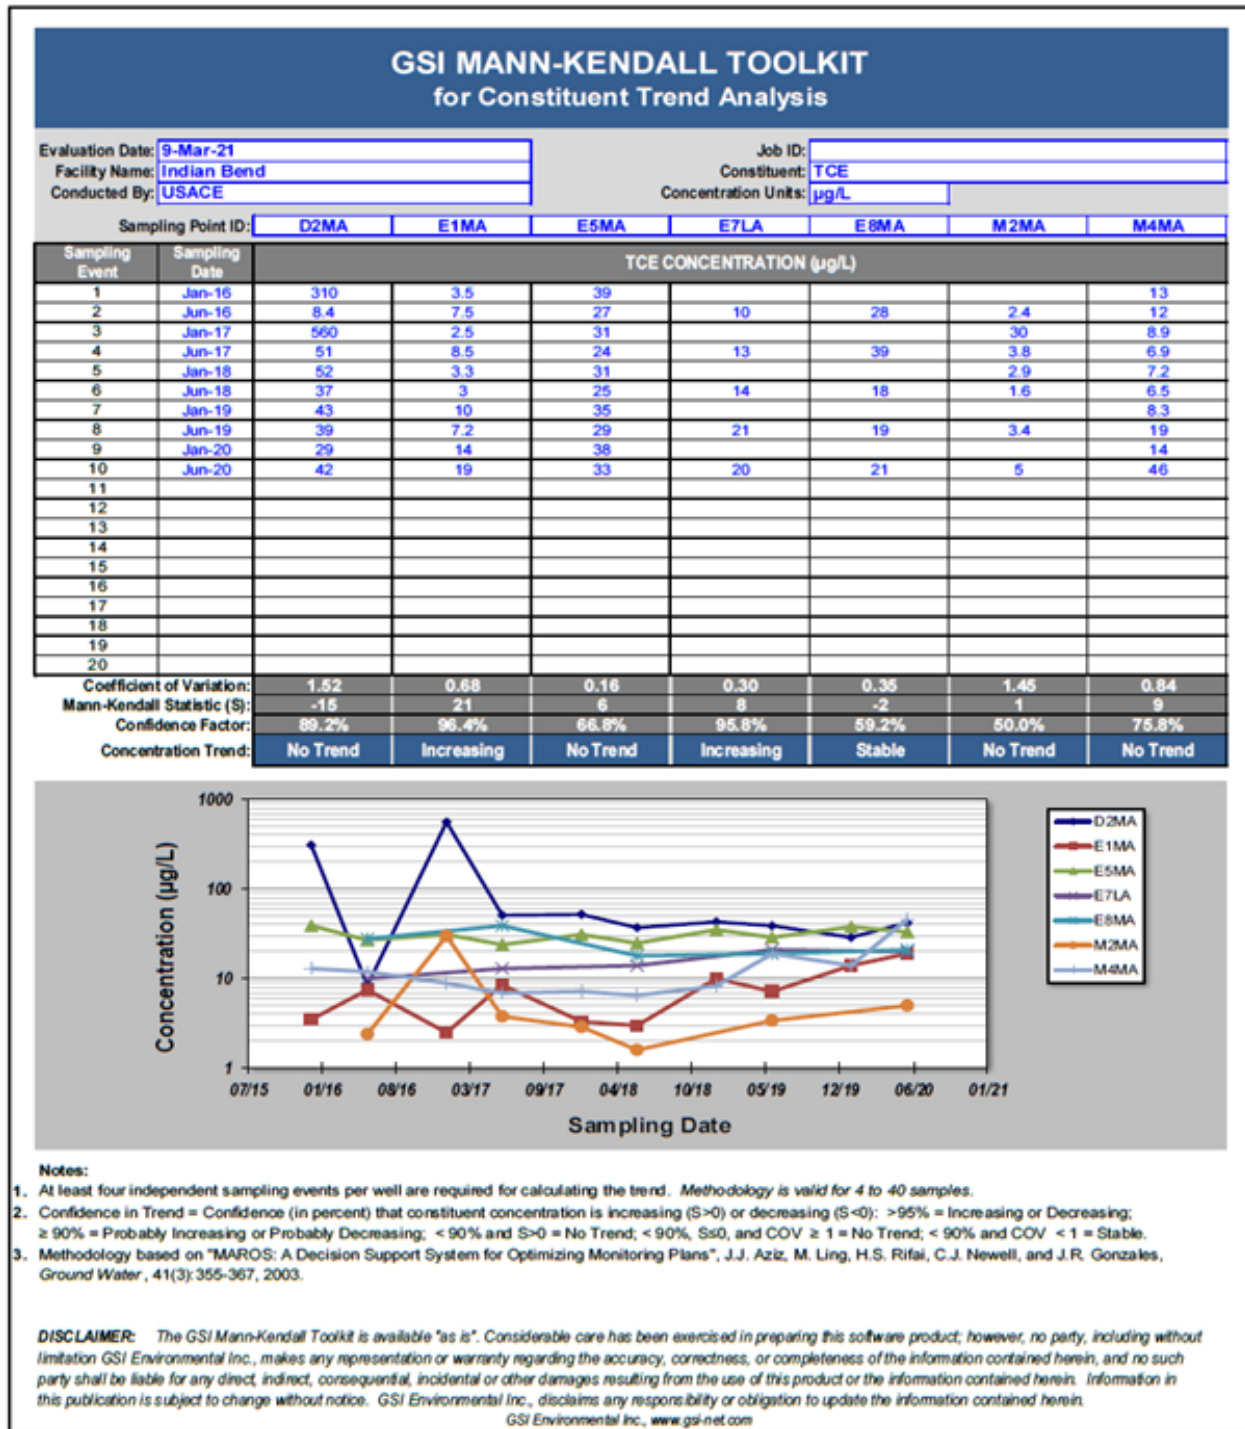
Of the seven selected wells with trends of increasing TCE concentrations, only three of these monitoring wells are within extraction well capture zones. M-9MA and E-1MA are within the Area 12 capture zone and PG-2LA is located near northern PCX-1 extraction well. PA-10MA and PA-12 MA monitoring wells are outside of the reduced CGTF/Area7 capture zone and TCE from these wells may be migrating to the Western Margin. M-14LA and E-7 LA are located within the southeast portion of the TCE plume (Figure D-2) TCE migrating from these two monitoring wells will eventually migrate northward toward the PCX-1 extraction well (see Figures D-4 and D-5).

Figure D-4. TCE concentration trend plot since the previous five-year review of middle and lower alluvial wells. Two wells are increasing in TCE concentrations, but both wells are near extraction well systems. The Federal drinking water standard for TCE is 5µg/L.

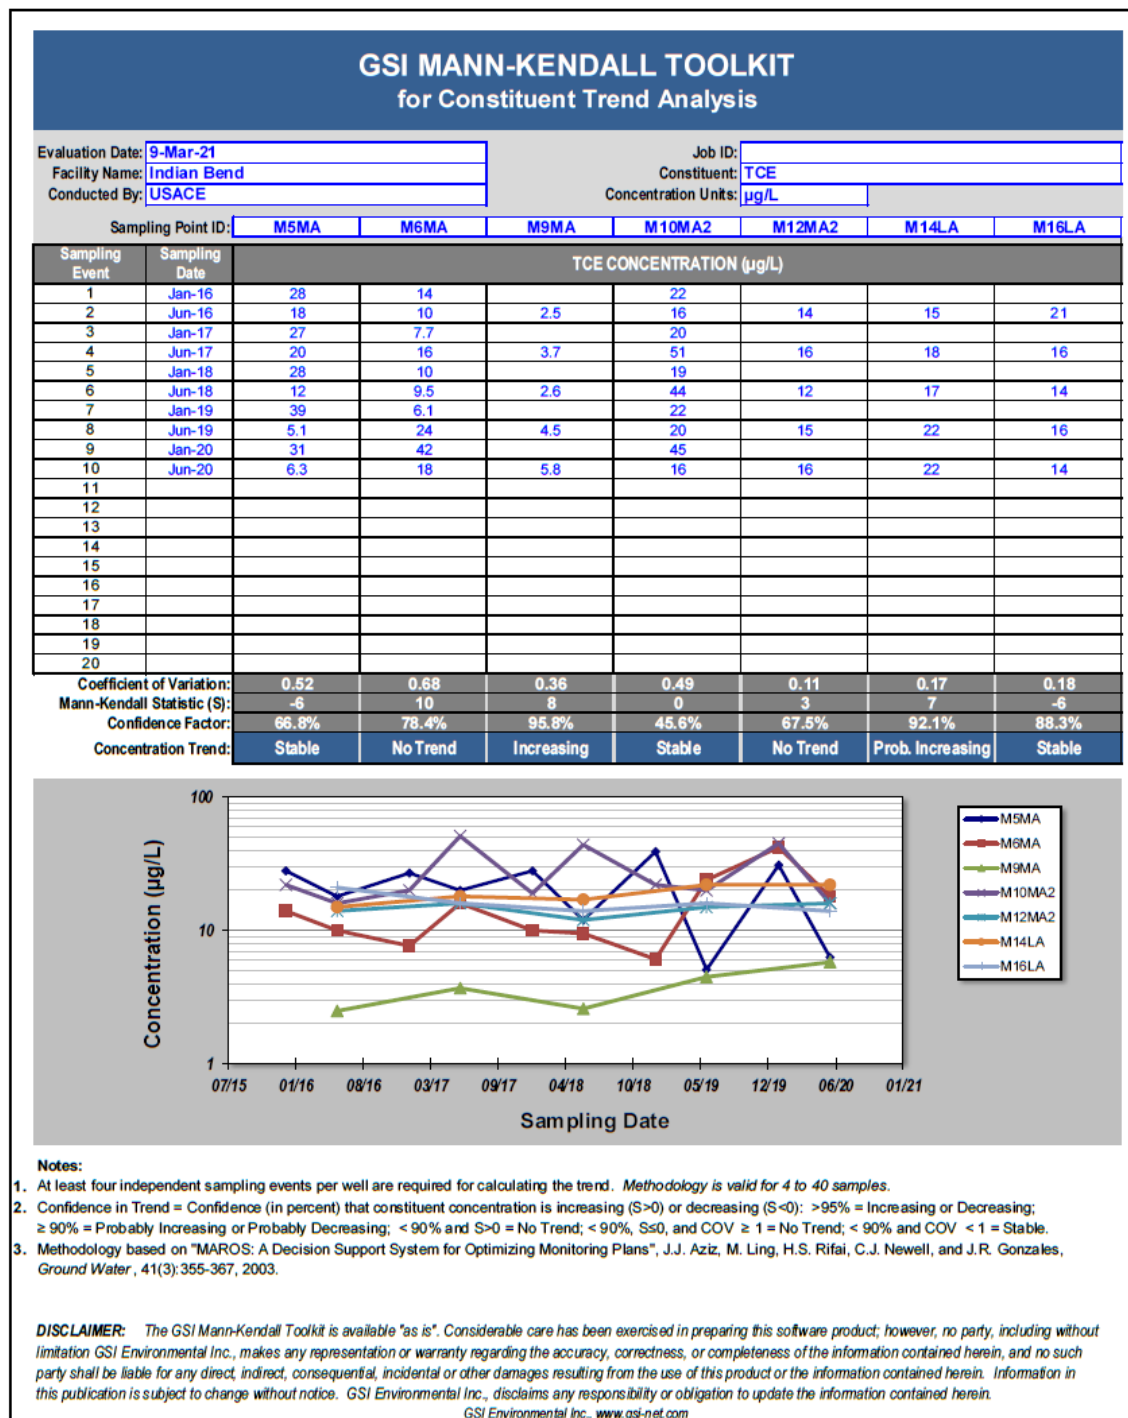
Figure D-5. TCE concentration trend plot since the previous five-year review of middle and lower alluvial wells. Two wells are increasing in TCE concentrations, but M14LA is upgradient from an extraction well and M9MA is upgradient of the Granite Reef extraction well. The Federal drinking water standard for TCE is 5µg/L.

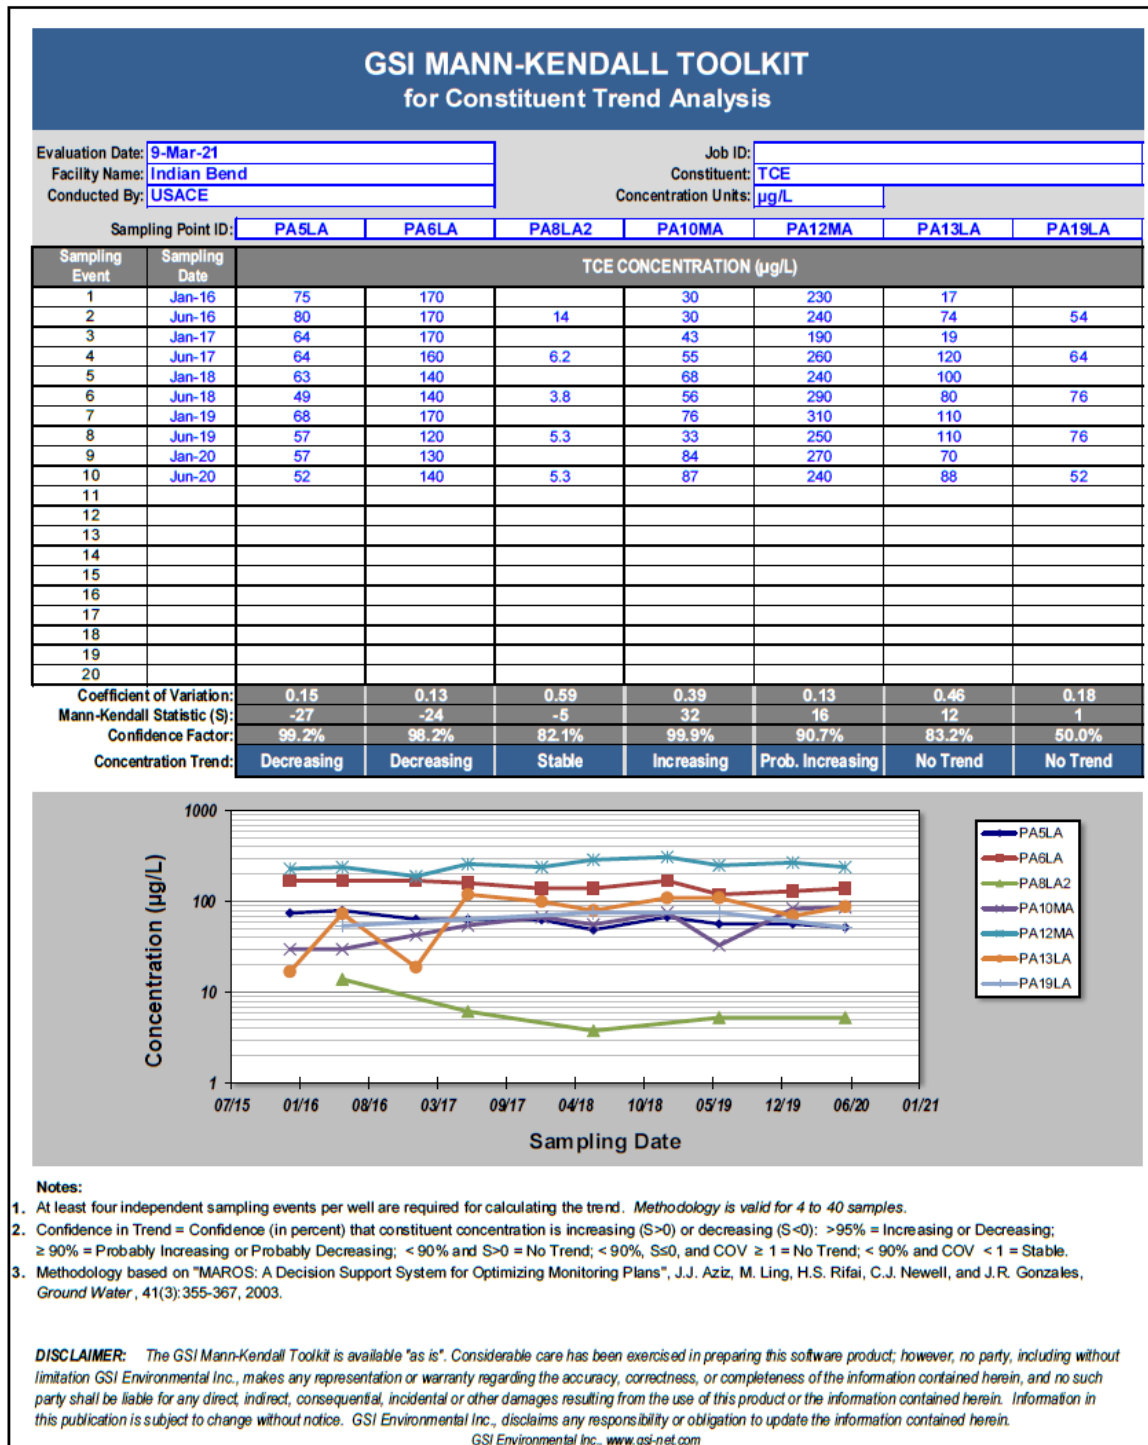
Figure D-6. TCE concentration trend plot since the previous five-year review of middle and lower alluvial wells. Two wells are increasing in TCE concentrations, PA12MA is downgradient from an extraction well, indicating a possible weakness in COS71 and PA10MA is downgradient and cross gradient to two extraction wells. The Federal drinking water standard for TCE is 5µg/L.

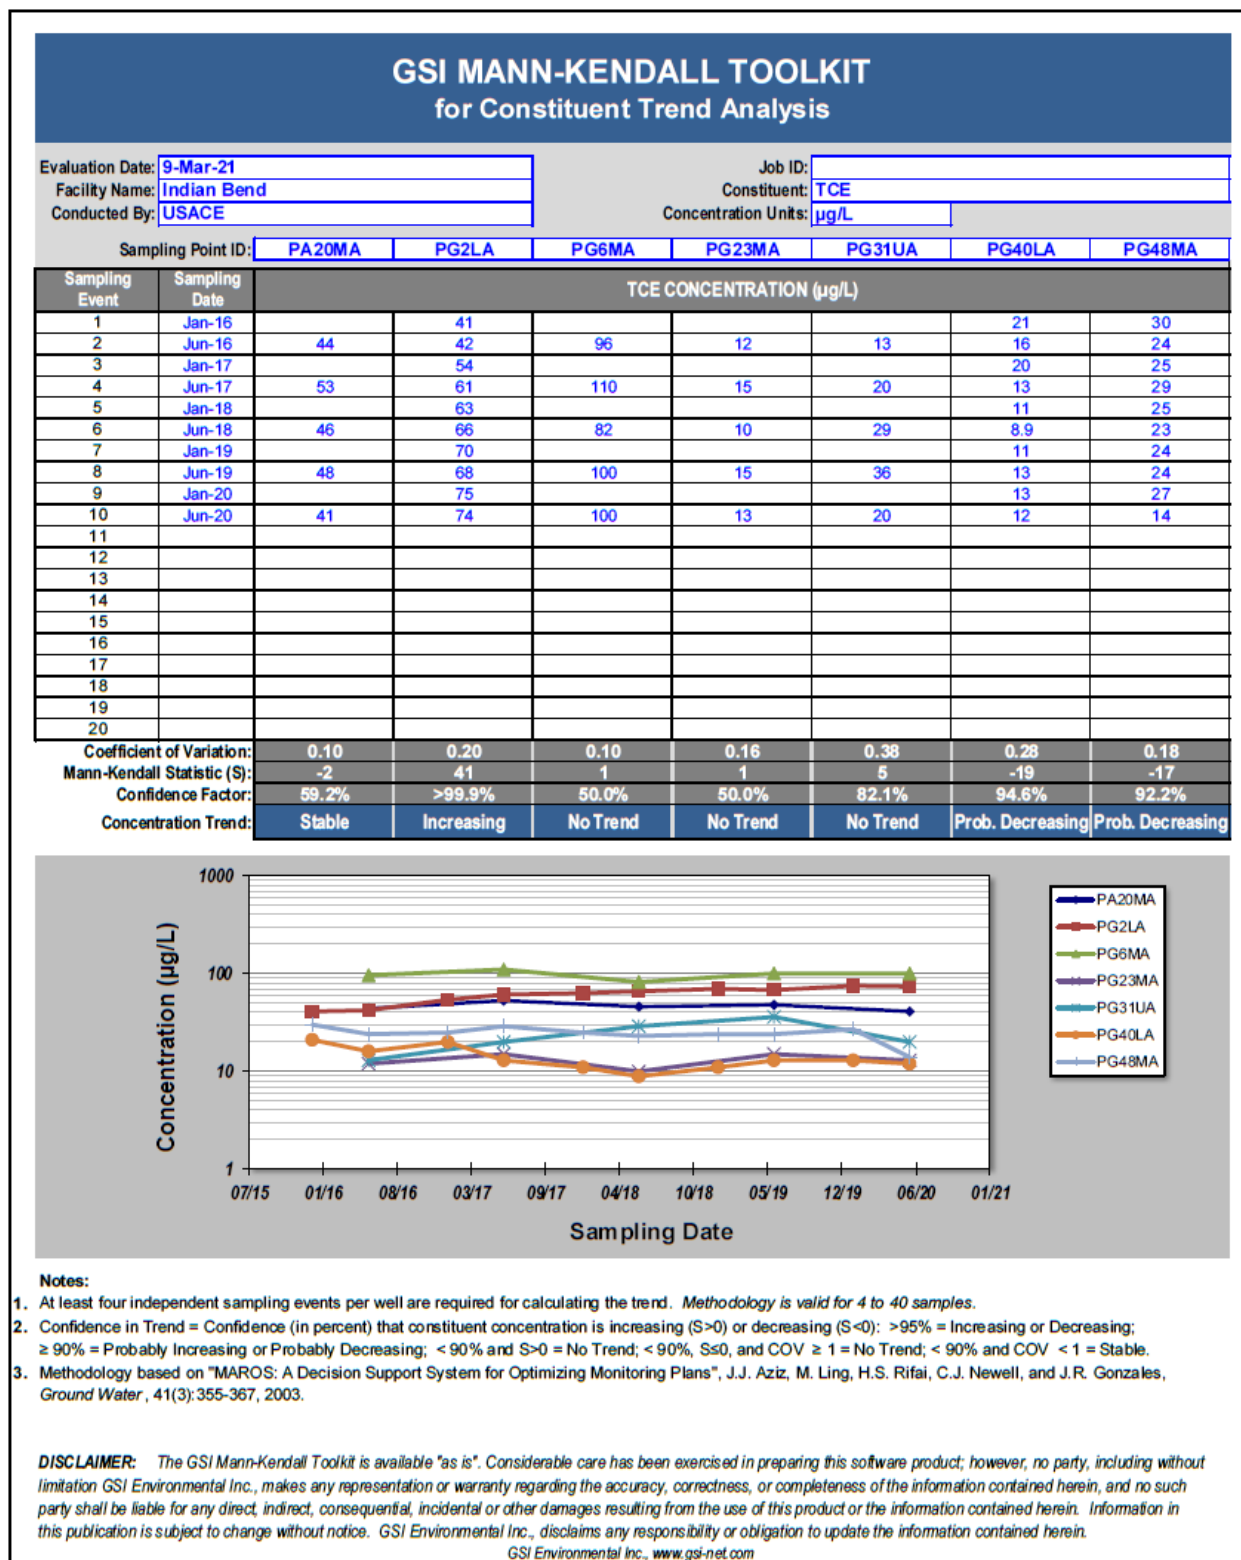
Figure D-7. TCE concentration trend plot since the previous five-year review of upper, middle, and lower alluvial wells. One well is increasing in TCE concentration, PG2LA is near an extraction well, so it is expected to be increasing. The Federal drinking water standard for TCE is 5µg/L.

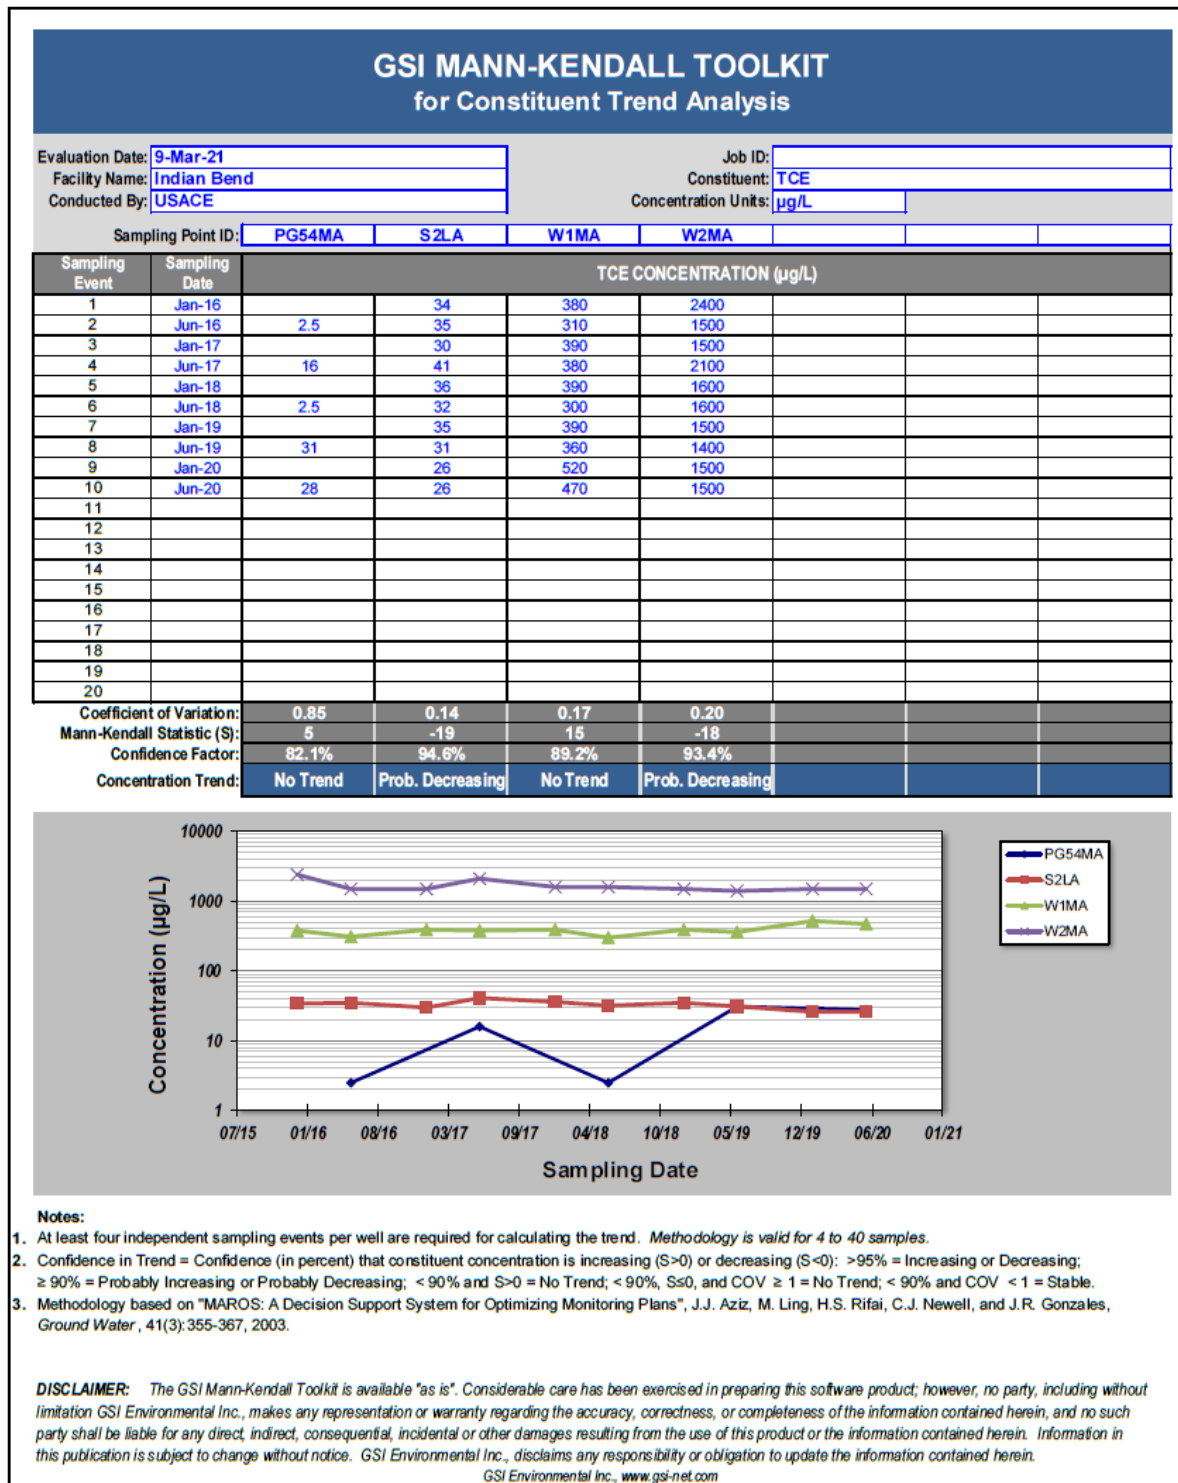
Figure D-8 TCE concentration trend plot since the previous five-year review of middle and lower alluvial wells. These wells are near the Area 7 groundwater extraction treatment systems and extraction wells and have some of the highest TCE values recorded across the Site. The Federal drinking water standard for TCE is 5µg/L.

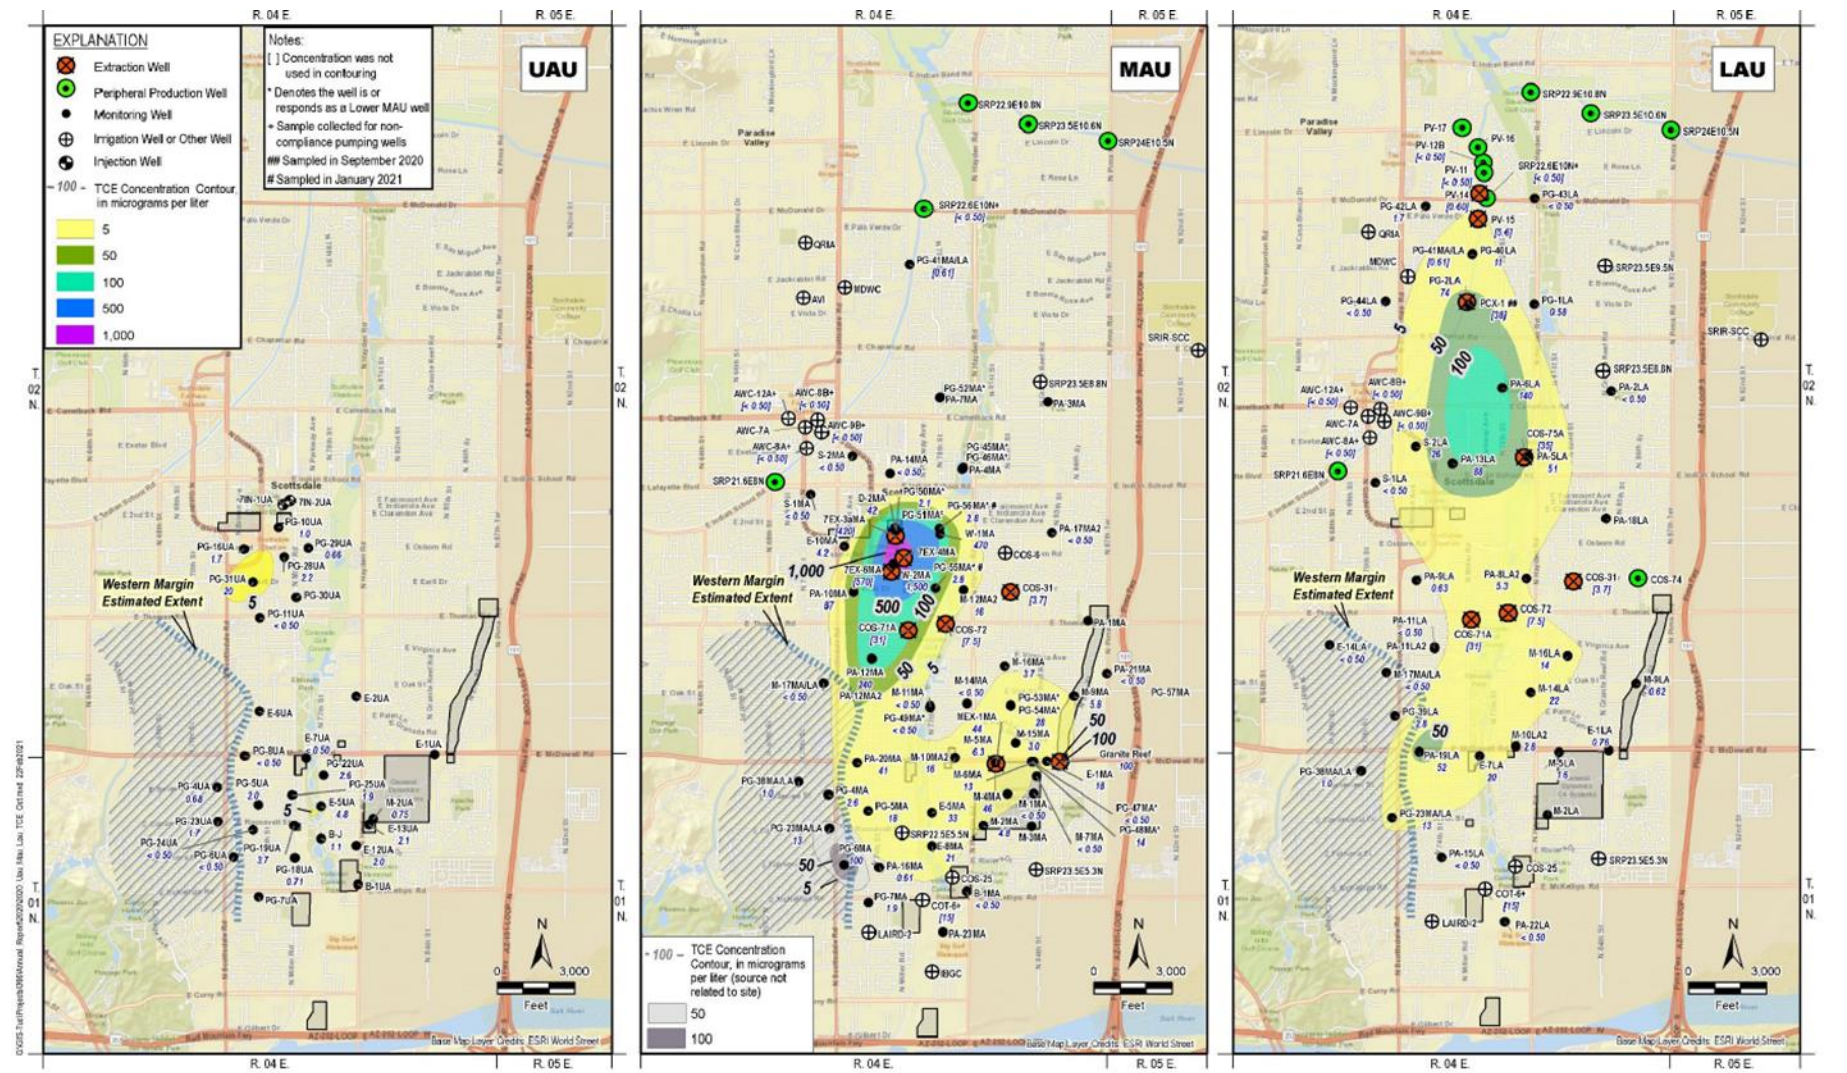
Figure D-10 TCE concentrations in the Upper (UAU), Middle (MAU) and Lower (LAU) Alluvial Units

Figure D-10 shows that groundwater within the upper alluvial unit has the lowest TCE concentrations, with a maximum of 36 µg/L in well PG-31 UA. The highest TCE concentrations are in the middle alluvial unit, particularly within the Area 7 capture zone where concentrations exceed 1000 µg/L. The highest concentrations of TCE occur at wells W-1MA and W-2MA with concentrations of 520 and 2100 µg/L respectively for this reporting period. (Figures D-8 and D-10). In the Area 12 capture zone near the Granite Reef extraction well TCE concentrations were approximately 150 µg/L in 2019. Groundwater in the lower alluvial unit has the second highest TCE concentrations, ranging up to 170 µg/L at PA-6LA for this five-year reporting period. Groundwater in the middle alluvial unit has the highest contaminant concentrations of the three aquifer units, particularly near Area 7 extraction wells, where concentrations are greater than 1,000 µg/L in a localized area. A very small area of higher concentrations in the middle alluvial unit is present near the Area 12 Granite Reef extraction well, with concentrations around 150 µg/L in 2019. Groundwater in most of the middle alluvial unit TCE plume is now between 5 and 50 µg/L. The lower alluvial unit TCE plume ranges from 5 to 50 µg/L.

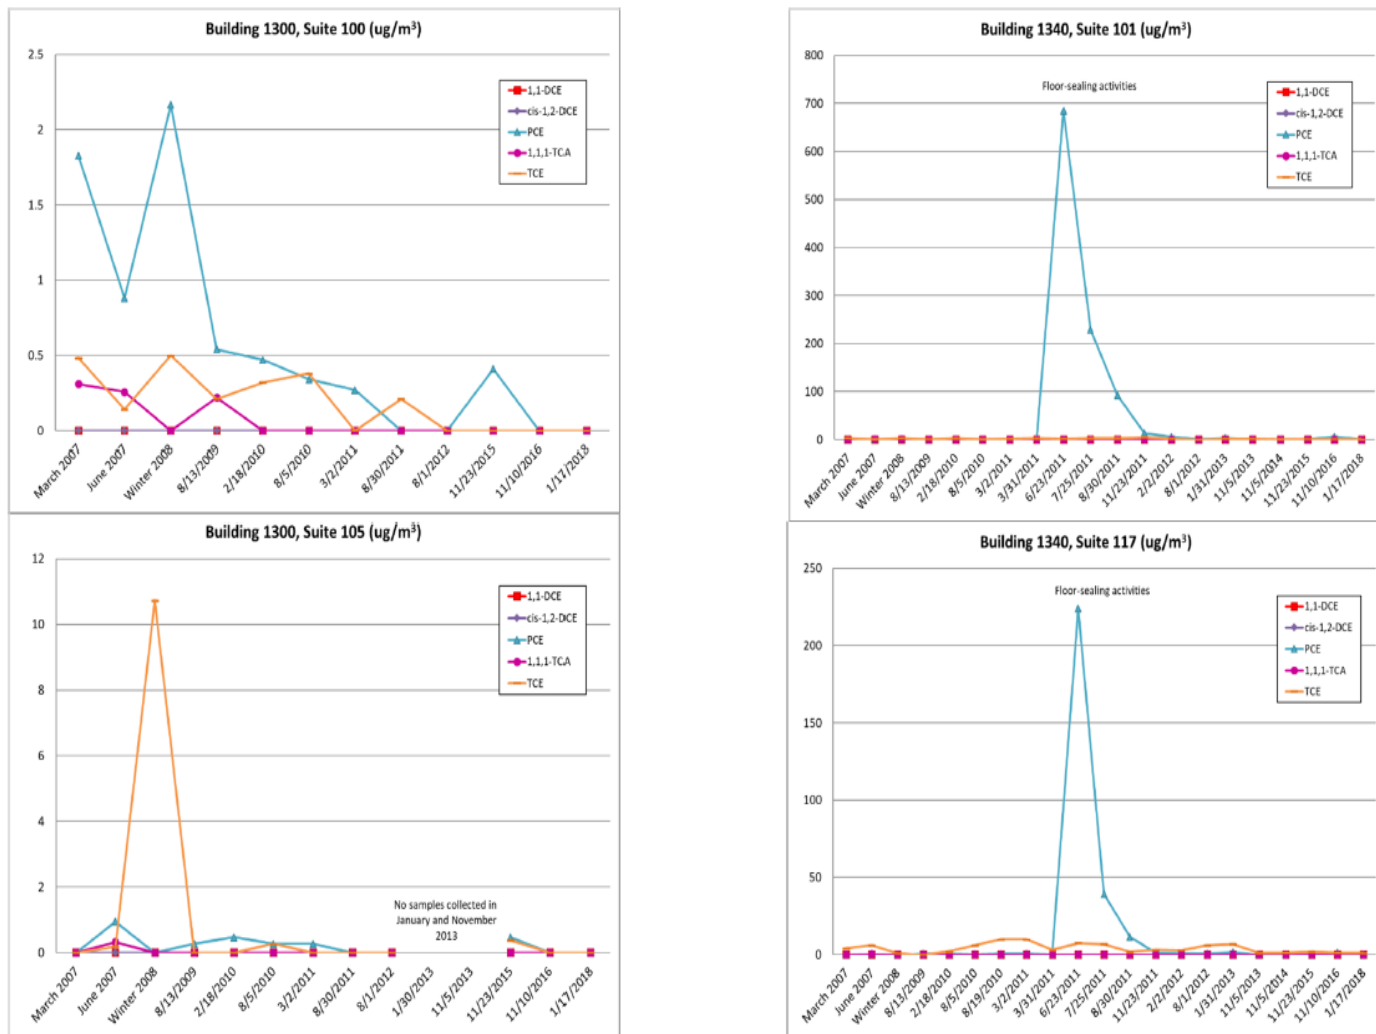
Figure D-12. Indoor Air Trends in commercial Suites at DCE Circuits Subsite

EPA collected soil gas samples of all former source areas with respect to the vapor intrusion pathway. Based upon the soil gas sampling results, all twelve former South Indian Bend Wash source areas were determined to require no further action for vapor intrusion. A vapor intrusion assessment for the DCE Circuits Subsite was conducted in April 2019 to assess the risk to human health. Neither the accelerated response action level or urgent response action level was exceeded in any of soil gas indoor/outdoor air samples for TCE for commercial/industrial or residential use (Figure D-12).
