**FIRST FIVE-YEAR REVIEW REPORT FOR  
COOPER DRUM COMPANY SUPERFUND SITE  
SOUTH GATE, LOS ANGELES, CALIFORNIA**

U.S. Army Corps of Engineers

**U.S. Environmental Protection Agency**

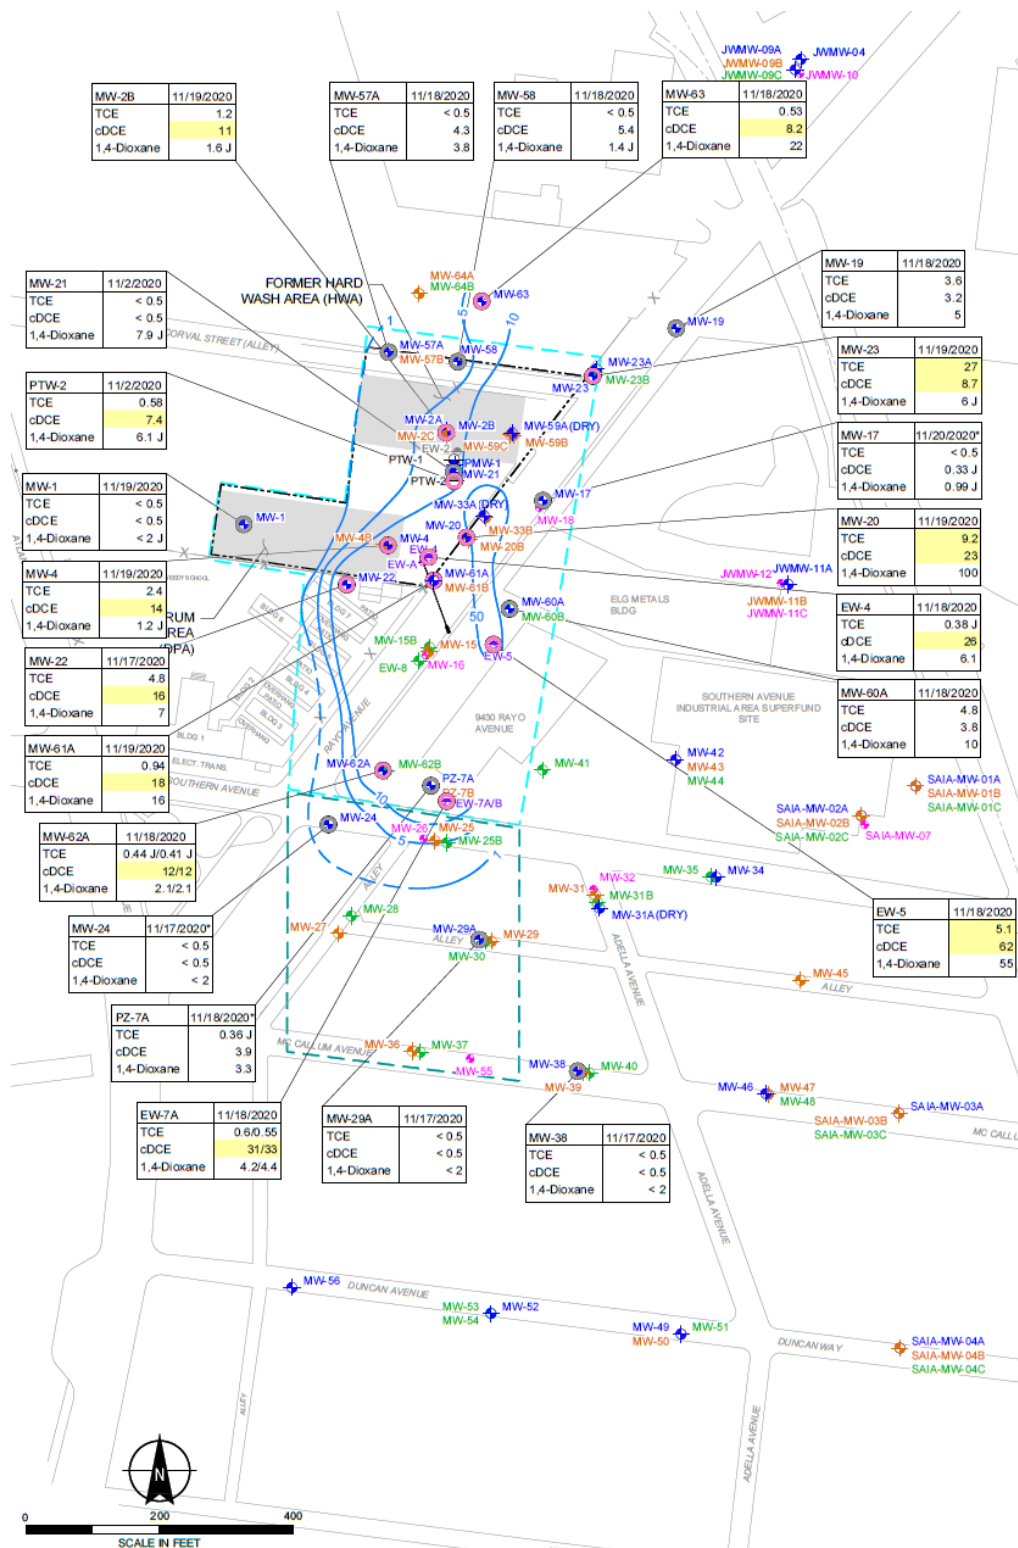
Figure 4. Contaminant Concentrations in the Upper Gaspar Aquifer, Nov. 2020.

The hydrogeology of the Site supports the potential for hydraulic downward transport of contaminants between the Gaspur and Exposition aquifers (Figure 3). According to recent investigations, clays pinch out toward CPT-29 from the north and south along A-A' (Figure 6). The presence of more coarse-grained material (silty sands and sand) noted between the two aquifers near CPT-29 represents an area where downward migration or “leaking” from the Gaspur Aquifer to the Exposition Aquifer seems likely. Monitoring well MW-55, located downgradient of the Property along McCallum Avenue, is one of two Exposition Aquifer monitoring wells with increasing contaminant concentrations and is also located near CPT-29. The other Off-property Exposition Aquifer monitoring well, MW-18, also exhibited its highest TCE concentration reported in 2020 (Haley 2021).

The increasing concentrations of cis-1,2-DCE and new detections of TCE in the Exposition Aquifer indicate that there is a failure in controlling vertical movement of the plume by the existing groundwater remedy. This is also supported by the previously noted downward gradients between the Gaspur and Exposition aquifers. Vinyl chloride, DCA, and benzene have been found in Off-property monitoring well MW-55 with concentrations as high as 41 µg/L for vinyl chloride in December 2018. Off-property monitoring well MW-18 also exhibits detections of Site-specific contaminants like DCA and 1,4-dioxane. These Site-specific contaminants increase the likelihood of an unknown migration pathway(s) from the Gaspur Aquifer into the Exposition Aquifer.

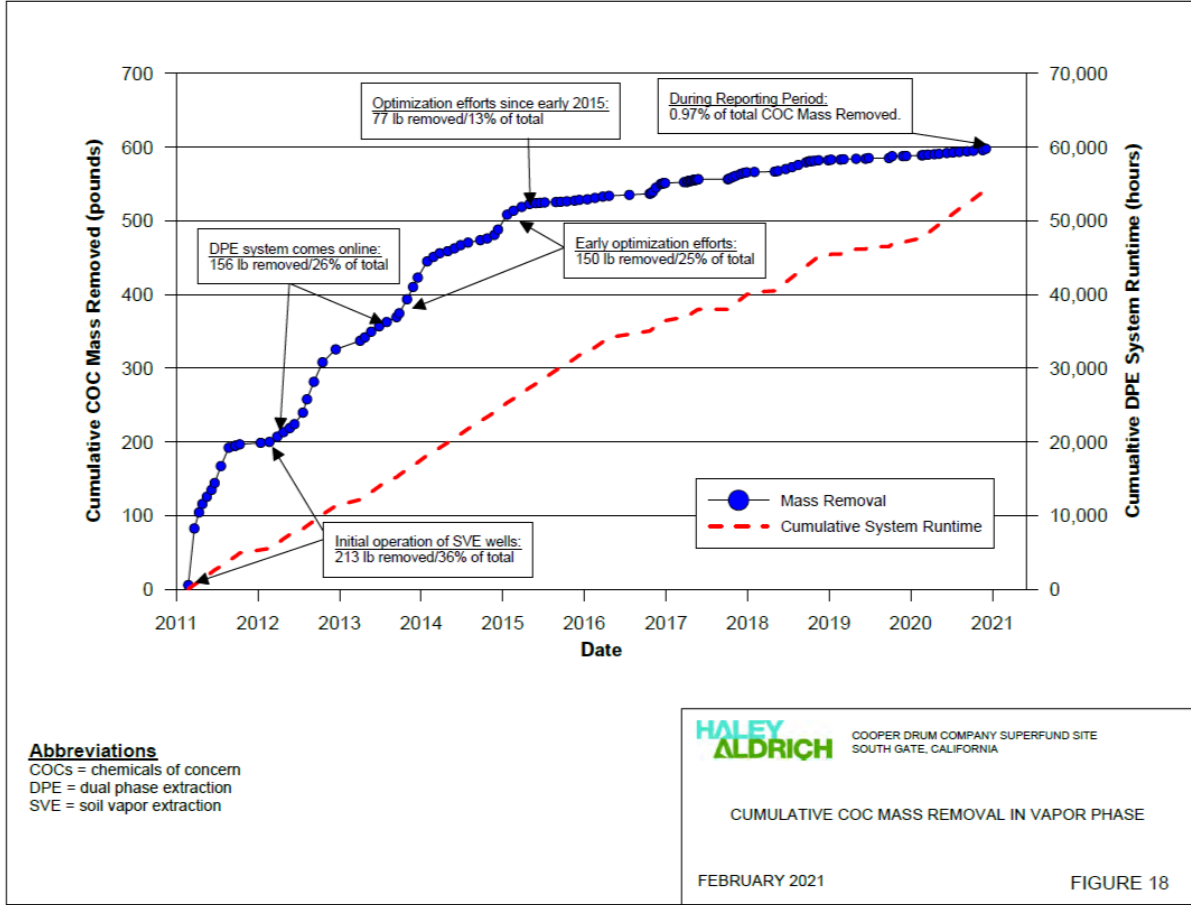
**Figure 8. Soil Vapor Extraction System Total Cumulative Mass Removal Graph**

The soil vapor extraction system began operation in February 2011 and has removed approximately 598 pounds of contaminant mass through December 2020. While the mass removal curve has flattened in

recent years, the system has removed approximately 78 pounds of contaminants since approximately 2015. Thus, the system may be approaching, but has not yet fully reached asymptotic conditions (Figure 7). Additionally, as noted in the soil gas concentration discussion above, some vapor monitoring point concentrations have increased, which indicates that significant contaminant mass remains in the soil.

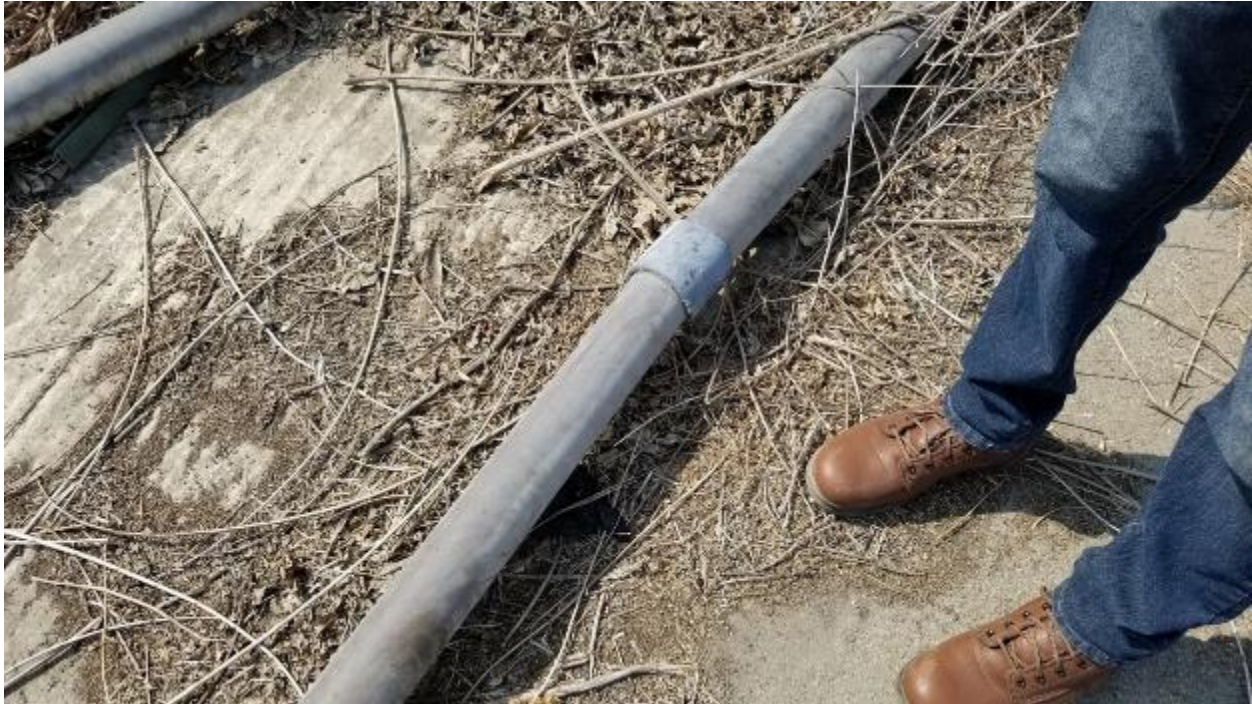
Figure 27. SVE joint which occasionally decouples due to thermal expansion.

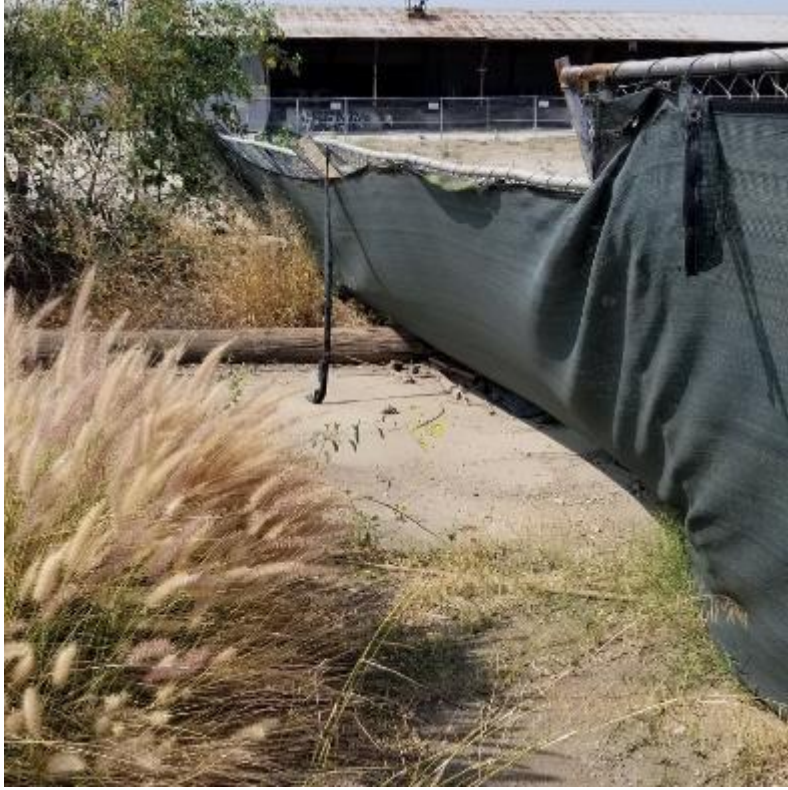
Figure 30. Length of fence partially toppled over along the west perimeter. Facing south.

- Detailed information on system operations and maintenance, such as carbon change outs, was not found in the Cooper Drum Cooperating Parties Group annual report and should be included in future reports.
- The section of fencing between the Cooper Drum Property and the adjacent industrial property should be repaired.

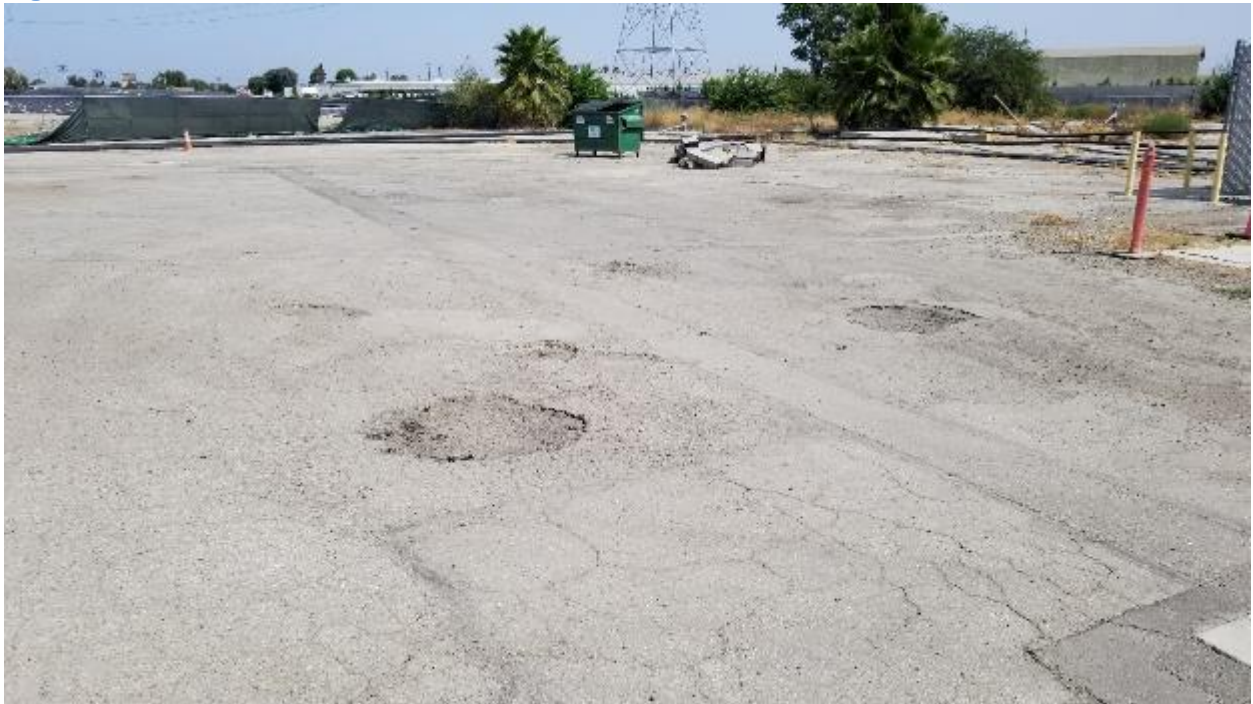
Figure 33. Potholes on the asphalt lot. Facing northwest.
