United Heckathorn Five-Year Review Site Inspection Report

- a. Date of Visit: July 26, 2022
- b. Location: Richmond, CA
- c. Purpose: A site visit was conducted to visually inspect and document the conditions of the remedy, the site, and the surrounding area.
- d. Inspector: Cynthia Wetmore, EPA, Five-Year Review Coordinator
- e. Participants:
 - EPA: Karen Jurist, Rusty Harris-Bishop, Josh Wirtschafter, Grace Elam (EPA intern) and Courtney Fung (EPA intern)
 - Contractor for EPA, CH2M Hill/Jacobs: Leslie Harlander
 - Levin Richmond Terminal: James Holland, Malcolm Whyte
 - Levin Enterprises, President and CEO: Chris Schaeffer
 - Outside Counsel for Levin Richmond Terminal, Farella, Braun + Martel: Chris Locke
 - Consultant for Levin Richmond Terminal, CDIM Engineering: Scott Bourn

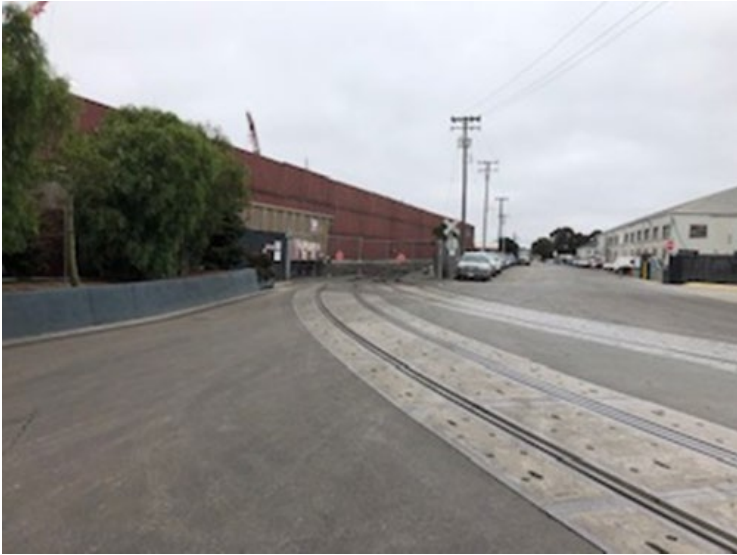
Ms. Wetmore arrived at the United Heckathorn Superfund Site at 9:30 AM. The weather was overcast and cool initially, but fog cleared by then of the inspection. Prior to meeting the participants at 10 AM, Ms. Wetmore walked around the property along the public streets to inspection the fencing and signage. The ship loading gate was fully opened, but a staffed by a guard while opened. Appropriate signage was at all entrances (Photo 2). No evidence of vandalism was noticed. The fence was in good condition.

Photo 1. Fence entrance standing in office parking lot

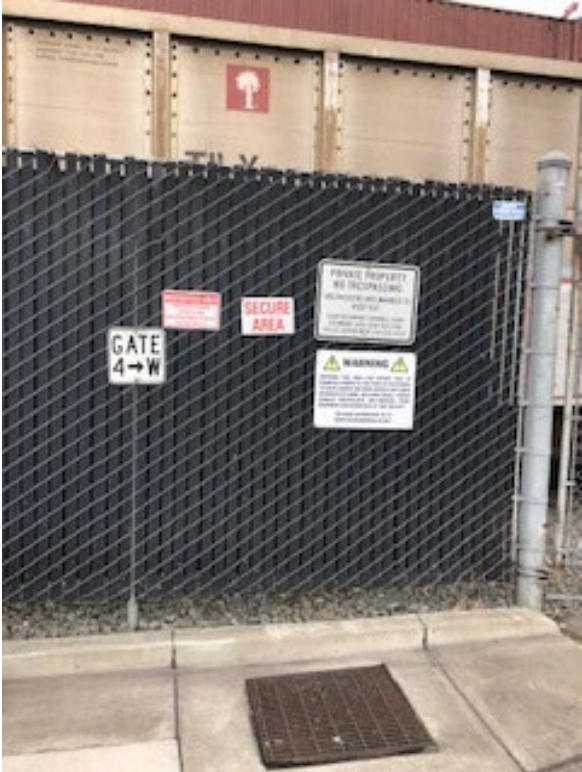
Photo 2. Gate signage

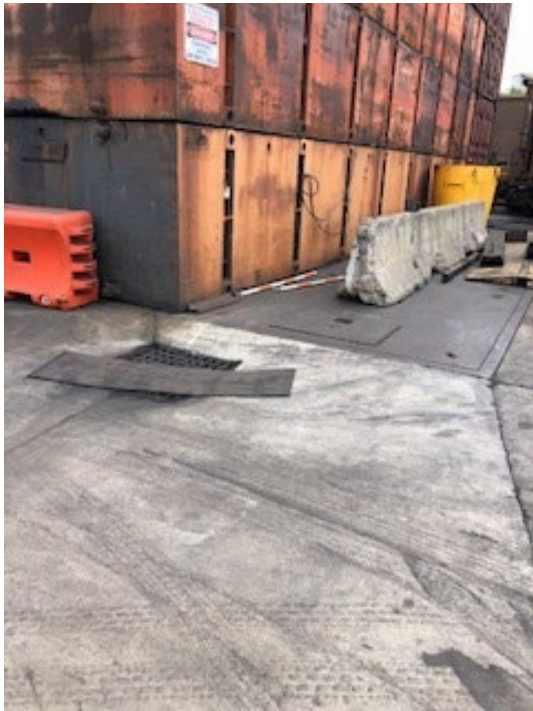
Photo 3. SW-3

After the meeting, the participants went to the southern edge of the upland cap at SW-3 (Photo 3). From there, the participants continued walking north. Large containers are stacked around the edges from about SW-3 to SW-5, creating a wind barrier for the area enclosed (see green line in Figure 2). Within this wind barrier area, a large pile of petroleum green coke was stored. The asphalt area within this wind barrier area had evidence of multiple cracks, and multiple repairs (Photos 4- 8). There was no evidence of soil exposure in the cracked areas. Mr. Bourne indicated that the cracks are repaired as needed, to prevent exposure of the underlying soil.

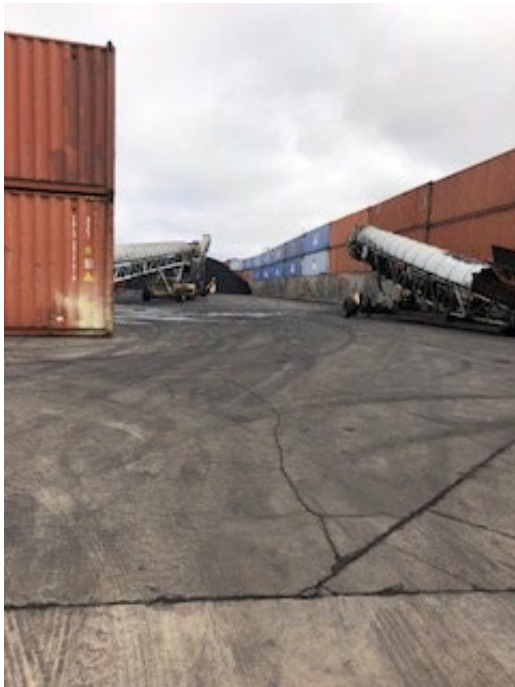
Photo 4. Example cracking (SW-3 looking north towards SW-4)

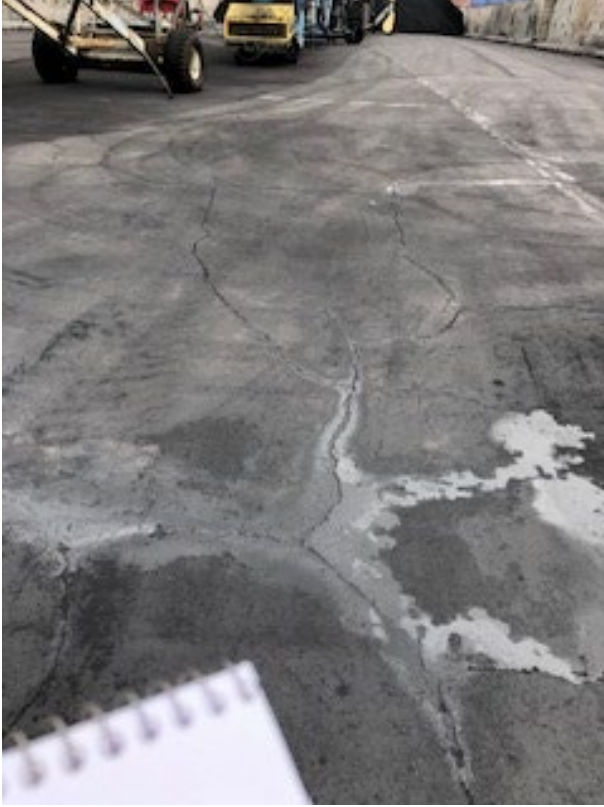
Photo 5. Cracking

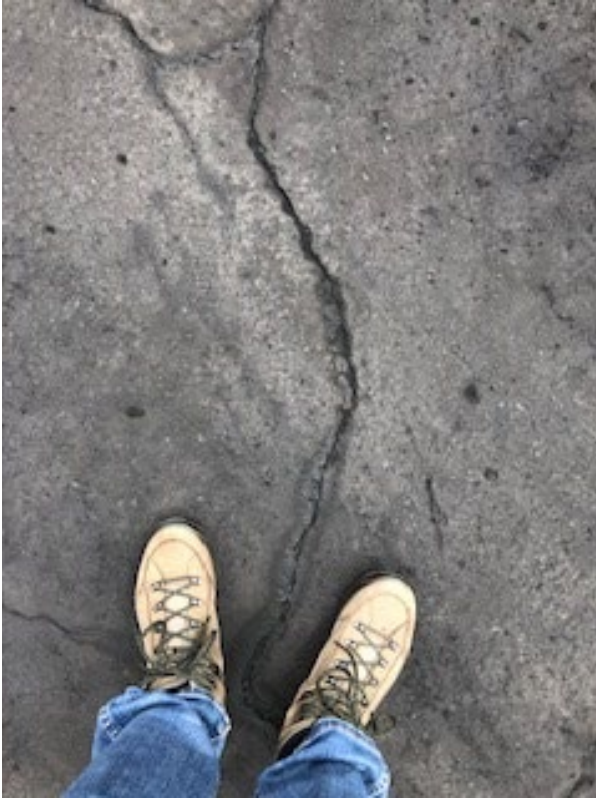
Photo 6. Cracking – no evidence of soil

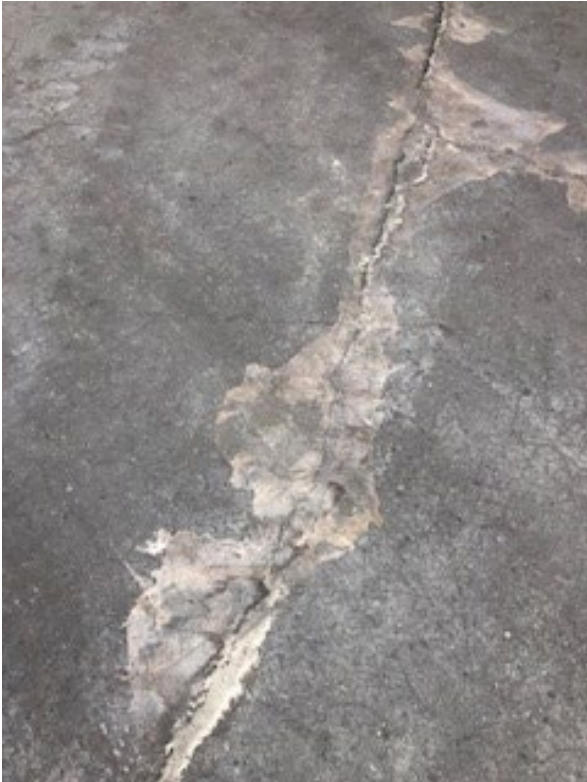
Photo 7. Cracking – previous repair

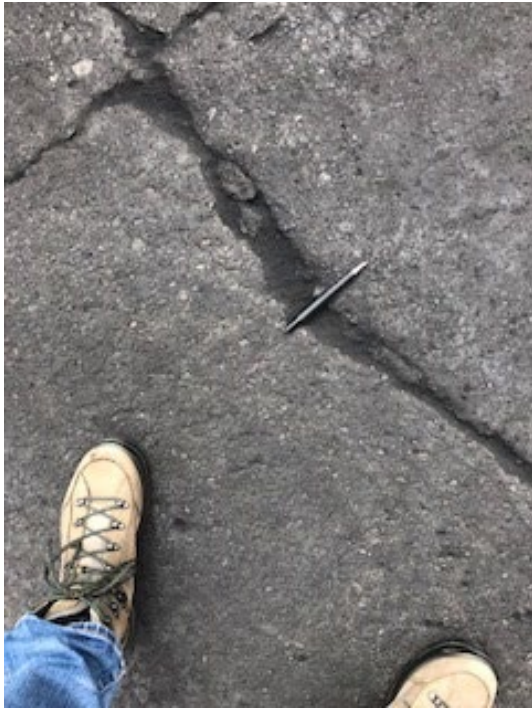
Photo 8. Largest crack observed

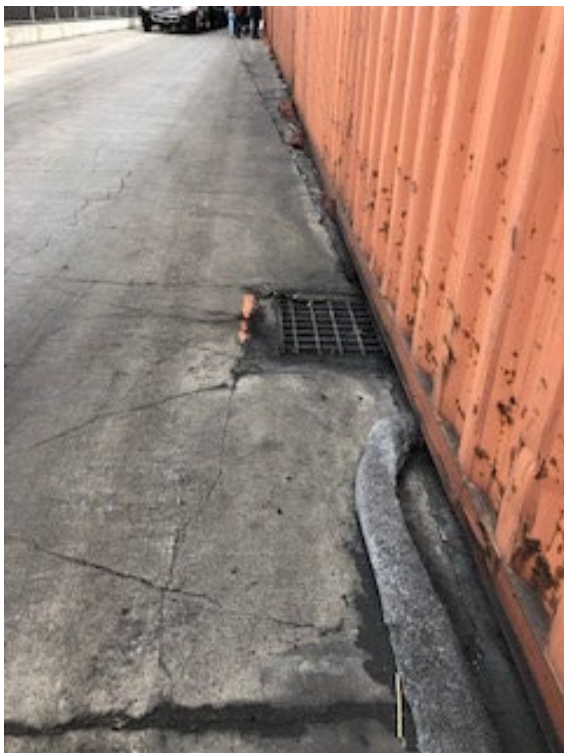
The participants then walked along the Lauritzen Channel along SW-4, to observe the concrete cap and the connection between the asphalt cap and concrete cap. Although there was evidence of cracking, it was superficial and limited. There was evidence of previous repairs. The connection between the asphalt cap and concrete cap was in good condition. (Photos 9-11).

Photo 9. At SW-4 looking back, concrete has some cracks and repairs

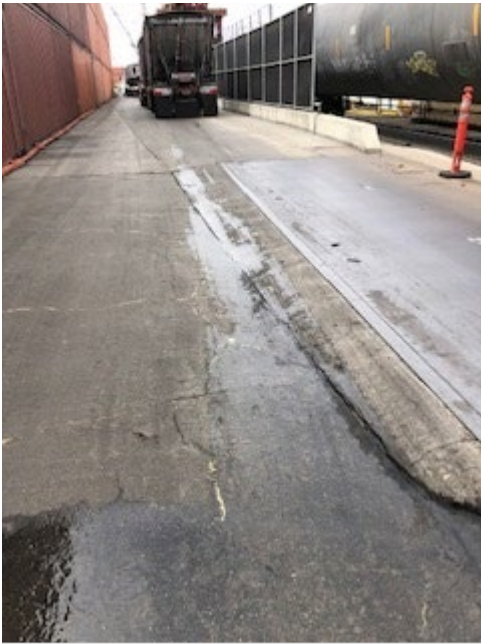
Photo 10. Looking south along SW-4

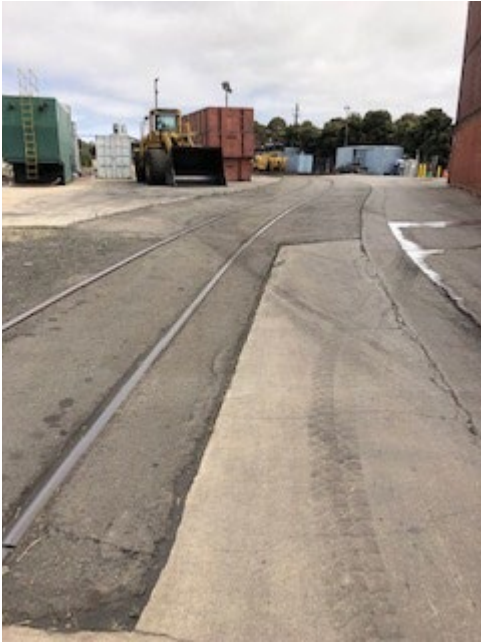
Photo 11. Connection between railroad pavement and asphalt (looking north past SW-4)

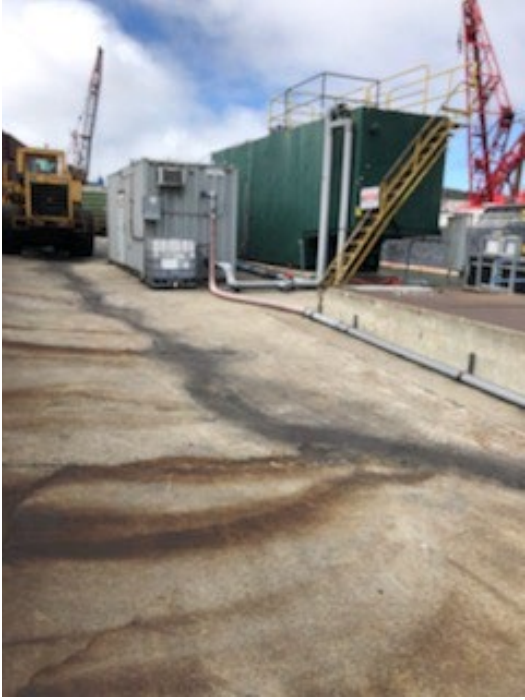
Although not part of the selected remedy, EPA walked around the treatment plant area, and no damage was noted. (Photo 12). Further north around the train tracks, was the gravel cover. There were no bare patches, nor evidence of exposure of the geomembrane fabric. (Photos 13 – 15).

Photo 12. Treatment plant (looking south)

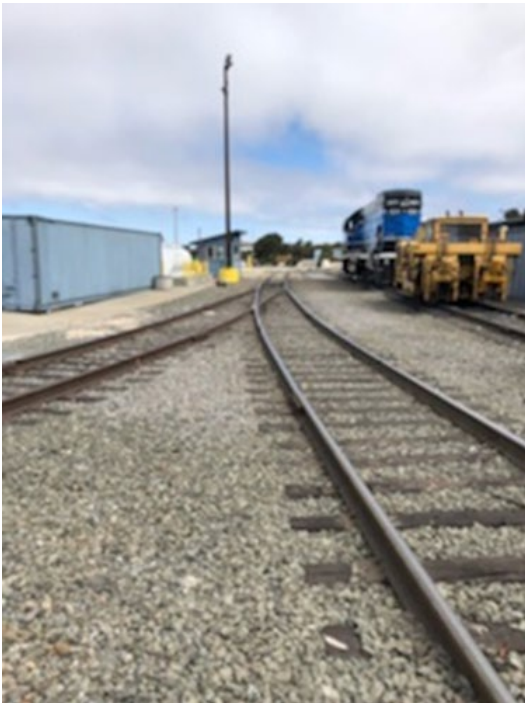
Photo 13. Gravel cover under railroad tracks

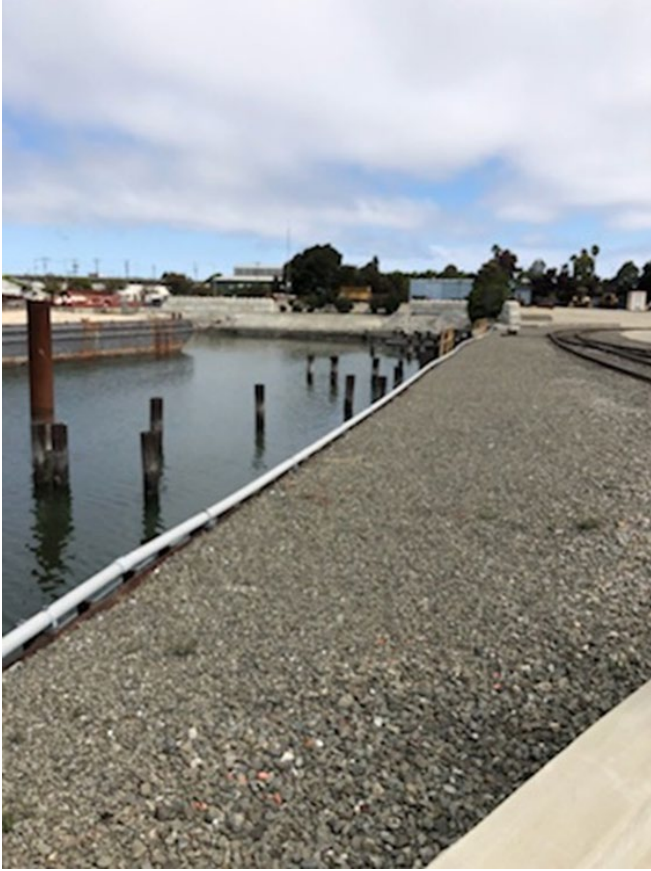
EPA then walked around the shoreline around near the City Outfall is located. The shotcrete was in good condition, and there was no evidence of seeps. Mr. Bourne stated that the shotcrete was about 8-10 years old. He also stated that there are still occasional seeps, but only during low tides. The tide was high during the inspection.

Photo 14. City Outfall and shotcrete along shore (looking north)

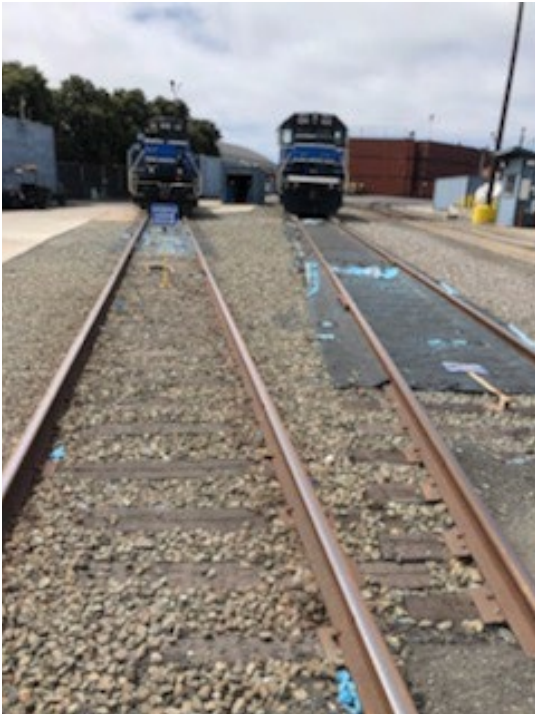
Photo 15. Railroad tracks (facing south)

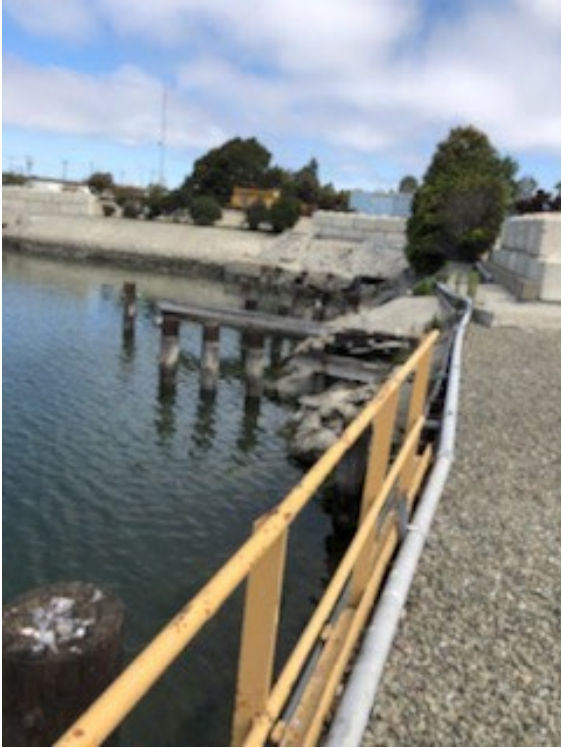
Photo 16. Shotcrete along shore near outfall

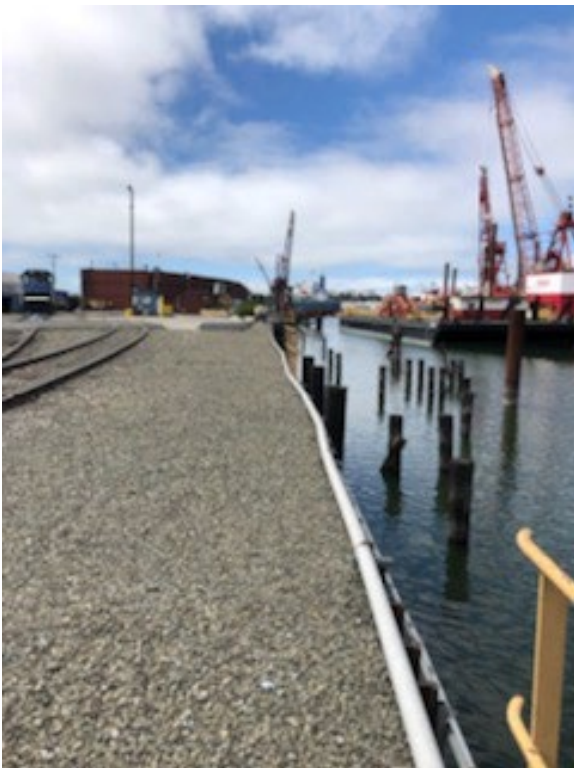
Photo 17. Shoreline facing south near outfall

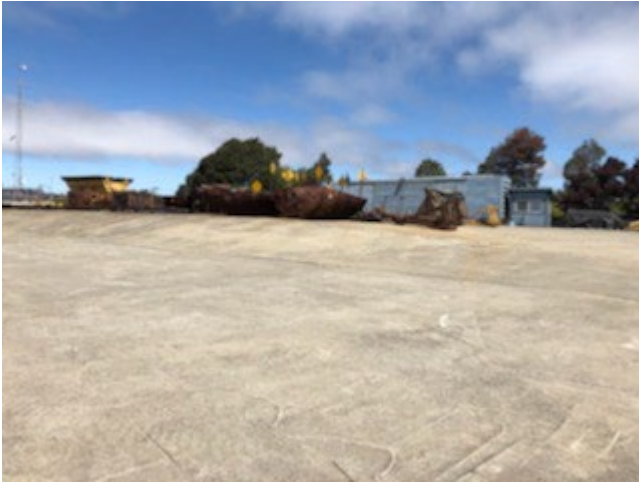
The final area inspected was the concrete cap at the furthest north of the Site (referred to as the hump). The concrete was in good shape with minimal cracking.

Photo 18. Concrete cap

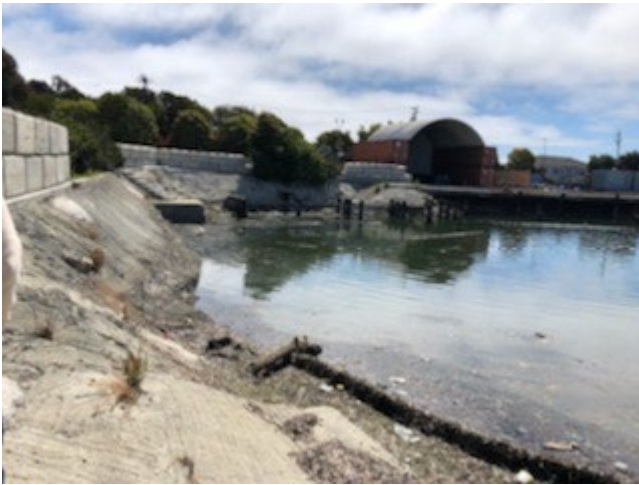
Photo 19. Outfall at SW-7 and shotcrete on shoreline (looking east)
