**FOURTH FIVE-YEAR REVIEW REPORT FOR  
MCCORMICK AND BAXTER CREOSOTING COMPANY SUPERFUND  
SITE  
SAN JOAQUIN COUNTY, CALIFORNIA**

PREPARED BY

U.S. Army Corps of Engineers

**U.S. Environmental Protection Agency**

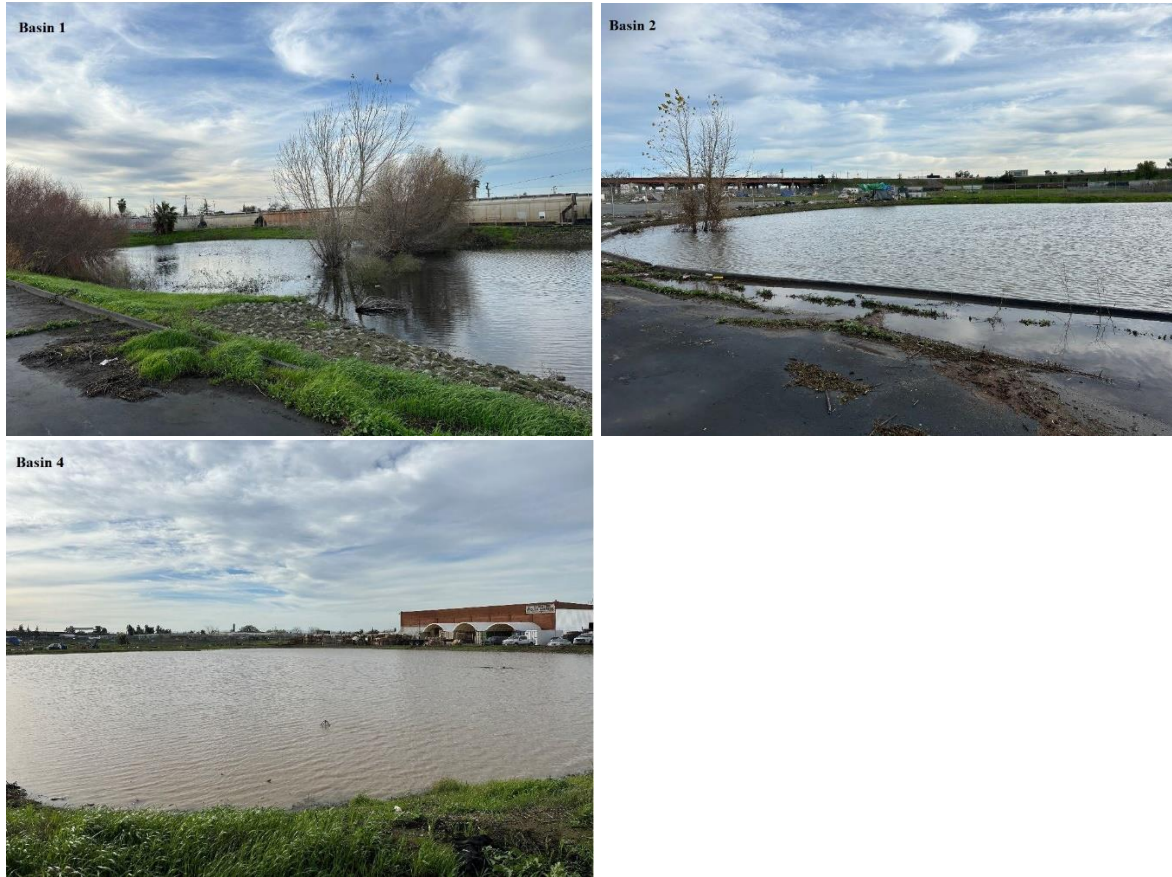
Figure 8. Basins 1, 2, and 4 Water Levels on January 12, 2023

Stormwater sampling was performed at least once per year between 2020 and 2023. In 2020 and 2021, DTSC reported both total and dissolved copper concentrations in stormwater detention Basins 1, 2, and 4 above the City of Stockton Municipal Utilities District criteria limits and exceedances of total PAHs in Basins 2 and 4 (Table 5). However, since the discharge limits only apply to stormwater discharged off-Site and no stormwater has historically been discharged off-Site, no violation of the City discharge limit occurred. Water levels were low during the December 2022 sampling event; however, samples were taken from the main basins for the January 2023 sampling event following a major storm that inundated all three basins and the water was assumed to have discharged into the city sewer system (Figure 5). Sampling results again exceeded discharge limits for total copper in Basins 1 and 4, dissolved copper in Basin 1, and PAHs in Basin 4. Therefore, water with concentrations exceeding the discharge limits may have been discharged off-Site during the storms in early January of 2023.

<b>Recommendation:</b> Consider upgrading the stormwater system for greater capacity and cleaning the outfall pipes of the stormwater basins. A source evaluation for the elevated contaminants found in the stormwater basins is recommended to determine where the sources may be coming from.			
<b>Affect Current Protectiveness</b>	<b>Affect Future Protectiveness</b>	<b>Party Responsible</b>	<b>Oversight Party</b>	<b>Milestone Date</b>
No	Yes	State	EPA	9/1/2028

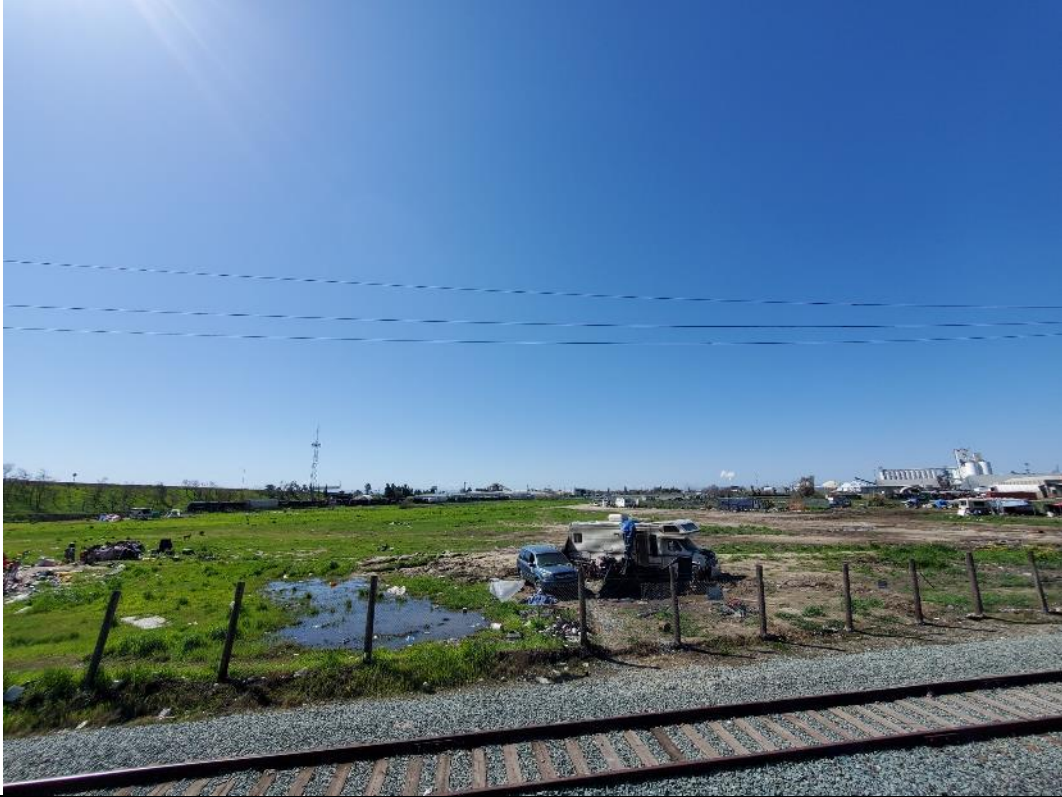
No.	Photo	Caption
1.

<p>View of Site from east on W. Washington St, looking West.</p> <p>Typical areas of campsites and debris.</p>
2.

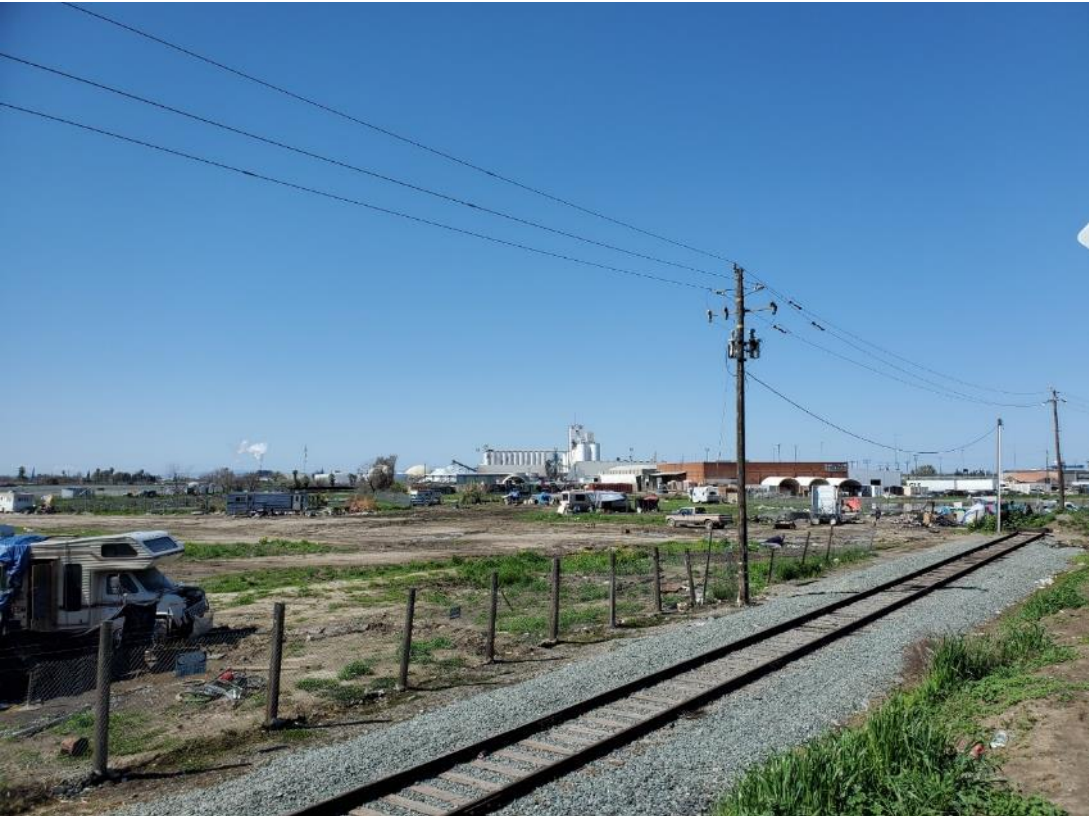
<p>View of Site from east on W. Washington St, looking North-West towards detention basin 4.</p> <p>Typical areas of campsites and debris.</p>

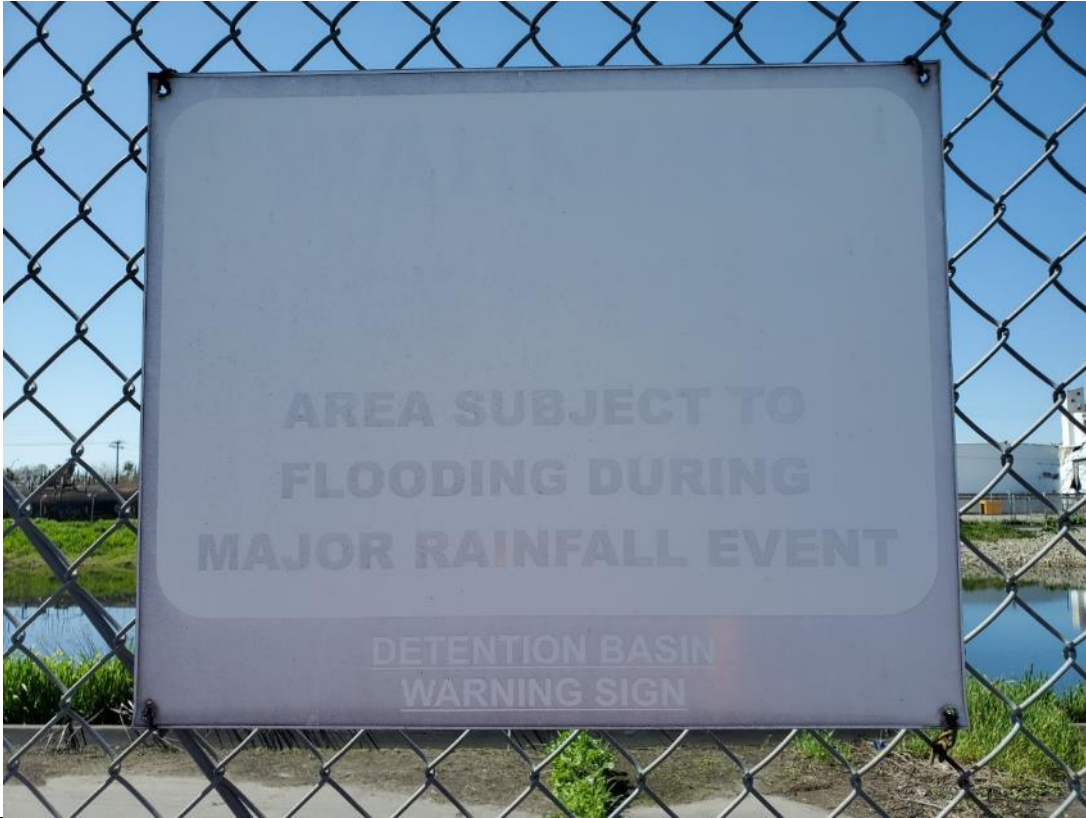
3.

Det Basin 1 –  
Typical Faded Sign  
on all detention  
basin gates.

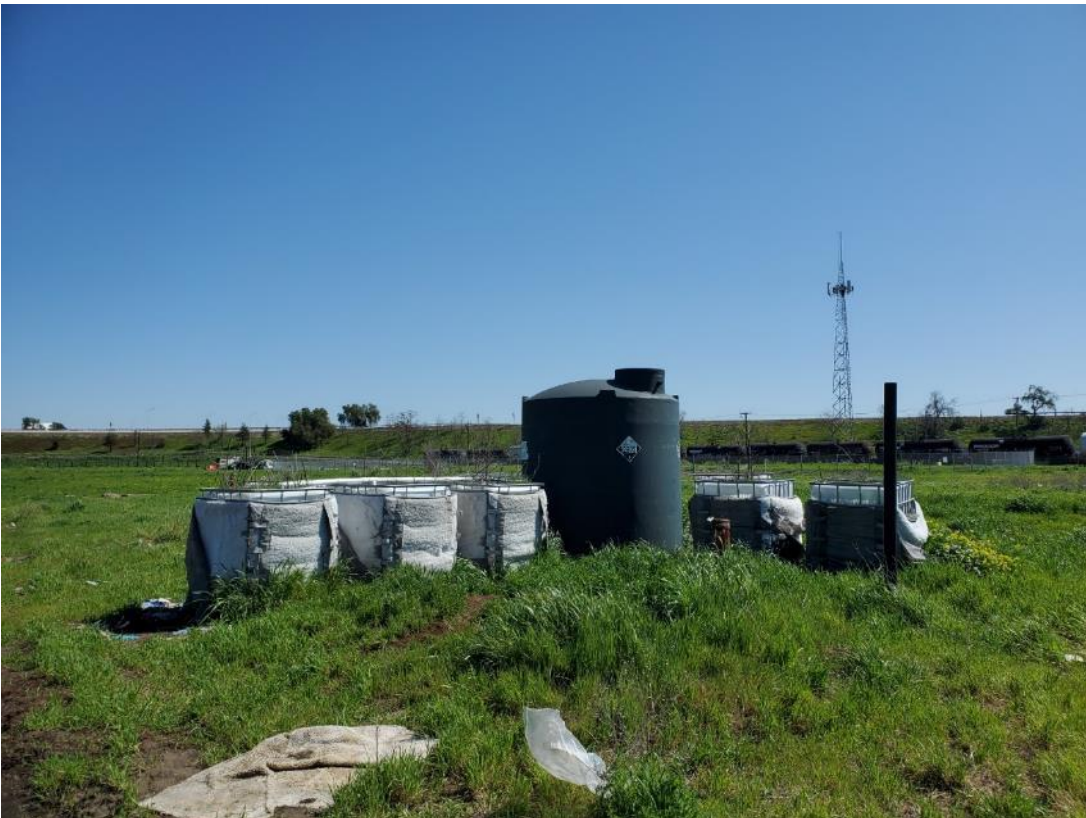
4.

Main area with  
leftover phyto-  
remediation study  
equipment.

Typical debris.

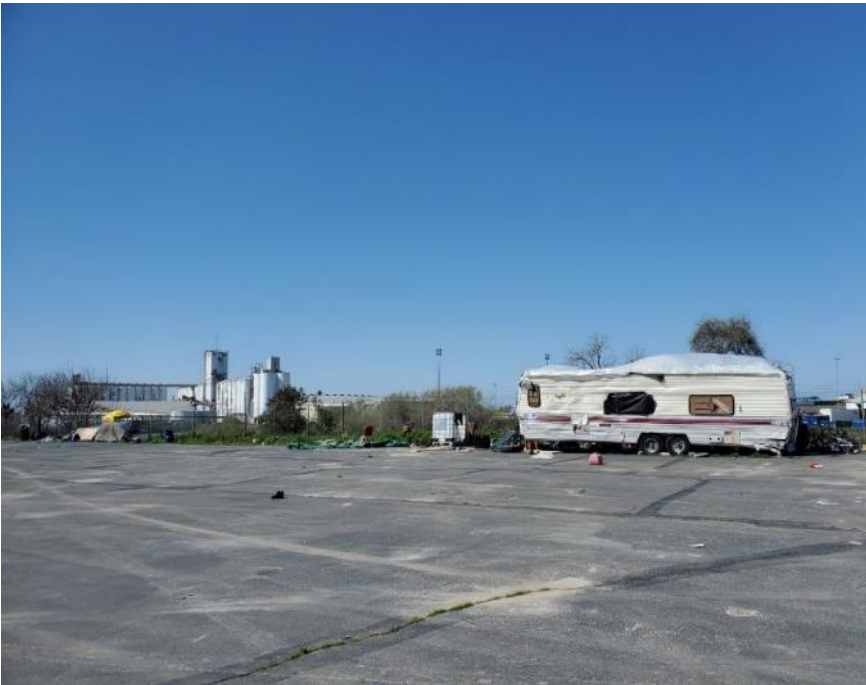
5.

<p>One phyto-remediation tank (previously filled with soil and tree saplings) spotted being improperly reused on northern side of Site.</p>
6.

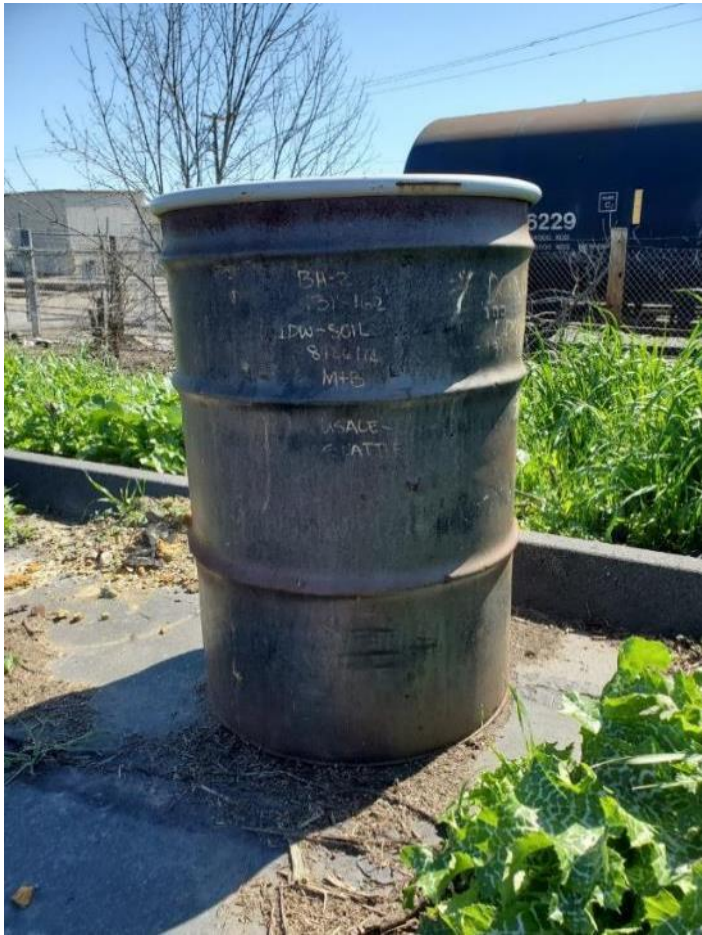
<p>Near main gate on south side of Site.</p> <p>One of two leftover drums of well cuttings from monitoring well construction in 2014. During a Site visit in December 2022, the second drum was still present. It appears that someone disposed of the contents of the second drum right behind it, in the vegetated area, visible on the left side of this photo. The location of the second drum is unknown.</p>

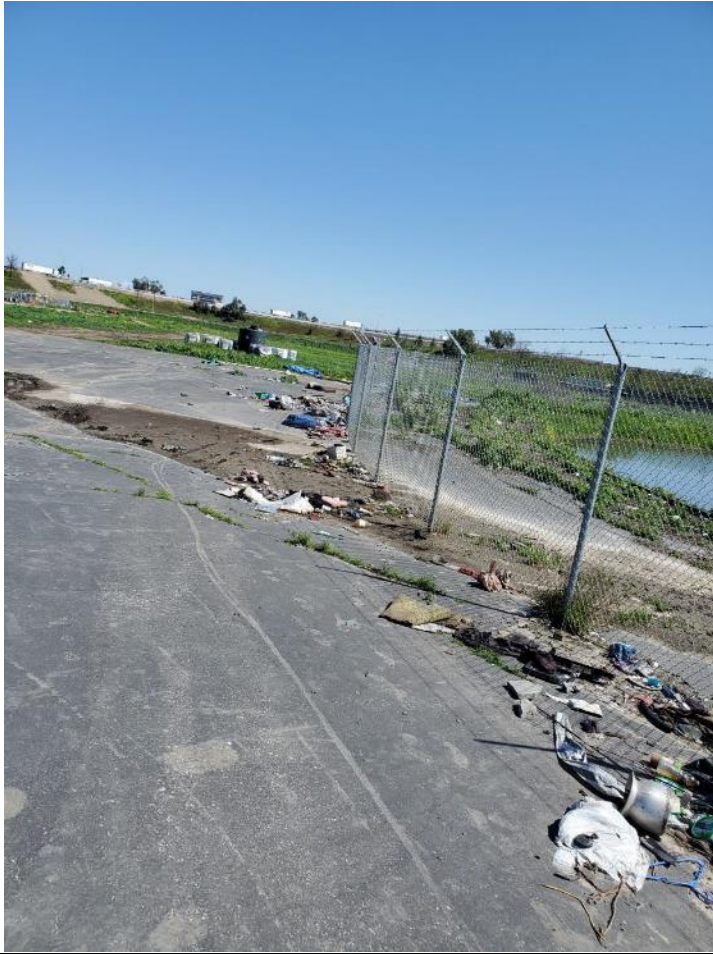
7.

Near Basin 2 looking East.

Typical Site debris, with Phyto-remediation system in mid-background, and area of subsidence/ponding on cap, with typical vegetation growth in cracks on cap in foreground.

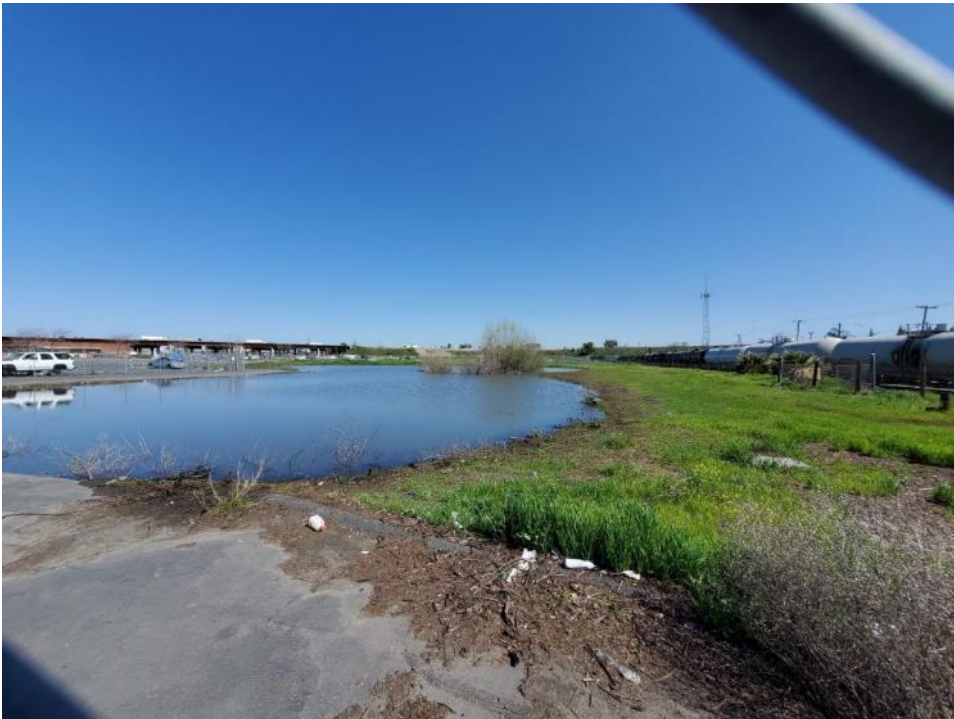
8.

Detention basin 2, looking East.

Forebay and Main basin merged due to recent rains.

2 stripped vehicles to left, debris.

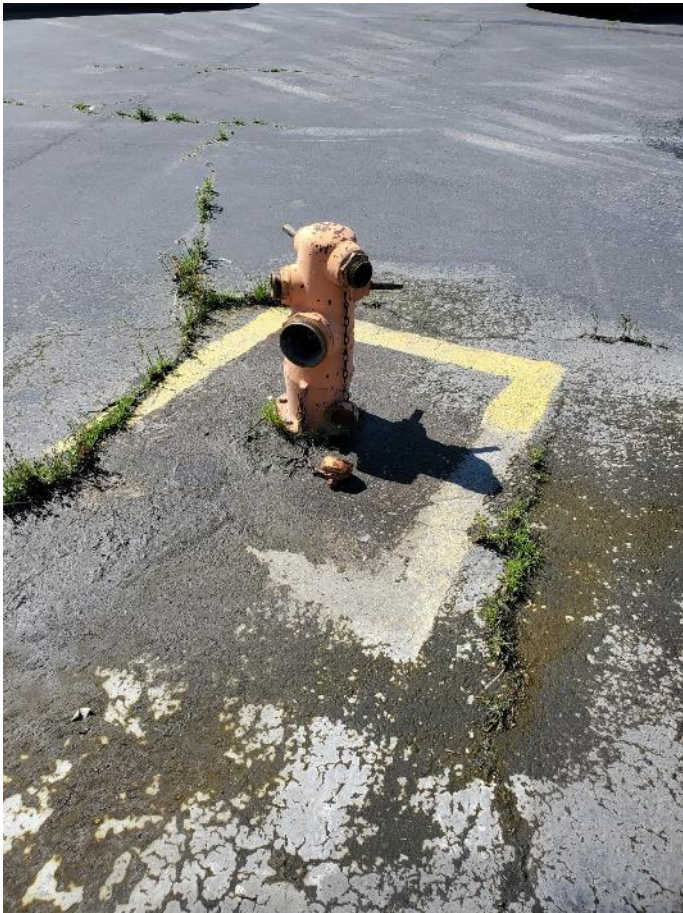
9.

<p>On-Site fire hydrant, opened.</p> <p>Typical asphalt cap cracking with vegetation.</p>
----	---	---

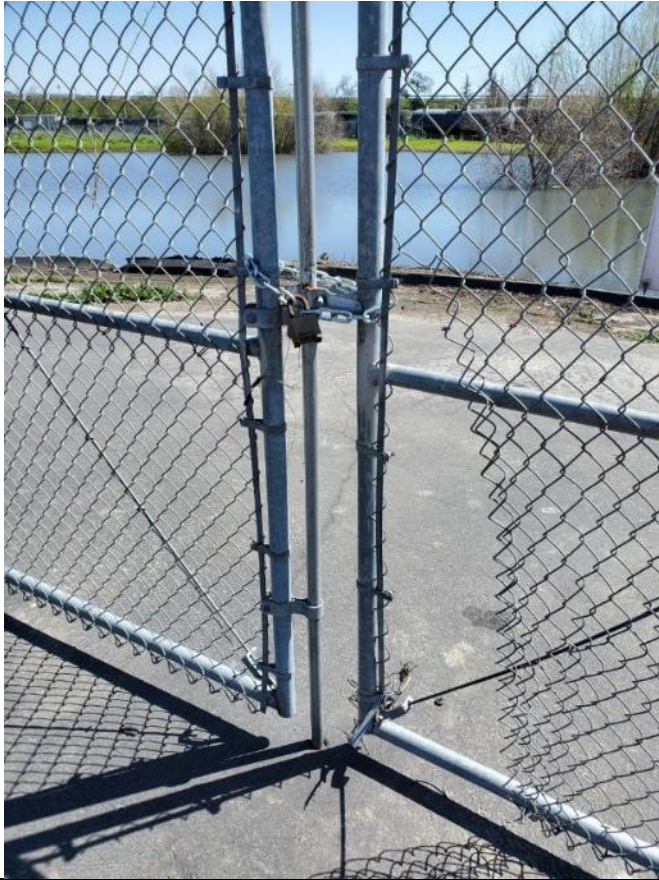
11.

Detention Basin 2.  
Typical small hole  
in fence at all  
detention basins.

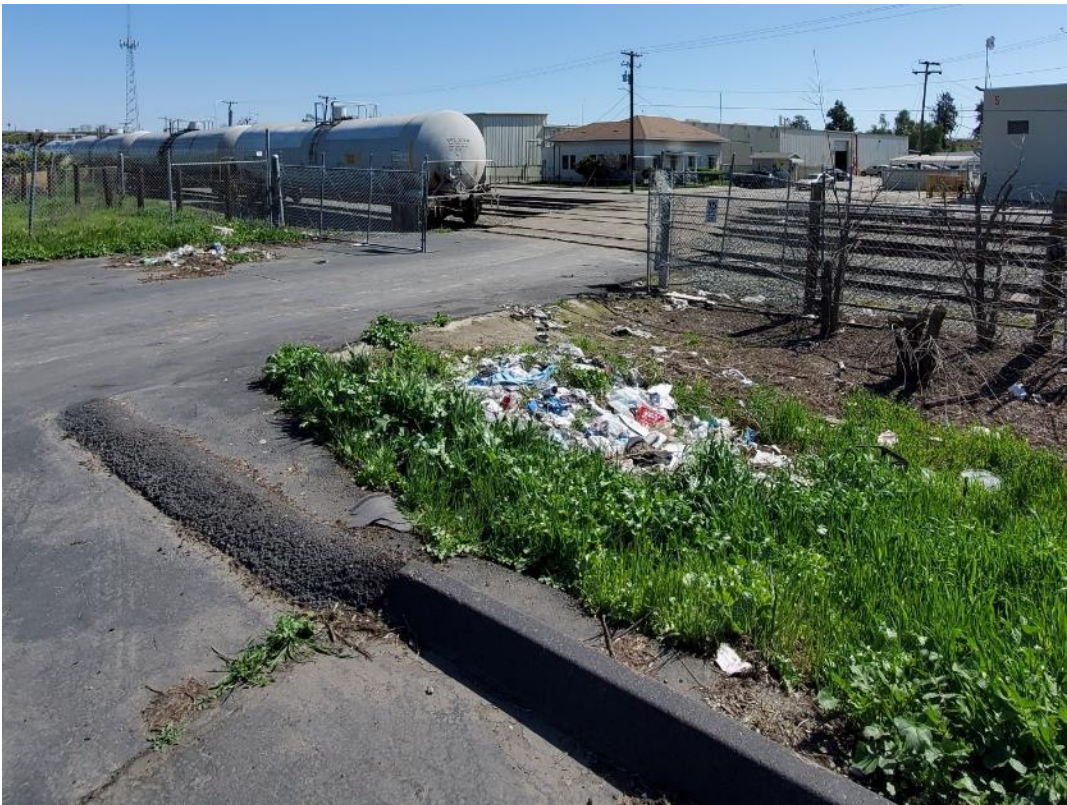
12.

Main entrance gate  
(south side of site)  
bent in half and  
typical debris and  
cap  
cracking/vegetation  
growth in  
foreground.

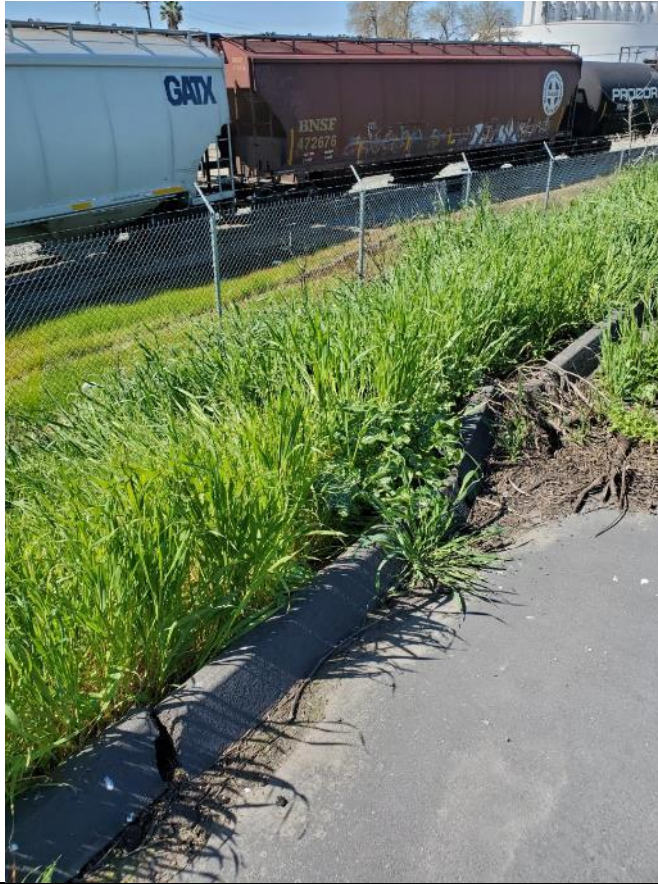
13.

Area of broken fence and broken curb on SW side of Site.

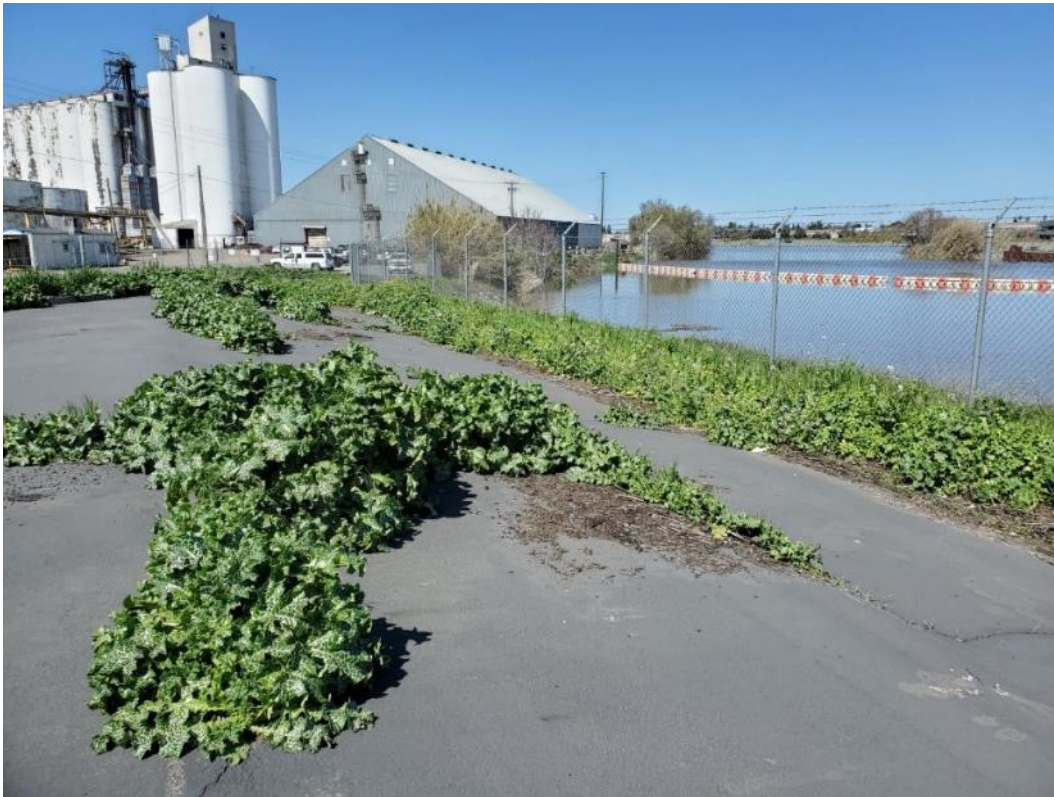
14.

NW corner of Site, looking NW –  
Small craft barrier intact.  
Some of largest of vegetation growing in cracks in cap up to ~1” wide.

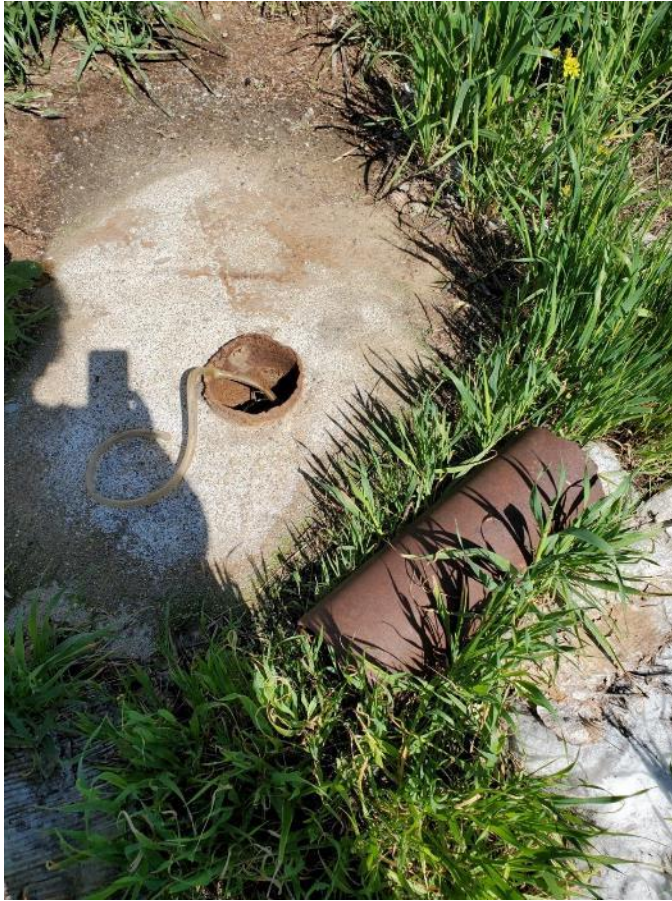
15.

Monitoring well near phyto-remediation system (possibly one of the DSW-1 wells?).

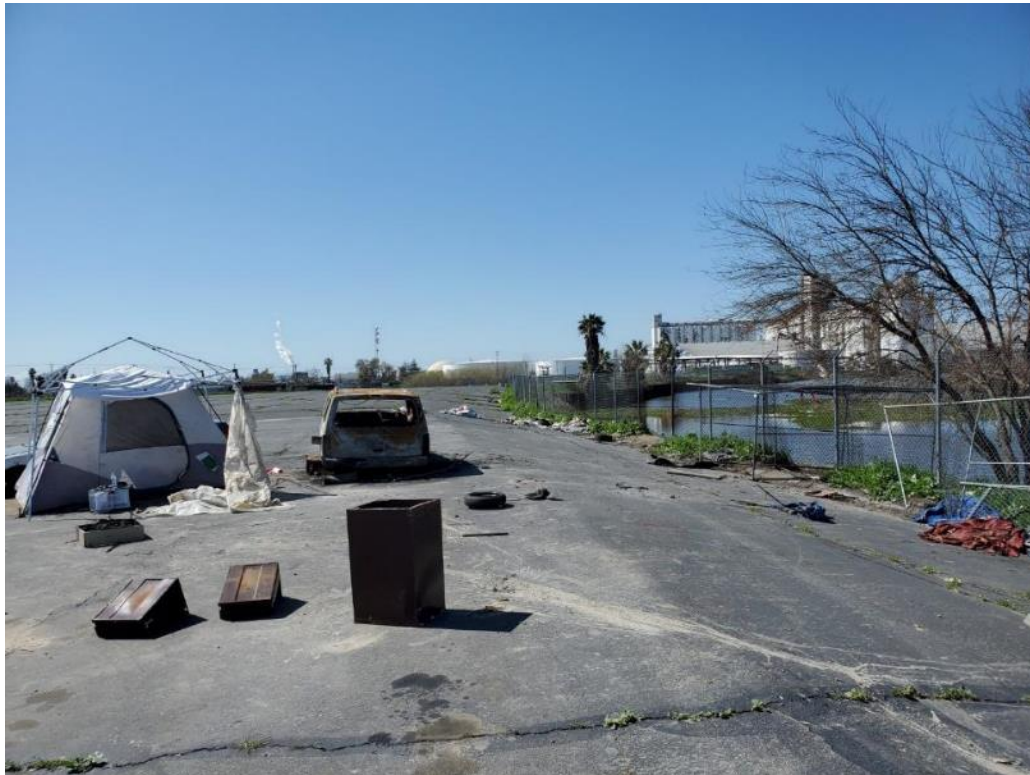
16.

On NW part of Site, looking NW – One of multiple burned out and/or stripped vehicles on Site, with a vehicle sized large hole in fence to right.

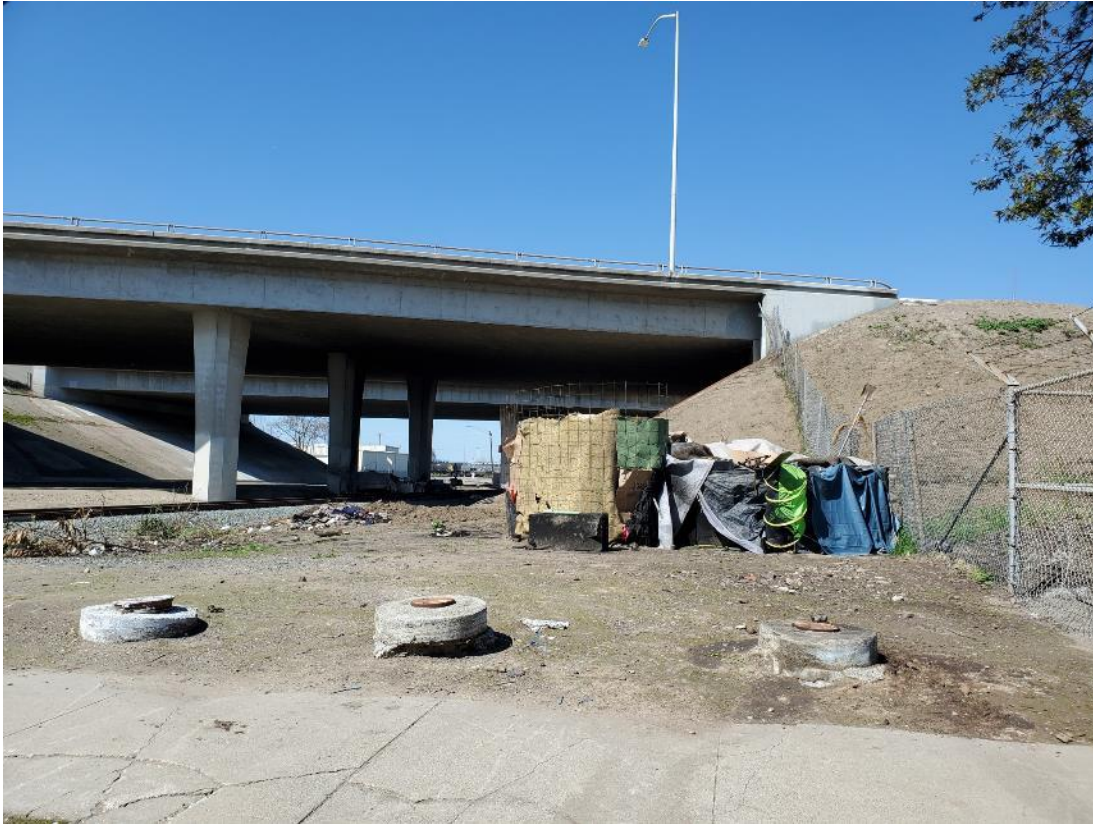
17.

Off-Site OS-4 wells on W. Sonora St., with nearby campsite.

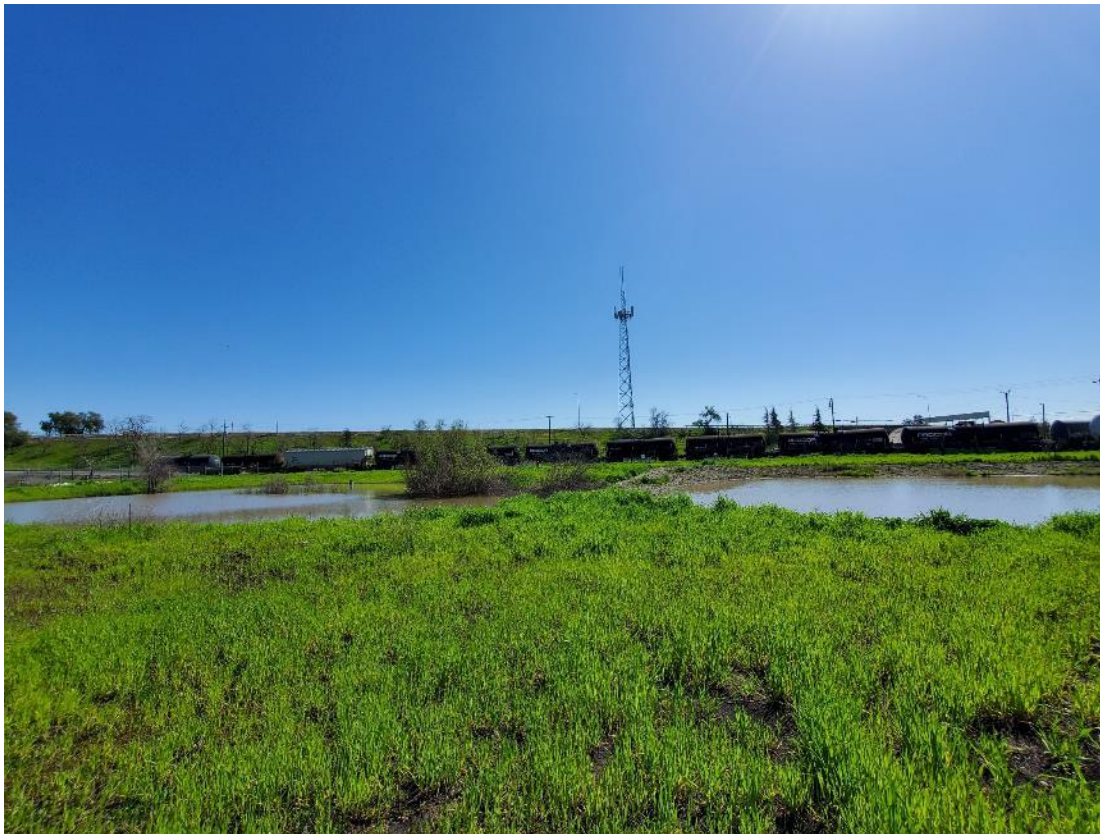
18.

Detention basin 3.

DSW-7 wells appear to be under water.

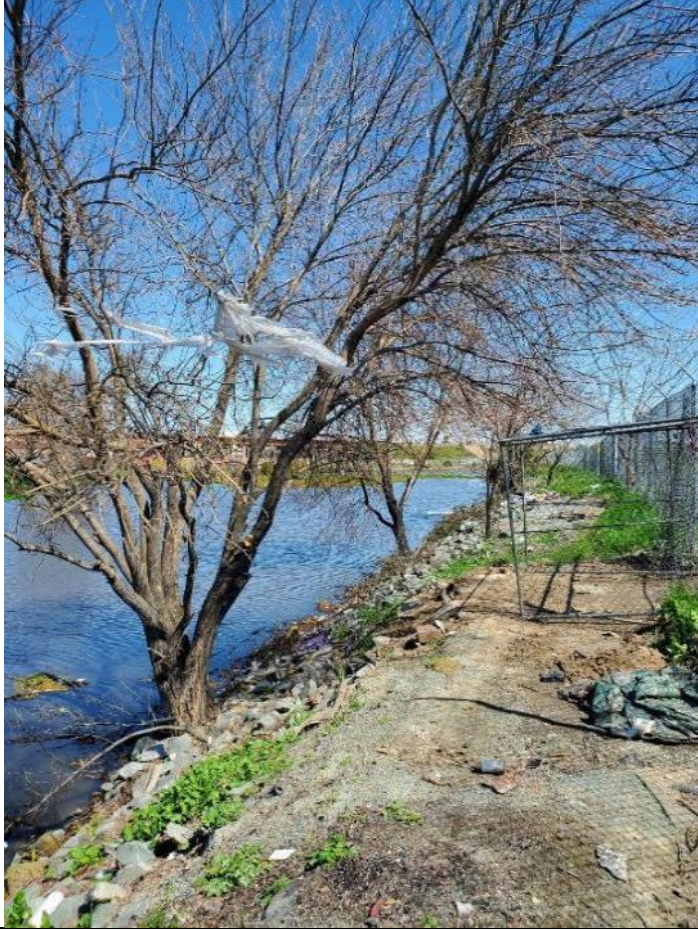
19.

Inside slough fence, looking east.  
Large hole/access portal through fence visible on right.  
Typical debris.

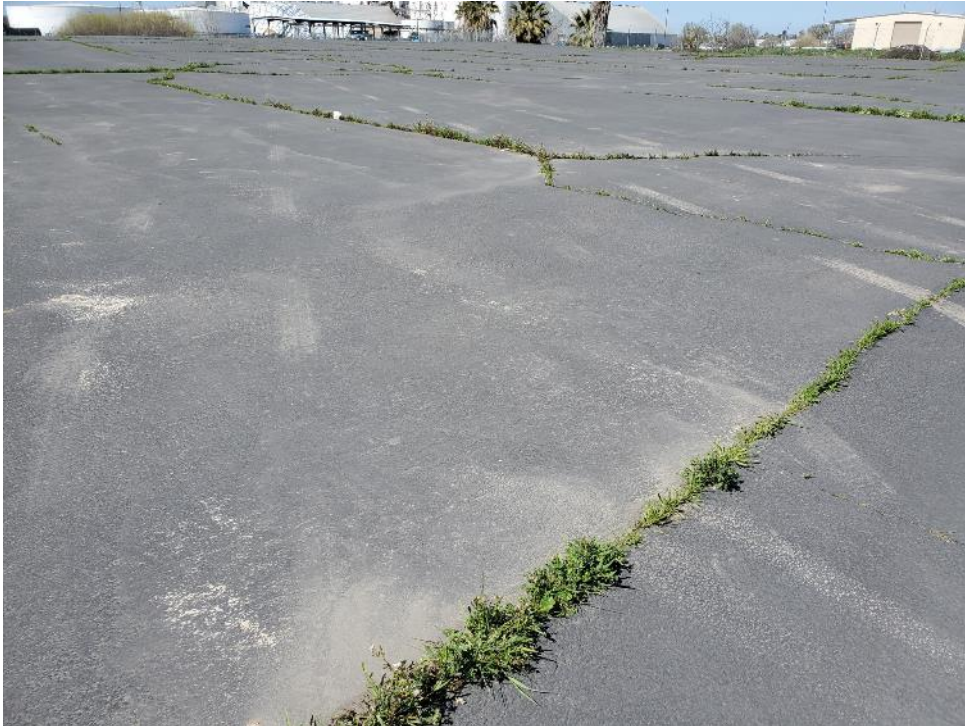
20.

Typical asphalt cracking with vegetation growth.
