**FIFTH FIVE-YEAR REVIEW REPORT  
FOR  
PHOENIX-GOODYEAR AIRPORT (NORTH AND SOUTH AREAS) SUPERFUND SITE  
MARICOPA COUNTY, ARIZONA**

EA Engineering, Science, and Technology, Inc.

**United States Environmental Protection Agency  
Region 9**

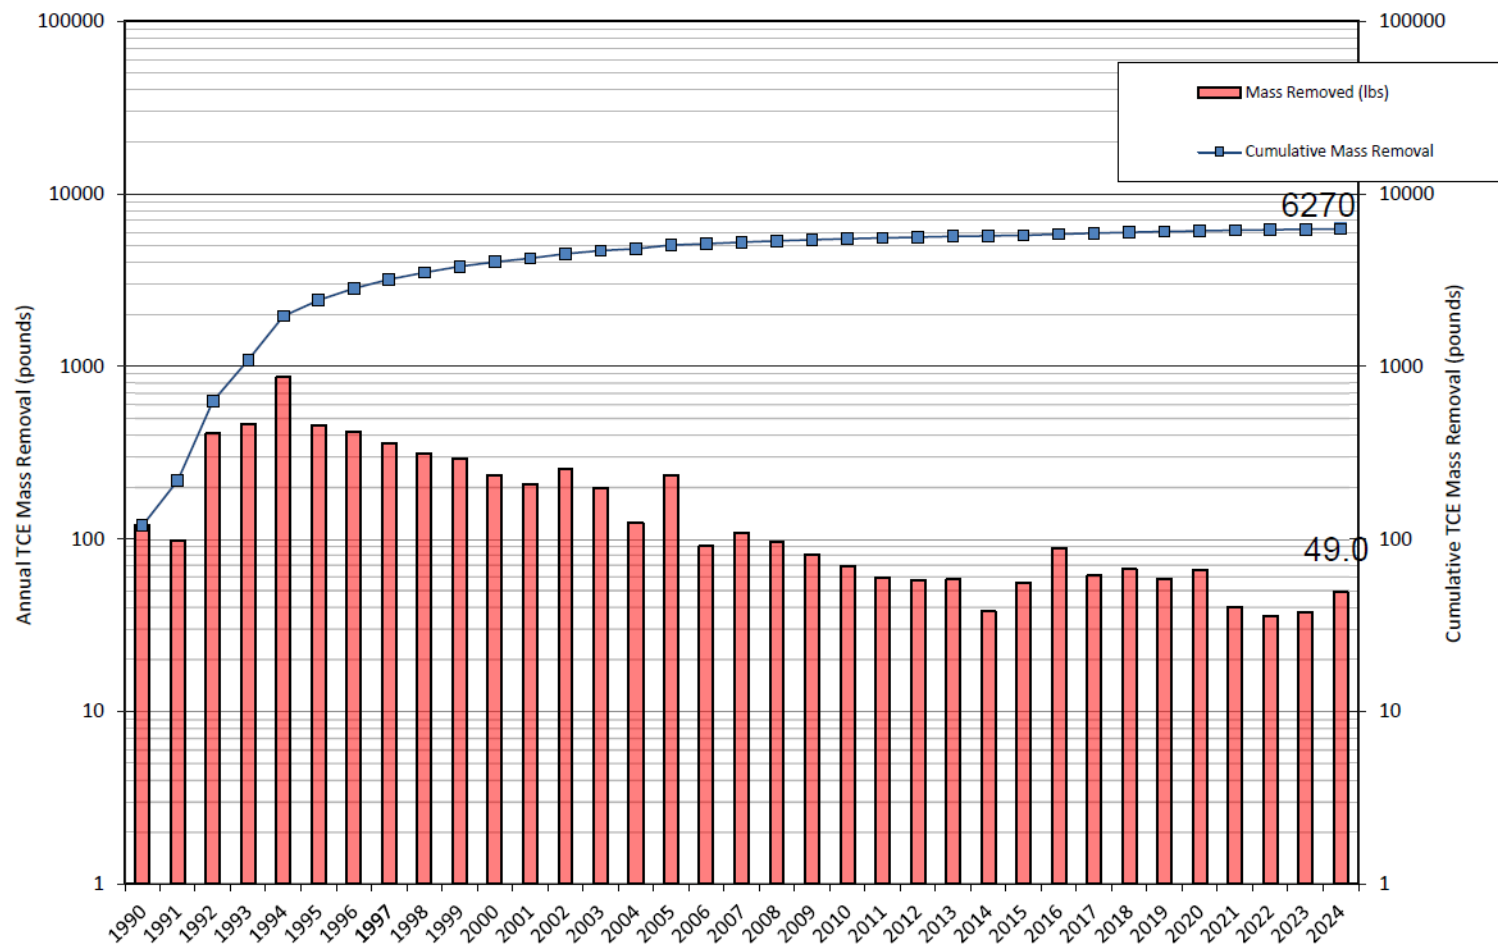
**Figure 6. PGA South Subunit A Annual and Cumulative TCE Mass Removal**

The TCE mass removal data for Subunit A (Figure 6) show an asymptotic trend for the cumulative amount of TCE removed and decreasing trends for TCE removed each year. Both the data sets and graphs indicate continued removal of TCE from the groundwater. Subunit C TCE Mass Removal (Figure 7) has not yet reached asymptotic trends yet even though mass removal has decreased. Subunit C treatment systems are younger and began operation in 2014 or 2025, and have not yet reached asymptotic conditions.

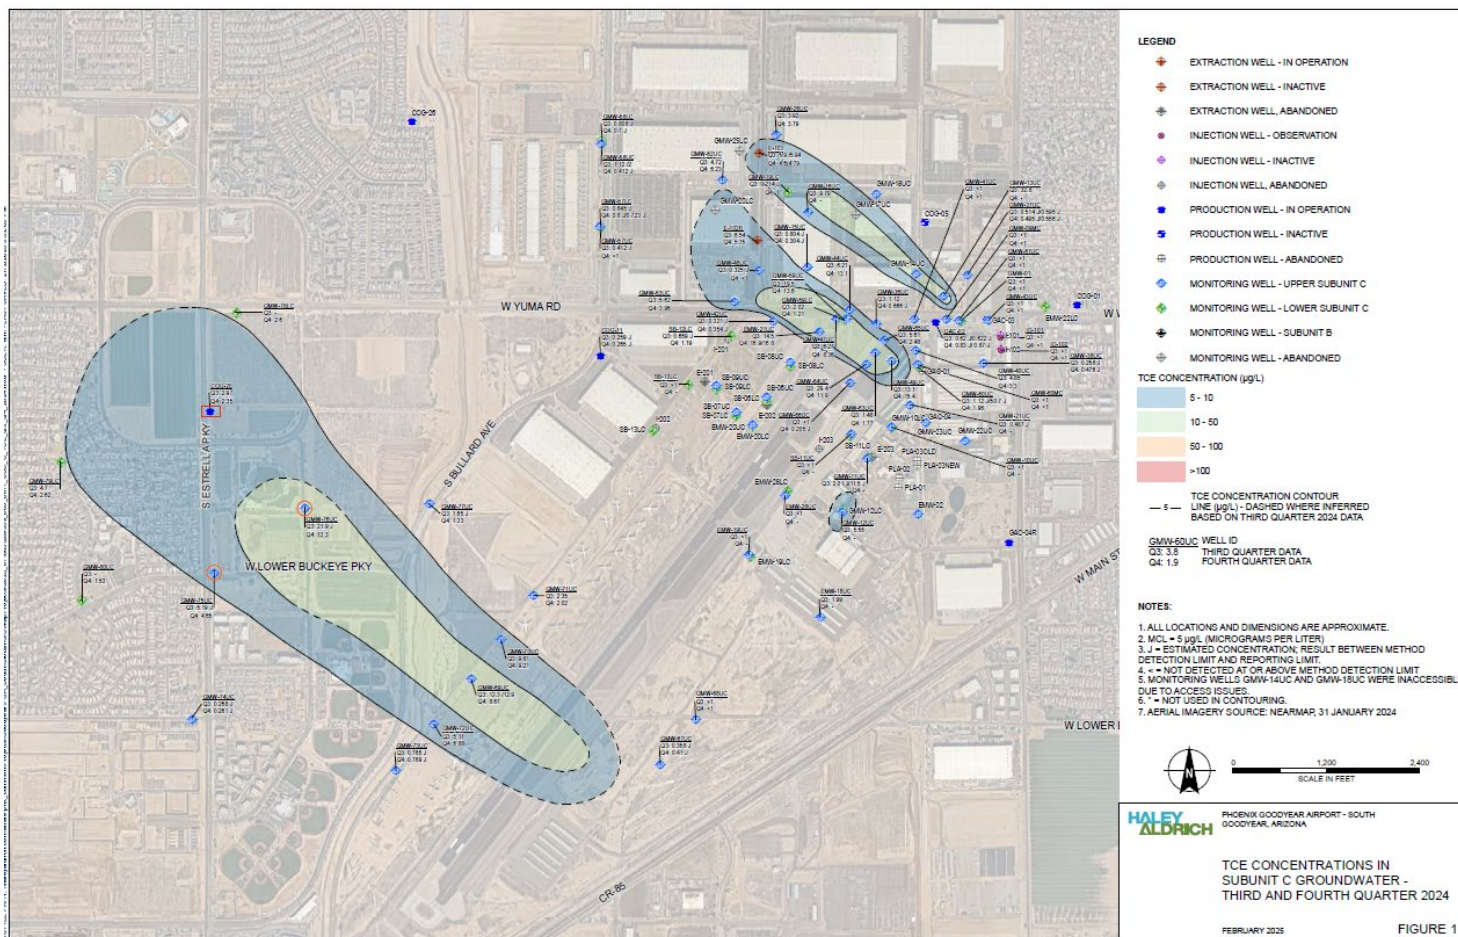
**Figure 10. PGA South New Southwestern Subunit C Plume and Investigation Wells**

The off-site investigation of Subunit C has confirmed that a TCE-impacted groundwater plume extends northwest from the PGA South area (Figure 10) toward the downgradient City of Goodyear production well COG-20 (red rectangle). Monitored on a monthly basis, concentrations at COG-20 remain below the cleanup level for TCE. Monitoring data from wells GMW-75UC and GMW-76UC (orange circles) indicates the presence of TCE above the cleanup level in middle Subunit C, with concentrations reaching up to approximately 21.2 micrograms per liter. The highest concentration was observed at GMW-76UC, with levels decreasing both to the southwest and northeast.

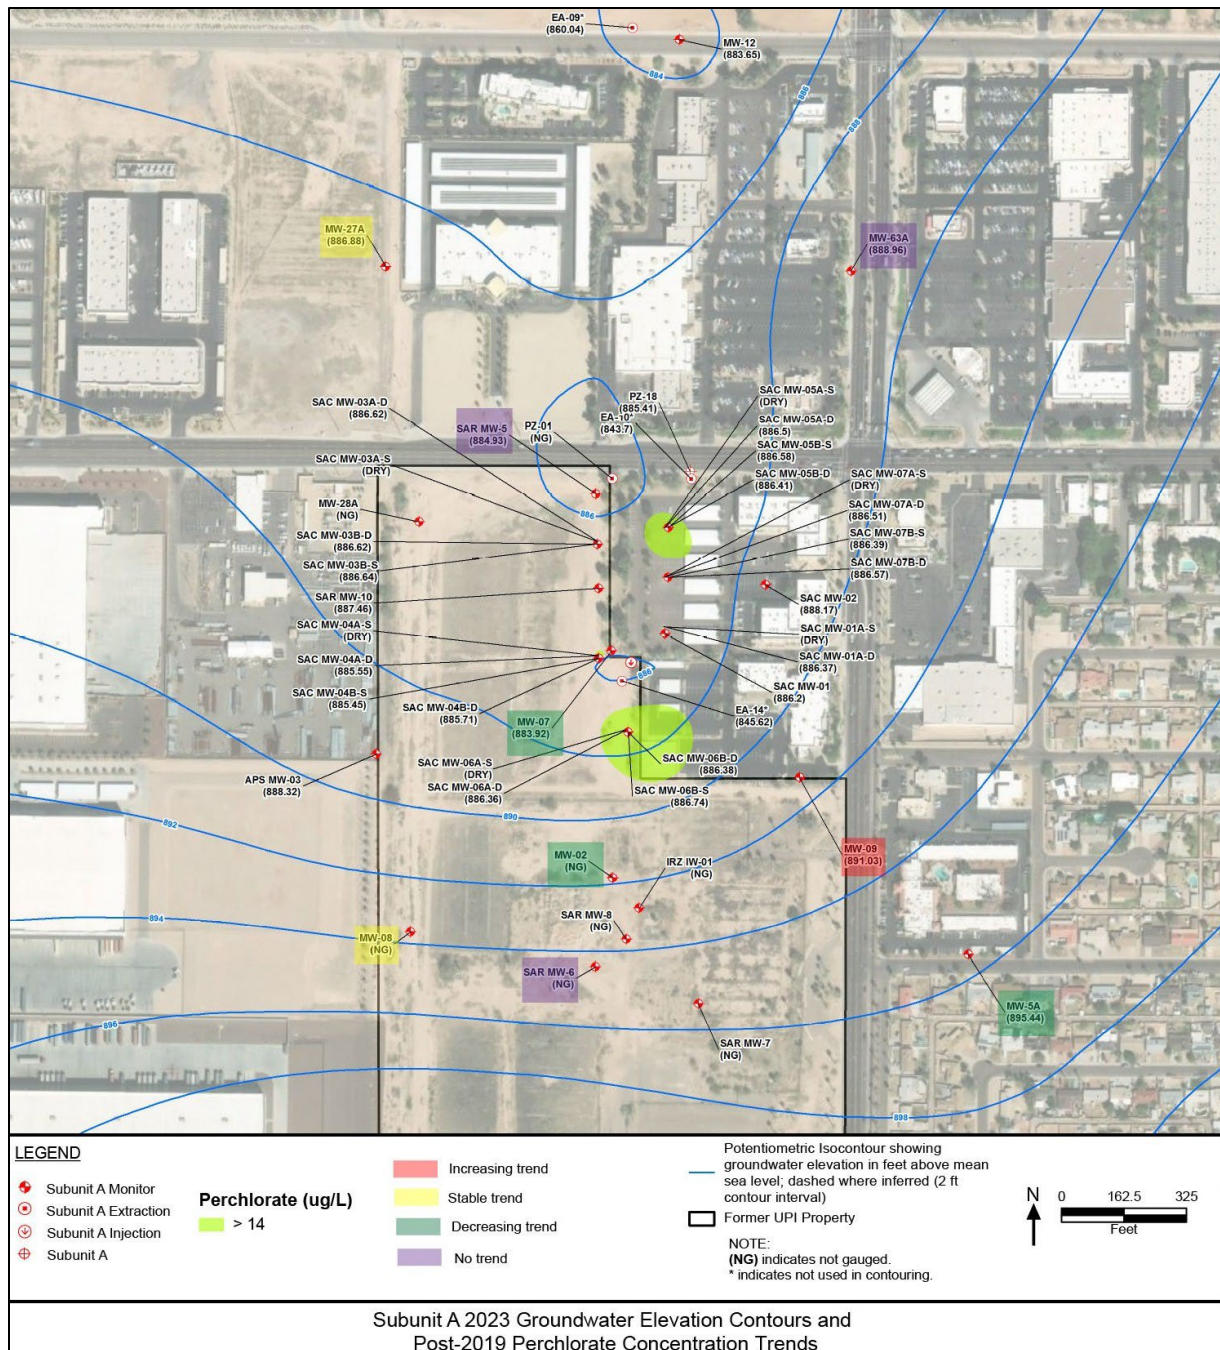
Monitoring well MW-07 is located within the target treatment zone defined in the 2021 Remedial Design and Remedial Action Work Plan and was evaluated during this Five-Year Review. The most recent perchlorate cleanup level exceedance at MW-07 was during the December 2022 sampling event (16.6 µg/L). Perchlorate concentrations were decreasing during the review period and have consistently been less than the cleanup level since December 2022. This indicates that the perchlorate contamination in the target treatment zone is being reduced, supporting the achievement of this remedial action objective at MW-07.

**Figure C-1:** PGA North Subunit A aquifer groundwater elevations from 2023 and current review period perchlorate concentration trends.

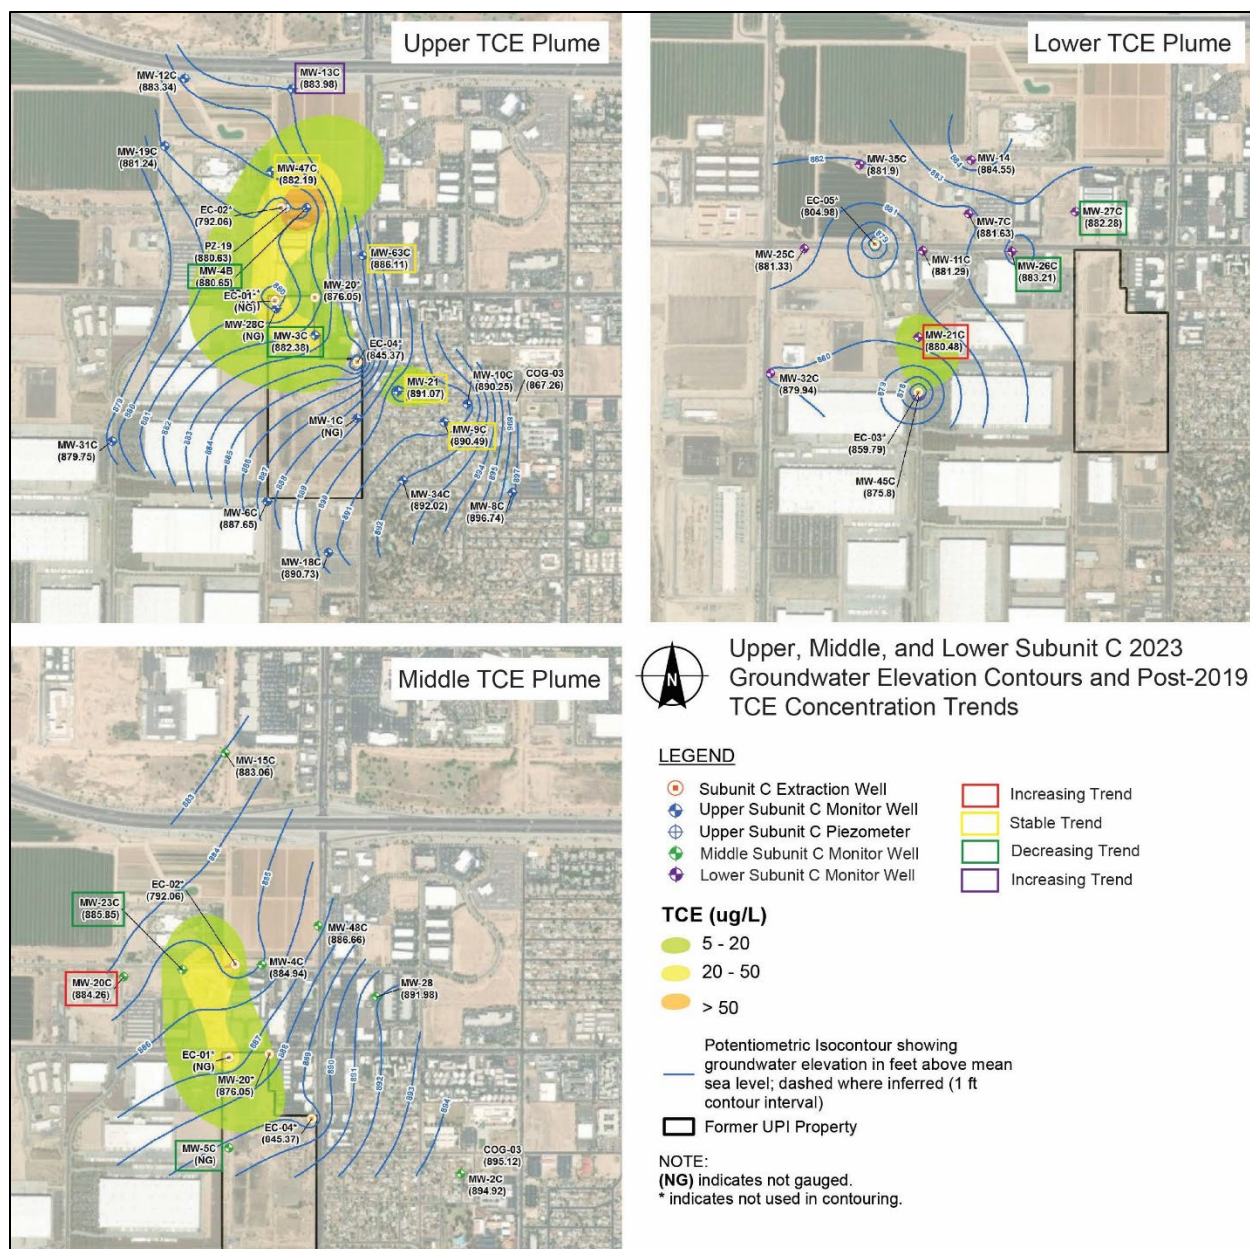
Groundwater flow in the lower layer is generally to the south and southwest. Of the three monitoring wells evaluated, monitoring wells MW-21C and MW-26C had TCE concentrations that exceeded the cleanup level during the review period. TCE trends in MW-26C are currently decreasing while trends in MW-21C are increasing, likely due to the southwestern groundwater flow from MW-26C to MW-21C. Based on current sample data and groundwater flow patterns, the plume is likely being contained by extraction wells EC-03 and EC-05 in this area.

**Figure C-3.** PGA North upper, middle, and lower Subunit C aquifer groundwater elevations from 2023 and current review period TCE concentration trends.

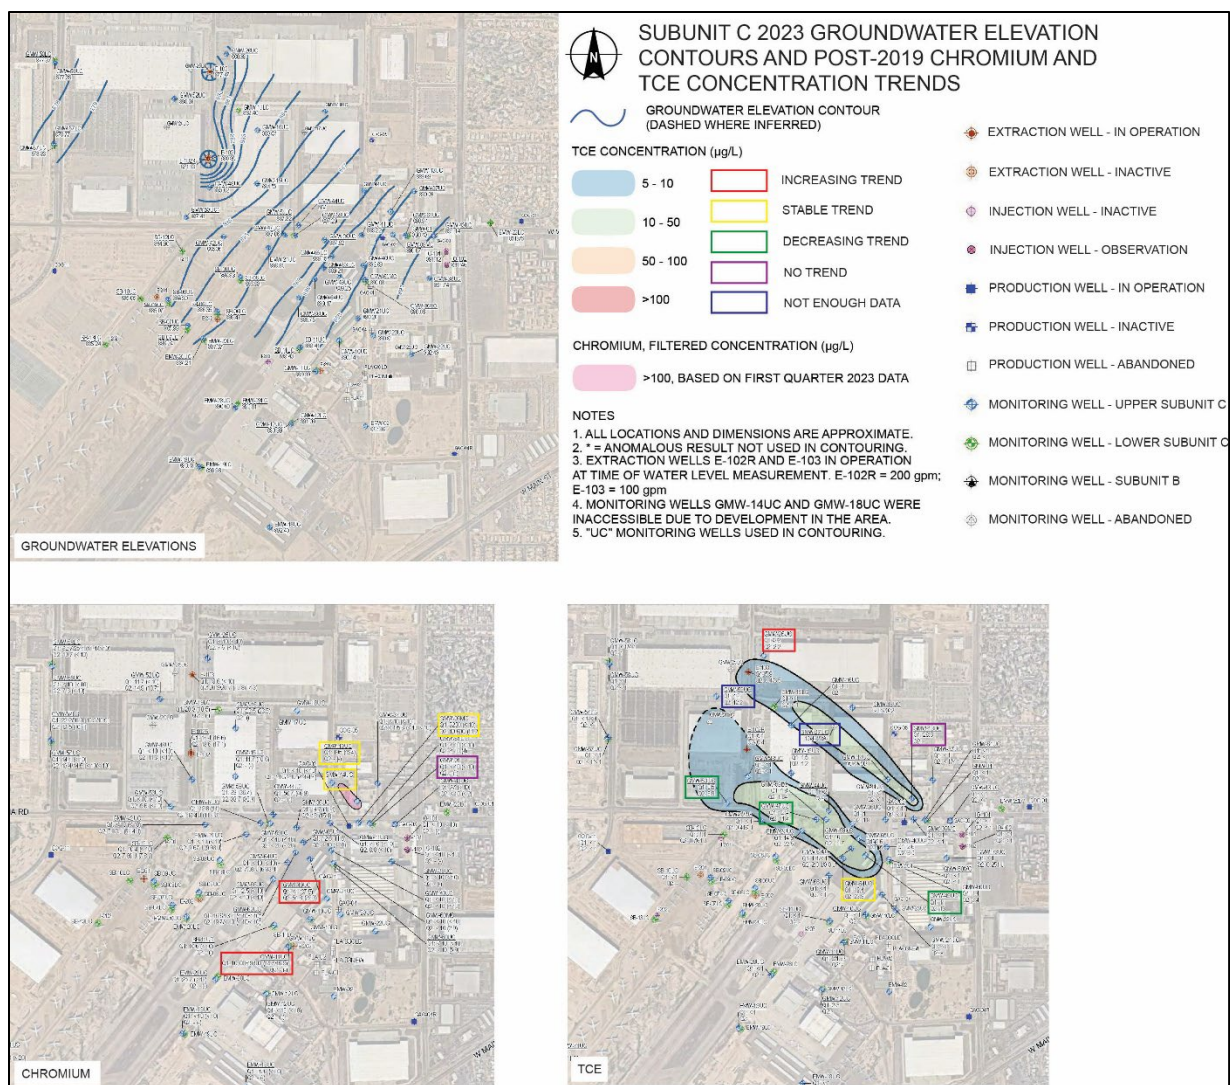
In the central plume, the four monitoring wells evaluated had TCE concentrations that exceeded the cleanup level during the review period. Monitoring wells GMW-49UC, GMW-47UC, and GMW-53UC had decreasing TCE trends during the review period, which could indicate that the plume is being captured by the downgradient extraction wells. Groundwater elevation data suggests that contaminated groundwater in GMW-53UC is expected to flow towards extraction well E-102R. The groundwater flow model presented in the 2023 First Semiannual Groundwater Monitoring Report states that groundwater from GMW-53UC that is outside of the capture zone of extraction well E-102R flows north towards extraction well E-103. Cleanup level exceedances have not been found in groundwater samples collected downgradient at GMW-57UC and GMW-58UC, further supporting groundwater flow from GMW-53UC to E 102R and E-103. Monitoring well GMW-64UC had a stable concentration greater than the cleanup level during the review period, and groundwater from GMW-64UC is likely flowing downgradient to extraction well E-102R.

**Figure C-5.** PGA South Subunit C aquifer groundwater elevations from 2023 and current review period chromium and TCE concentration trends.

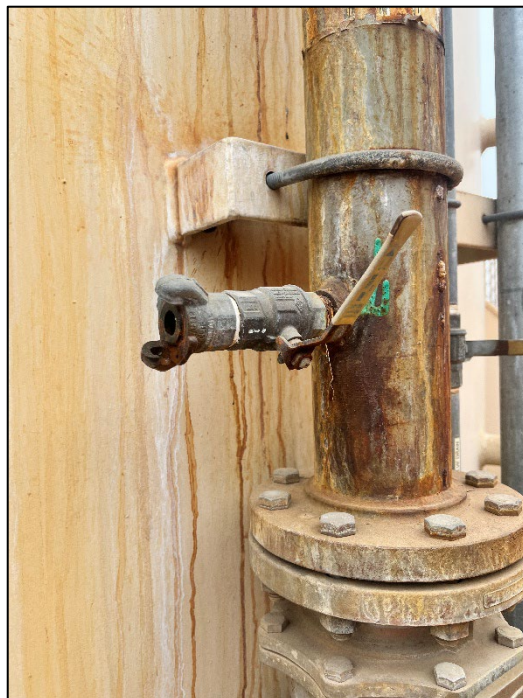
**Photograph 18.** February 13, 2025, 01:51 PM  
PGA North groundwater treatment system EA-05 corroded pipe. Facing south.
