Structural Evaluation Report  
October 12<sup>th</sup> 2007

CTE/Environmental Protection Agency  
Halaco Engineering Company  
Oxnard, CA

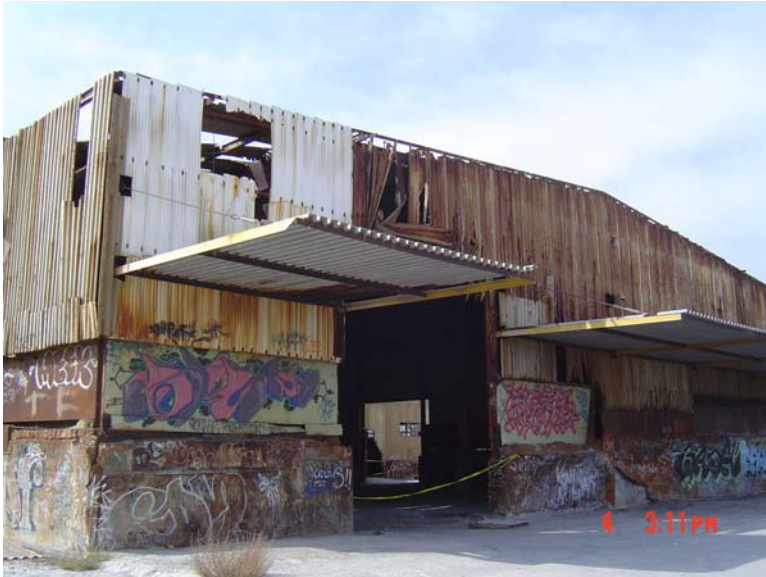
Exhibit A

- The exterior vertically spanning metal wall panels were observed to be shredded and/or missing. See Exhibit A.
- A few X bracing tie rods, which are part of lateral load resisting system, appear to be sagging. This indicates that they are not tight and will not provide the tension resistance they are designed for in resisting lateral loading during a seismic or wind event. Thus, the lateral load will be redistributed into a different method of resistance until failure occurs in those engaged elements. Other tie rods are cut or corroded excessively. See Exhibit B.

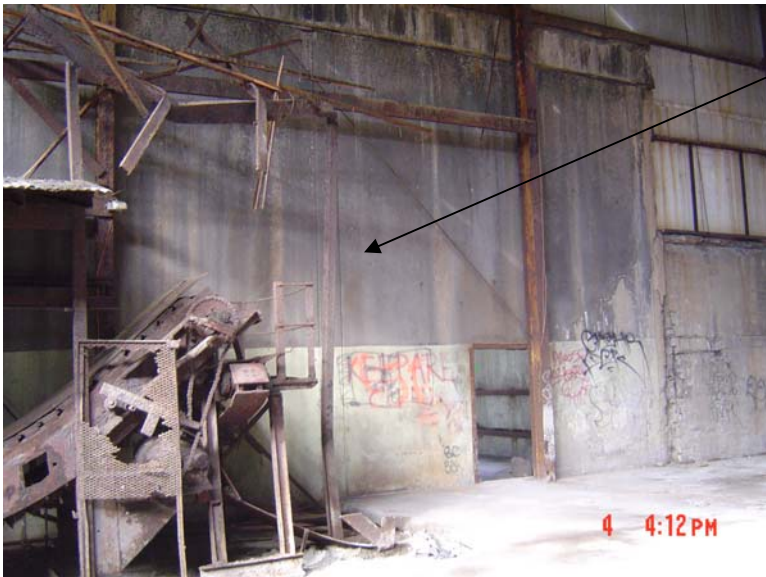
Exhibit B.1

Missing Rod

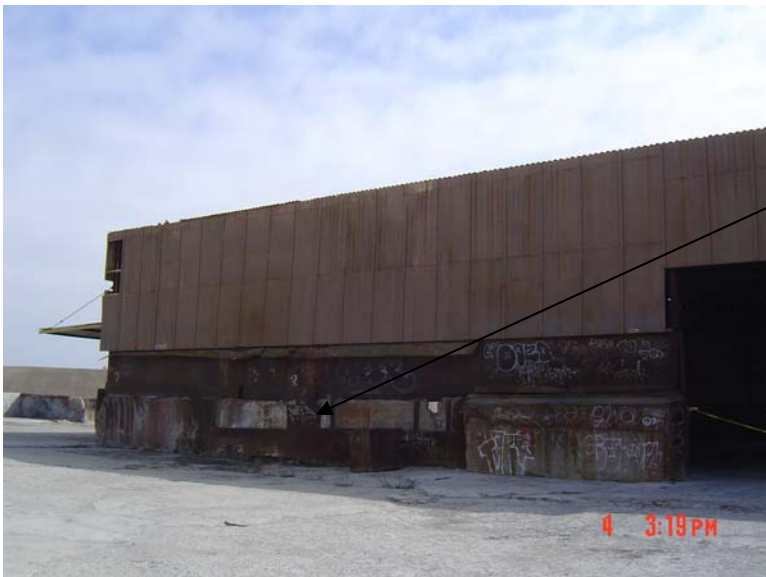
Exhibit C

- The 6 ft high wainscot wall along the north face was badly damaged and warped out of plane approximately 18 inches along a 100 ft length of wall. The damage most likely occurred from impact loading from moving equipment against the interior push wall. This impact must have also caused the lateral deflection of the PEMB columns. See Exhibits C & F.

Bent out of plane  
CMU wall & columns

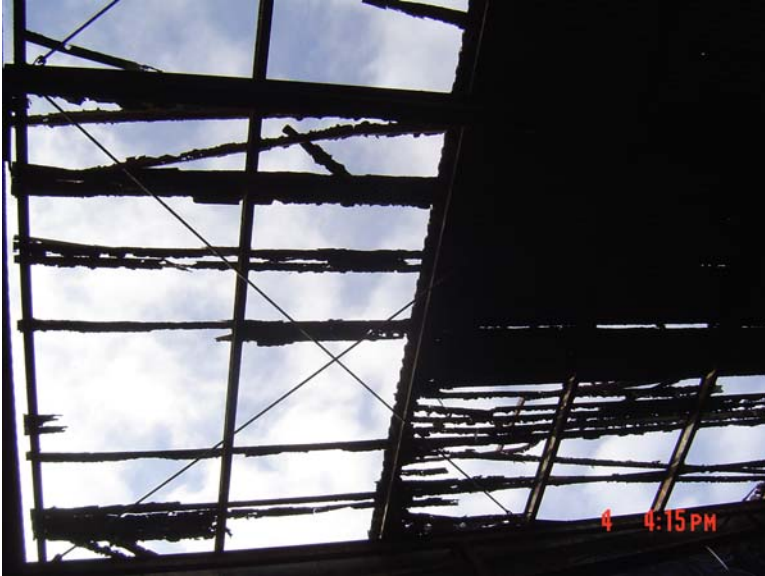
Exhibit D

- All roof beams and columns appear to be intact and show no other signs of distress other than for rust.
- Some pieces of the metal roof panels are shredded and/or missing. See Exhibit D.

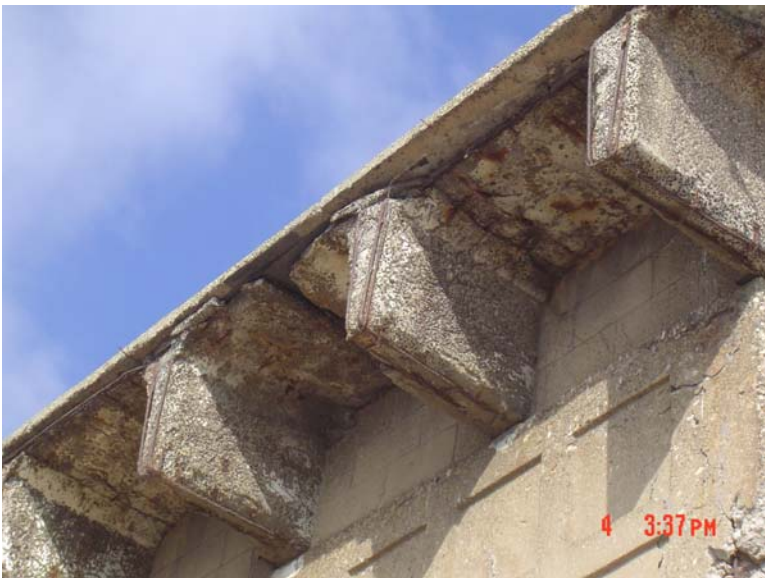
Exhibit E

- The canopy cover at the east of the building appeared to be in good condition and there were no observed structural damages.
- The concrete roof T-beams appear to be in good condition and there were no observed structural damages except on the west exterior face of the building; the concrete was weathered and the exterior joist stirrups are exposed. See Exhibit E.

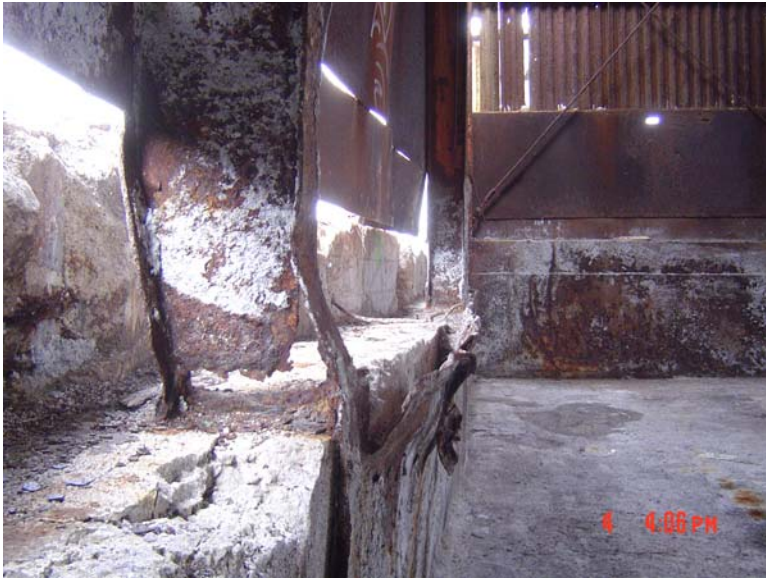
Exhibit F

- Several structural steel columns were observed to be rusted through with less than 25% of the section remaining. Other columns were warped and do not appear to be structurally sound in any way. See Exhibit F.

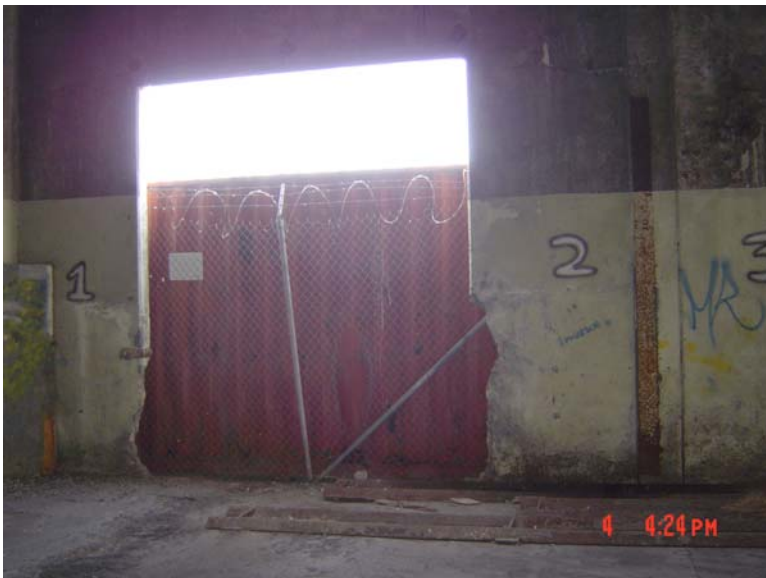
Exhibit G

- At other concrete walls, existing openings were widened near the base. This was probably caused by impact due to the jagged edge of what is remaining. See Exhibit G.
- Wood panels and other exterior CMU walls were observed to have excessive damage and significant inadequacies in their attachments and consistency.

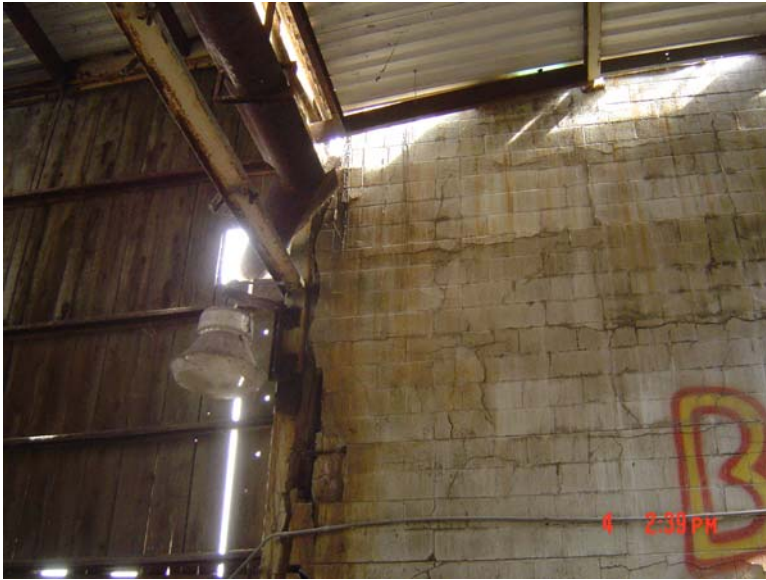
Exhibit H.1

- Extreme vertical and horizontal shear cracking was observed on all corners and upper portions of CMU walls. Some cracks are so severe that the face shells of the CMU block are ruptured off and may fall at any moment. These wall damages mostly occur at the corners of the building, near the roof, and at various locations along the walls. See Exhibit H.

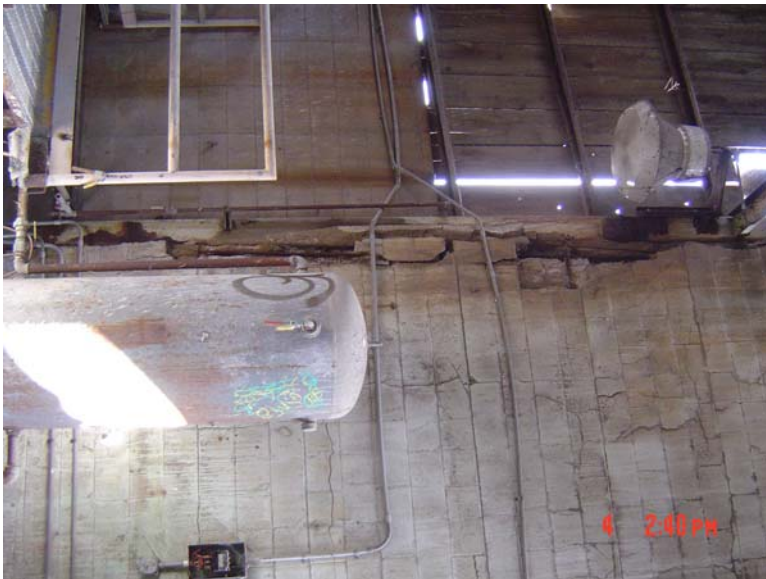
Exhibit I

- At the exterior corners of the building the vertical jamb bars, which resist tension during wall overturning, are completely exposed, as the face shells had ruptured off. Most likely the shear failure of the wall occurred during past seismic activity or wind event where the lateral load transferred into the shear walls from the roof diaphragm induced a shear force into the wall which was greater than that which the wall could resist, thus shear failure of wall occurred. This same failure condition appears slightly at other openings in the walls. See Exhibit I.

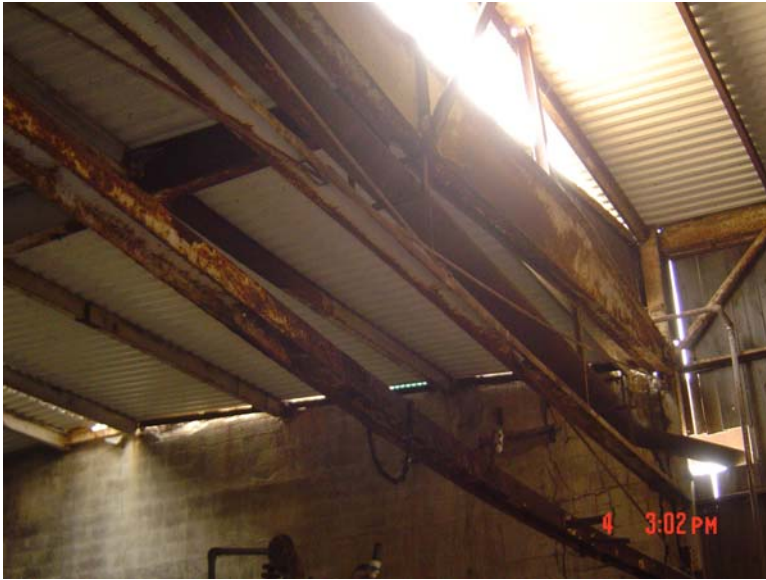
Exhibit J

- At the top of the north and south CMU walls, the top course of the CMU wall is withered away and rebar is most likely exposed, though not observed.
- A structural steel girder which supports the roof framing members was observed to be failing in lateral torsional buckling, with out of plane deflections greater than 8 inches. See Exhibit J.

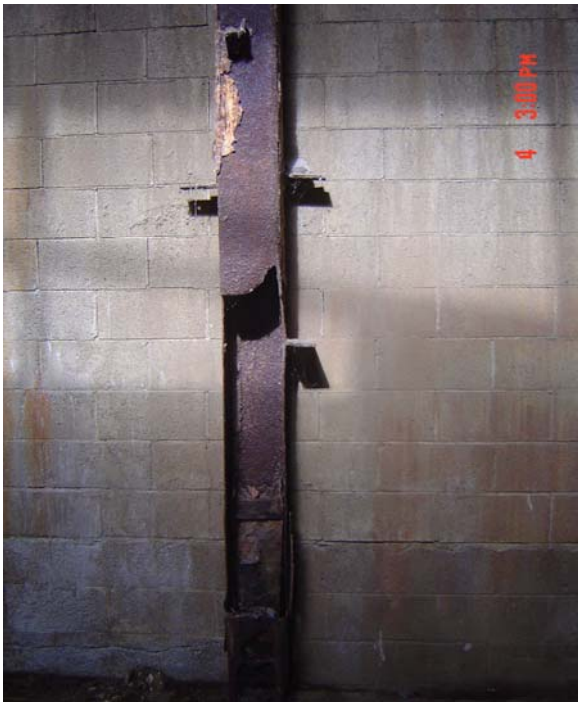
Exhibit K

- A structural steel column was observed to be rusted through with less than 25% of the section remaining. See Exhibit K.
- A large (approx 18" X18") square cut was observed in a roof beam. See Exhibit L.
