## First Five-Year Review of Remedial Actions Implemented at Hunters Point Shipyard

San Francisco, California

**APPENDIX D**  
**PHOTOGRAPHIC LOG**

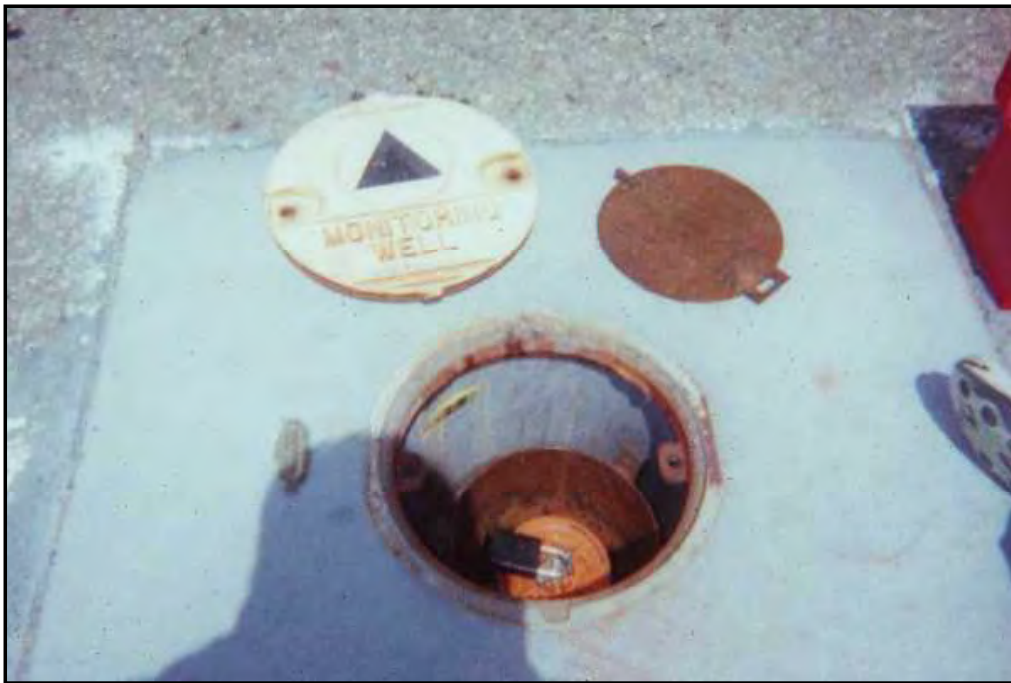
**Photograph D-1. Well IR06MW42A; padlock on well and new concrete associated with vault.**

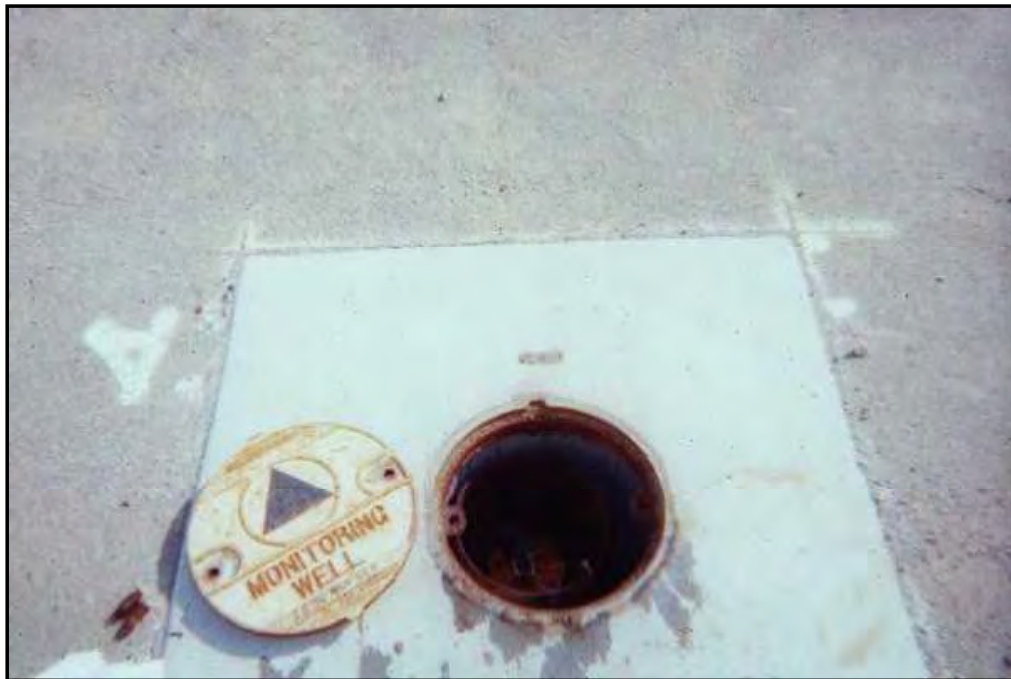
**Photograph D-2. Well IR06MW45A; padlock on well and new concrete associated with vault.**

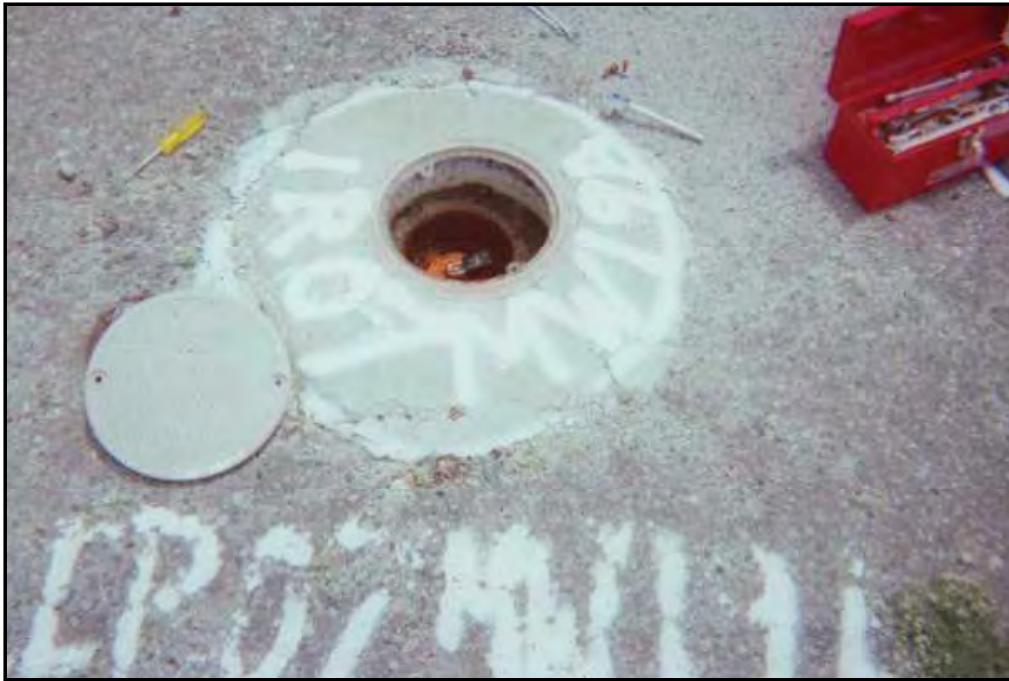
No significant issues were identified during the site inspection. Minor issues that were noted include the need for well vault repairs at wells IR07MW19A, IR10MW59A, IR18MW21A, IR26MW46A, PA50MW01A, and UT03MW11A and potholes along Parcel B roads. Overall, monitoring wells were in good condition. Wells were clearly labeled, locked, and appeared to be regularly maintained because some vaults had been recently replaced. Access to Parcel B and contaminated areas appeared to be sufficiently restricted. Permanent fences, temporary fences, and locked gates that block access to areas of Parcel B that are not occupied by tenants were observed throughout the site. New fences along the shoreline and locked gates at the end of the piers were also observed. In addition, abandoned buildings were boarded up and various signs were posted on the buildings and fences identifying and providing warning of site hazards.

**Photograph D-3. Well IR07MW19A; padlock on well and standing water with rust in vault.**

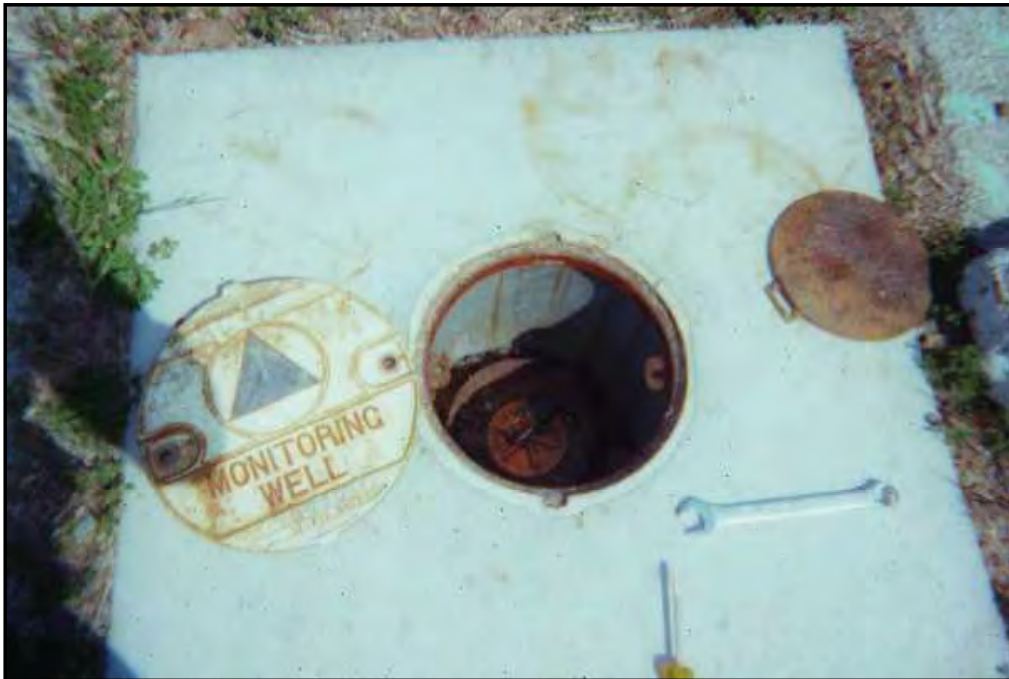
**Photograph D-4. Well IR07MW20A1; padlock on well and new concrete associated with vault.**

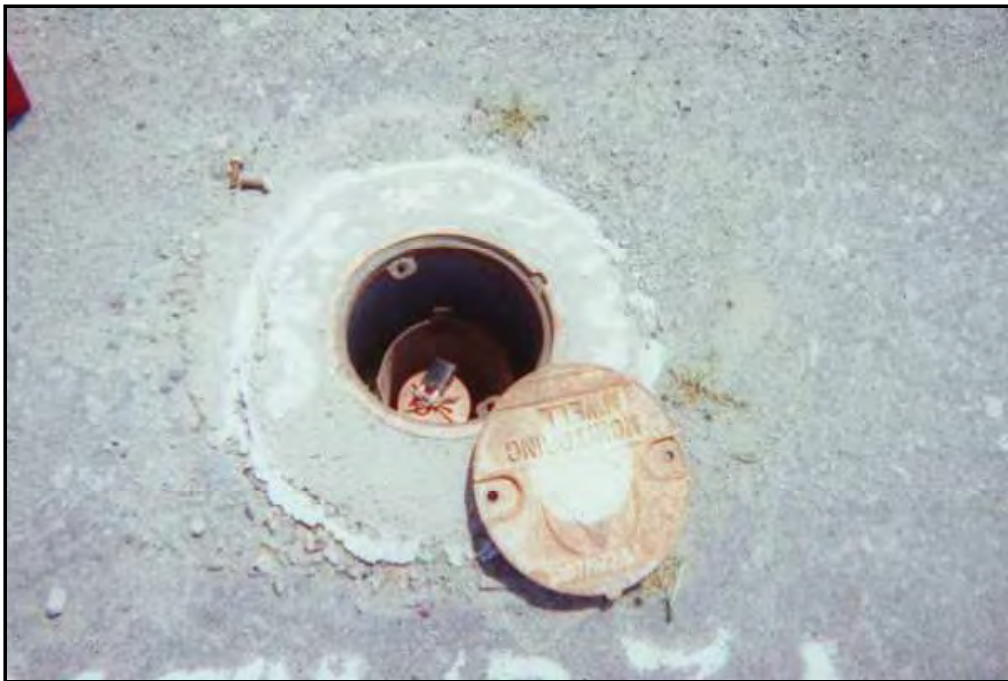
**Photograph D-5. Well IR07MW23A; padlock on well.**

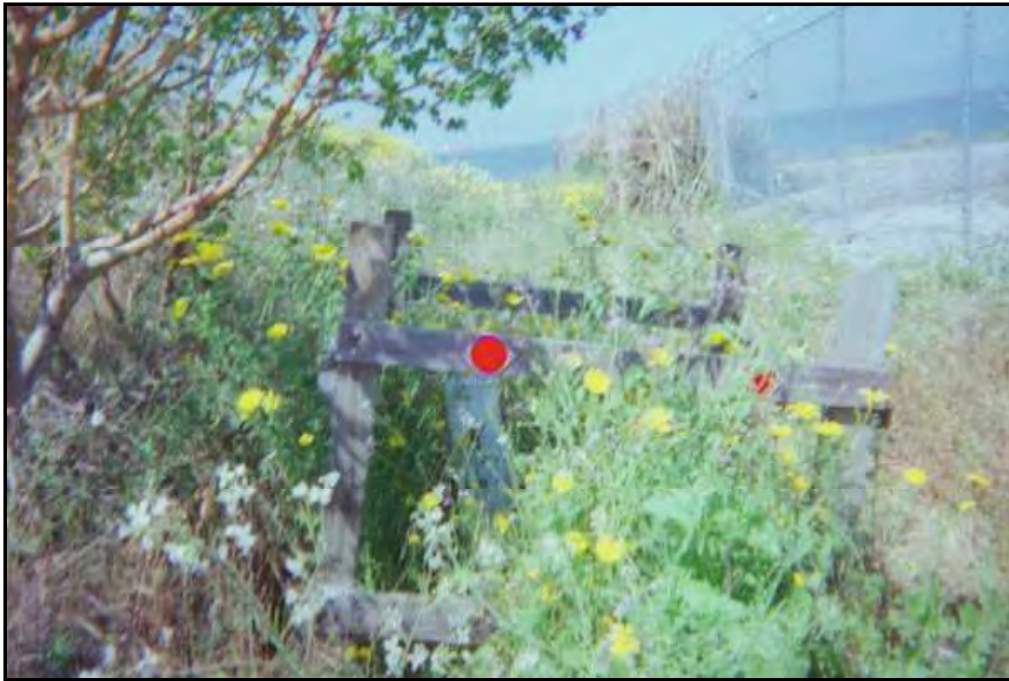
**Photograph D-7. Well IR07MW28A; wellhead is above ground and protected by well casing and wooden fencing with reflectors.**

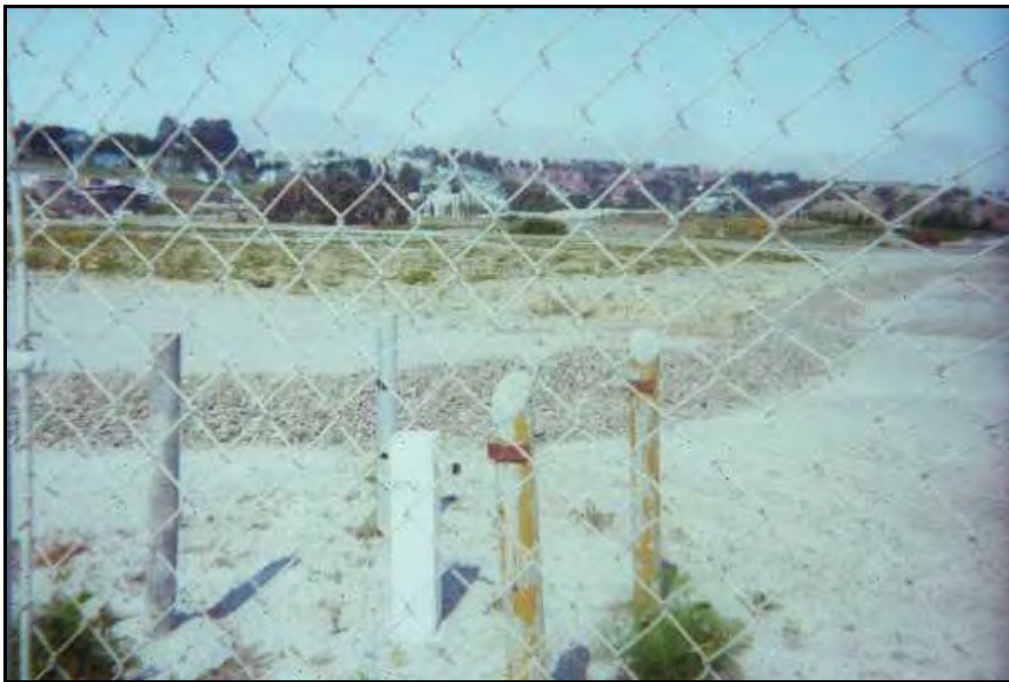
**Photograph D-8. Well IR07MWS-2; wellhead is above ground and protected by well casing and concrete bollards.**

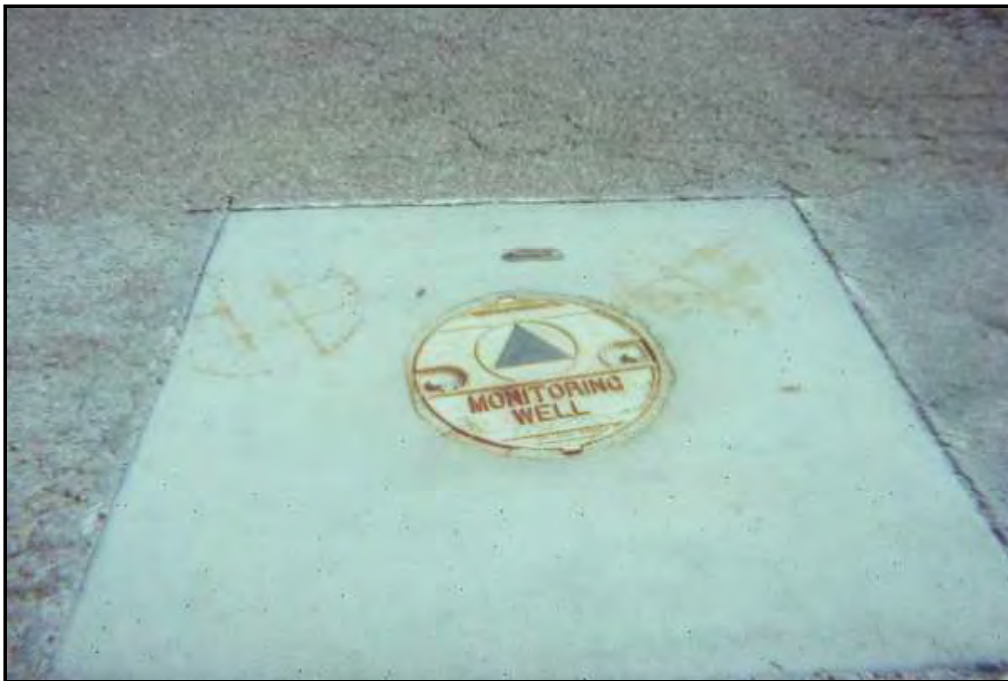
**Photograph D-11. Well IR10MW14A; note new concrete associated with vault.**  
Orientation: North  
Date: May 13, 2003

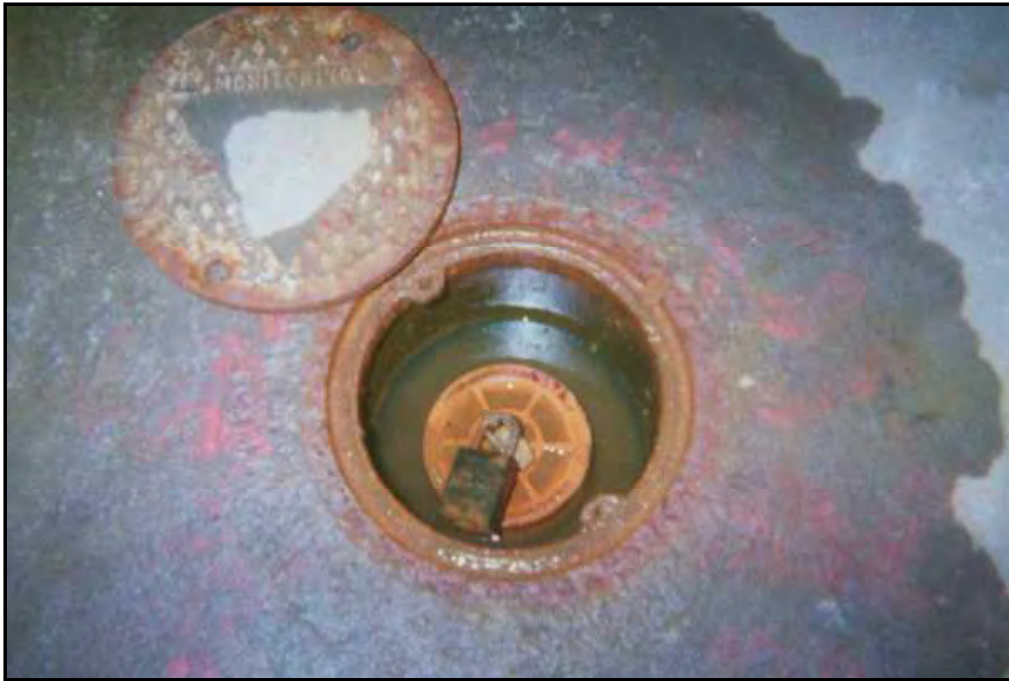
**Photograph D-15. Well IR10MW59A; padlock on well and standing water in vault.**

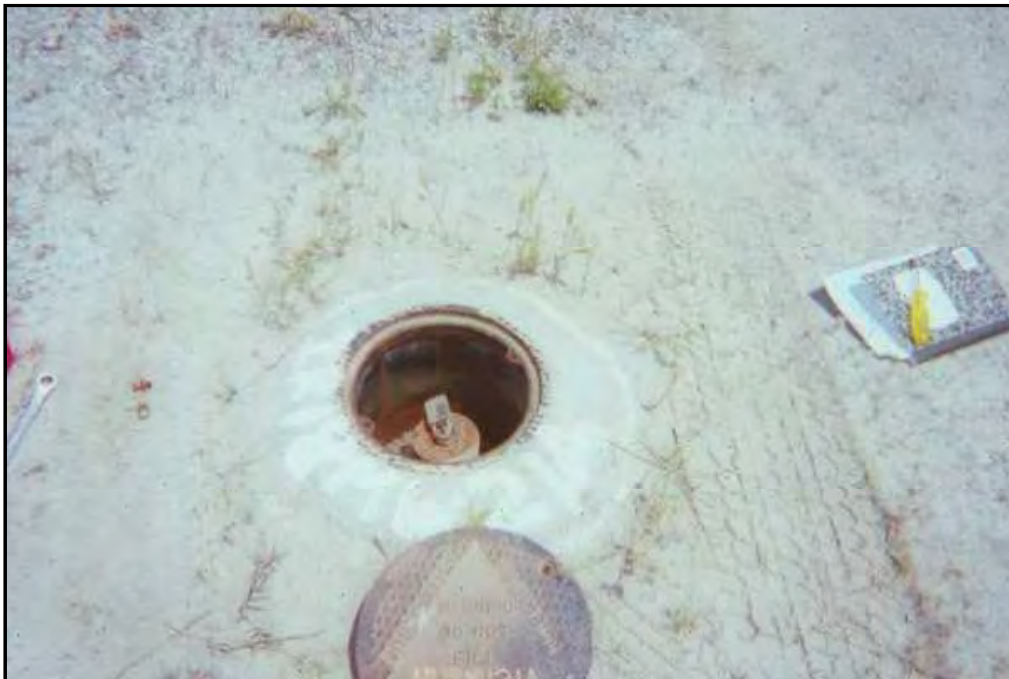
**Photograph D-16. Well IR18MW21A; padlock on well and standing water in vault.**

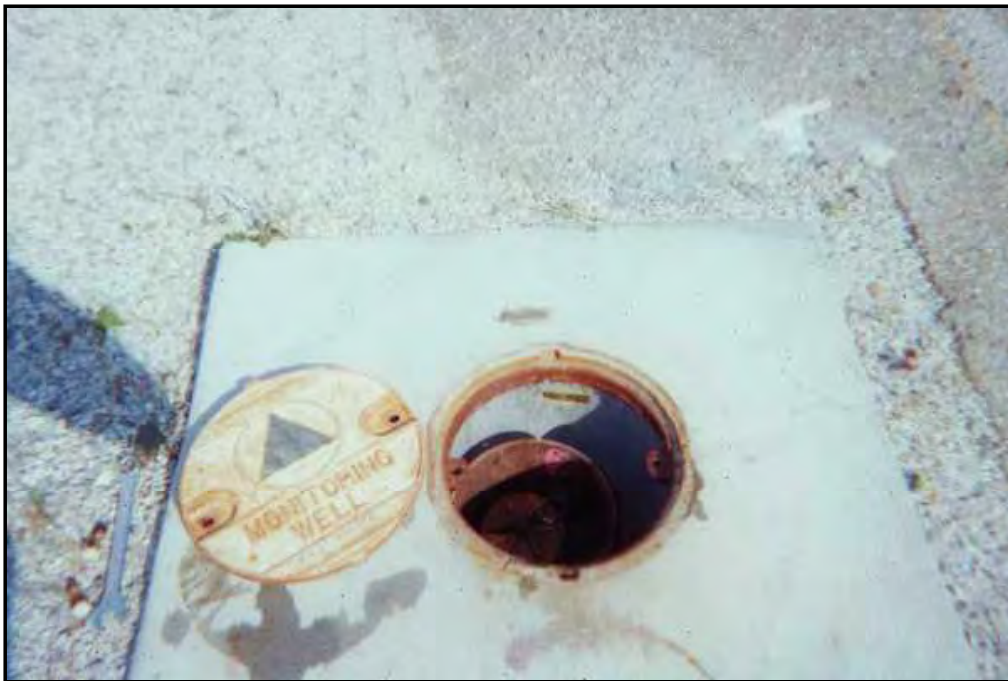
**Photograph D-17. Well IR25MW17A; padlock on well and new concrete associated with vault.**

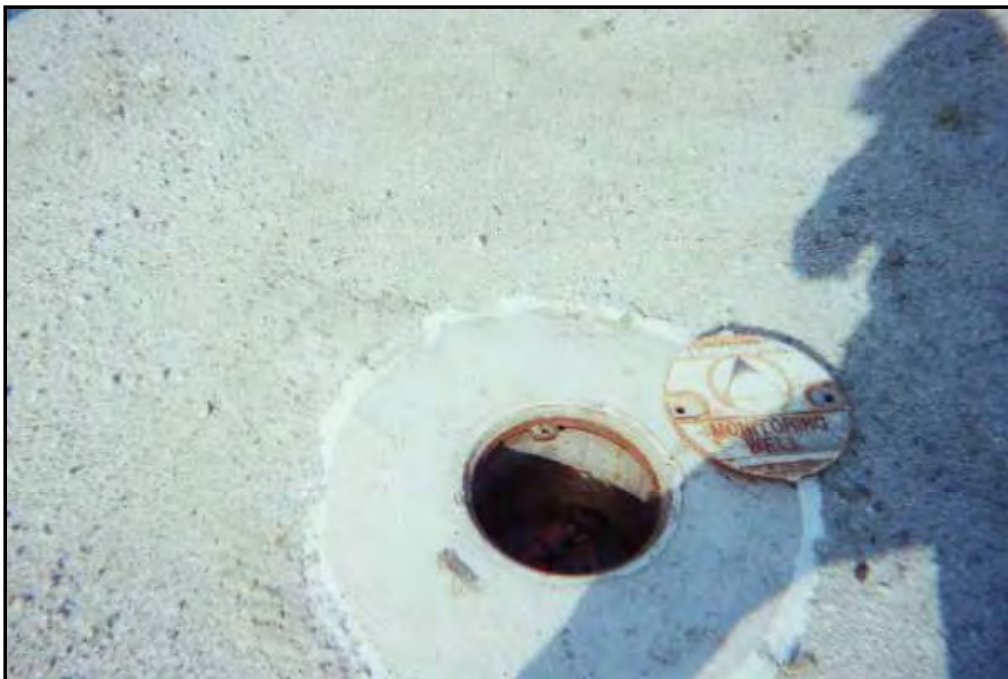
**Photograph D-20. Well IR26MW46A; padlock on well and standing water in vault.**

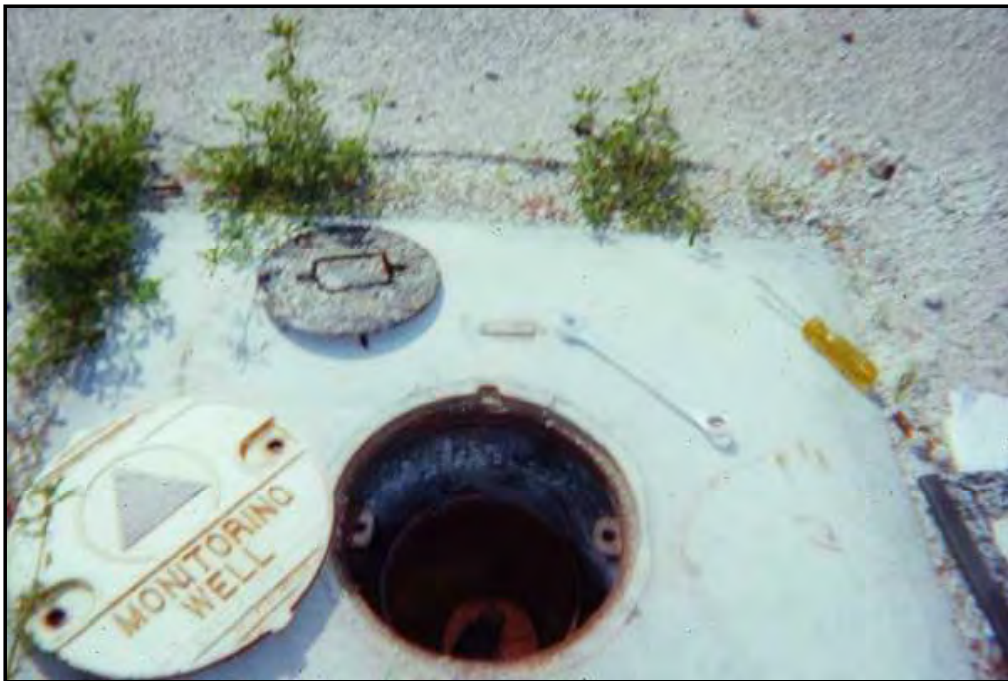
**Photograph D-23. Well IR46MW37A; padlock on well and new concrete associated with vault.**

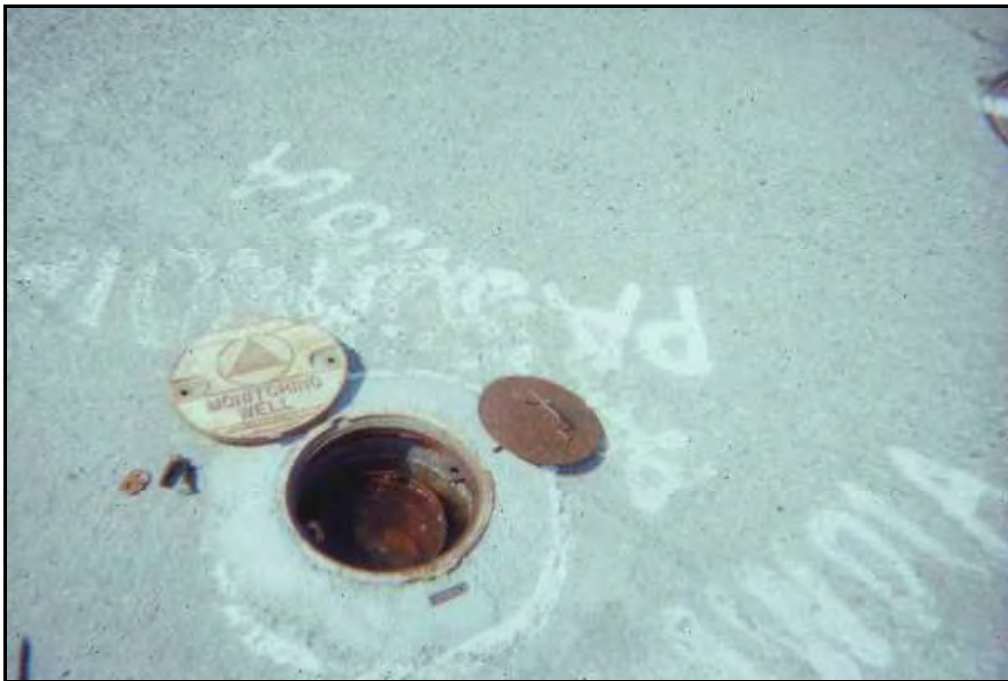
**Photograph D-25. Well PA50MW01A; padlock on well and standing water in vault above wellhead.**

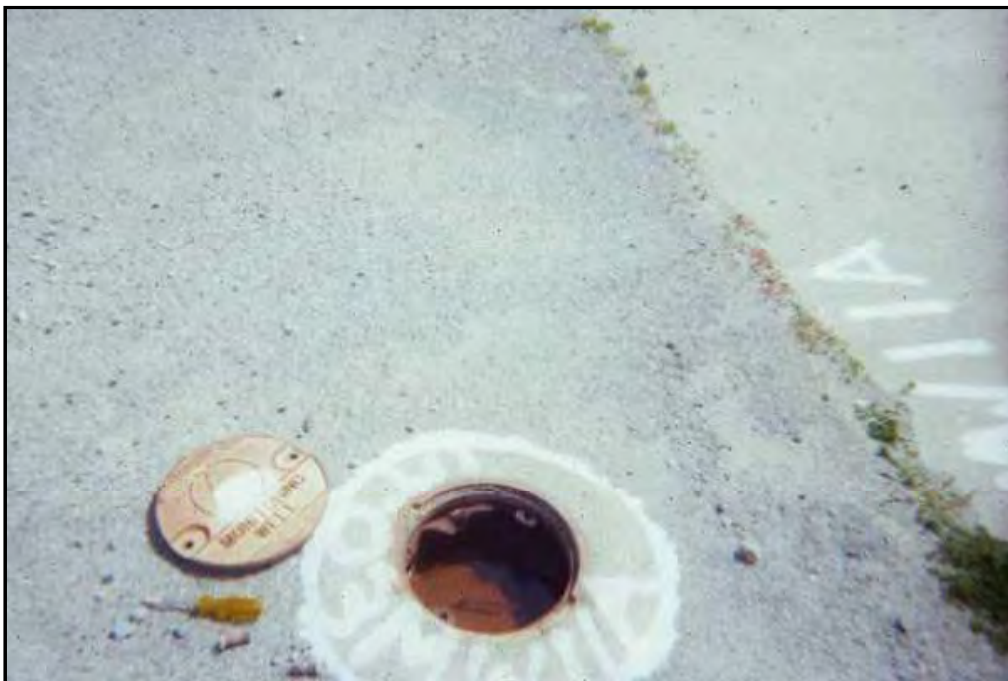
**Photograph D-26. Well UT03MW11A; padlock on well and standing water in vault above wellhead.**

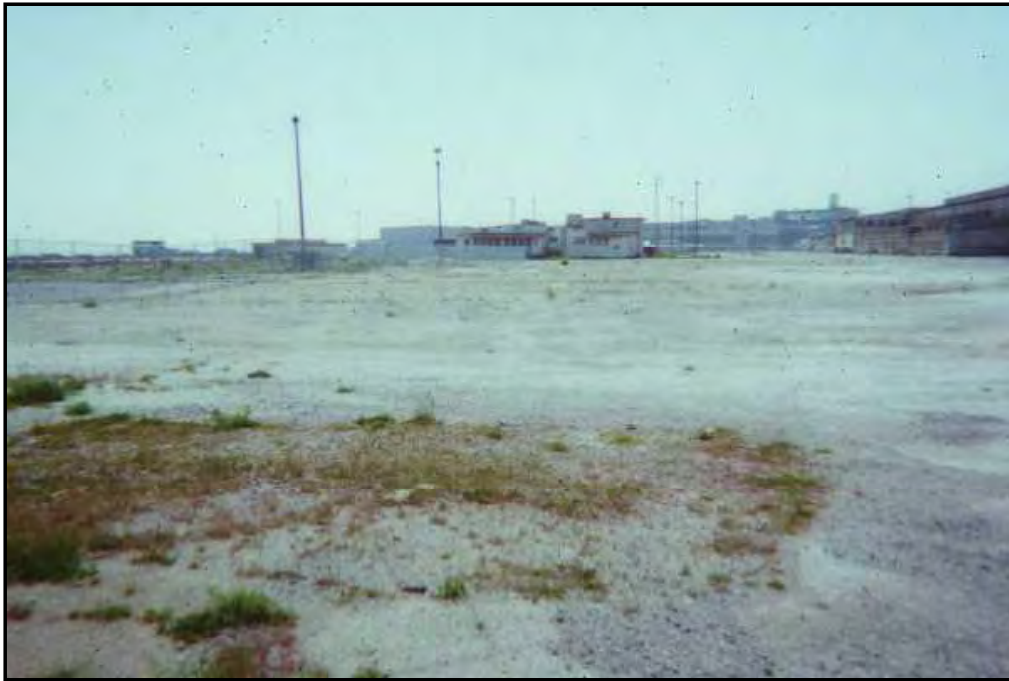
**Photograph D-27. Newly installed permanent fence along shoreline new Dry Docks 5, 6, and 7. The fence runs perpendicular to the shoreline between Buildings 125 and 128.**

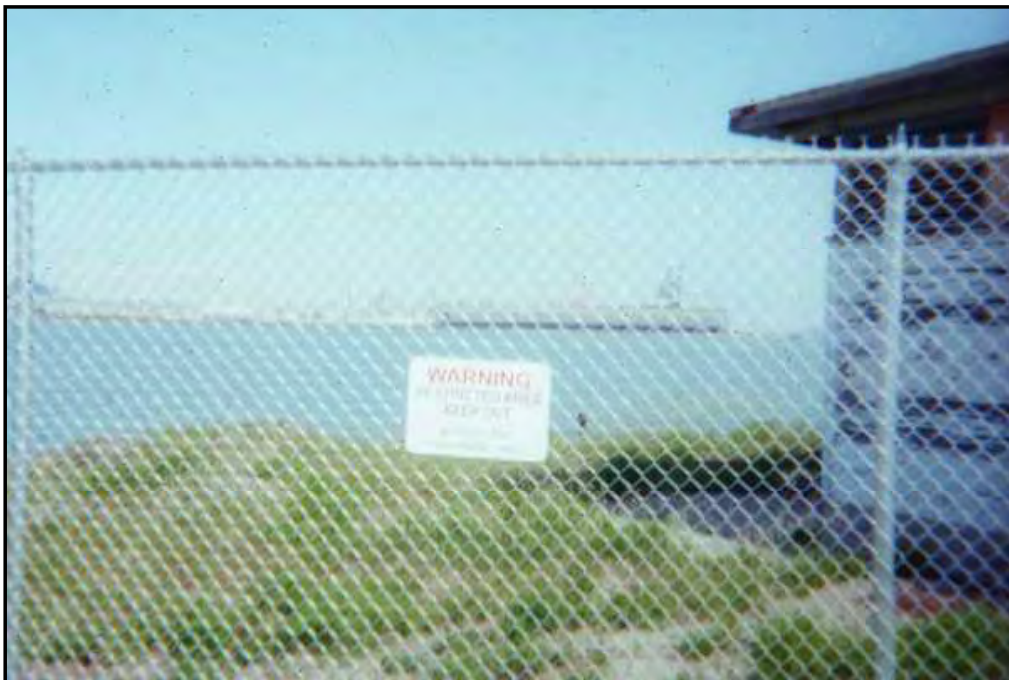
**Photograph D-28. Warning sign posted on newly installed permanent fence along shoreline near well IR07MW20A1; representative of signs posted along the length of newly installed fencing.**

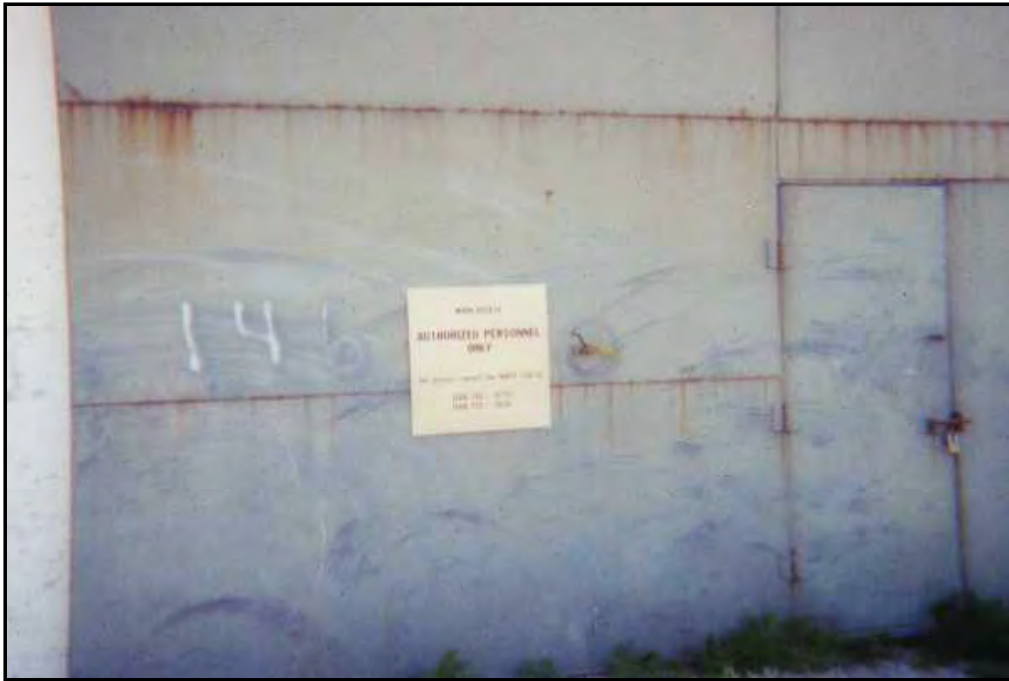
**Photograph D-29. Access restriction sign posted on Building 146; representative of signs posted on abandoned buildings throughout Parcel B.**

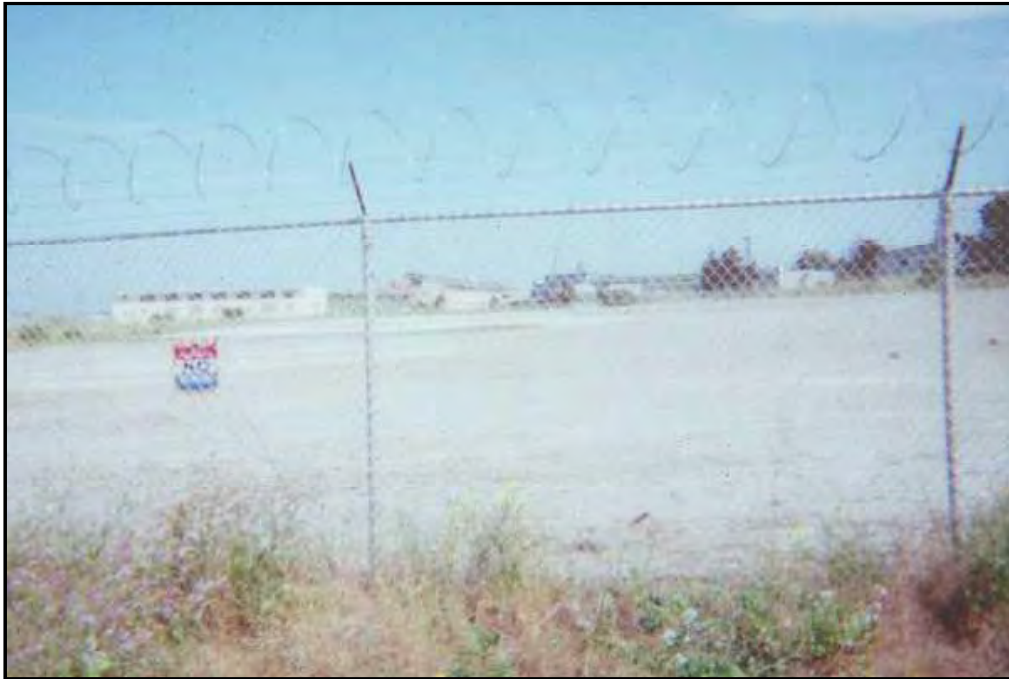
**Photograph D-30. Permanent fence along west property line, with no trespassing sign and barbed wire.**

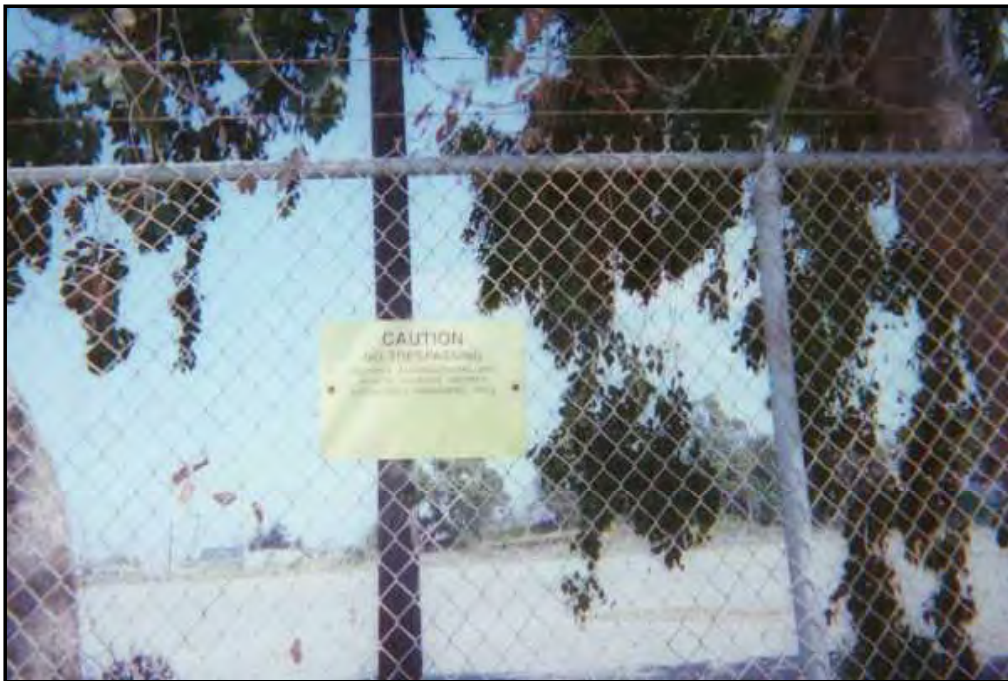
**Photograph D-31. Permanent fence along west property line, with no trespassing sign that provides warning of environmental health hazards.**

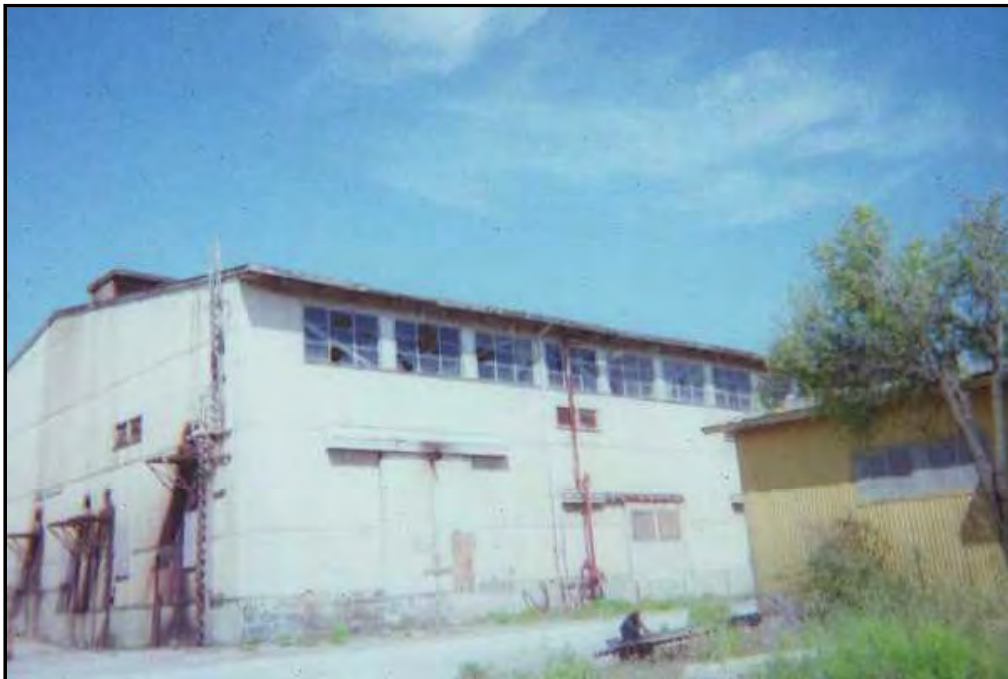
**Photograph D-32. Broken windows on Building 123; representative of broken windows on abandoned buildings throughout Parcel B.**

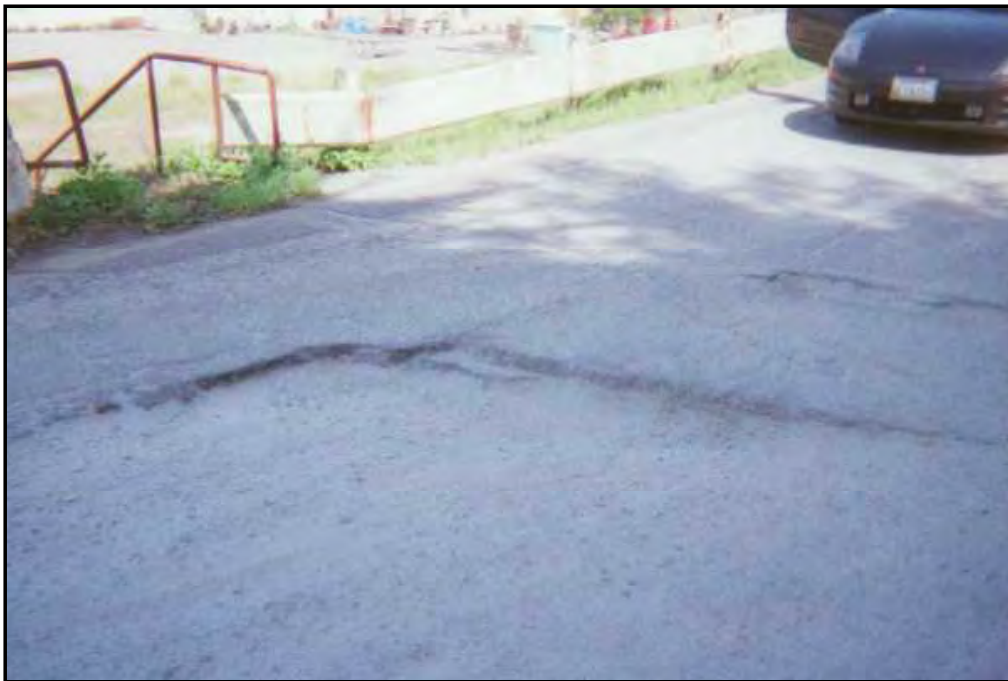
**Photograph D-33. Large pothole in road on Parcel B near Building 104;  
extreme example of potholes observed throughout Parcel B roads.**
