UNITED STATES ENVIRONMENTAL PROTECTION AGENCY

Re: Sunrise Mountain Landfill  
Findings of Violation and Order for Compliance  
Docket No. CWA-309-9-99-14

Attachment A-2  
PHOTOS TAKEN BY INSPECTOR JOHN HILLENBRAND, with additional description in  
Attachment A-3)

Attachment A-4  
Excerpted photos from Kandice Bellamy and Steve Wail

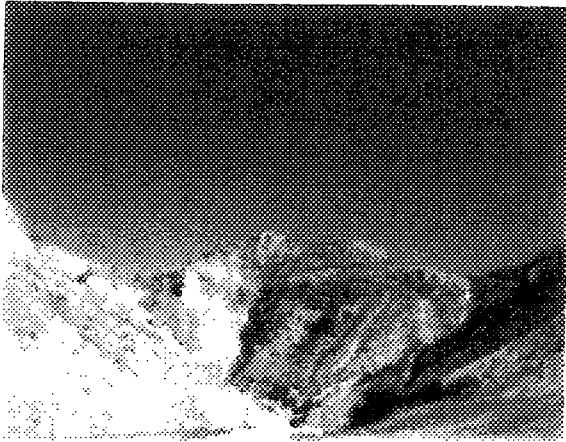
Several collection channels directing runoff from east-side canyons crossed the final landfill cover to reach the main drainage channel (photo JH-1). These channels still contained visible waste. As previously mentioned, the liner, riprap, and dirt cover along the entire drainage channel had been broken up, torn apart, and washed out by the September rains. At the time of the inspection, only a temporary dirt cover layer had been placed and compacted. A large gabion drop structure (a wire mesh basket dam filled with stone, used to dissipate energy) in the main drainage channel was distorted but intact.

JH-1 WEST SIDE OF MAIN DRAINAGE  
CHANNEL LOOKING EAST - drainage  
from side canyon crossing main landfill  
deck to connect with main drainage channel

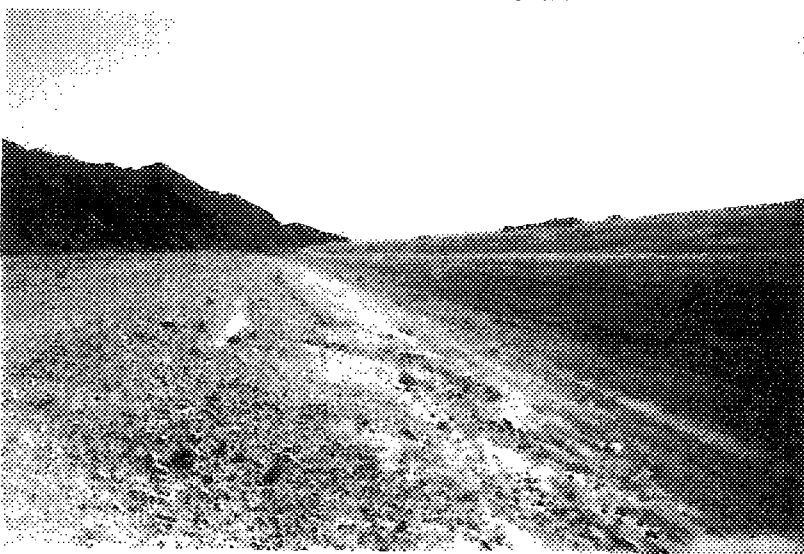
JH-2

LOOKING SOUTH AT NORTH ENTRANCE TO THE MAIN DRAINAGE CHANNEL -  
channel is cut into landfill deck above refuse

Photo 2. N 17,750, E 15,250. Photo taken at the entrance to the main drainage channel looking due south (photo 1 taken approximately 1800 feet down this channel). This photo shows graded main drainage channel inadequately protected from both scour and infiltration. This channel was inadequately designed to withstand the flash-flood type of high intensity rainfall experienced in the area. This channel should be moved to the east on native material against the hills where failure would occur on native ground instead of over refuse. Movement of this channel would also entail construction of a settling/equalizing basin upstream, off of refuse.

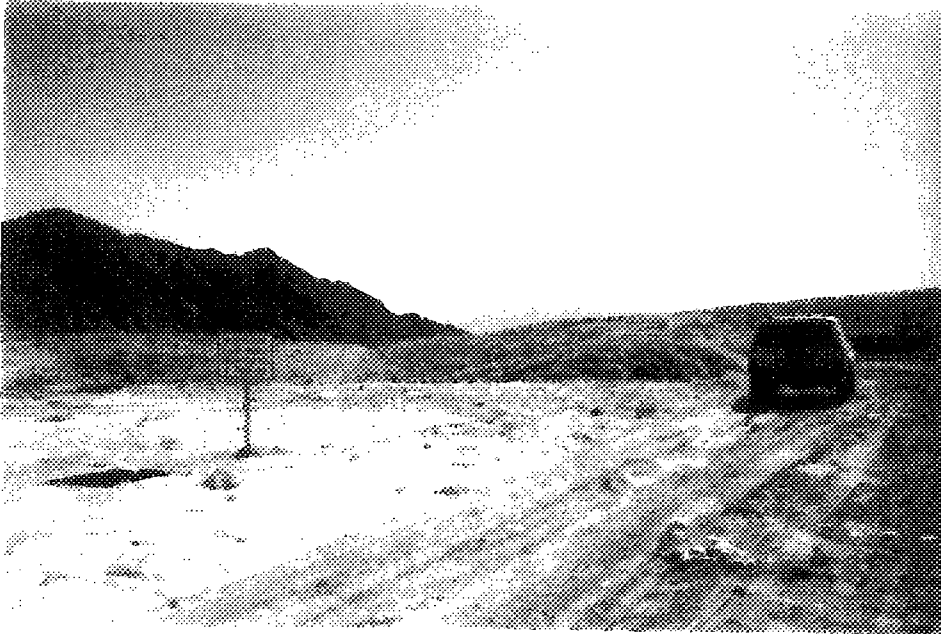
JH-3

North of the main drainage channel and the main landfill (south end of the Northeast Canyon Area), a large depressed area appeared to have acted as an unengineered sediment basin prior to runoff entering the main channel (photo JH-3). The bottom of this basin was covered with dry silt deposits, mixed with loose refuse which was more concentrated at the north end of the basin (photo SW-11). Both BLM and operator representatives felt that several feet of additional refuse probably existed under the silted areas. Evidence was noted of probable percolation from the south edge of this basin into the north edge of the main Landfill, which appeared to have acted as a dam for the basin.

NORTH MAIN DRAINAGE CHANNEL LOOKING SOUTH - silt bottom of acting settling/flow-equalizing basin. Refuse probably exists under the silt.

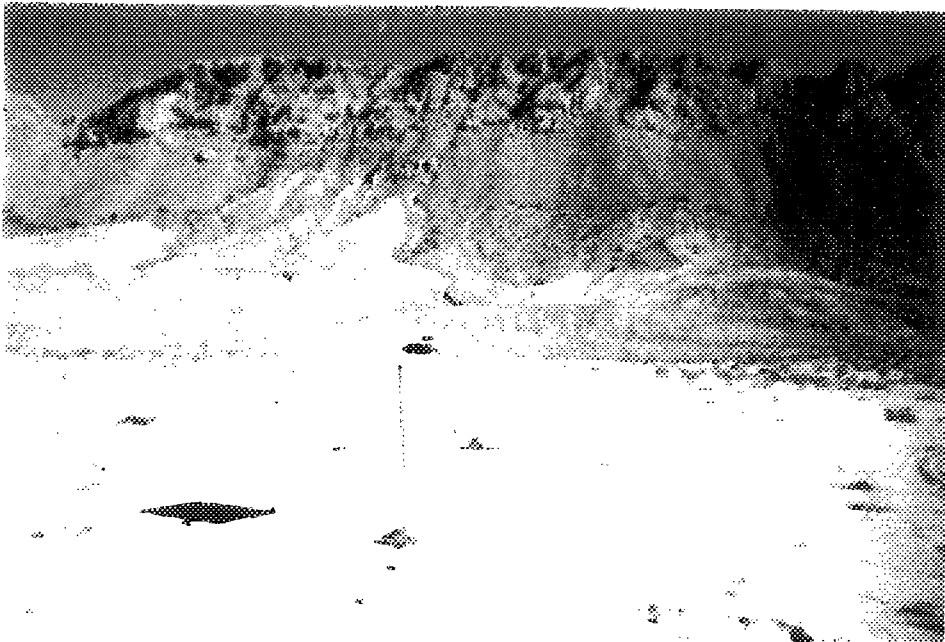
JH-4

We drove further north up the Northeast Canyon Area following a rough trail, stopping and getting out to observe at several points along the way. Multiple areas were found containing exposed and uncontrolled municipal waste and sewer septage (as indicated by characteristic snail shells and white lime-treatment residue, photos SW-13, JH-14, 15, and 20). We observed several apparent landfill cells estimated to be as deep as 10-15 feet relative to neighboring exposed bedrock (photo JH-4).

NORTH OF MAIN DRAINAGE CHANNEL LOOKING EAST - truck in distance is parked at the base of a refuse cell shown in more detail in following photos JH-5 through JH-9.

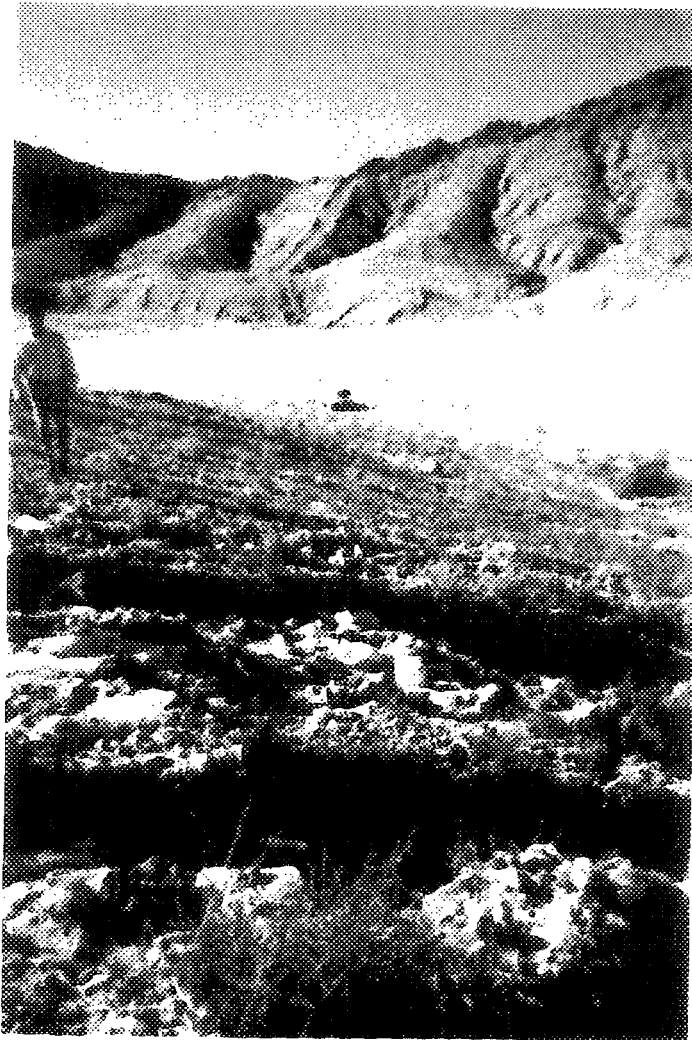
JH-5 FROM TOP OF CELL SHOWN PREVIOUSLY IN JH-4 - shows erosion and exposed refuse

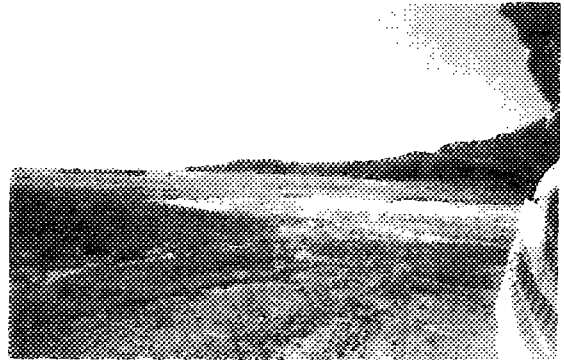
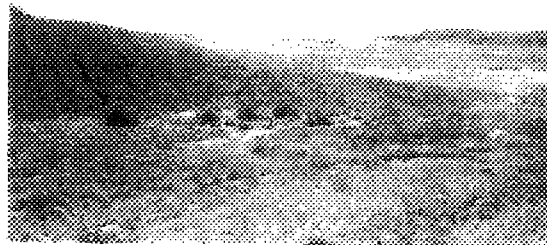
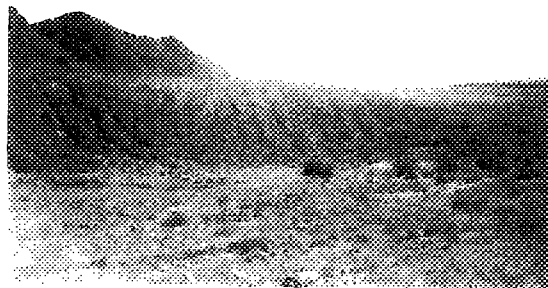
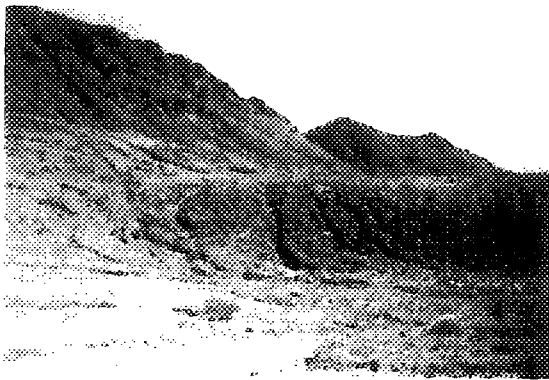
PANORAMIC OF CELL SHOWN IN JH-4 FROM NORTH LOOKING SOUTHWEST TO SOUTH - large acting sediment basin at right in JH-6 (in the distance), and exposed refuse at the top of a cell is at left in JH-9.

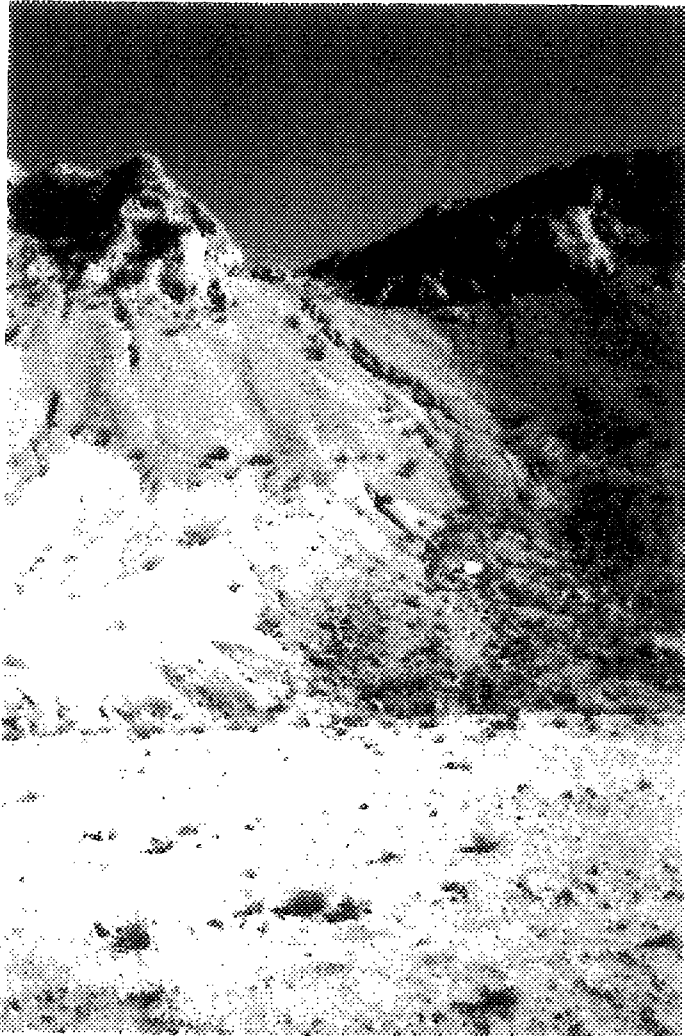
JH-10 LOOKING EAST AT  
APPARENT SETTLEMENT  
BASIN RESULTING FROM  
REFUSE DAM

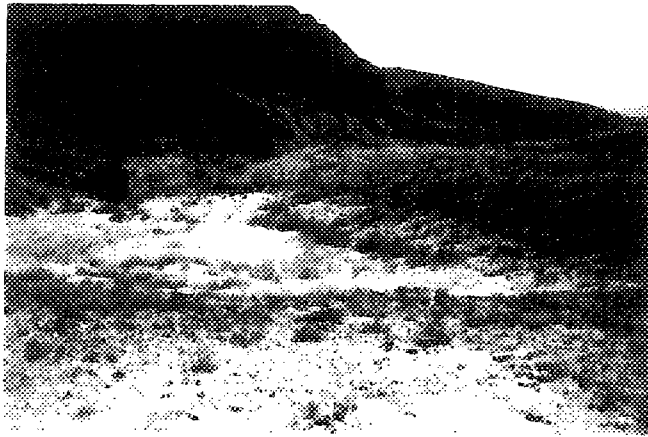
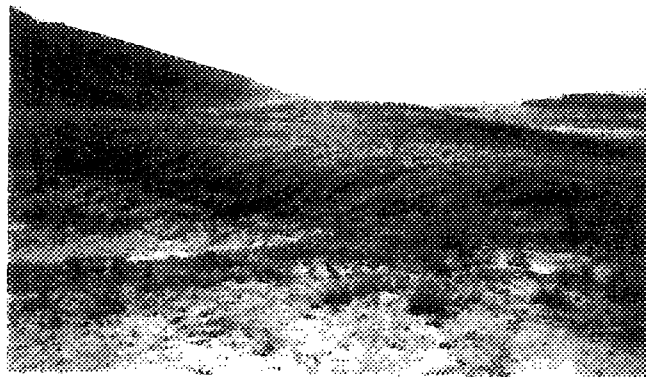
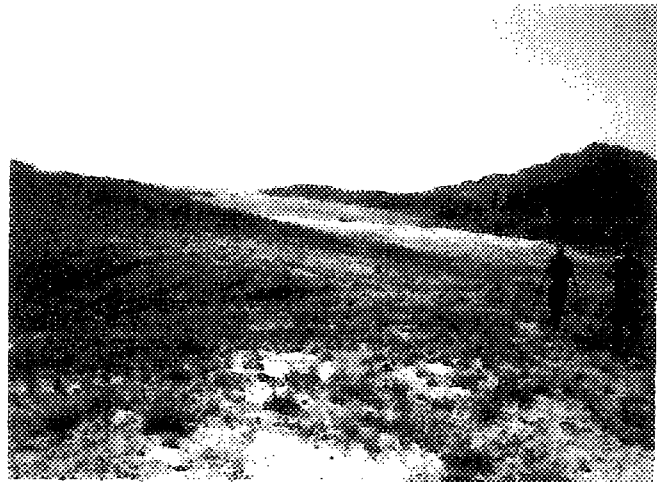
PANORAMIC VIEW OF SMALL SEDIMENT BASIN LOOKING SOUTH TO SOUTHWEST FROM NORTH SIDE - east canyon wall at left in JH-11 to refuse dam at right in JH-13 (shown from below in JH-10)

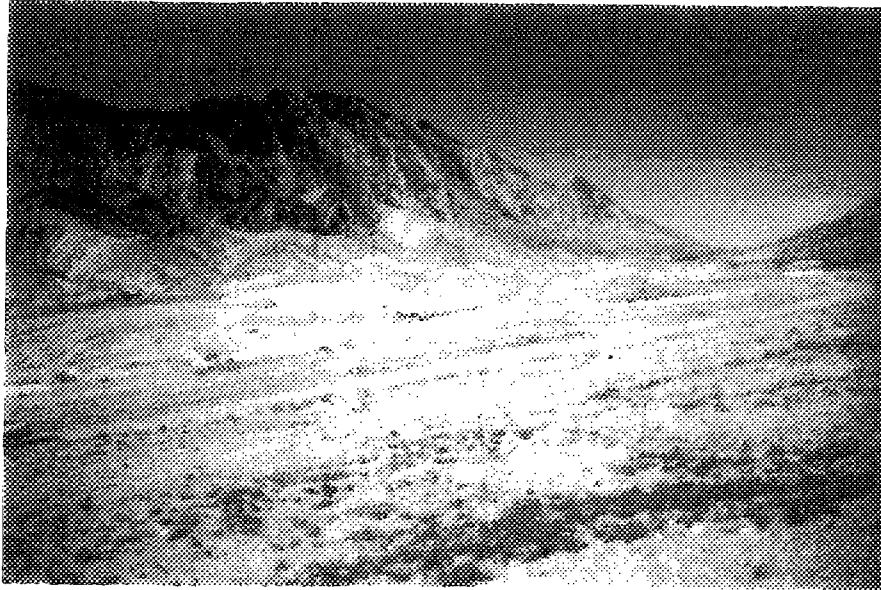
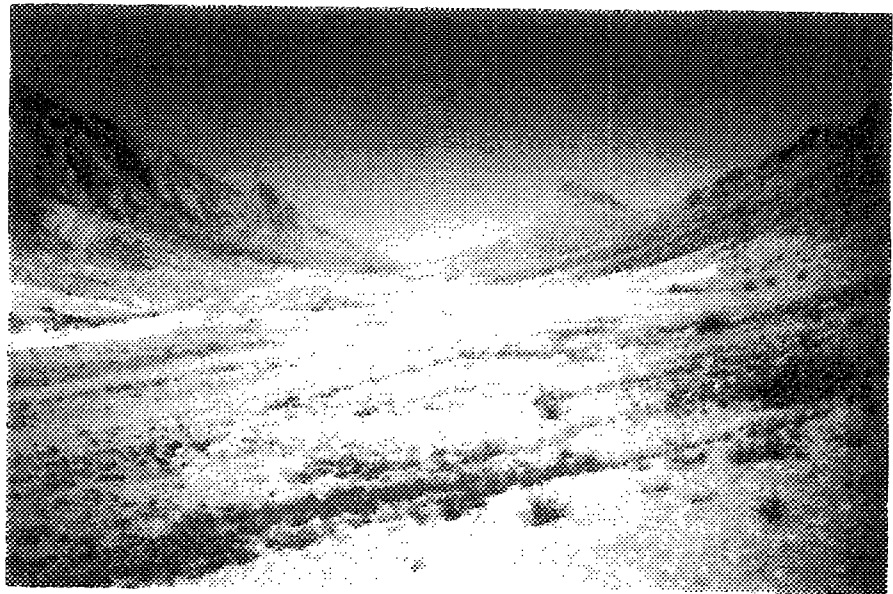
PANORAMIC VIEW OF REFUSE POCKETED ALONG EAST SIDE IN NORTH CANYON  
- areas between photographer and white areas are landfill. White areas appear to be limed septic sludge.

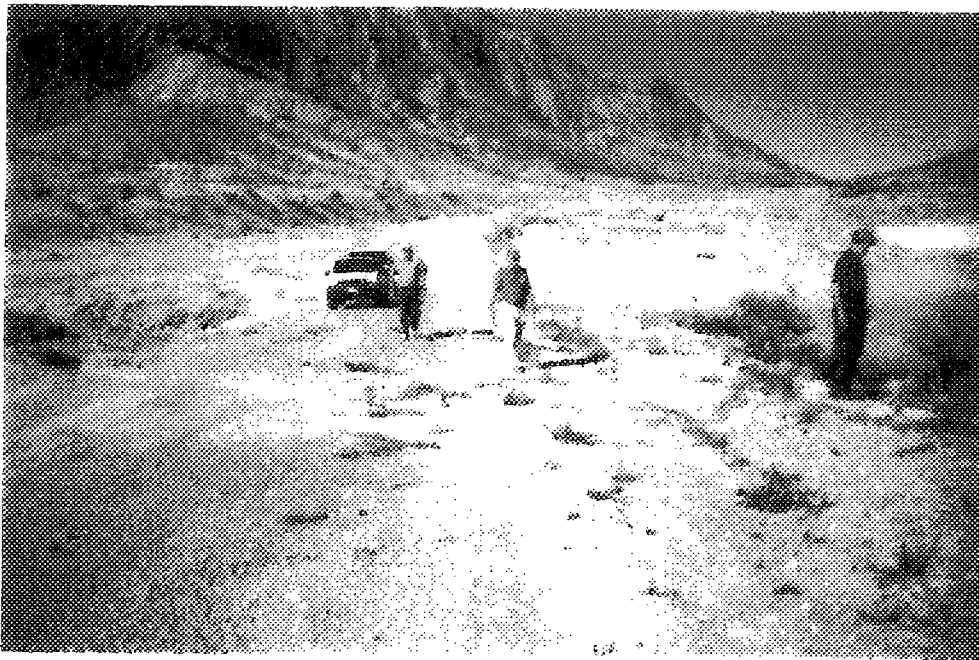
JH-16 FROM TOP OF FILL SHOWN IN JH-14 AND JH-15 LOOKING NORTH AT NORTH EDGE OF FILL - sludge detail in JH-20 is of brown cliffs to left of vehicles

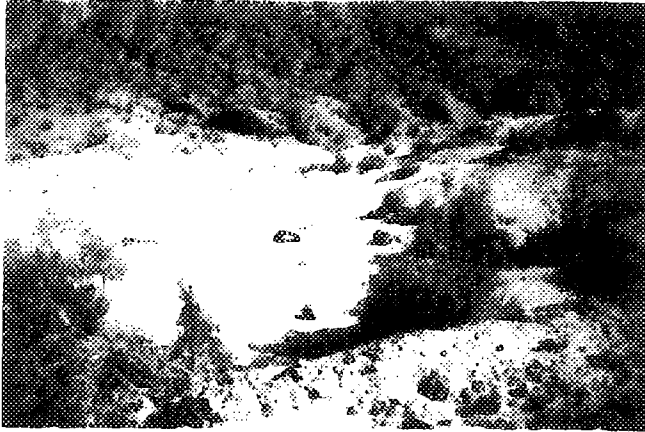
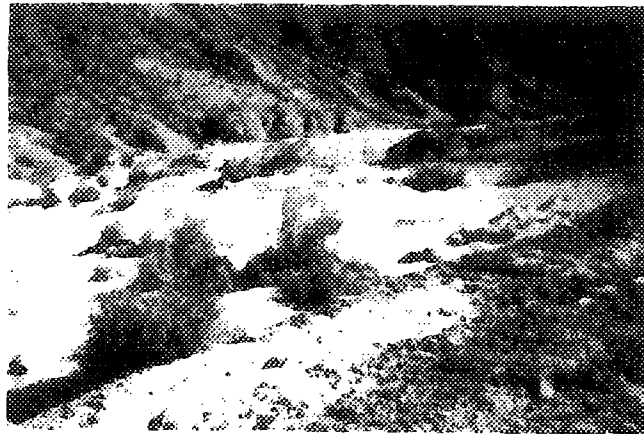
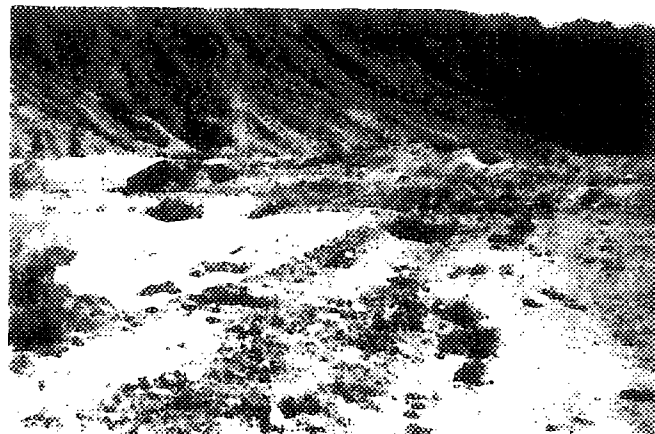
PANORAMIC VIEW TAKEN FROM NORTH EDGE OF DISPOSAL AREA IN NORTH CANYON NEAR FRONT OF VEHICLES IN JH-16 LOOKING SOUTHEAST - looking towards the location from which JH-16 was taken. The debris on the road is likely from spillover of a deep pool above the landfill area after a rain.

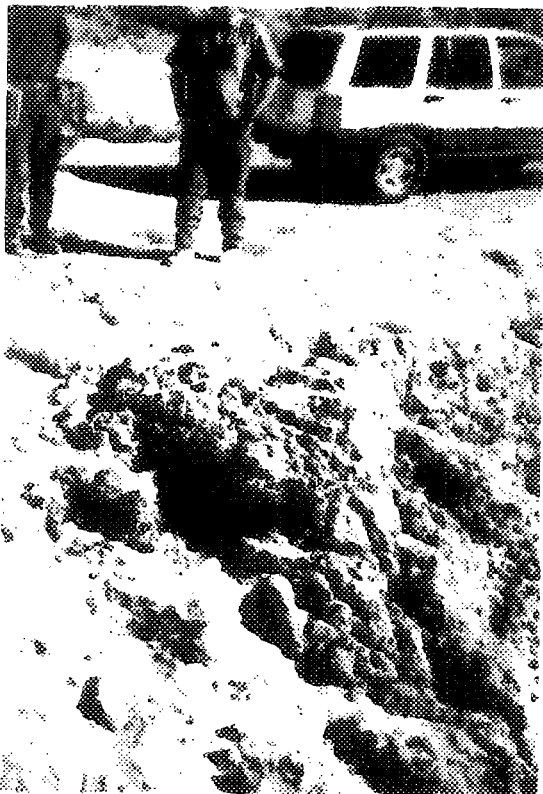
JH-20 DETAIL OF SEWAGE SLUDGE AT THE NORTHERNMOST EDGE OF THE NORTH CANYON DISPOSAL - as referred to in JH-16. The municipal waste shown in JH-21 and JH-22 was just to the south of this and was apparently underneath this sludge

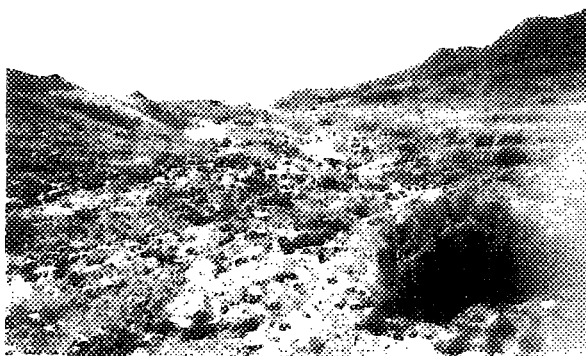
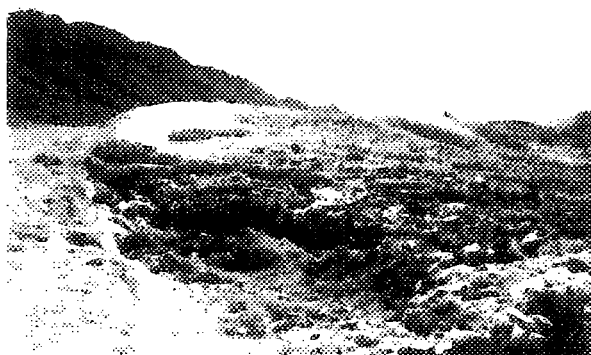
Along the center of the Northeast Canyon Area we discovered an area where municipal waste under a thick layer of septage sludge had been washed-out and exposed. This area was likely the main source for most of the loose trash in the silt basin previously described. We found trash dating from the late 50's to the early 70's (photos SW-14, JH-21, and 22). No form of drainage or storm water control was observed.

JH-21 AND JH-22 ARE A PANORAMIC VIEW LOOKING SOUTH AND EAST FROM THE TOP OF THE SLUDGE SHOWN IN JH-20

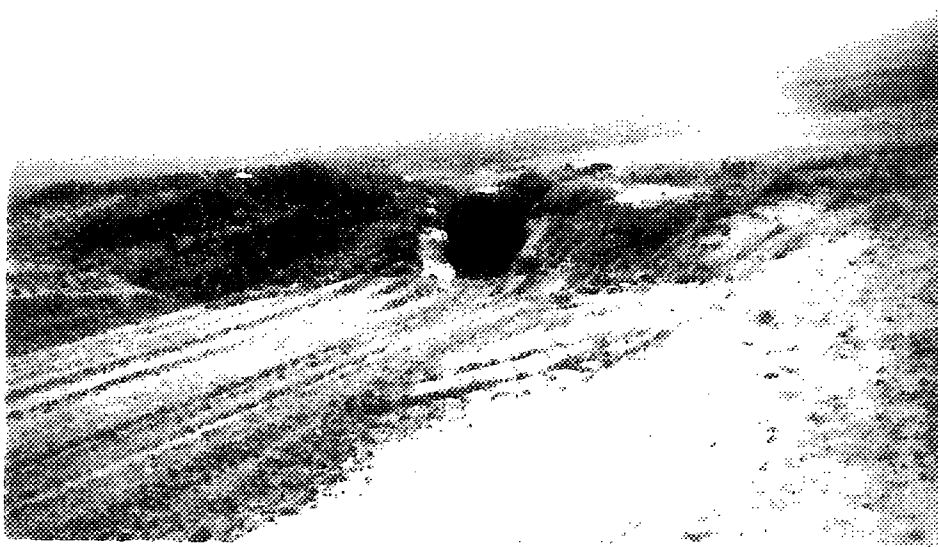
JH-23

We next drove south along the west edge of the main drainage channel to the southeast corner. We reviewed the observations in this area of the previous day with Inspector Hillenbrand. A poor-quality concrete pipe apron was observed in the area (photo JH-23).

PIPE APRON AT SOUTHEASTERN CORNER OF TOP LANDFILL DECK - no side eddy protection, reinforcement, or anchorage. Probably a temporary structure to replace failed original

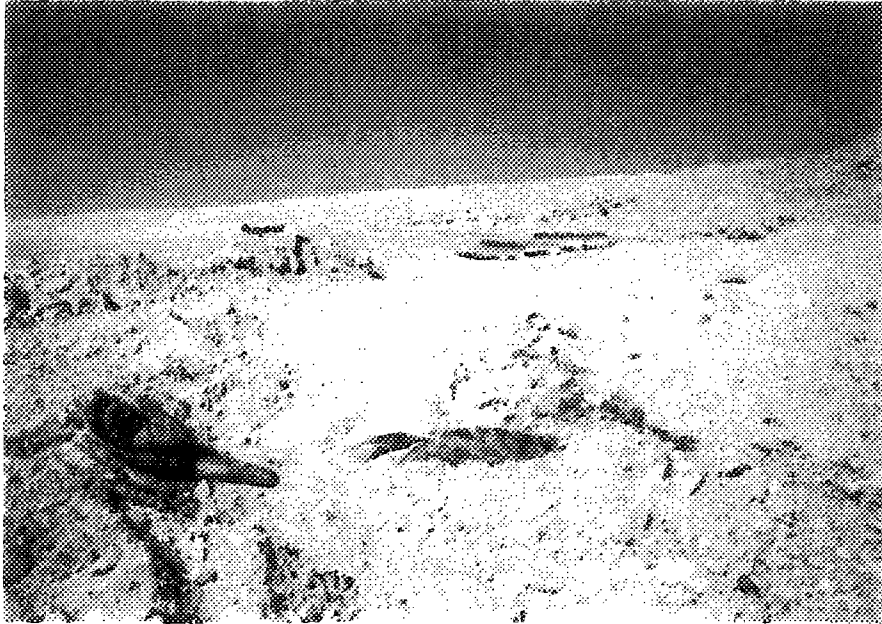
As we drove and upon disembarking we observed that many of the existing corrugated metal half-pipe drainage culverts used for surface water control were damaged and partially filled with sediment (Attachment A-4, photo KB-7). Soil at both edges of the drainage pipes was generally severely undermined, often exposing landfill waste. Culvert joints were commonly disconnected, dead-ended (photo KB-10), or poorly connected. It appeared that some damaged culverts had been removed, and new uninstalled culverts were laying on the ground nearby (photo KB-2).

KB-2 LOOKING NORTHWEST TOWARDS MAIN LANDFILL FROM SOUTHEAST CORNER - bent half-pipe out, new half-pipes not installed; exposed trash in foreground

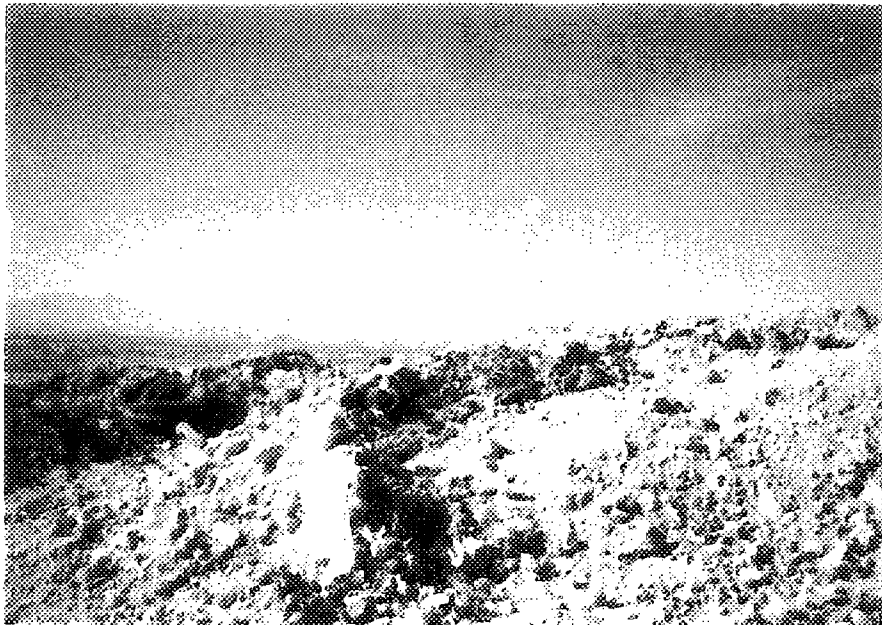
Along the main drainage channel in the rock channel section, much exposed refuse was observed on the upper west side slopes (photos KB-3 and SW-6), although this area had been regraded since the September storms. On the east side, additional exposed refuse was noted.

KB-3 LOOKING WEST TO LAS VEGAS FROM SAME AREA AS KB-2 - exposed trash even after regrading

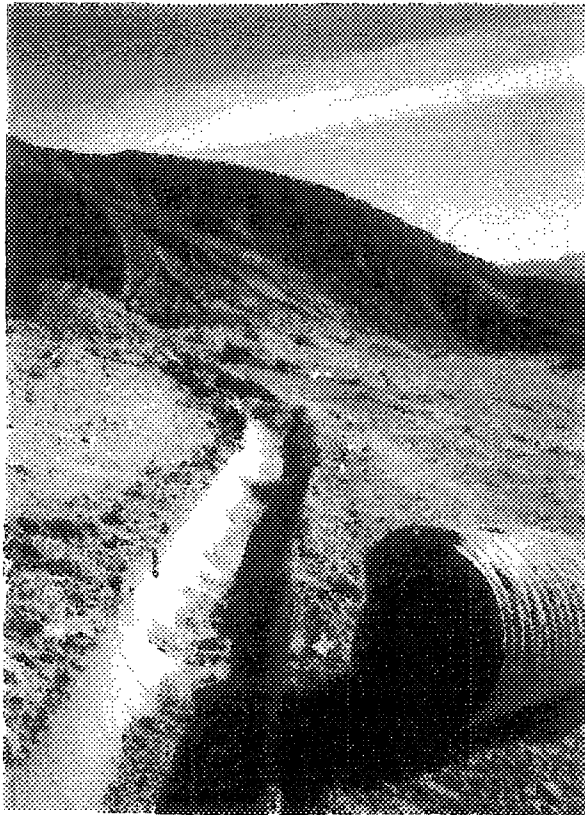
KB-7 LOOKING EAST SOUTHEAST ALONG EXISTING HALF-PIPES - bent, partially sedimented, poor joints, undermining at edges

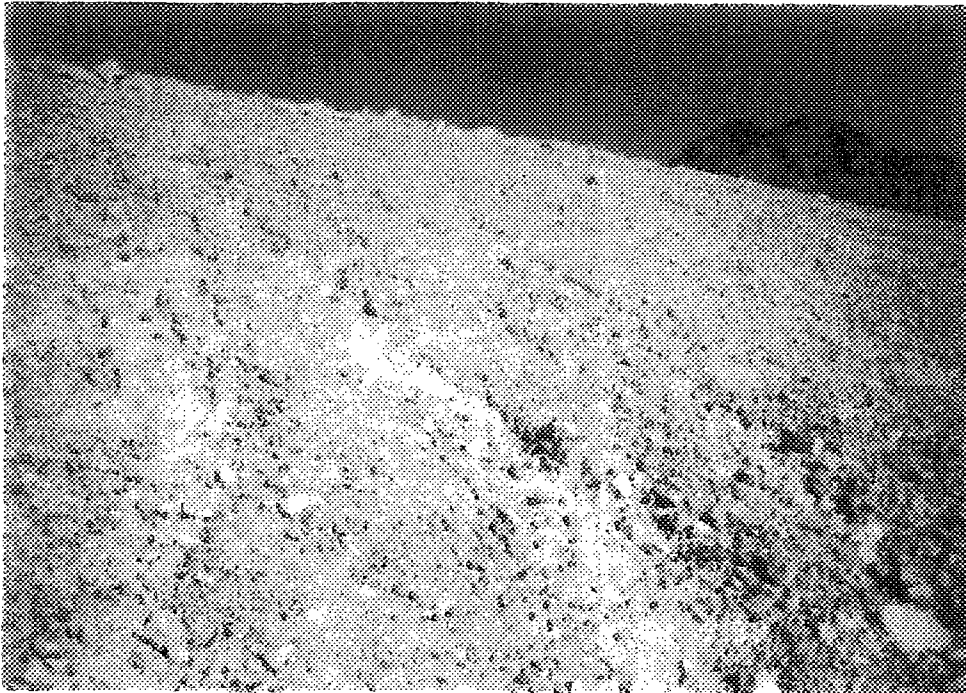
Along the eastern edge of the top cell and on the east side slopes leading to the main drainage channel above the rock channel area, methane venting was observed as evidenced by discolored soil [photo SW-9], even in recently regraded areas. A strong downwind odor was noted in these areas. We observed several six-inch deep erosion gullies sloping down toward the main drainage channel on the east side slope, with larger rocks washed to the bottom of the slope (photo KB-8).

KB-8 SLOPE AT SOUTHEAST CORNER ON MAIN LANDFILL - big rocks at bottom, deep rilling

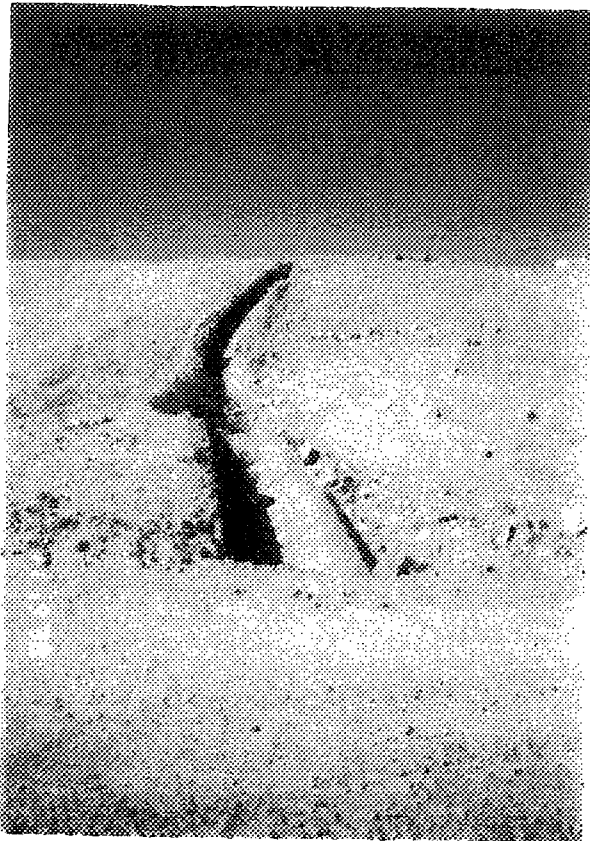
KB-10 AT SOUTHEAST CORNER,  
LOOKING WEST ACROSS  
LANDFILL - installed half-pipe with  
undermined edges, partially sedimented,  
dead-ended by regrade road

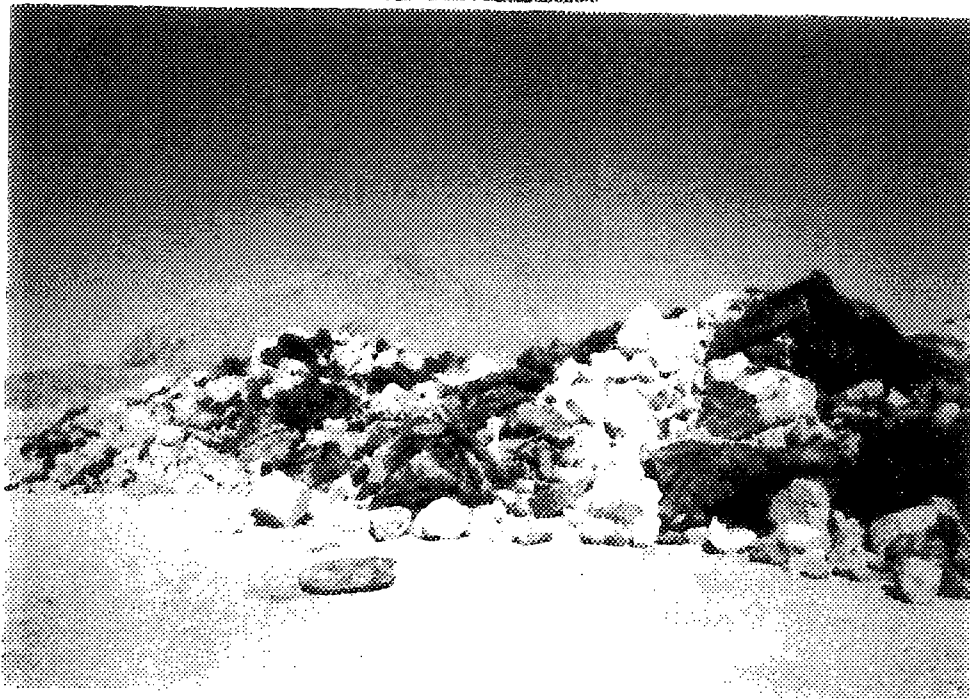
Walking across the top main Landfill surface, we observed large piles containing the broken liner segments (described as “rough 30 mil” HDPE by the operator) and displaced riprap from the main drainage channel, which the operator said were awaiting separation and reuse (photo KB-12). These materials had been torn loose during the September rainfalls. We observed visible waste imbedded or uncovered at various locations in the cap cover material exposed to future rainfall. We observed additional drainage culverts in various states of disrepair and large expanses of discolored soil combined with strong odors, similar to those previously described.

KB-12 RIP-RAP AND LINER PILES - on top of main landfill deck

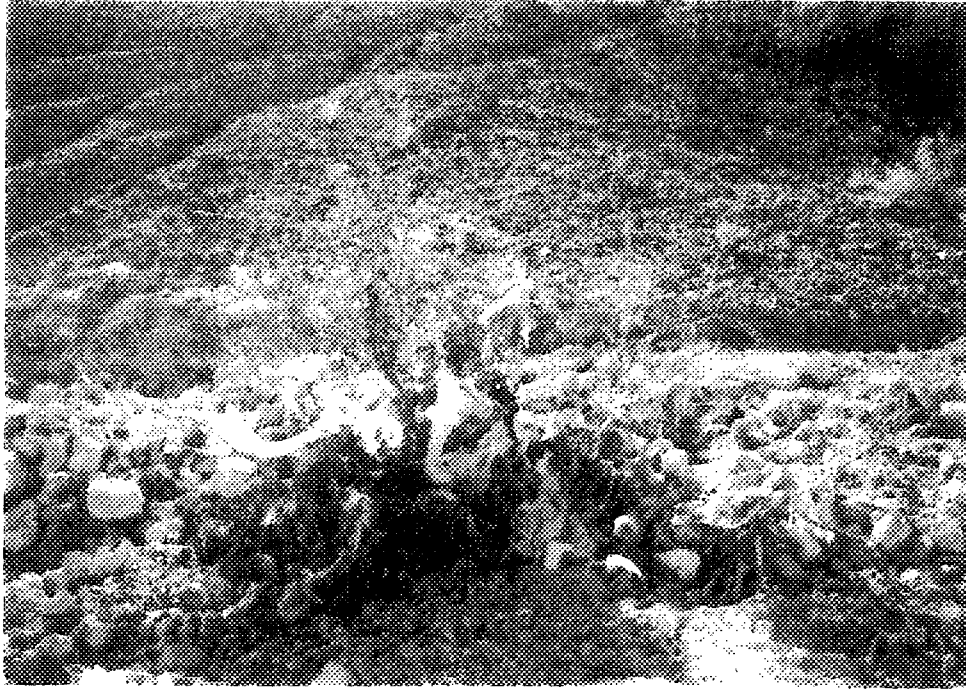
Part of the group walked and part drove as we traveled next along the south property line. Inspectors Hillenbrand and Basinger observed a lot of dispersed and pocketed debris (photos KB-19, 20, and SW-20) in prominent gullies (photos SW-21, JH-24) extending toward the Las Vegas Wash in the Southern Wash Area. This debris appeared more concentrated in gullies which reached the southern

KB-19 DEBRIS ALONG SOUTH BOUNDARY

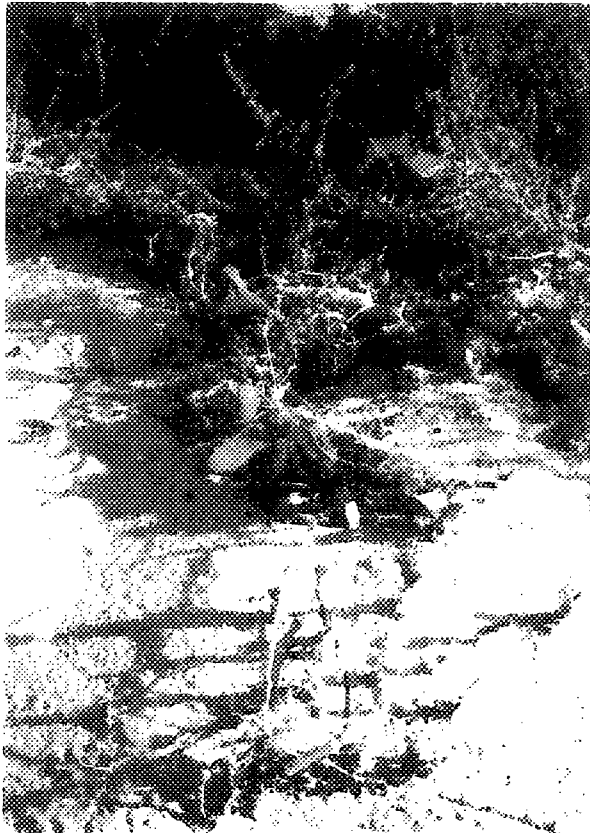
KB-20 EMBEDDED DEBRIS ALONG SOUTH BOUNDARY - including needles

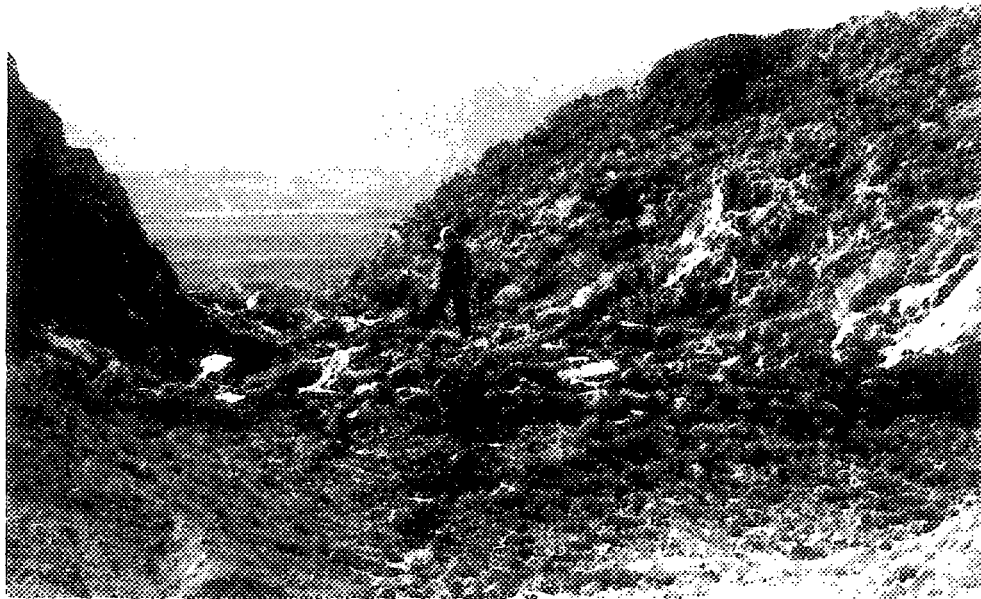
Near the southeast corner, the bottom of the main drainage channel as it crossed the Landfill appeared to have been regraded and covered with new dirt, but remained without riprap or the HDPE (High Density Polyethylene) liner which had failed in the September rains. As the main drainage channel exited the Landfill, rock had been blasted out to form the channel which connected to a large unnamed tributary of the Las Vegas Wash (east of Southern Wash Area). The rock channel bed in this area remained scoured clean as a result of the September rains (photo SW-1).

SW-1 SOUTHEAST OUTLET LOOKING SOUTH TOWARDS HENDERSON - through scoured rock channel, exposed trash in SW-6 on top, upper right

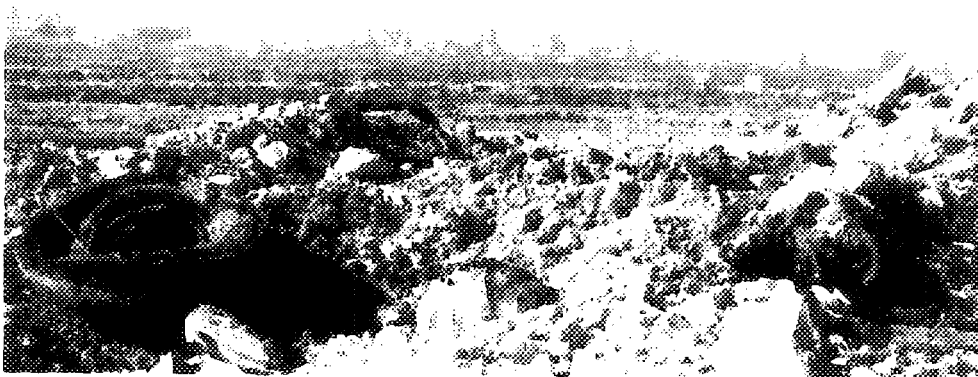
SW-6 WEST SIDE OF DRAINAGE CHANNEL AT TOP OF SIDE SLOPE, LOOKING WEST ACROSS SOUTHEAST CORNER OF UPPER LANDFILL - exposed trash in regraded area

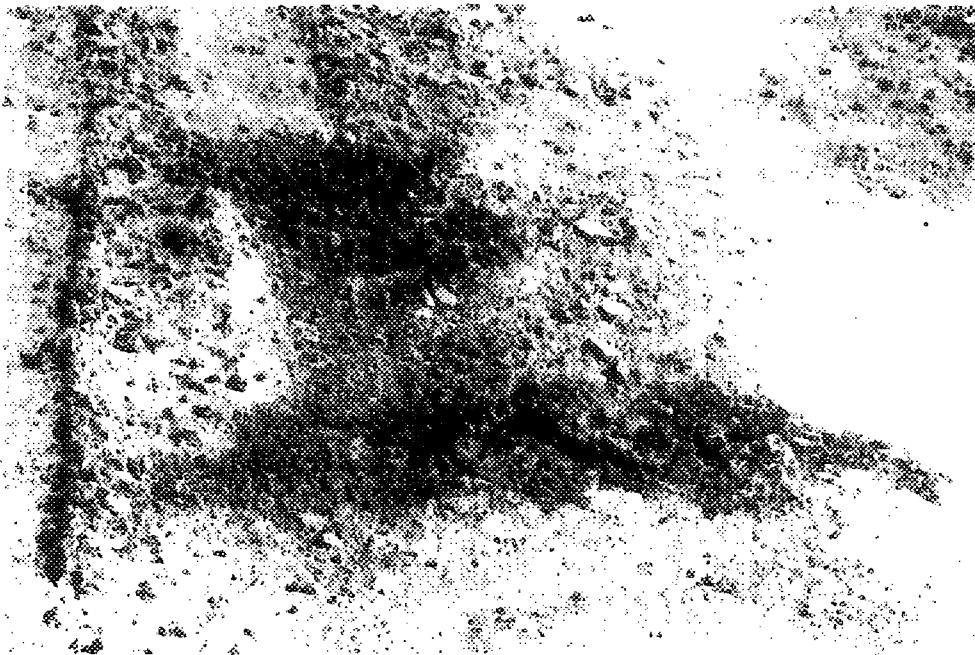
SW-9 SOUTHEAST QUARTER OF TOP LANDFILL DECK - discolored soil, area of methane venting in recently regraded area

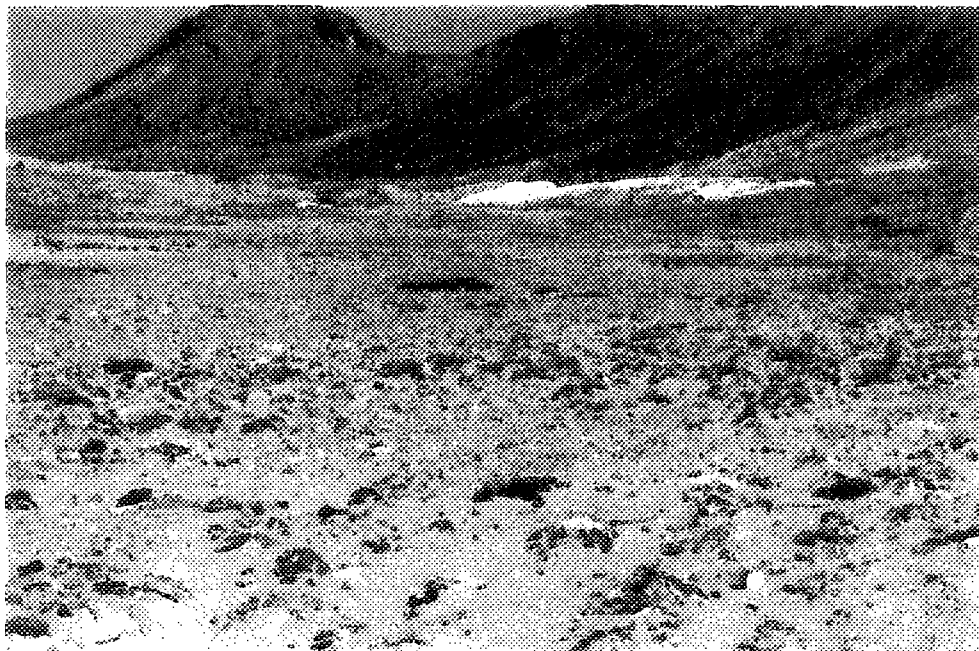
SW-11 LOOKING AT NORTHEAST CANYON AREA FROM NORTH END OF ACTING SETTLEMENT BASIN - white areas are exposed limed sewage sludge, dispersed refuse in silt bottom of basin, foreground

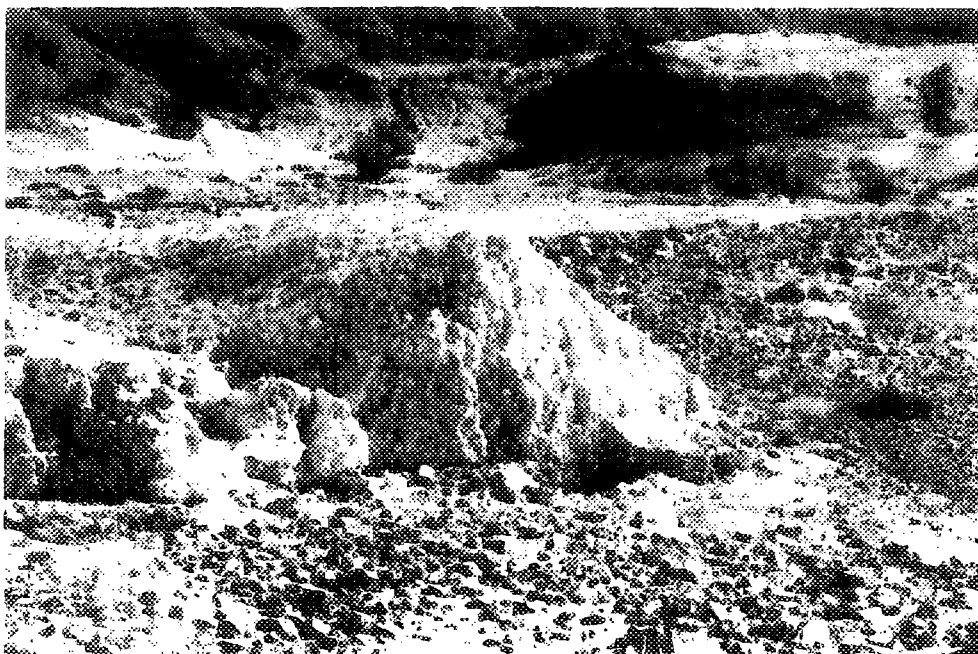
SW-13 NORTHEAST CANYON AREA - lime sludge pile just north of wash-out area in SW-14, shows erosion

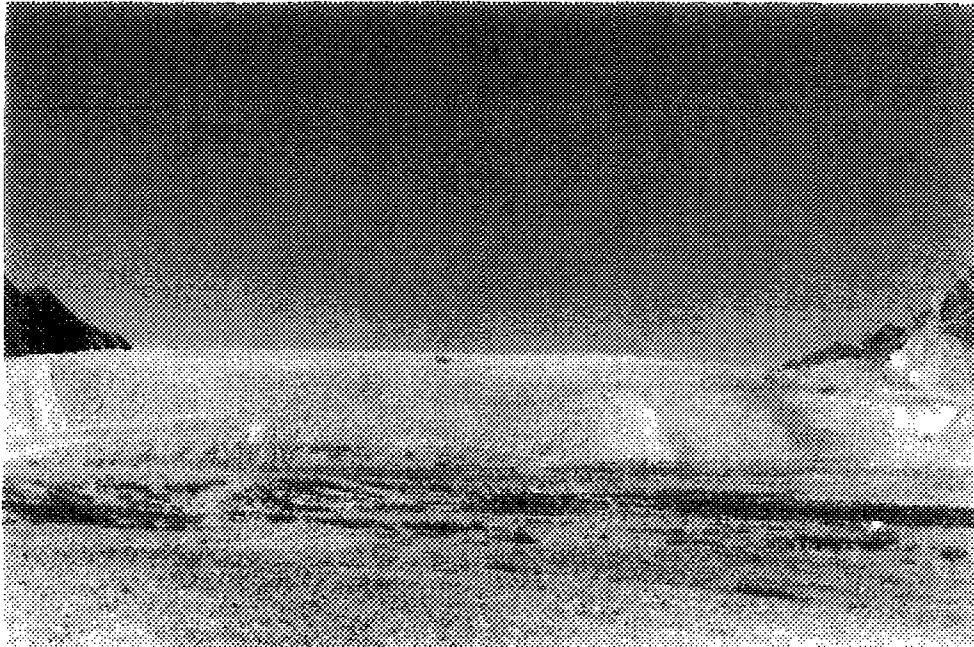
As we returned to our vehicles, on the southern slope to the main upper landfill, in an area actively being regraded during the inspection, we observed four to six-inch deep erosion furrows, but without evidence of exposed waste (photo SW-18).

SW-18 LOOKING AT MAIN LANDFILL SOUTH SLOPE FROM SOUTH LEASE BOUNDARY AREA - being actively reworked during inspection

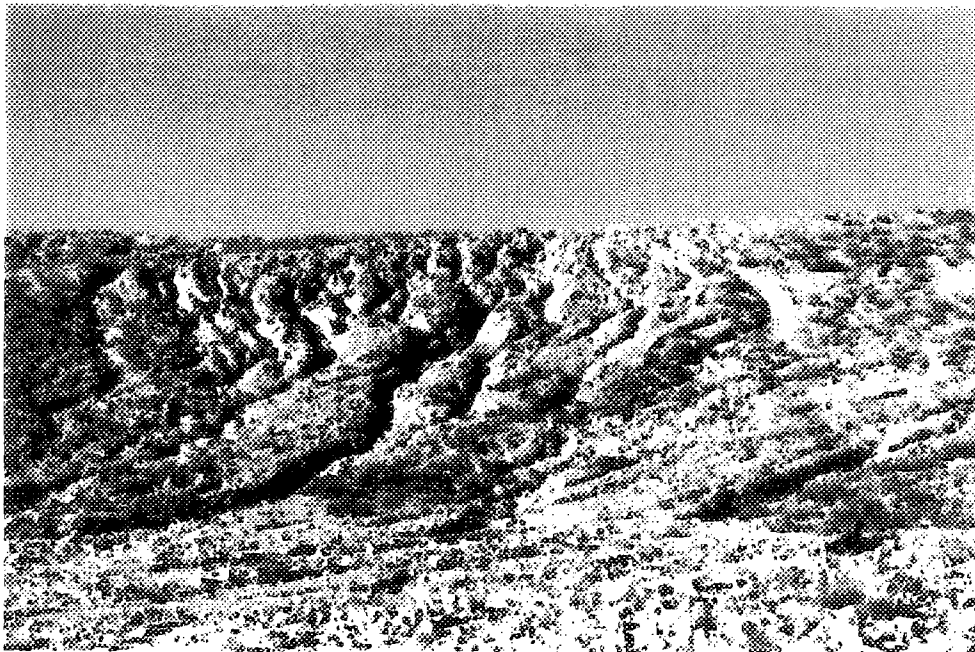
SW-20 LOOKING NORTH FROM SOUTH LEASE BOUNDARY AT SOUTH LANDFILL SLOPE - deep gullies on south slope, trash including medical waste at toe of slope

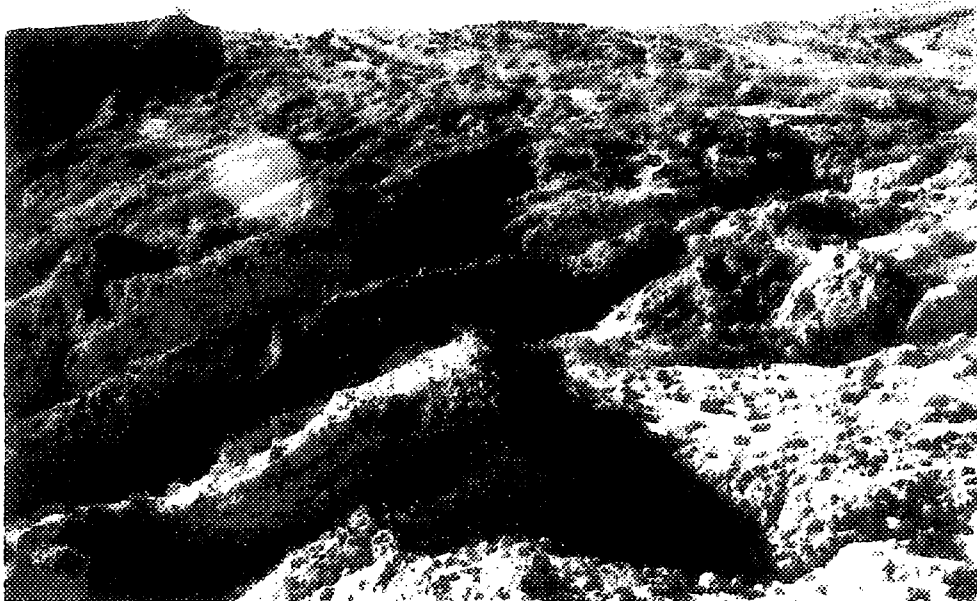
SW-21 LOOKING WEST ALONG SOUTH LEASE BOUNDARY - deep gullies

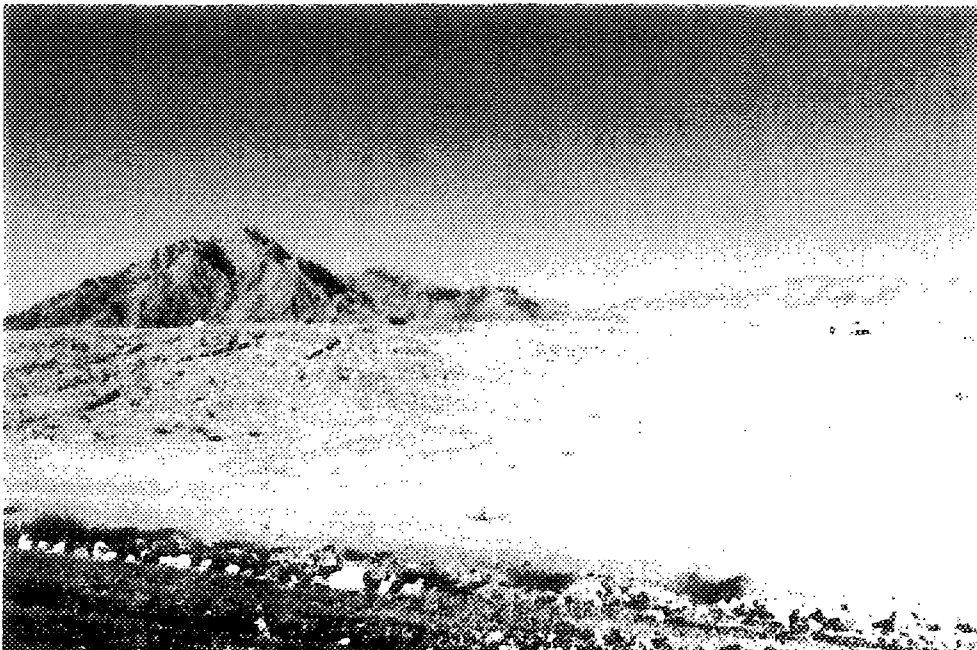
SW-22 LOOKING AT TOE OF LOW PERMEABILITY COVER IN SOUTHWEST AREA - deep rills on slope, with evidence of previous ponding from float remnant

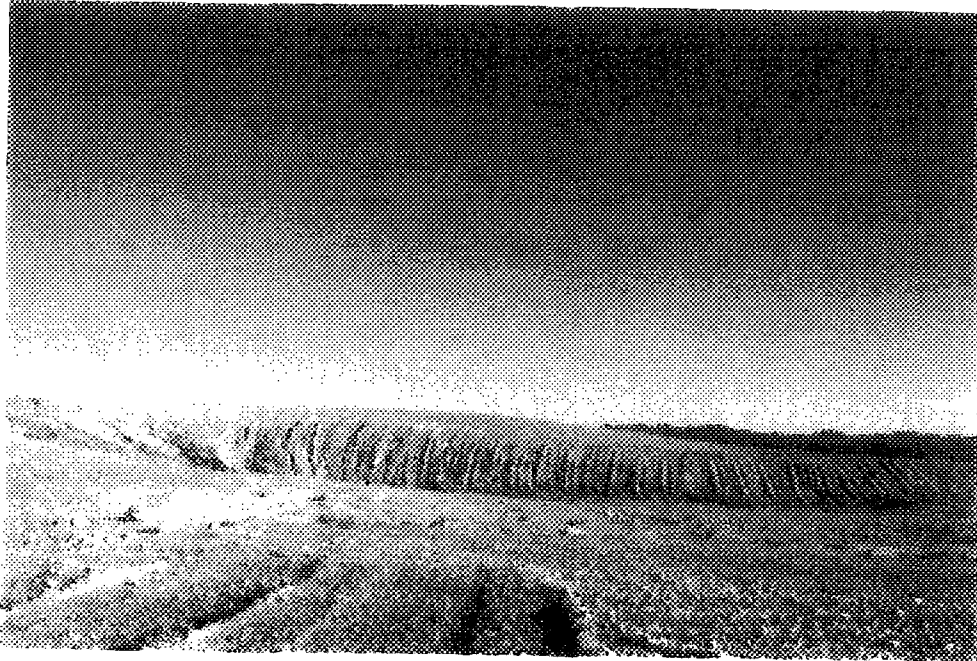
SW-24 LOOKING EAST SOUTHEAST AT EROSION ON FACE OF PRE-91 COVER IN SOUTHWEST CORNER
