UNITED STATES ENVIRONMENTAL PROTECTION AGENCY

Re: Sunrise Mountain Landfill  
Findings of Violation and Order for Compliance  
Docket No. CWA-309-9-99-14

Attachment A-2  
PHOTOS TAKEN BY INSPECTOR JOHN HILLENBRAND, with additional description in  
Attachment A-3)

Attachment A-4  
Excerpted photos from Kandice Bellamy and Steve Wail

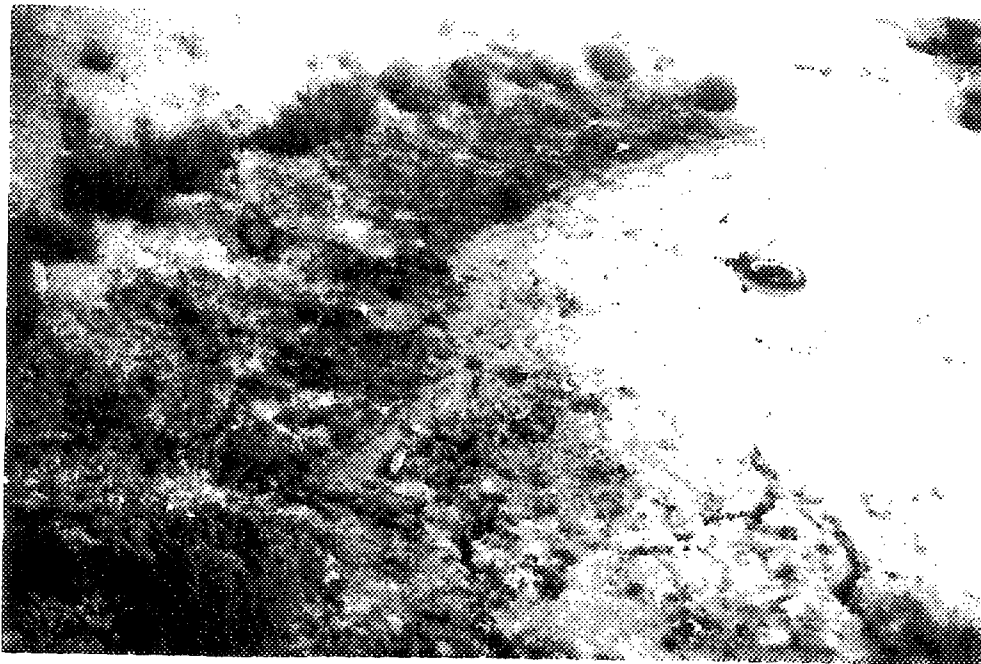
While in the same area, we walked to the Western Burn Pit Area, just outside the west lease boundary, which contained several ponds characterized as "black lagoons," with a dry tar-like residue on the bottoms. We were told by several parties that the County had operated a burn pit in this area at one time. At the edge of one pit, inspectors observed an empty, corroded, partially-buried drum (photo SW-25). No stormwater or drainage controls were evident.

SW-25 LOOKING NORTH FROM SOUTH EDGE OF PREVIOUSLY PONDED AREA IN WEST BURN PIT AREA - tire, tarry bottom
