Fourth Five-Year Review Report

FMC Corporation Yakima

Superfund Site

SEPTEMBER 2013

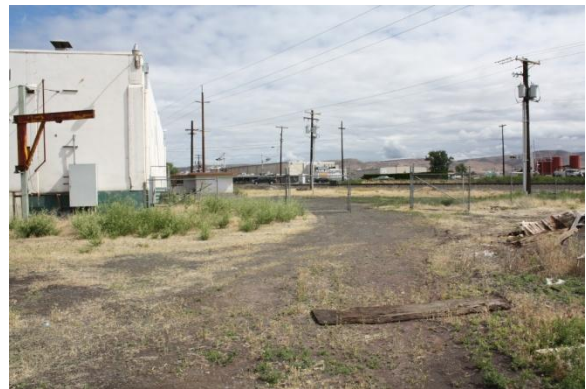
Looking north from the yard at the Stephens Metal Products property. Plume is underneath the location where the photograph was taken and the former pit area is between that position and the warehouse visible in the photograph.

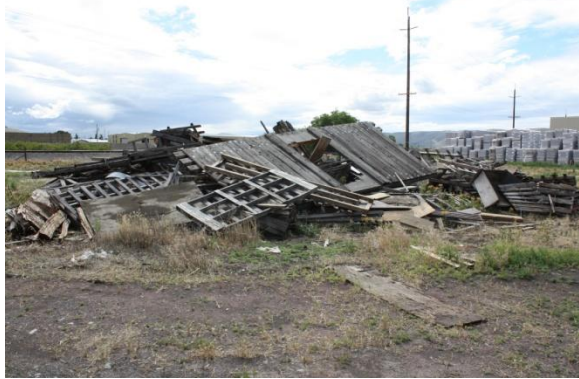
B. Other Site Conditions			
Remarks <u>There was a large pile of debris in the backyard of the Stephens Metal Products owned property. However, it was not in the way of any monitoring wells. Also, some soil was brought in to regrade a portion of the southern border of the Stephens Metals property to make it more level and attractive to a</u>			
VII. LANDFILL COVERS		Applicable	(N/A) Lessee,

Pile of debris in the yard of the Stephens Metal Products property.

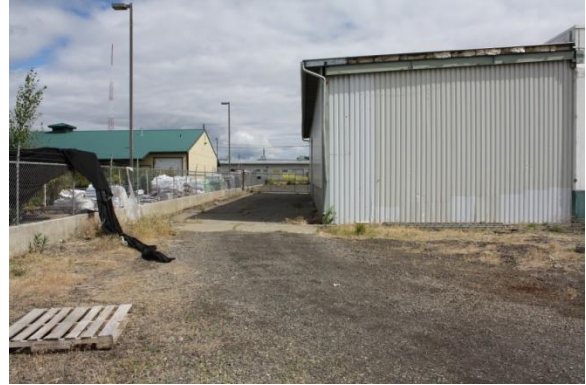
Area between the TrueValue store location and Stephens Metal Products warehouse. Plantings at the store are kept in large above ground planter boxes that are on top of asphalt.

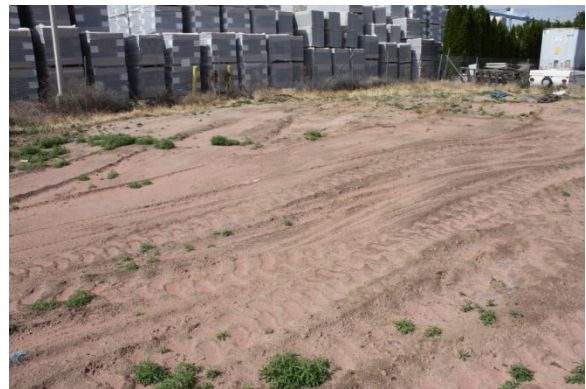
Soil brought in to help grade back part of Stephens Metal Products yard. One of the monitoring wells needed to be uncovered for the fall sampling campaign because it was buried under a couple feet of this material.

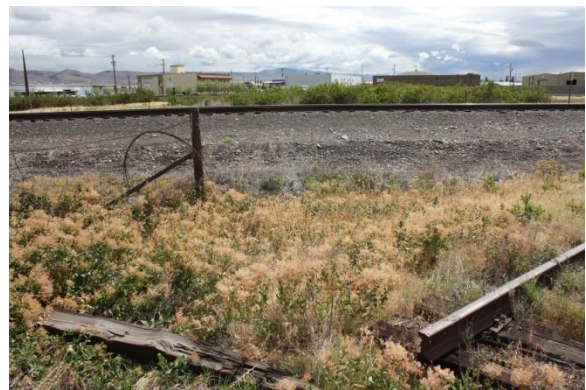
1. **Fencing damaged** Location shown on site map Gates secured N/A
 Remarks No unlocked route for driving onto property.
 However, could access on foot because fence along

Fence down along railroad track (eastern border of the Stephens Metal Products yard).

2.	Adequacy	<input checked="" type="radio"/> ICs are adequate	<input type="radio"/> ICs are inadequate <input type="radio"/> N/A
	Remarks <u>No violation of ICs, however the site would benefit from having eastern fence repaired to prevent trespassing.</u>
