Lower Duwamish Waterway Slip 4 Early Action Area

LONG-TERM MONITORING DATA REPORT: YEAR 4 (2016)

FINAL

January 12, 2017

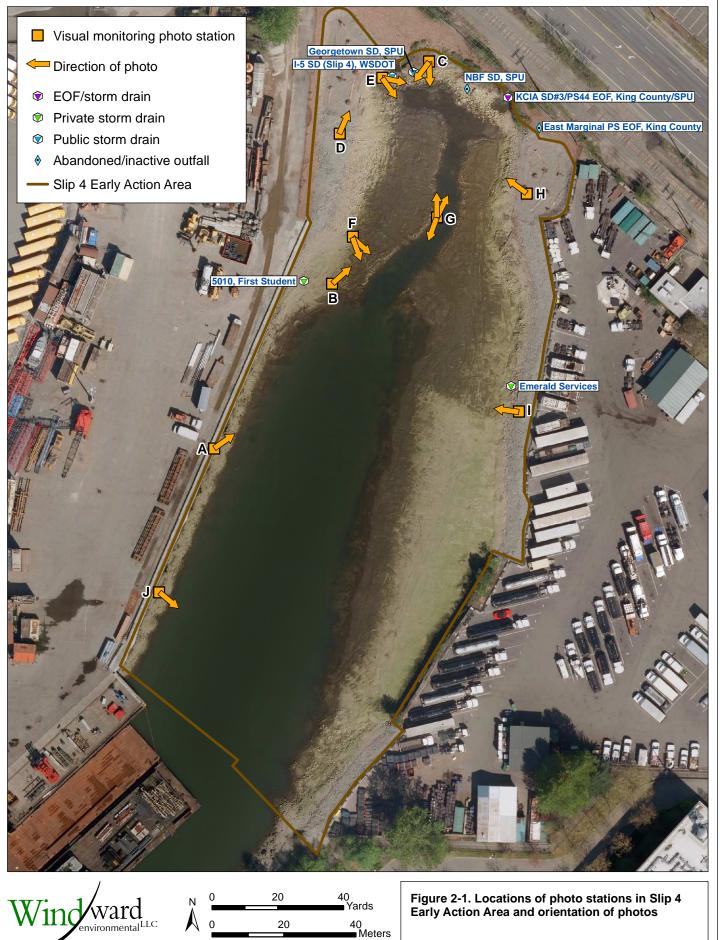
During prior years' surveys, photo station locations were marked using brightly painted rebar stakes. All such stakes were still upright during the Year 4 (2016) inspection and were repainted by field personnel. Visual inspection forms and copies of the field logbook (Appendices B and D, respectively) were used to record observations of conditions in the areas represented by the photographs (Appendix C1). Figure 2-2 presents the nomenclature of the cap areas surveyed; a summary of the visual inspection observations is provided in Table 2-2.

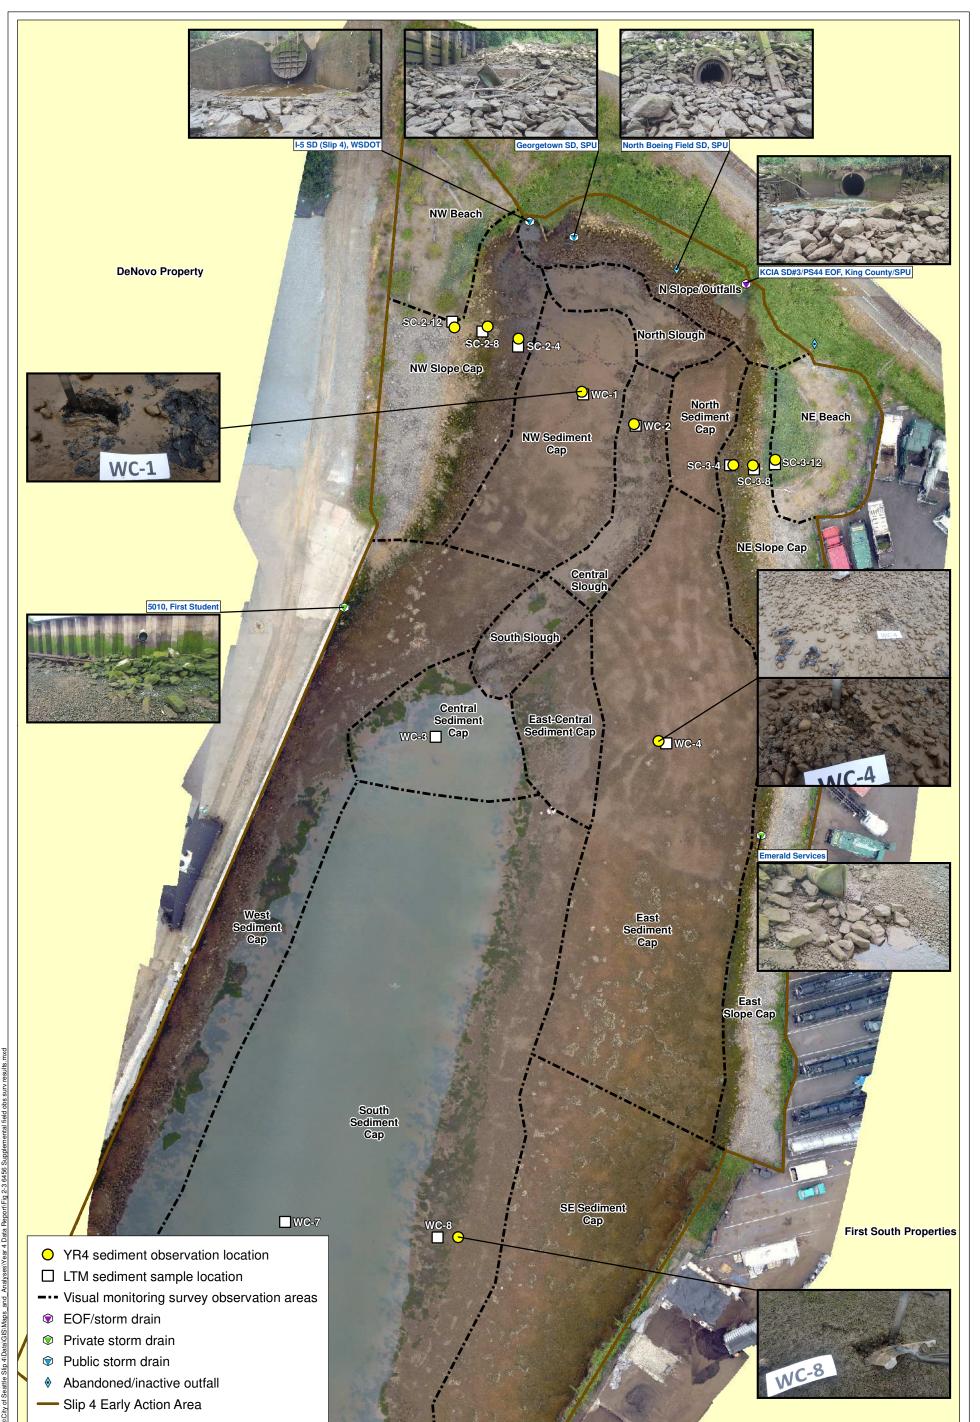
Figure 2-3. Unmanned aerial vehicle (UAV) image with field observation and outfall locations

A UAV was used to collect aerial imagery of the Slip 4 EAA during the low tide to document the condition of the exposed portion of the cap. A mosaic image of the flight was created from the images collected by the UAV (Figure 2-3). This image and images taken in future years may be used to help identify changes in areas where fine silt has been deposited on the cap. Generally, depositional areas can be determined by comparing the color differences between darker areas, which represent the gravel cap surface, and lighter areas, which represent deposited material. Field observations indicate that the deposited material tends to have a light gray surface approximately 1 cm thick; the remaining depth of the deposit is black.

- Accumulated fine sediment was frequently observed, and accumulation depths varied within small areas throughout the entire Slip 4 EAA (Table 2-2). The aerial images produced by the UAV survey show the patchiness of the distribution of fine sediment throughout the slip, with considerable variability in the thickness of the accumulated sediment within each area (Figure 2-3). In general, there was less accumulated sediment in the slope cap areas and towards the mouth of the slip, except for some mounding of fine material at the base of outfalls on the north slope cap and along the downslope edge of the west sediment cap (Figure 2-3). The slough areas were observed to have some of the thickest accumulation (e.g., up to 22 cm in the south slough). Sediment accumulations in the slough areas appears to have increased since Year 3 monitoring in 2015 (Figure 4-1).

The UAV data collected during the supplemental field observations provided useful insight to the sediment fines depositional areas that are difficult to study solely through the established visual survey methods and photographs. To better capture the spatial variability and dynamics of sediment deposition over time, Windward recommends including a UAV survey component in future long-term monitoring efforts, now that a real-time baseline aerial image has been established for the EAA.
