SECOND PERIODIC REVIEW

**GENERAL ELECTRIC SPOKANE SITE
SPOKANE, WA**

TOXICS CLEANUP PROGRAM

APRIL 2008

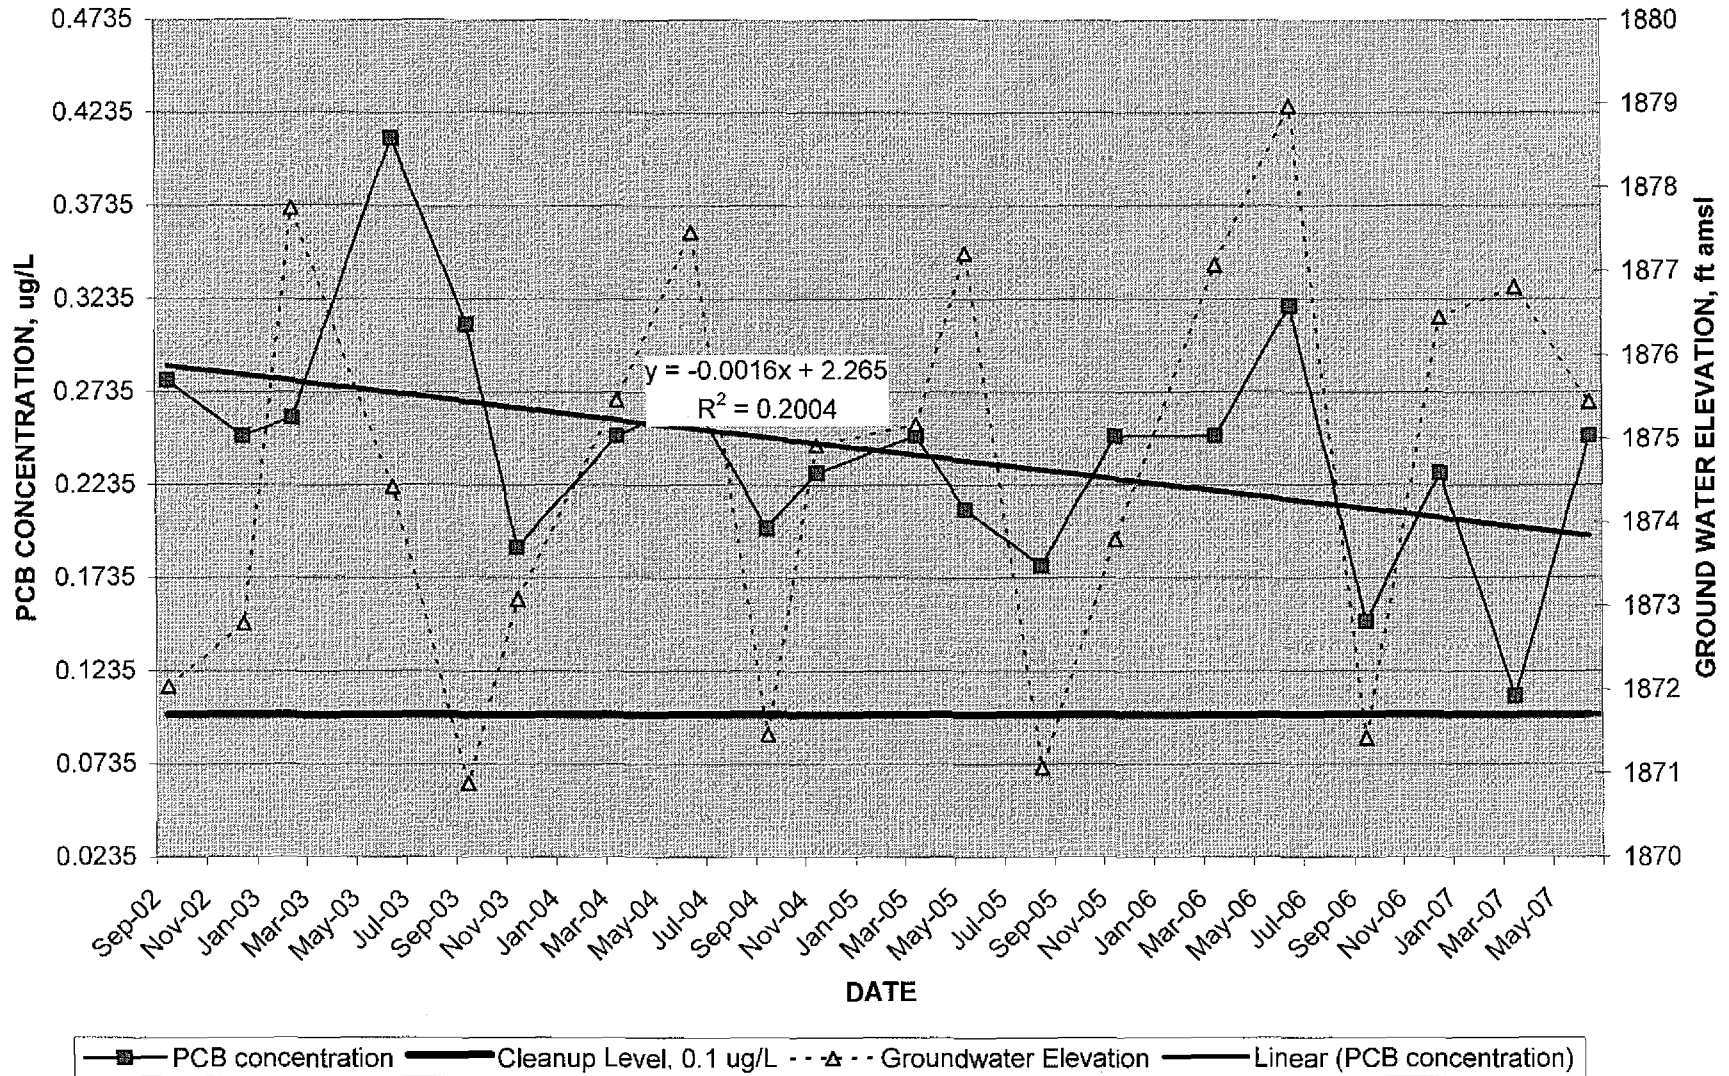
FIGURE 11. MW18 PCB CONCENTRATIONS AND GROUND WATER ELEVATIONS

PCB detections were all below the cleanup level. Higher detections occurred following high ground water elevation periods.

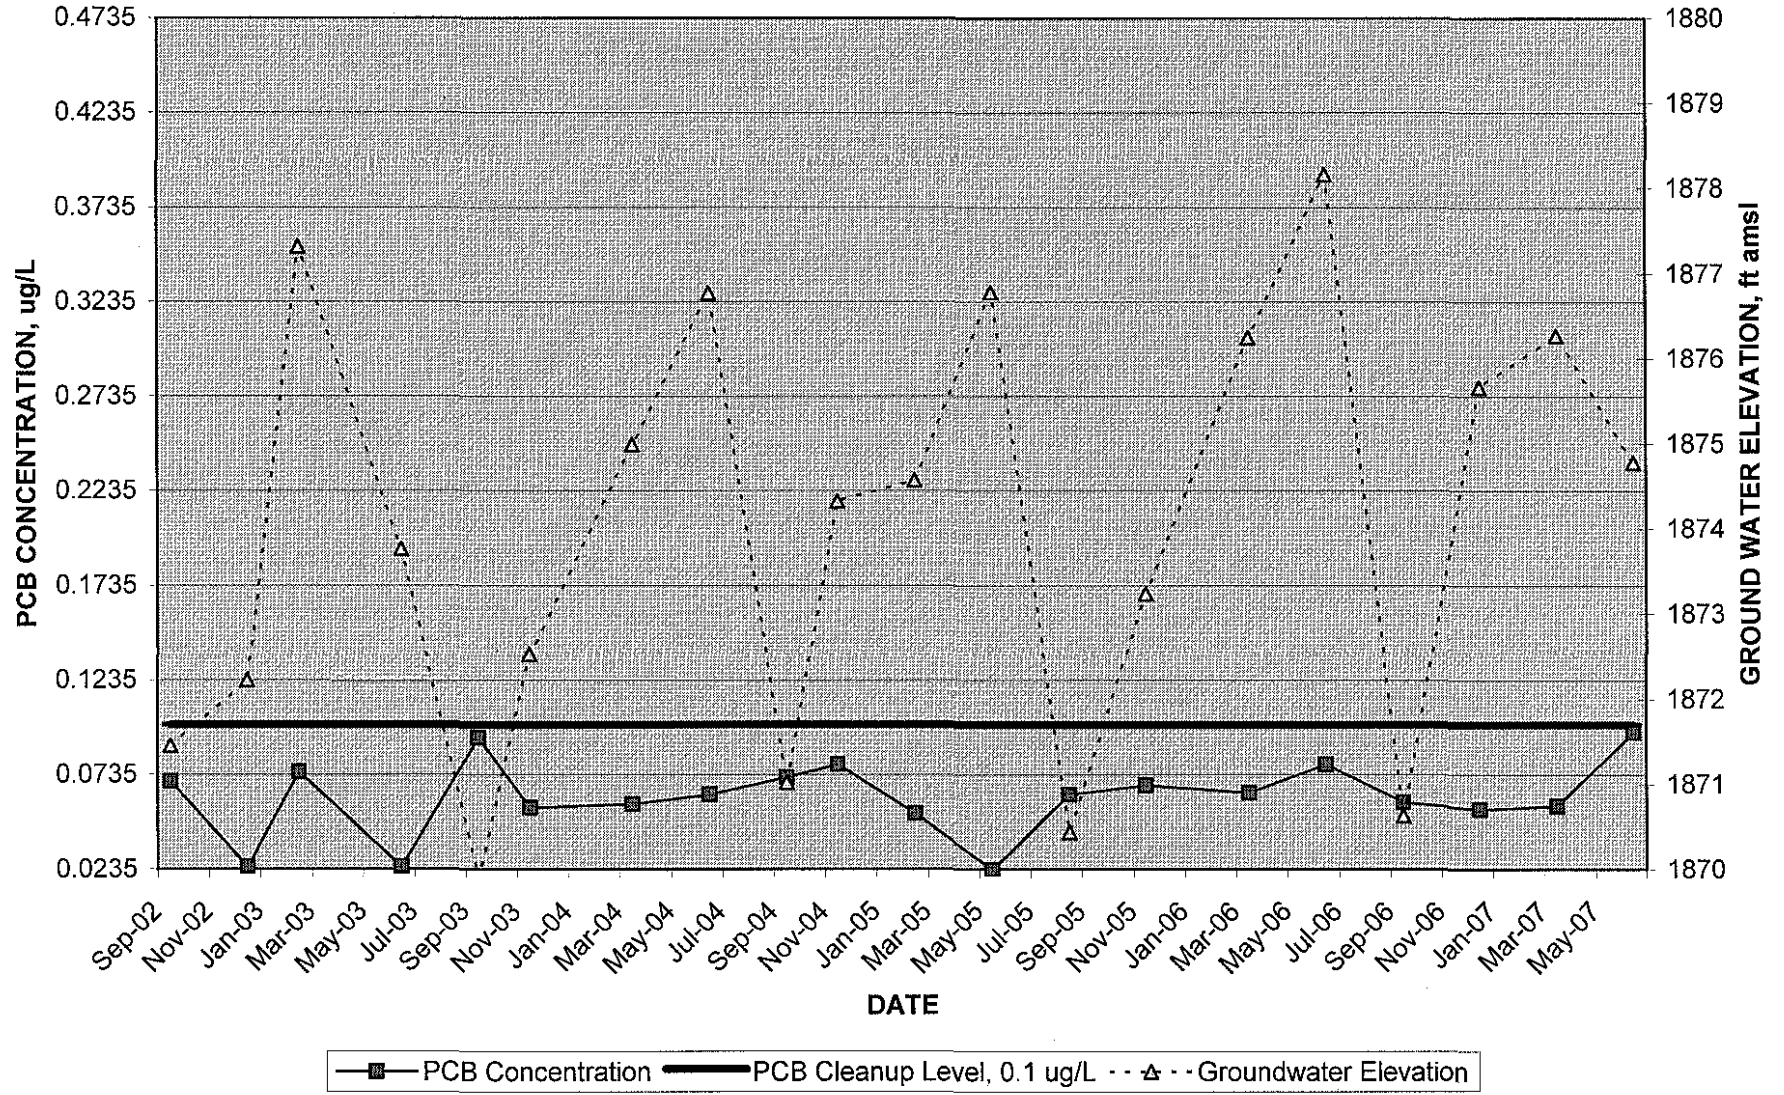
FIGURE 12. MW22 PCB CONCENTRATIONS AND GROUND WATER ELEVATIONS

This is the monitoring well that is closest to the Spokane River. PCB concentrations throughout this review period were nondetects except for one that is below the cleanup level observed in June 2003.
