SECOND PERIODIC REVIEW

GENERAL ELECTRIC SPOKANE SITE SPOKANE, WA

TOXICS CLEANUP PROGRAM

APRIL 2008

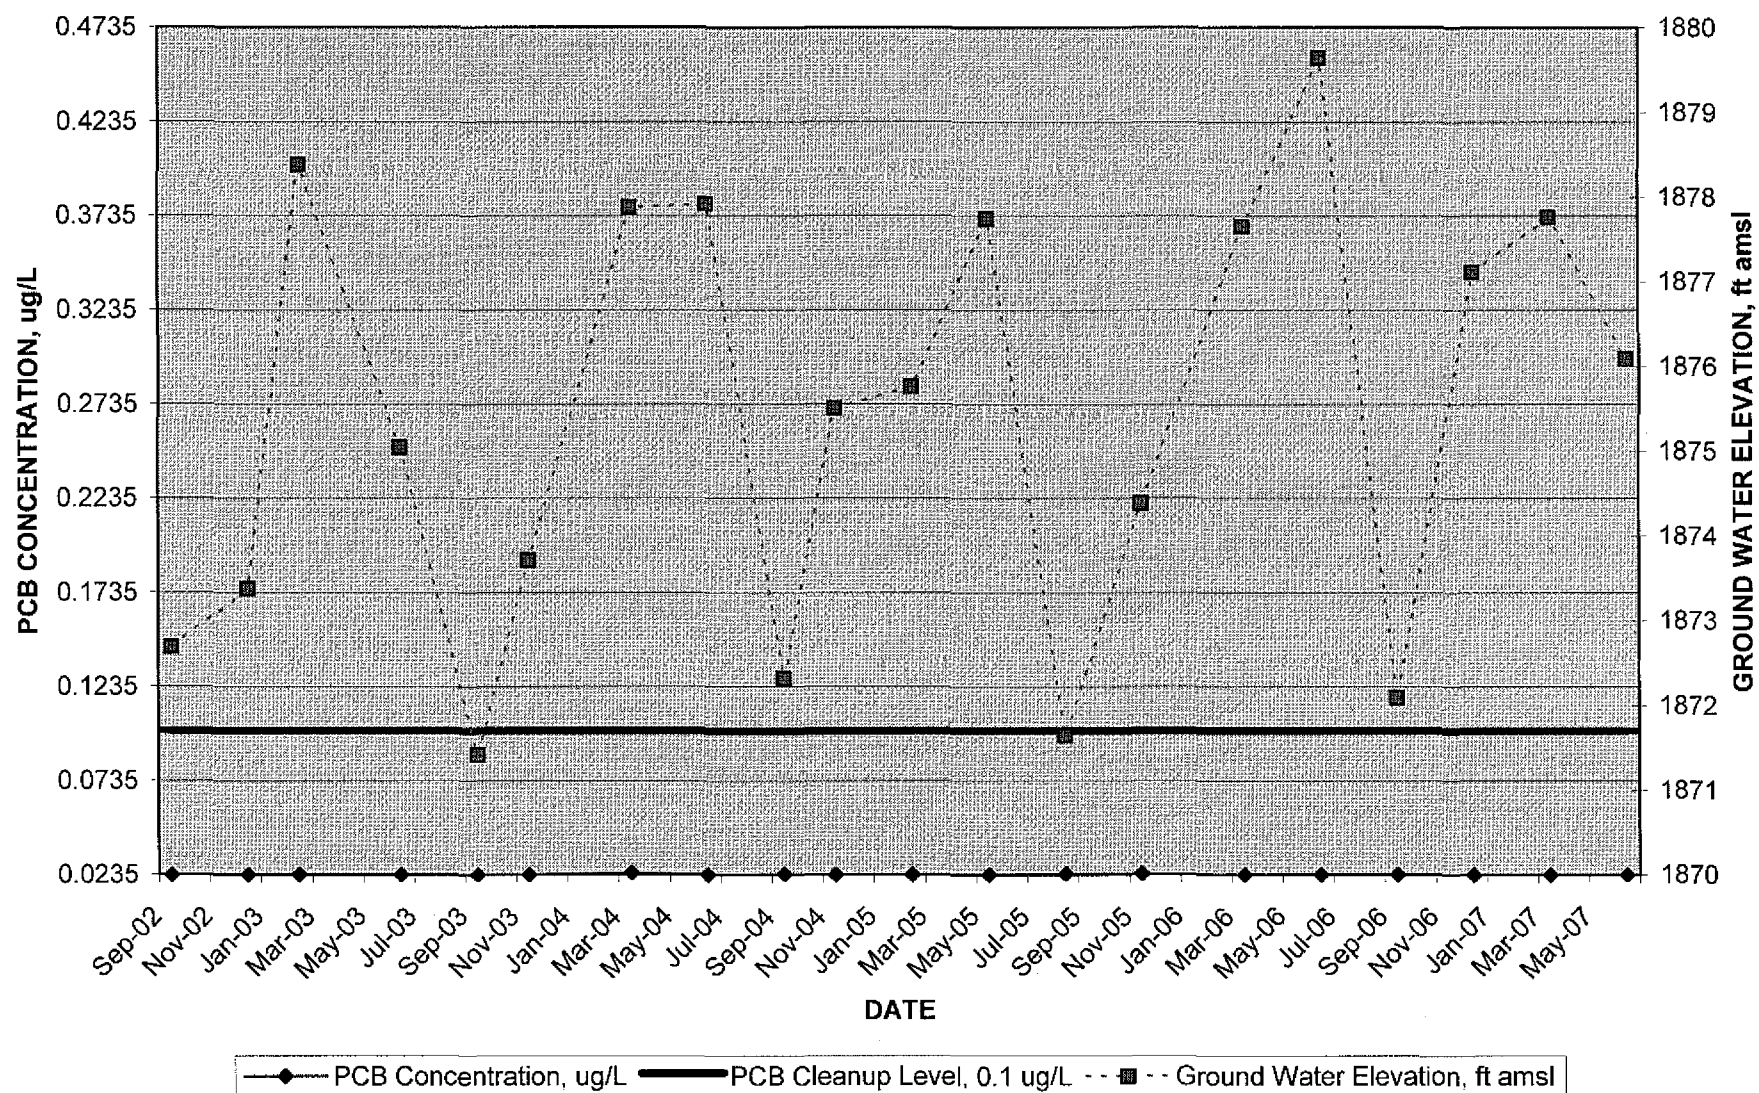
FIGURE 5. MW01 PCB CONCENTRATIONS AND GROUND WATER ELEVATIONS

MW01 (Figure 5)

This is the upgradient well. PCBs in this well were all nondetects.

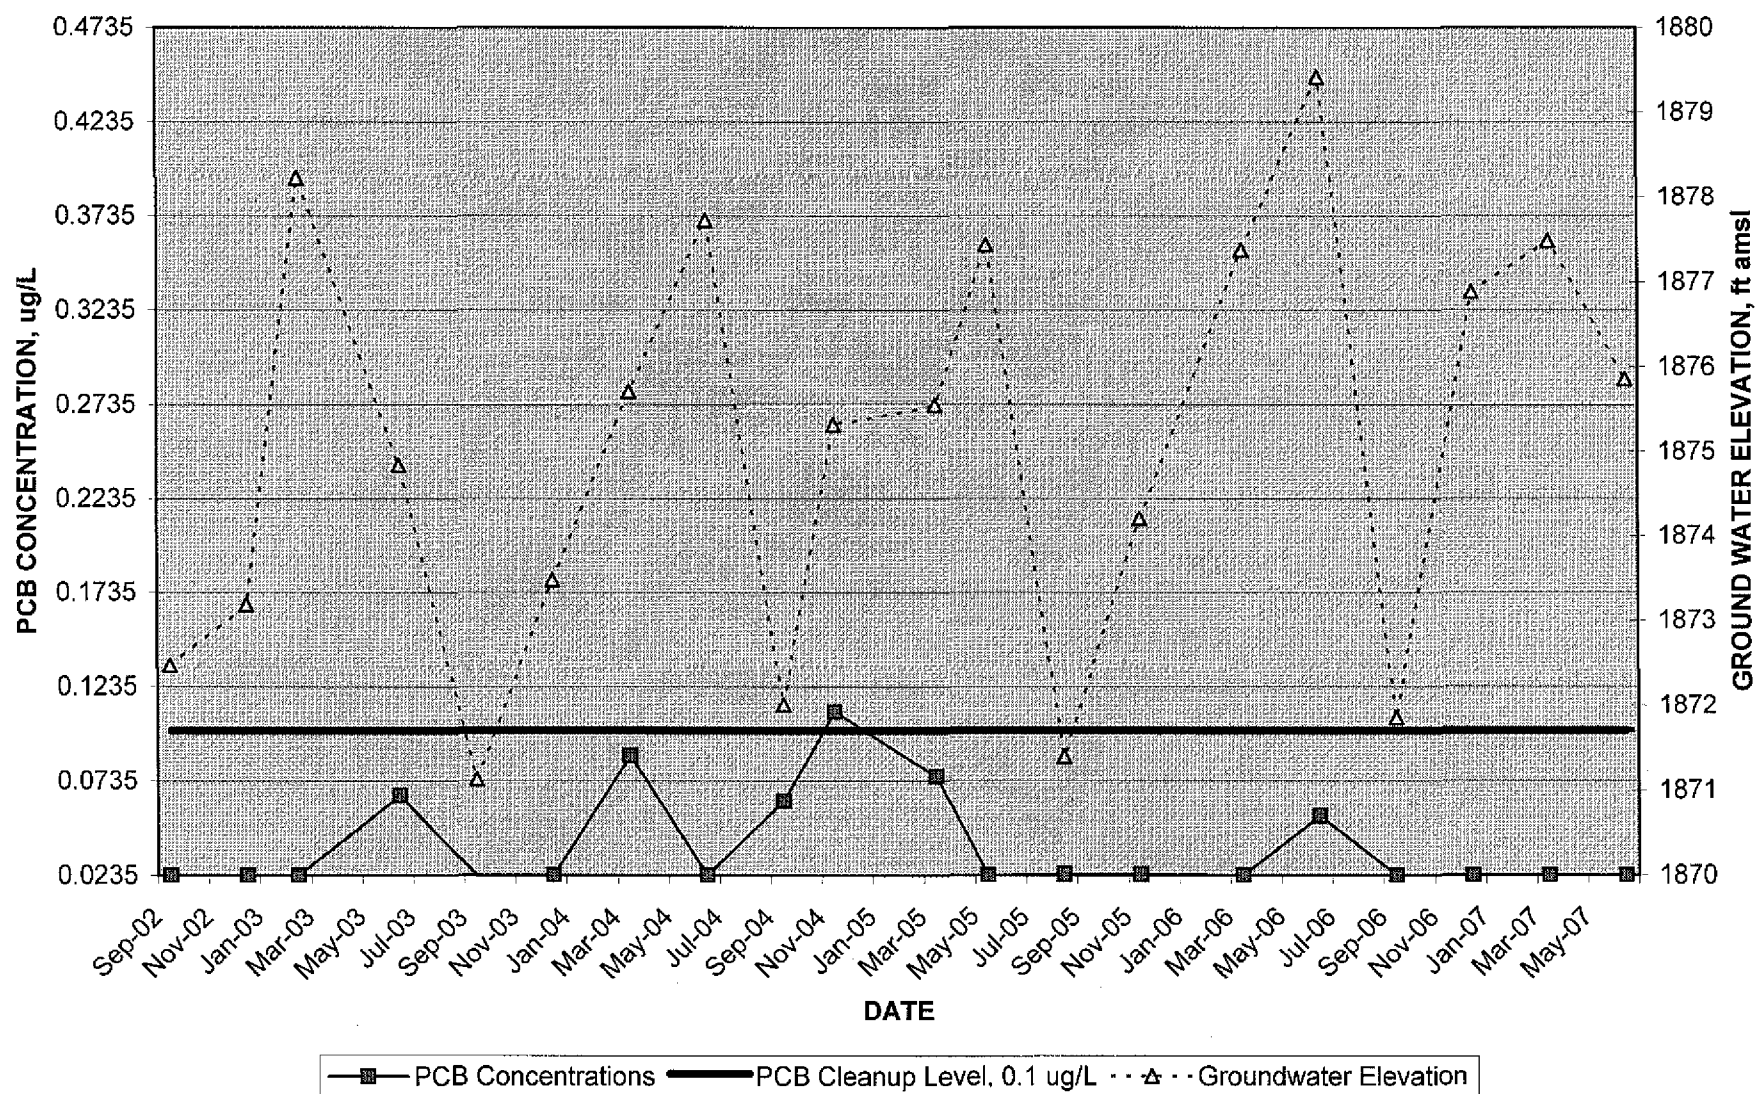
FIGURE 6. MW20 PCB CONCENTRATIONS AND GROUND WATER ELEVATIONS

MW20 (Figure 6)

This well is in the vicinity of the West Dry Well, the PCB source area and the grouted zone. PCBs were detected in seven out of the twenty sampling events and exceeded the cleanup level only once (at 0.11 ug/L) in November 2004. From May 2005 through June 2007, PCBs were detected only once in June 2006 but was below the cleanup level. Higher detections were associated with higher ground water elevations.

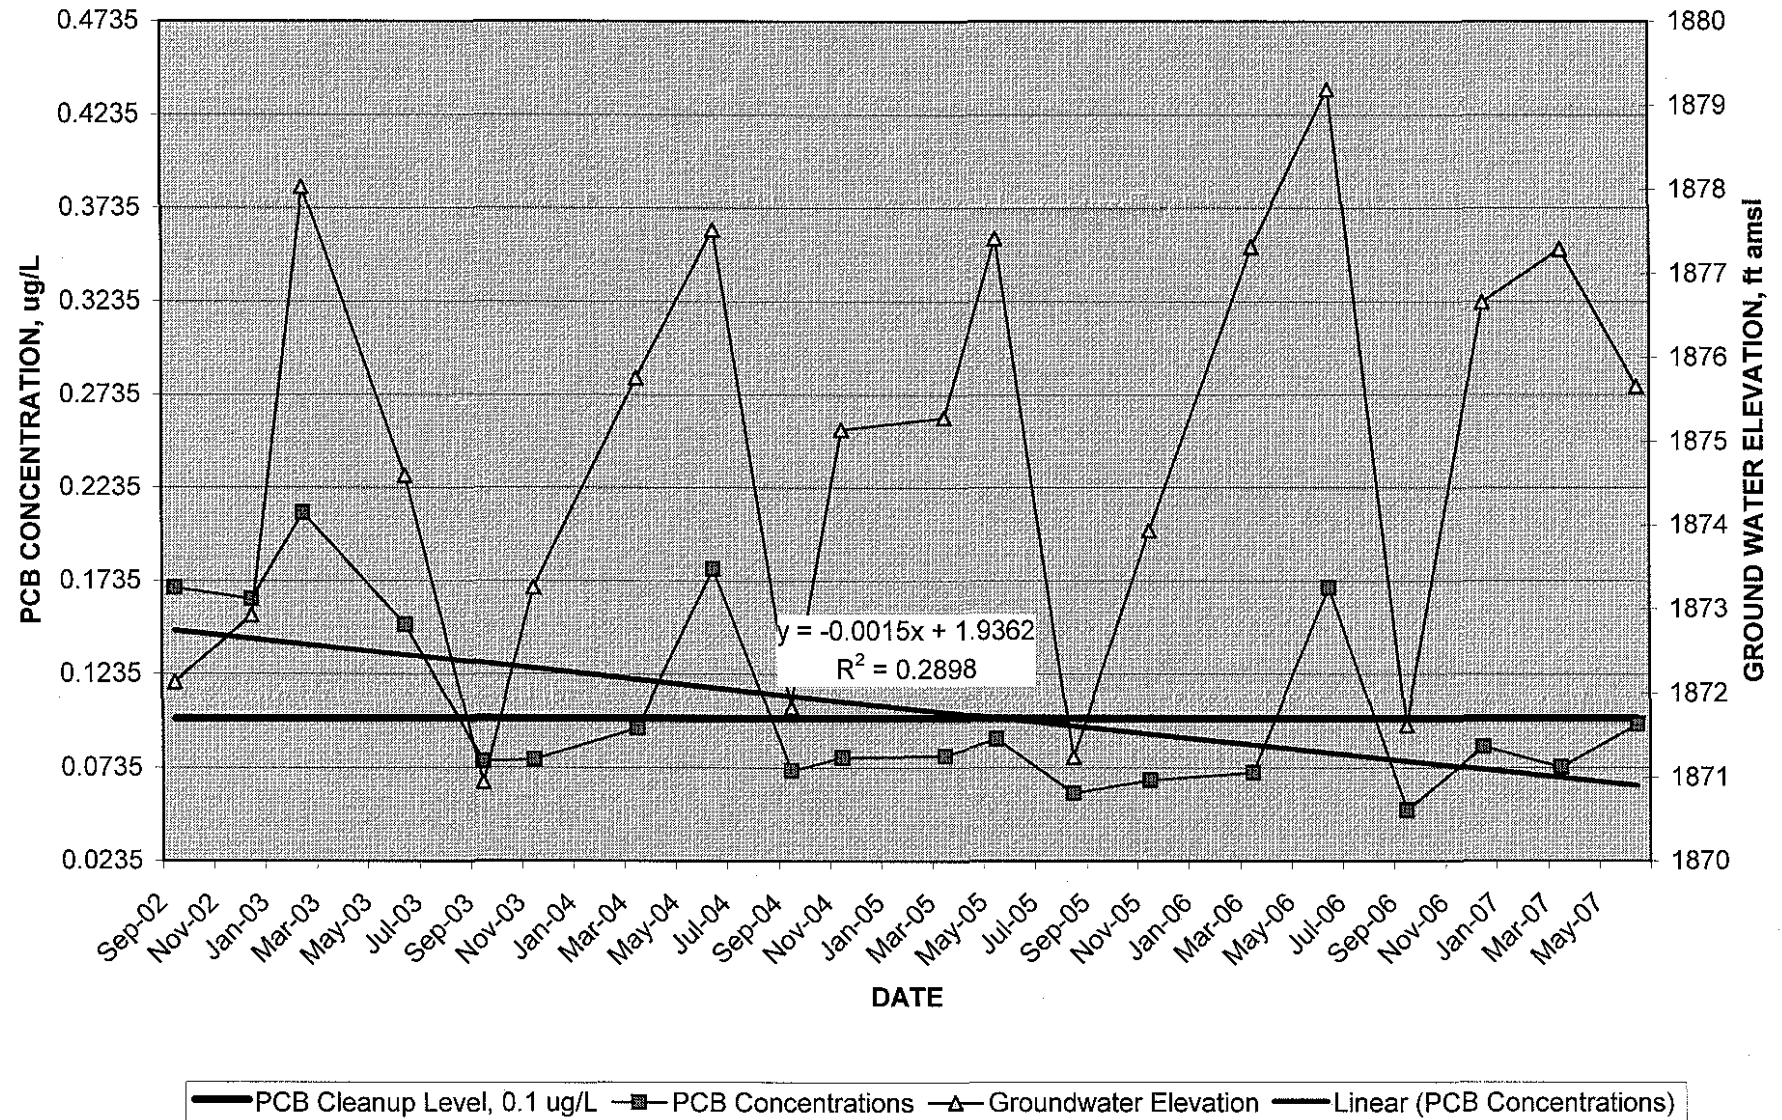
FIGURE 7. MW19 PCB CONCENTRATIONS AND GROUND WATER ELEVATIONS

MW19 (Figure 7)

This well is downgradient of the West Dry Well. PCBs were detected in this well throughout this review period. PCB concentrations initially exceeded the cleanup level during 2002 and 2003. However, from September 2003 through June 2007, cleanup levels were exceeded only twice: June 2004 at 0.18 ug/L and June 2006 at 0.17 ug/L. Both concentrations are less than two times the cleanup level. These two concentrations occurred at the highest ground water elevation for the particular year. The observed concentrations show a decreasing trend in PCB concentrations despite the general increasing trend in ground water elevations at the Site.

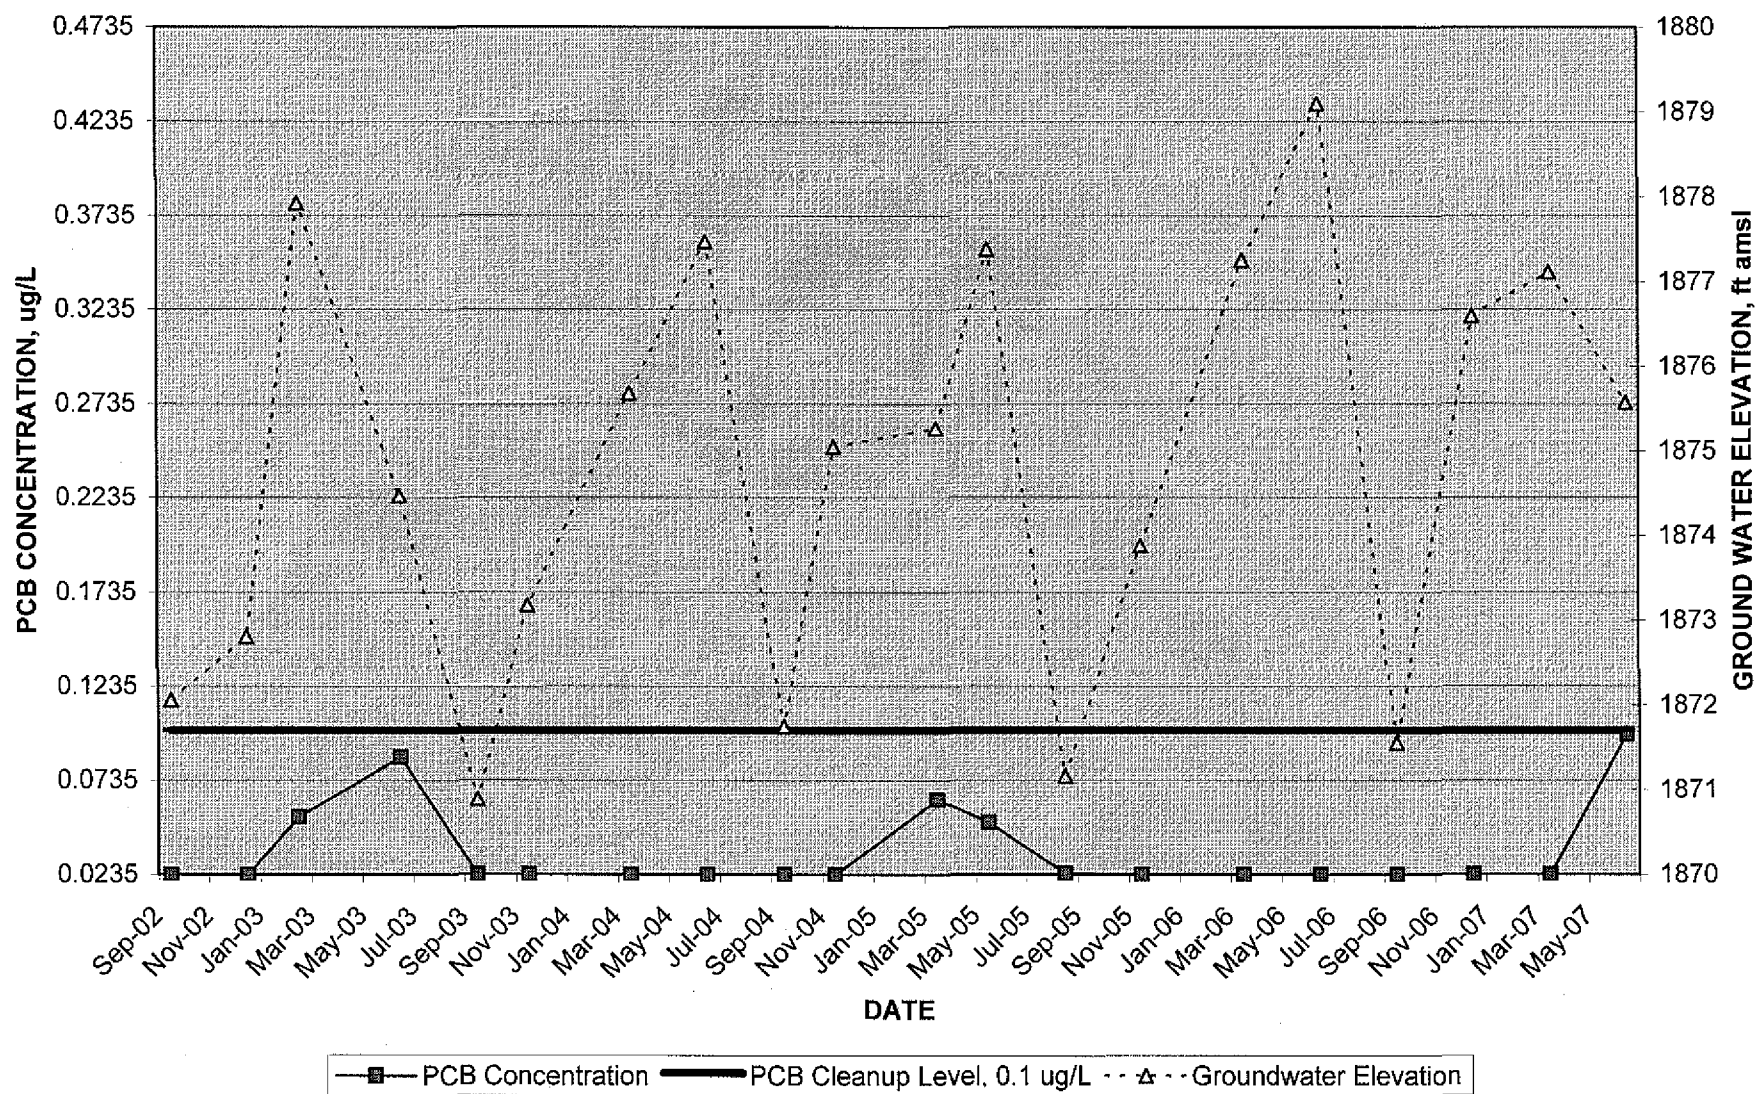
FIGURE 8. MW21 PCB CONCENTRATIONS AND GROUND WATER ELEVATIONS

MW21 (Figure 8)

PCB detections in this well were very sporadic. These detections did not exceed cleanup levels. This well appears to be near the edge of a long narrow plume. Higher detections occurred during high ground water elevations.

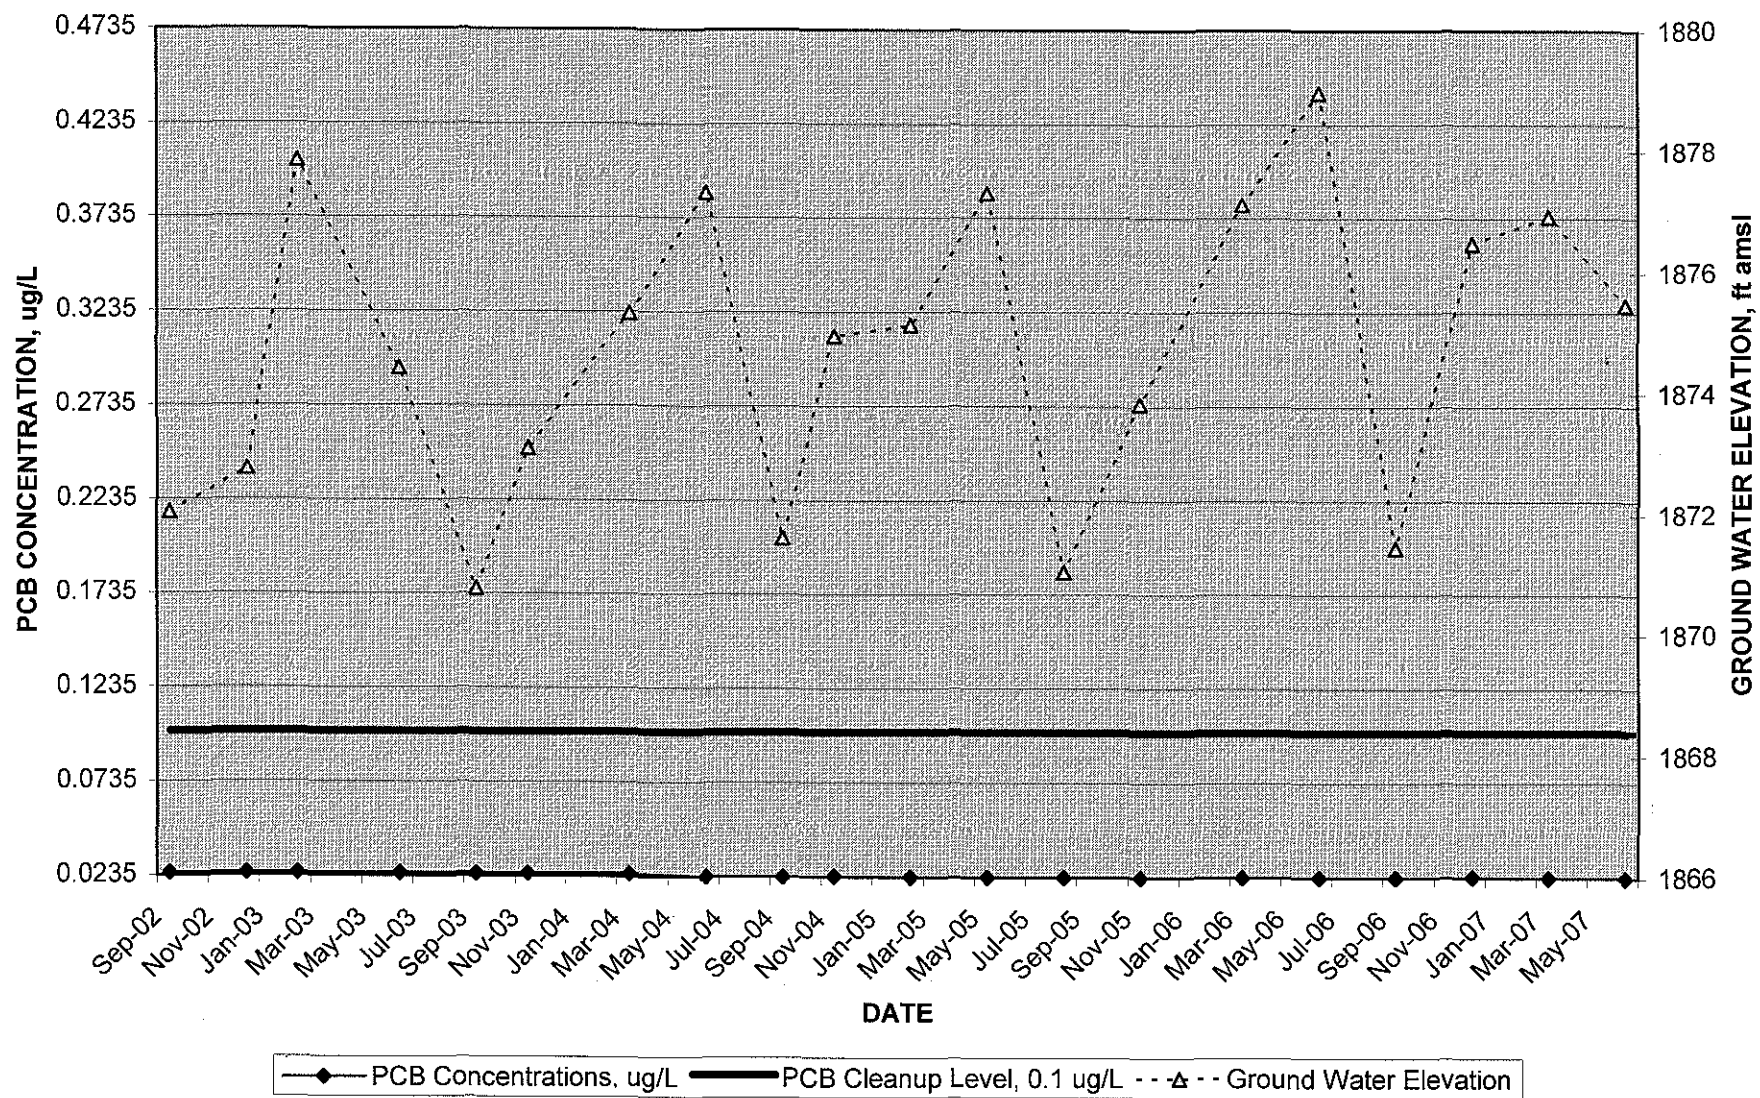
FIGURE 9. MW10 PCB CONCENTRATIONS AND GROUND WATER ELEVATIONS

MW10 (Figure 9)

PCB concentrations in this well were all nondetects for the second five-year review period.

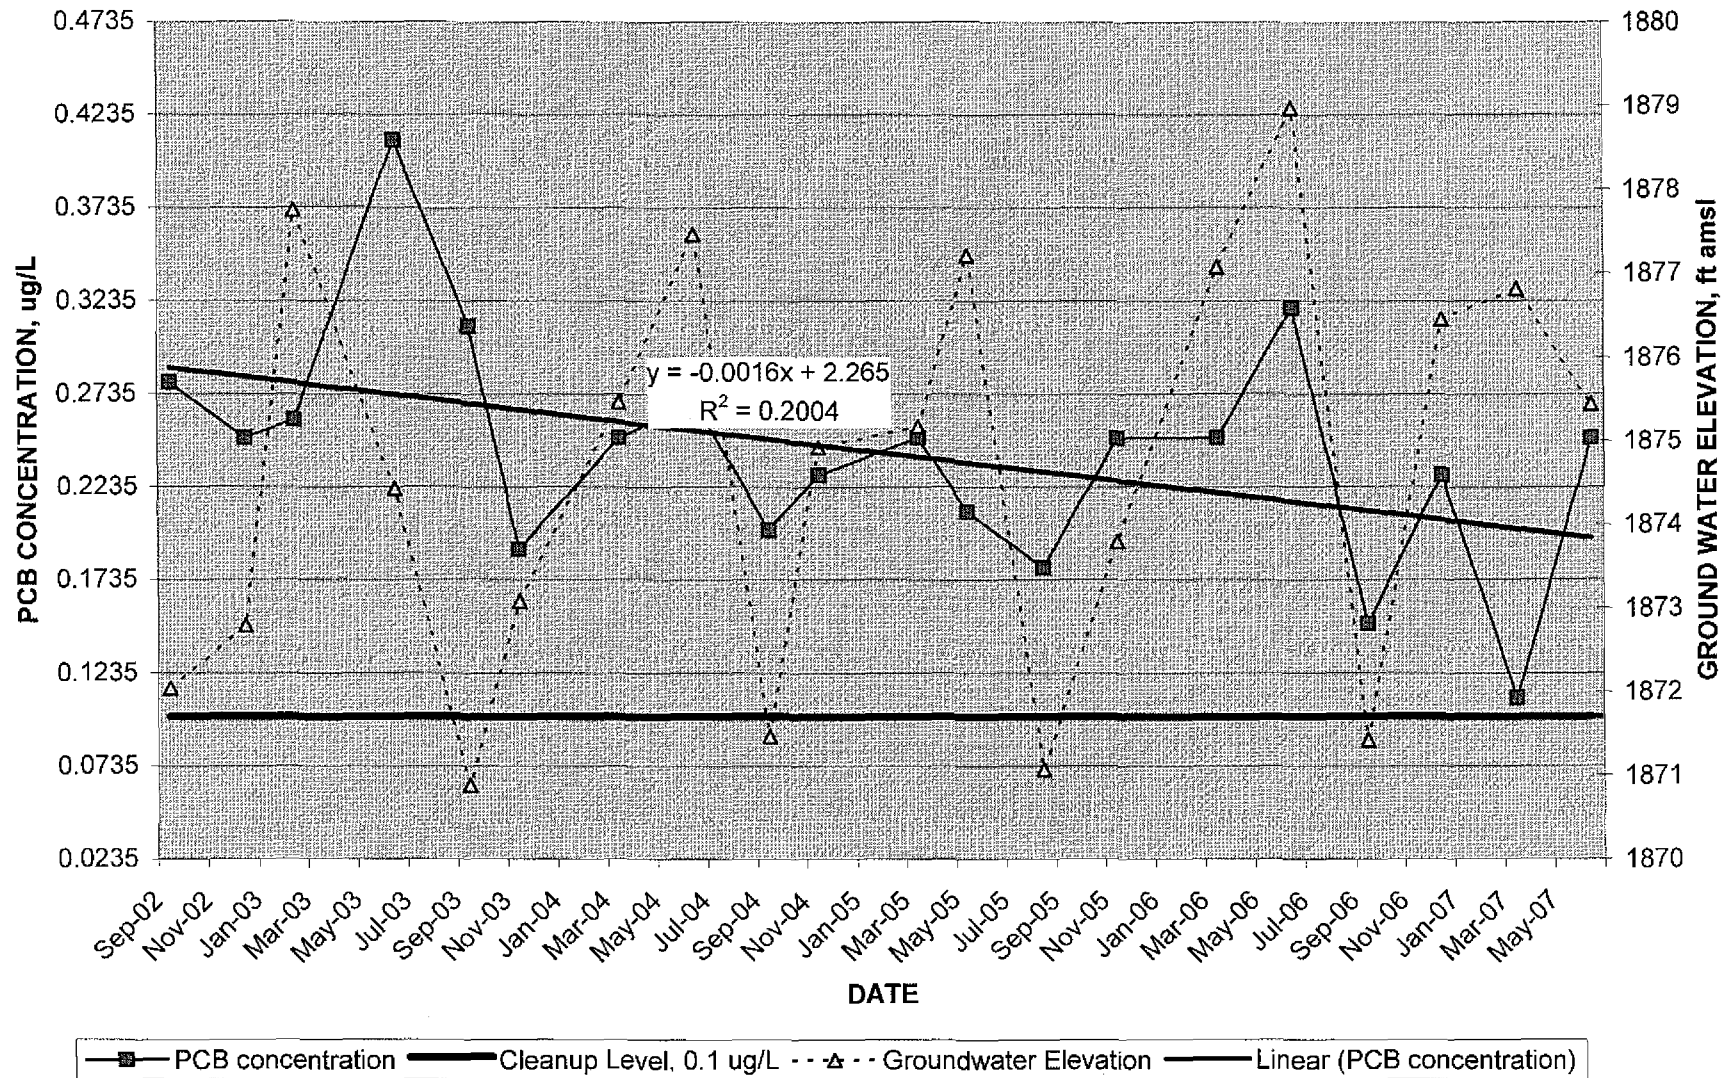
FIGURE 10. MW11 PCB CONCENTRATIONS AND GROUND WATER ELEVATIONS

MW11 (Figure 10)

This is the only well that consistently showed PCB concentrations above the cleanup level. PCB concentrations appear to be strongly correlated to ground water elevations with the maximum PCB concentrations for each year occurring during or slightly following the highest ground water elevations. Observed maximum concentrations for each year have been decreasing even though ground water elevations have been increasing. PCB concentrations during this review period exhibit a decreasing trend despite increasing ground water elevations.

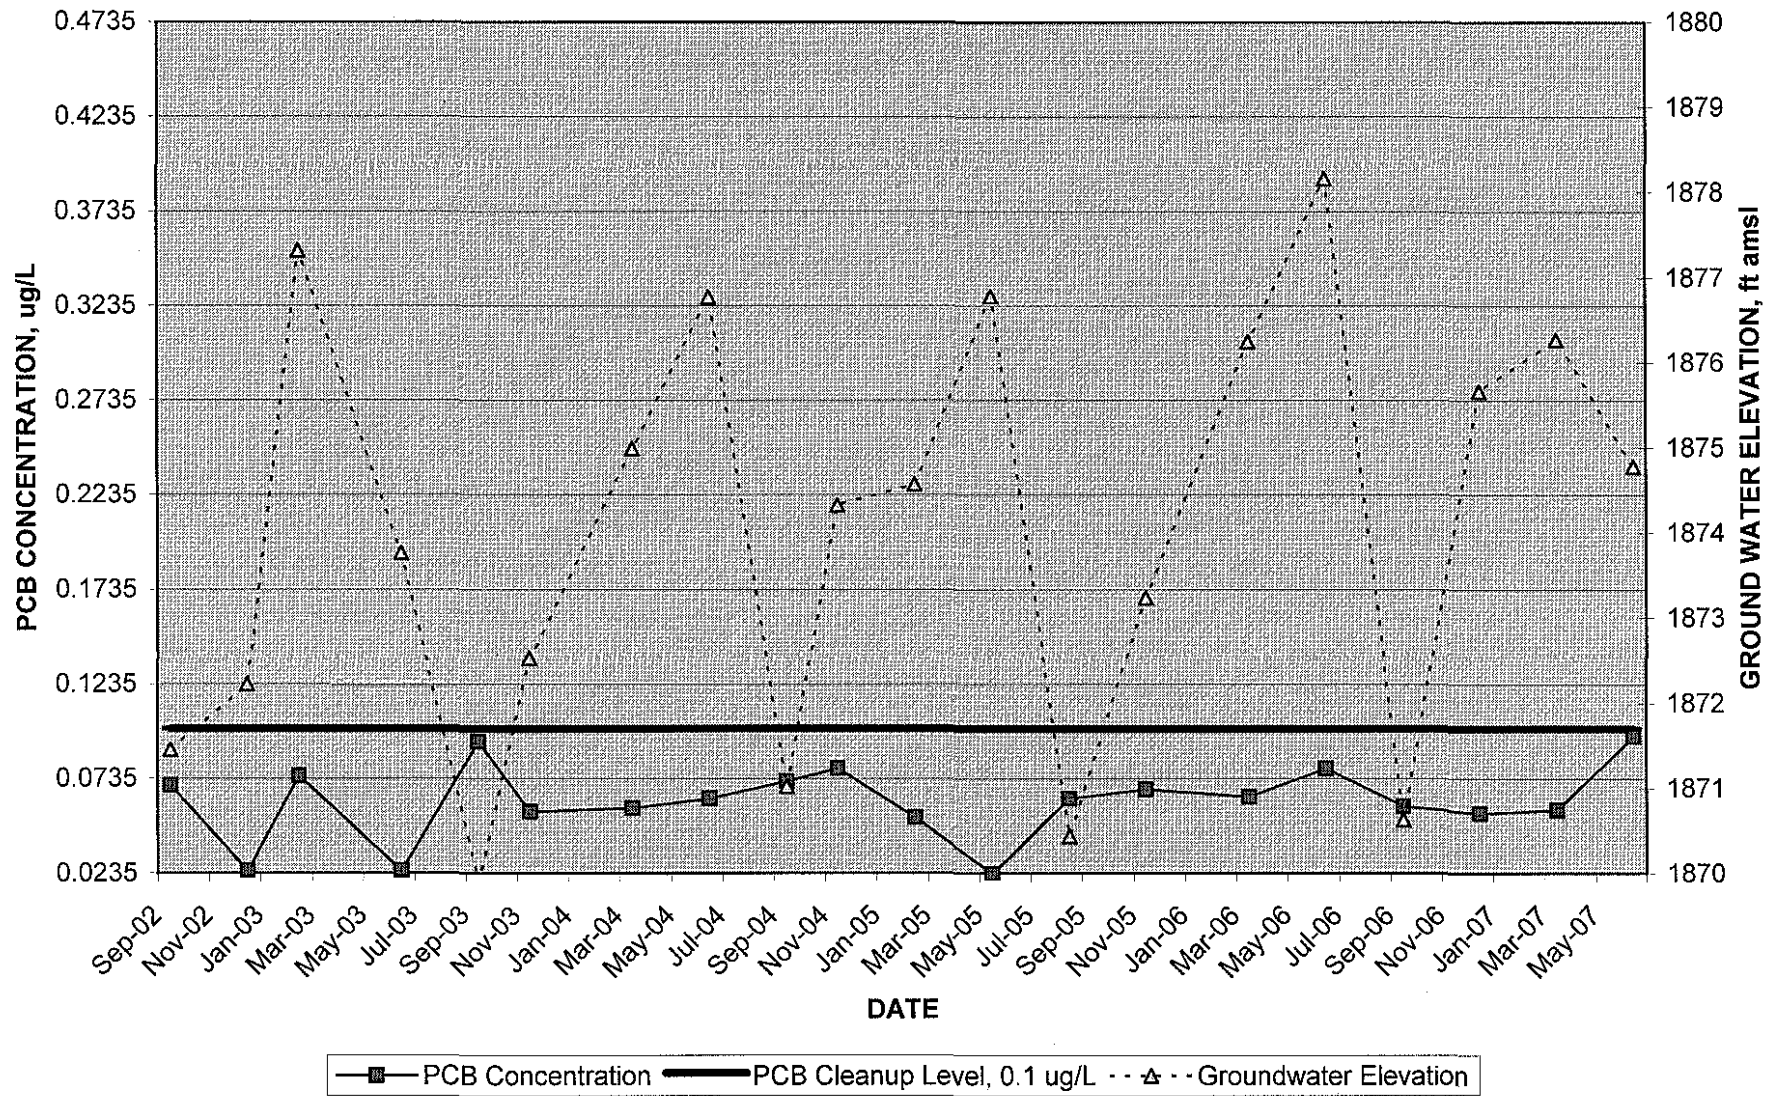
FIGURE 11. MW18 PCB CONCENTRATIONS AND GROUND WATER ELEVATIONS

MW18 (Figure 11)

PCB detections were all below the cleanup level. Higher detections occurred following high ground water elevation periods.

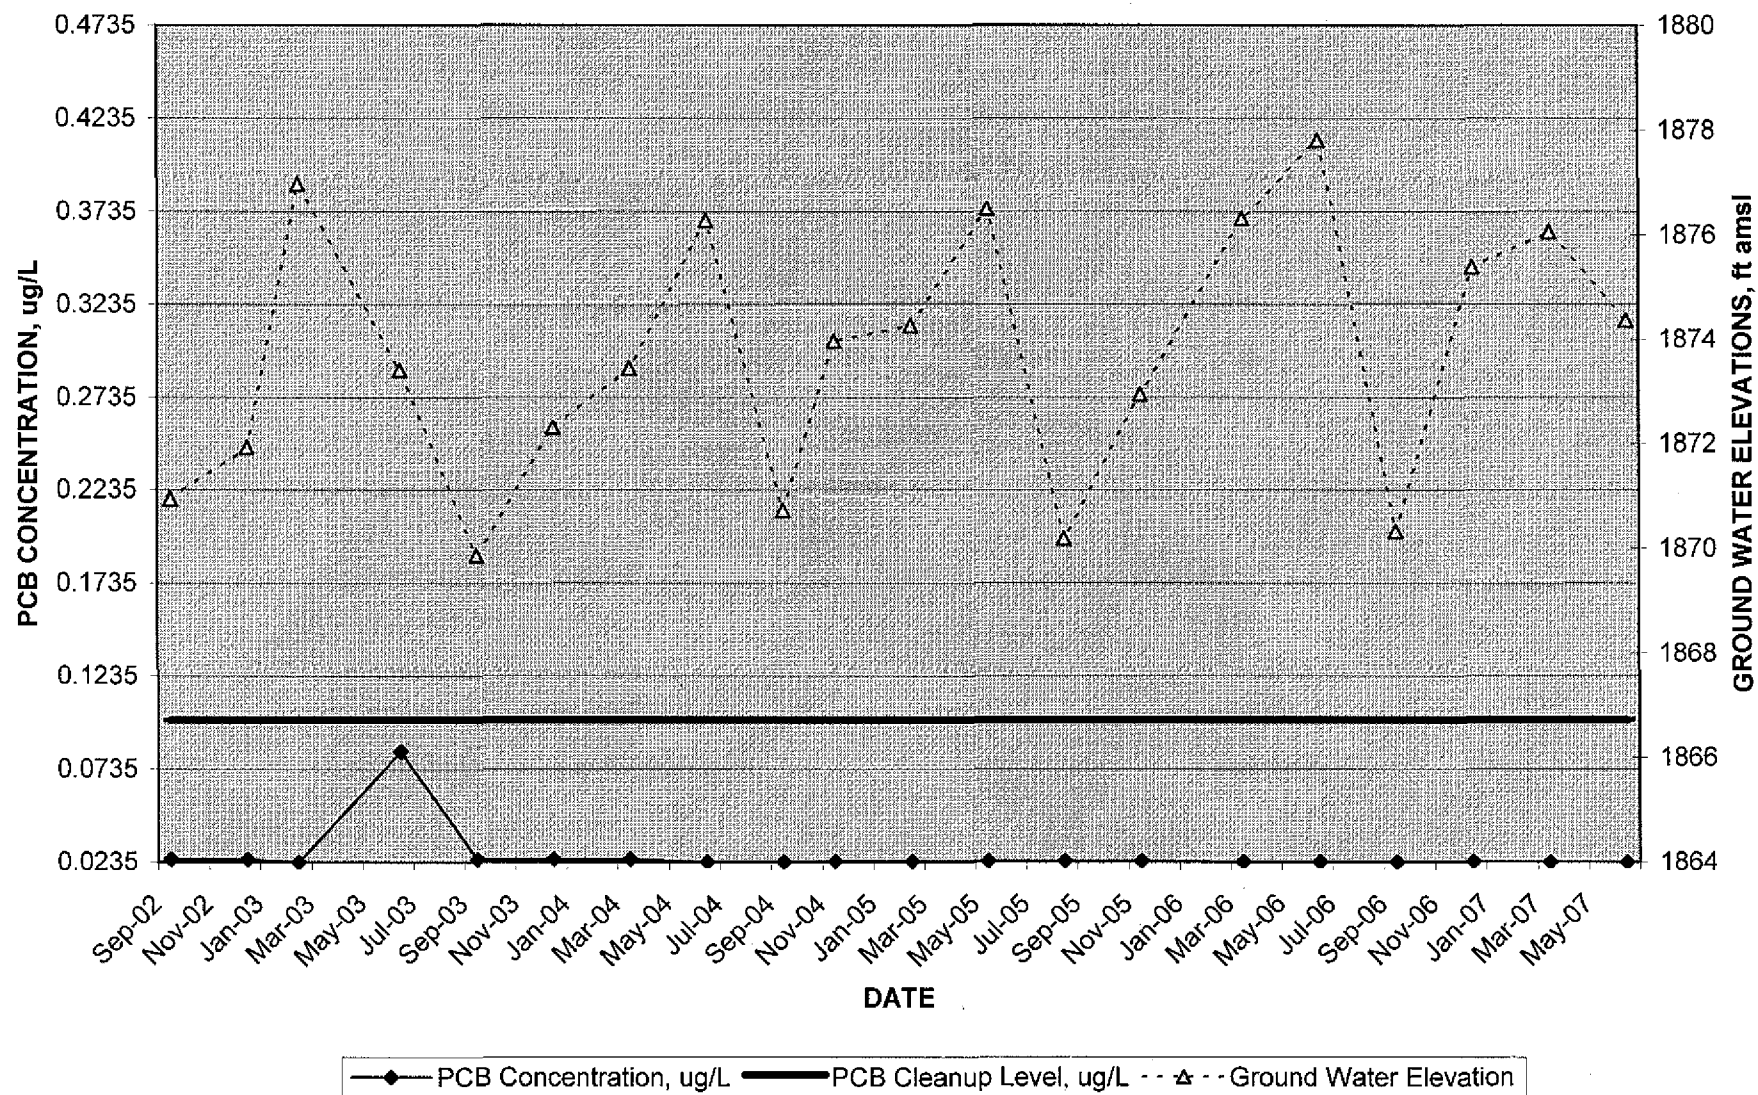
FIGURE 12. MW22 PCB CONCENTRATIONS AND GROUND WATER ELEVATIONS

MW22 (Figure 12)

This is the monitoring well that is closest to the Spokane River. PCB concentrations throughout this review period were nondetects except for one that is below the cleanup level observed in June 2003.
