FOURTH FIVE-YEAR REVIEW REPORT FOR **KERR-McGEE SUPERFUND SITE** CARIBOU COUNTY, IDAHO

Prepared for: U.S. Environmental Protection Agency **Region 10** Seattle, Washington

This is the fourth FYR for the Kerr-McGee Chemical Corporation Superfund Site (Site). This statutory review was prompted by the completion date of the previous FYR. The FYR was prepared because hazardous substances, pollutants, or contaminants remain at the Site above levels that allow for unlimited use and unrestricted exposure.

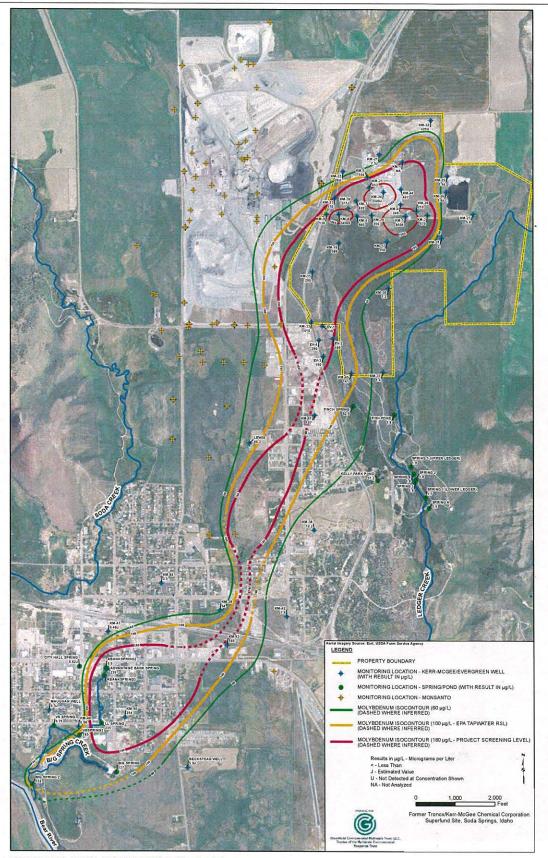
Figure 3. Shallow Groundwater and Spring Sampling Locations and Results – Molybdenum Kerr-McGee 2017 Five Year Review

Three wells currently exhibit concentrations that are at or above the MCL for arsenic of 10 µg/L; KM-2, KM-3, and KM-8 (Figure 3). These same wells were also observed above the MCL during the 2012 FYR. Wells KM-2 (Figure 4) and KM-3 (Figure 5), monitoring wells located near the former Scrubber Pond/Calcine Cap, have trended relatively stable since 2012 with concentrations near 10 µg/L. Similar to KM-2 and KM-3, arsenic concentrations at Well KM-8, located southwest of S-X Pond, (currently 72 µg/L) remains above the MCL of 10 μ g/L and has been stable between 2012 and 2015 (Figure 6).

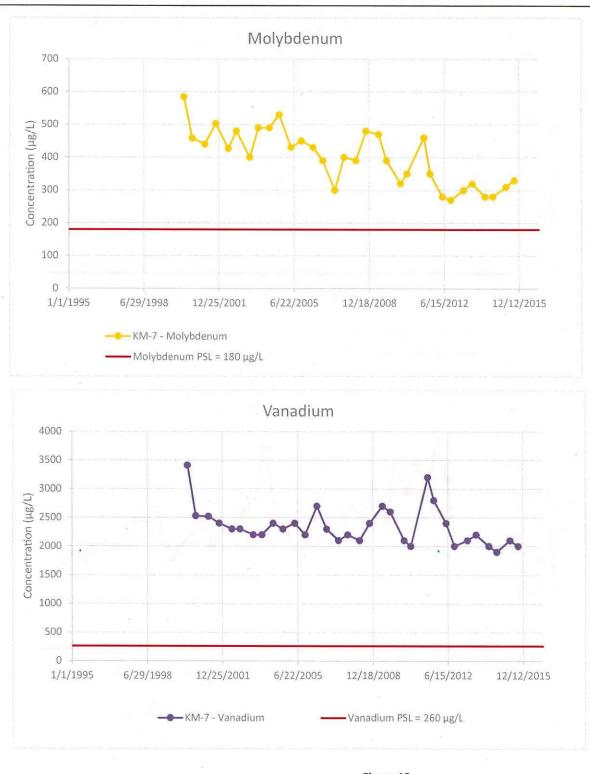
Figure 15. KM-7 COC Data Trends Kerr-McGee 2017 Five Year Review

Except for wells KM-5, KM-9, KM-13, and KM-19; all monitoring wells have current concentrations that exceed the risk-based groundwater performance standard on the west side of the facility near the S-X Pond and plant production areas. KM-5 has exceeded the PSL in 2013 and 2014, but has shown a decreasing trend since 2014 to below the PSL (Figure 13). Concentrations at KM-6 have shown a decreasing trend from 2012 to 2014, but a slight increase was found during the most recent sampling events (Figure 14). Molybdenum concentrations at KM-7 have been variable, with an overall increasing trend above the PSL (Figure 15).
