FOURTH FIVE-YEAR REVIEW REPORT FOR MONSANTO CHEMICAL CO. (SODA SPRINGS PHOSPHOROUS PLANT) SUPERFUND SITE CARIBOU COUNTY, IDAHO

Prepared for: U.S. Environmental Protection Agency Region 10 Seattle, Washington

9/12/2018

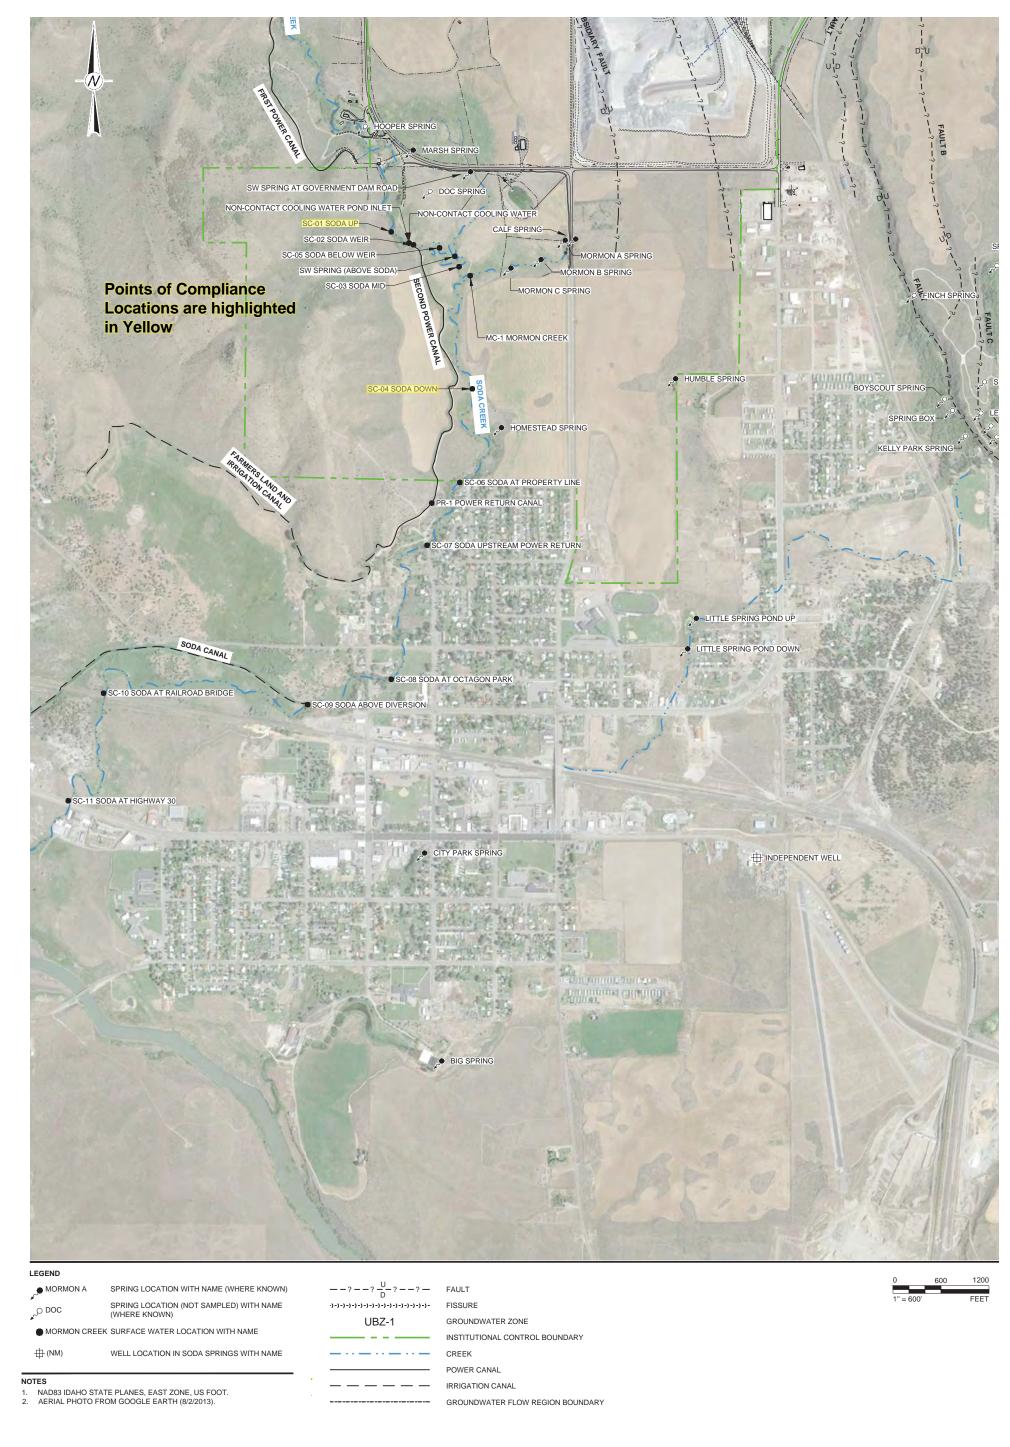
FIGURE 3 Soda Creek and Springs Sample Locations Monsanto Site 2018 Fourth Five-Year Review Caribou County, Idaho

Figure 3 shows the principal surface water bodies affected at the site including Soda Creek (downstream from the effluent discharge) and Mormon Creek (fed by discharging impacted groundwater). EPA requested that Monsanto analyze surface water discharges to Soda Creek for hazardous substances at a level of detail consistent with ongoing groundwater data reporting. Thus, upstream and downstream sample locations were added to Soda Creek in 2001, and Mormon Creek sampling was added in 2002 (EPA, 2008).

As identified in the ROD, Soda Creek is the only natural stream which is nearby and potentially affected by the Site. Exceedances of selenium and cadmium WQS were noted within the flow impaired reaches of Soda Creek and upgradient surface water expressions (i.e., springs). The upper portions of Soda Creek do not support a fisheries resource due to naturally-occurring carbon dioxide concentrations in the water. The lower reach of Soda Creek, just above its confluence with the Alexander Reservoir, provides suitable conditions to support fisheries. Exceedances of selenium and cadmium WOS have not been observed in these lower reaches.

Issues and Recommendations Identified in the Five-Year Review:					
OU(s): N/A	Issue Category: Remedy Performance Issue: Concentrations of surface water in location where groundwater discharges to several streams and creeks exceed Idaho WQS.				
	Recommendation: Continue monitoring surface water annually. Execute a ROD amendment or ESD to add surface water RAOs, ARARs, and RGs, and require any necessary remedial action.				
Affect Current Protectiveness	Affect Future Protectiveness Party Responsible Oversight Party Milestone Date				
Yes	Yes	PRP	EPA	8/18/2023

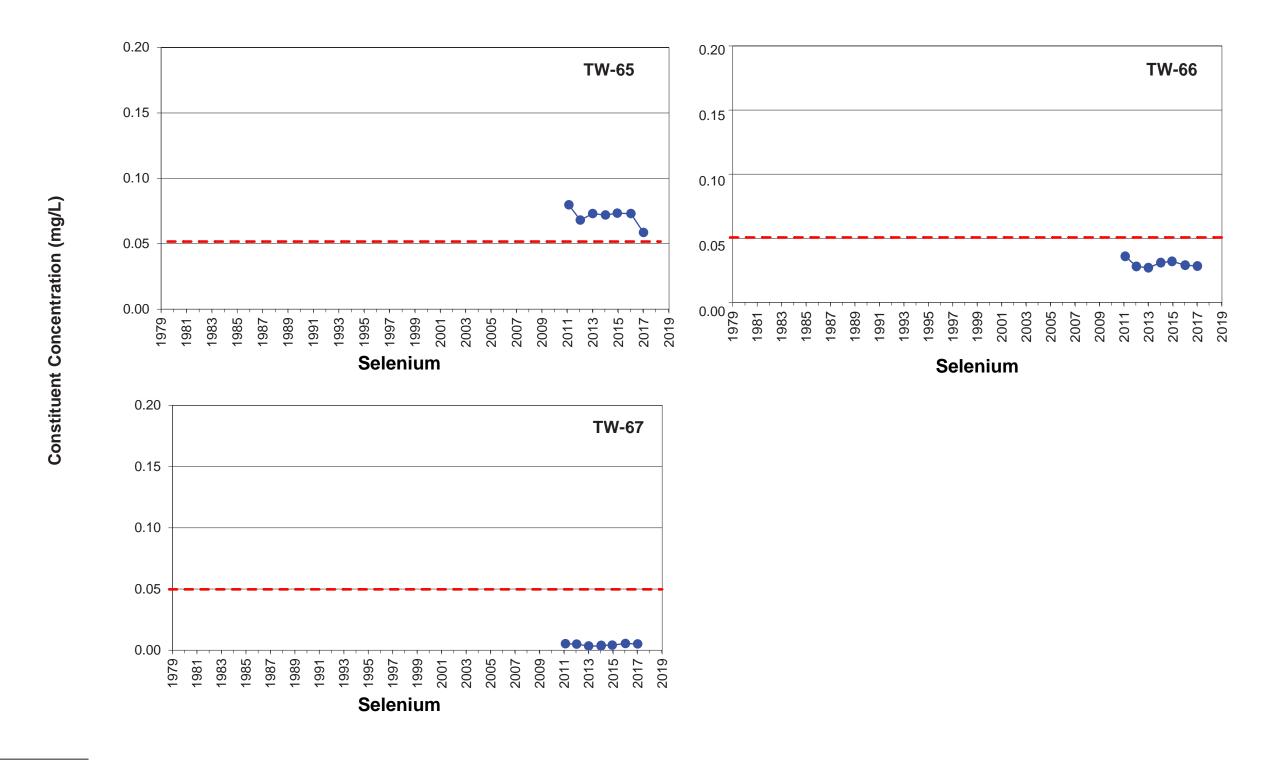
Figure 13.
Selenium Trends in UBZ-2 Wells at South Property Line (UBZ-1 and 2 Downgradient)
Monsanto Site 2018 Fourth Five-Year Review Caribou County, Idaho

Based on a review of current groundwater data and source area conditions, the groundwater remedy (MNA) is not performing as intended. Groundwater monitoring data reveal that after initially decreasing, some COC concentrations have been increasing over the last several years in some of the monitoring locations, and at some locations appear relatively stable above the RGs. In addition, the COC selenium has been detected at the southern property boundary in monitoring well TW-65 at concentrations that exceeded its RG. Monitoring wells upgradient from the southern property line are interpreted to be increasing in the short-term (Figure 8; Table 6; Golder, 2018a). These trends indicate the selenium is not attenuating at the previously-estimated rate.

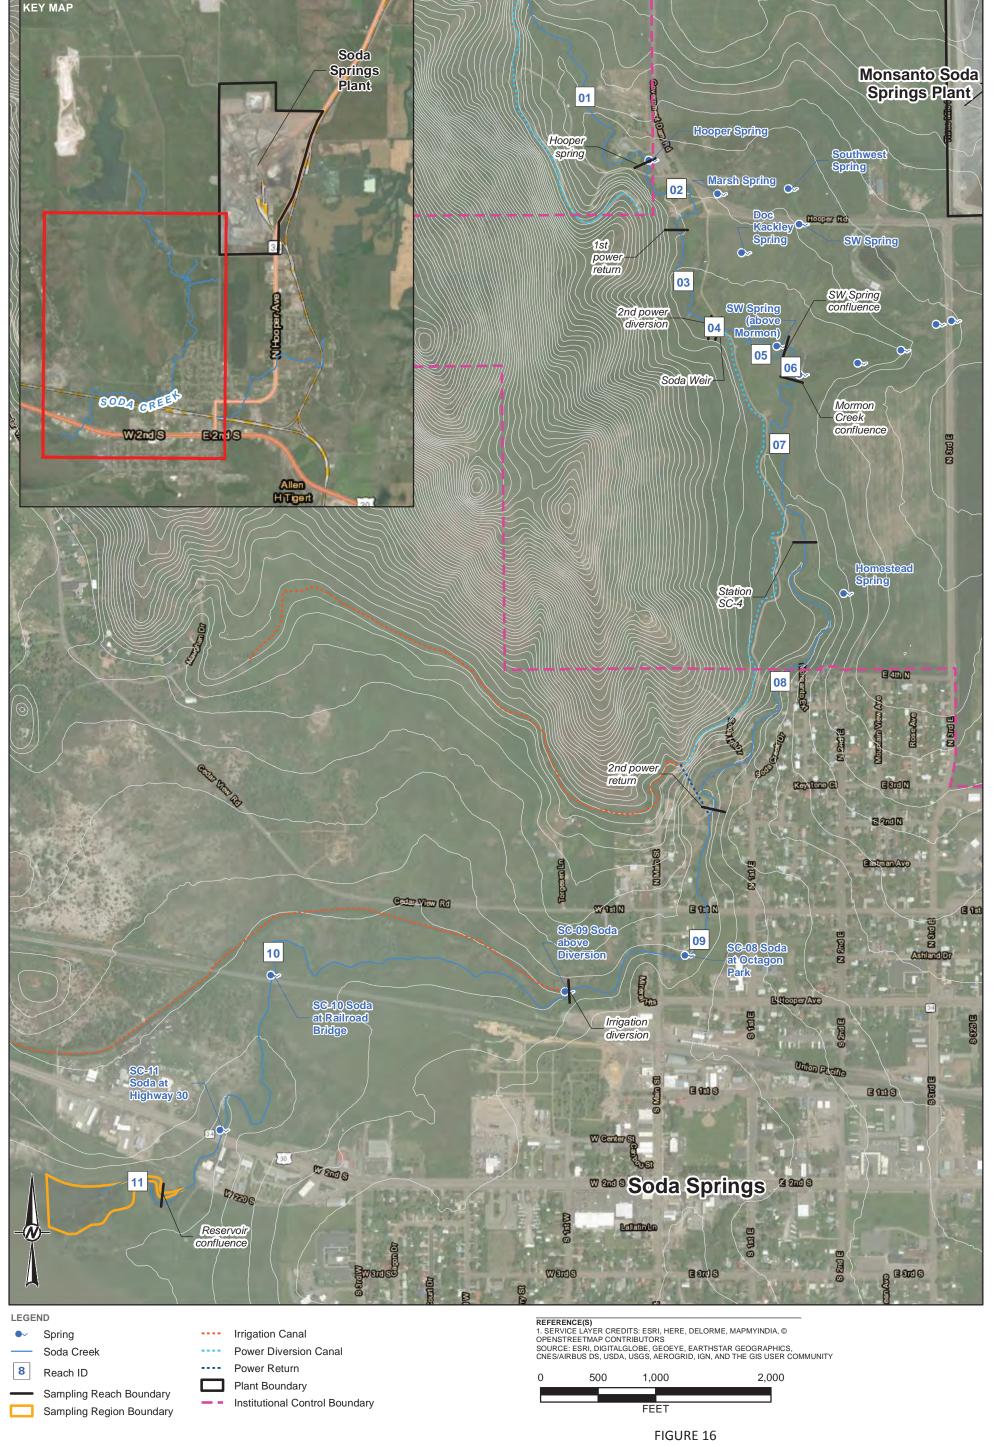
Locations of the Sediment Sample Reaches in Soda Creek
Monsanto Site 2018 Fourth Five-Year Review
Caribou County, Idaho

constituent concentrations in sediment and variations in concentrations from upstream to downstream in the 11 reaches sampled. Both the 2017 and previous 2012 ISM data are shown for comparison to observed increases or decreases.

Overall, in the downstream reaches, cadmium concentrations decrease from Reach 07 to the Soda Creek Arm, but are slightly higher than the upstream control reaches. Concentrations of arsenic, beryllium, cadmium, nickel, selenium, silver, and vanadium all decrease from Reach 08 (in the flow-diverted portion of Soda Creek) to the Soda Creek Arm (Region 11). The copper concentration in sediments is slightly higher in the Soda Creek Arm than in Reaches 05, 06, 07, and 08. COC concentrations are lower than observed in the upstream control reaches except for cadmium and copper.

Issues and Recommendations Identified in the Five-Year Review:					
OU(s): N/A	U(s): N/A Issue Category: Remedy Performance				
Issue: Concentrations of contaminants in sediments in Soda Creek are elevated on statistical analyses and relative to ecological risk benchmarks downstream in the flow-diverted reaches.					
	Recommendation: Continue monitoring the sediments every five years. Consider whether remedial action is necessary to address ecological risks due to elevated contaminant concentrations in sediments.				
Affect Current Protectiveness	Affect Future Party Responsible Oversight Party Milestone Date				
No	Yes	PRP	EPA	8/18/2023

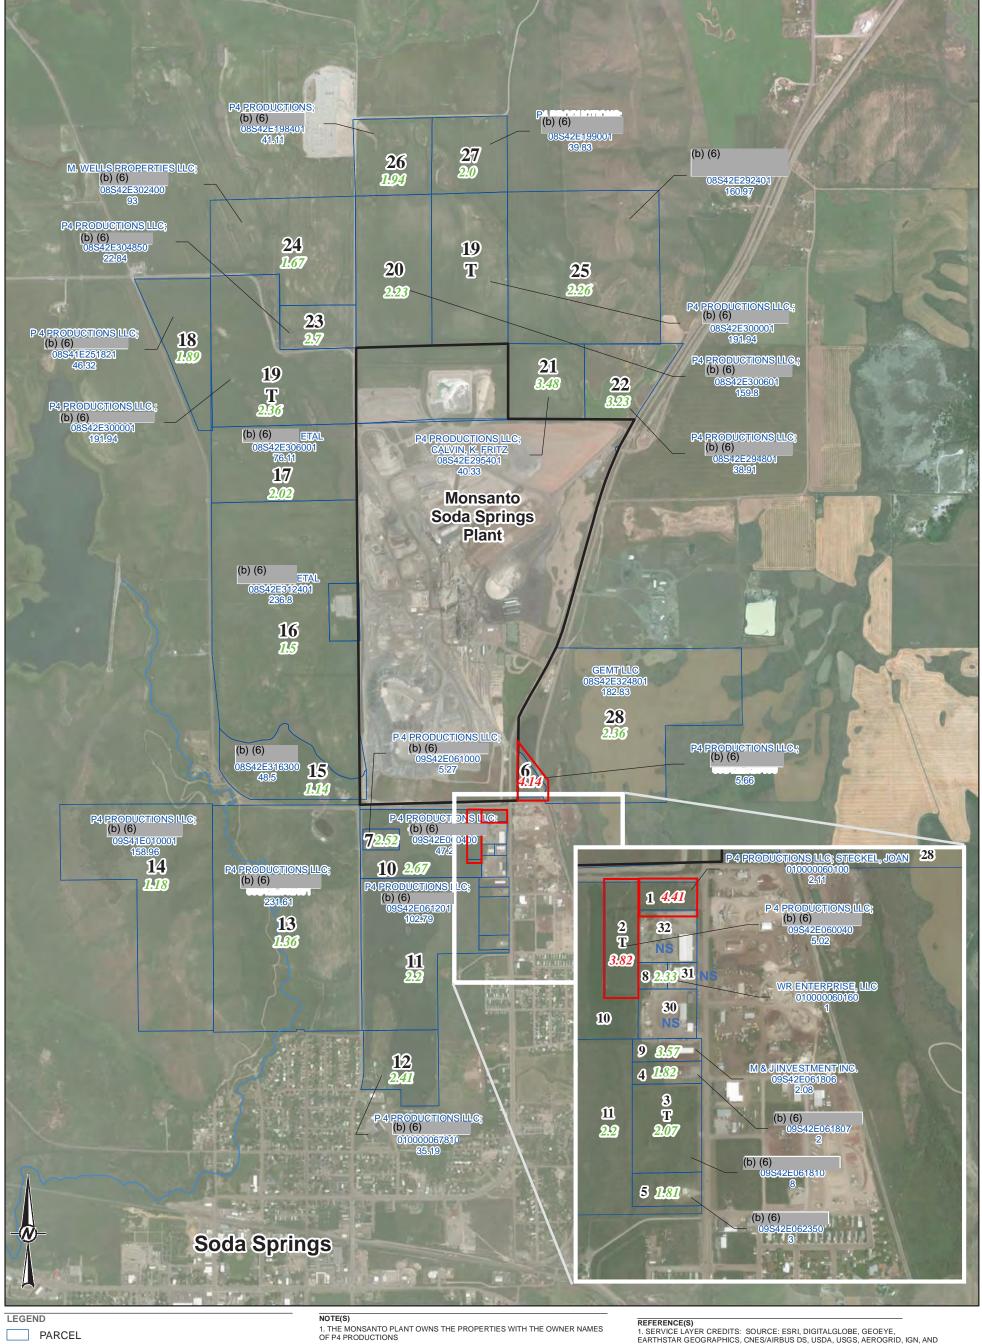
FIGURE 26 **Soil Sampling Parcels and Radium-226 Concentrations** Monsanto Site 2018 Fourth Five-Year Review Caribou County, Idaho

Radium-226 Fourth FYR (pCi/g) Result 3.82 Concentrations > remediation goal (3.71 pCi/g)
