Five-Year Review Summary Form

Site name (from WasteLAN): Silver Mountain Mine

**Second 5-Year Review of the Silver Mountain Mine Superfund Site,
Okanogan County, Washington**

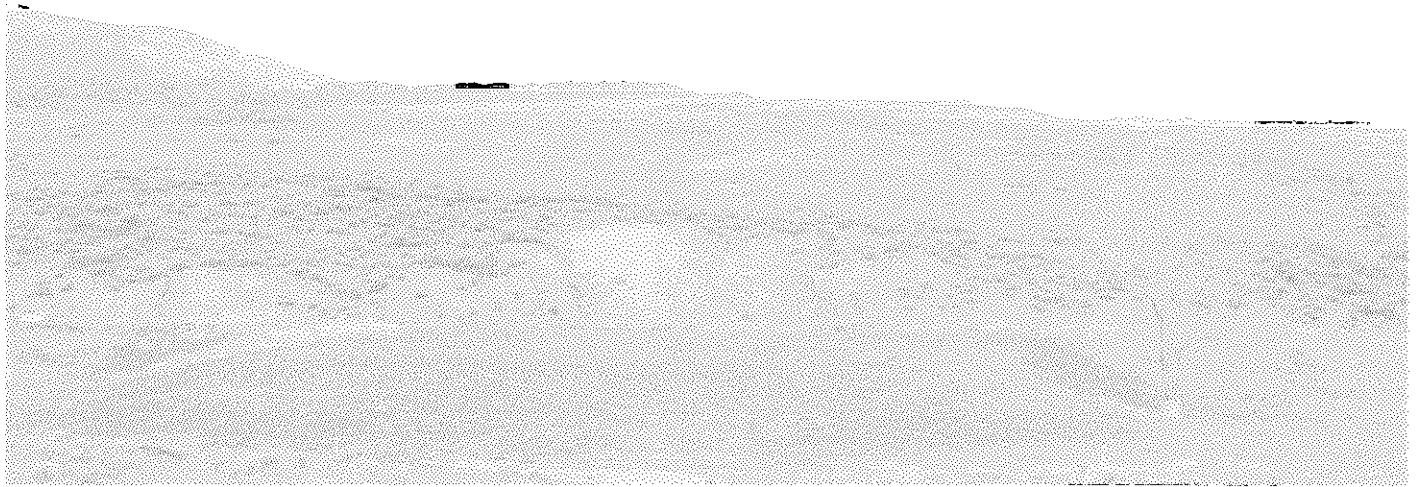
Picture 1: Silver Mountain Mine Cover 4/26/02

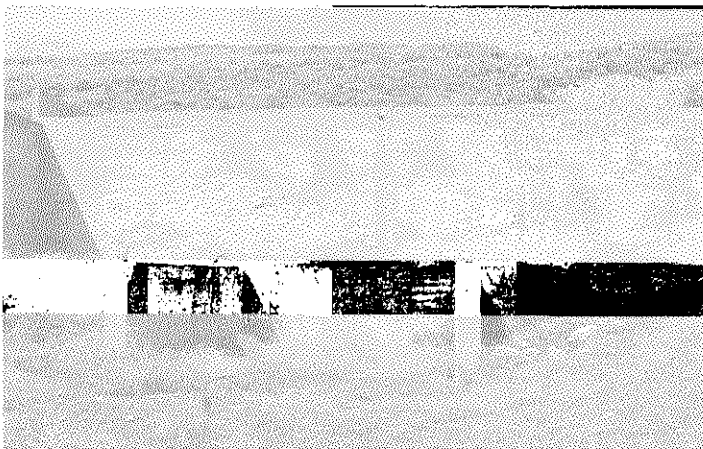
Technical Assessment Summary: Based on my review and investigation of the site, the remedy is functioning as intended by the decision documents. Physical hazards do remain on this remote site, specifically, steep drop-offs and pits from the mill's foundation walls and interior pits. Cellular phone service is not currently provided to the area.

Picture 2: Structural Hazards & Old Graffiti Present

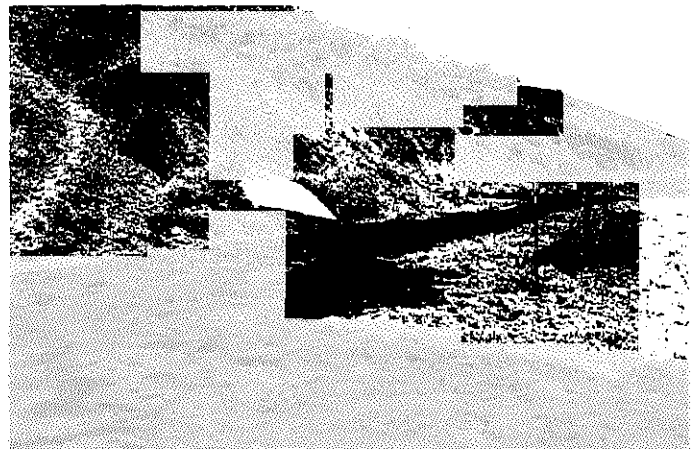
Following construction activities, surface water continued to enter the site at a slow rate from a new seep coming from the blocked mine entrance. This flow was diverted away from the capped landfill area towards an area offsite and infiltrates into the ground before reaching the site fence.

Picture 3: Water course from Mine Adit drainage

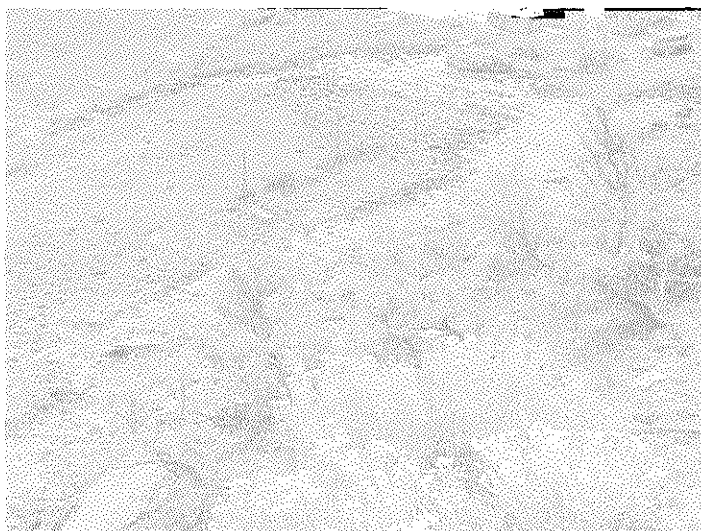
Picture 4: Water course descending adjacent to Structure shown in Picture 2.

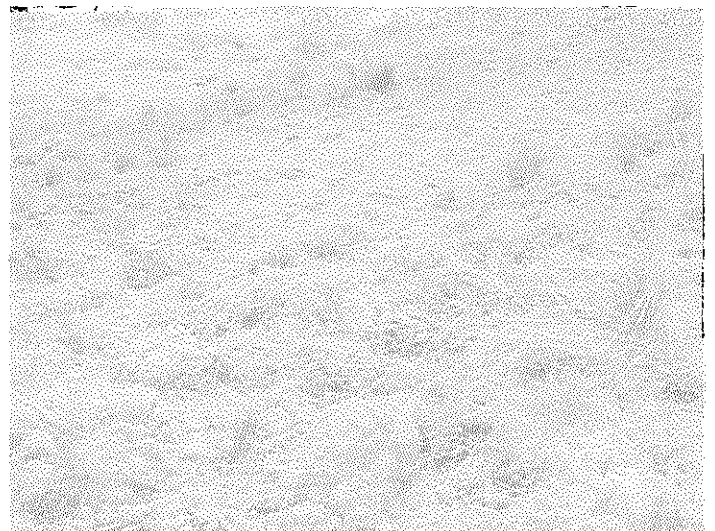
Picture 5: Isolated location on Cap sidewall showing impact of cattle trampling the cover.

As part of this five-year review, a single recommendation is being identified in the table below to improve remedy performance or protectiveness in alignment with the Remedial Action Objectives and performance standards of the Site. Conducting annual inspections and maintenance of the cap will ensure continued protection of human health and the environment at this site.
