**FIVE-YEAR REVIEW REPORT FOR
SILVER MOUNTAIN MINE SUPERFUND SITE
OKANOGAN COUNTY, WASHINGTON**

Washington State Department of Ecology
Central Regional Office
Yakima, Washington

U.S. Environmental Protection Agency
Region 10
Seattle, Washington

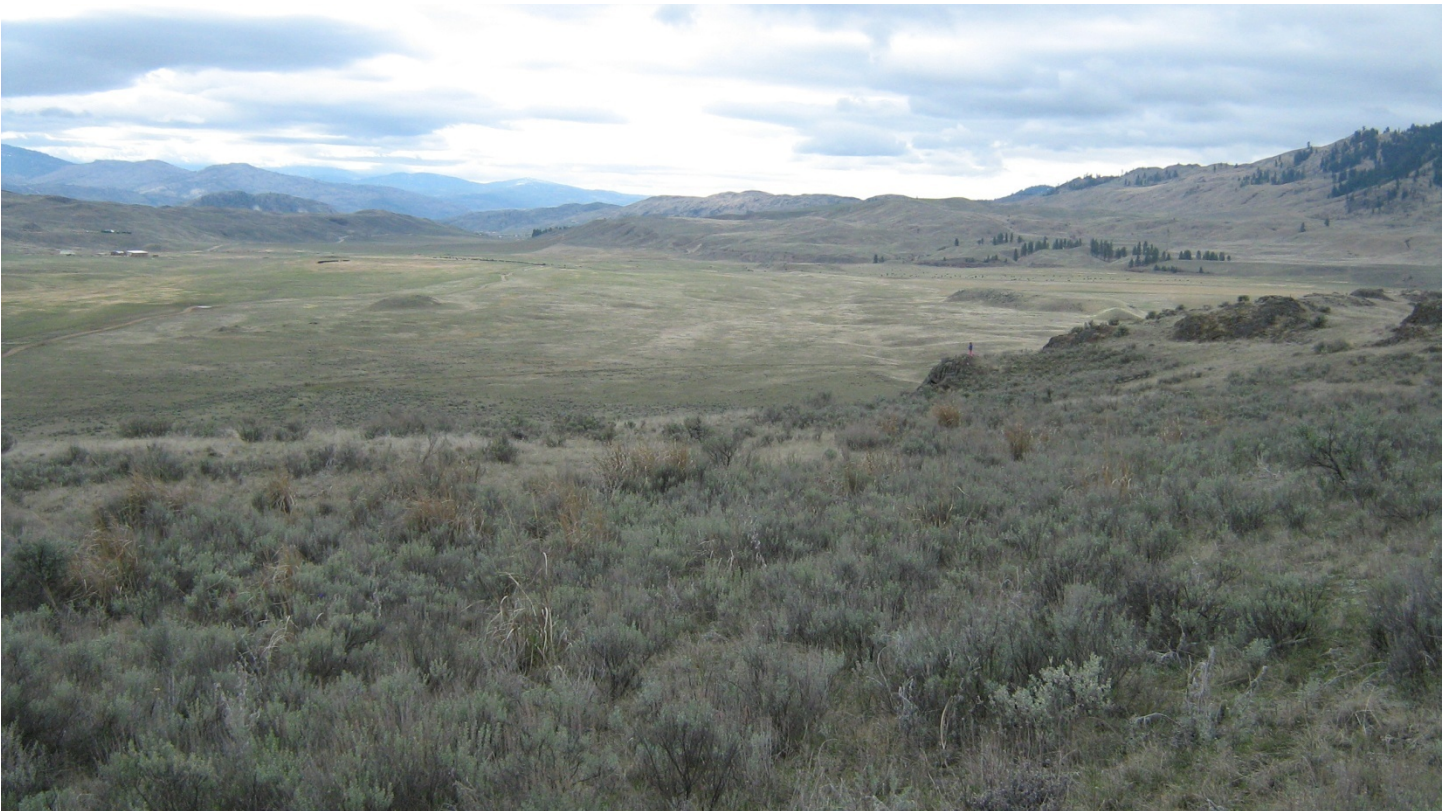
SMM Vicinity from the Northwest

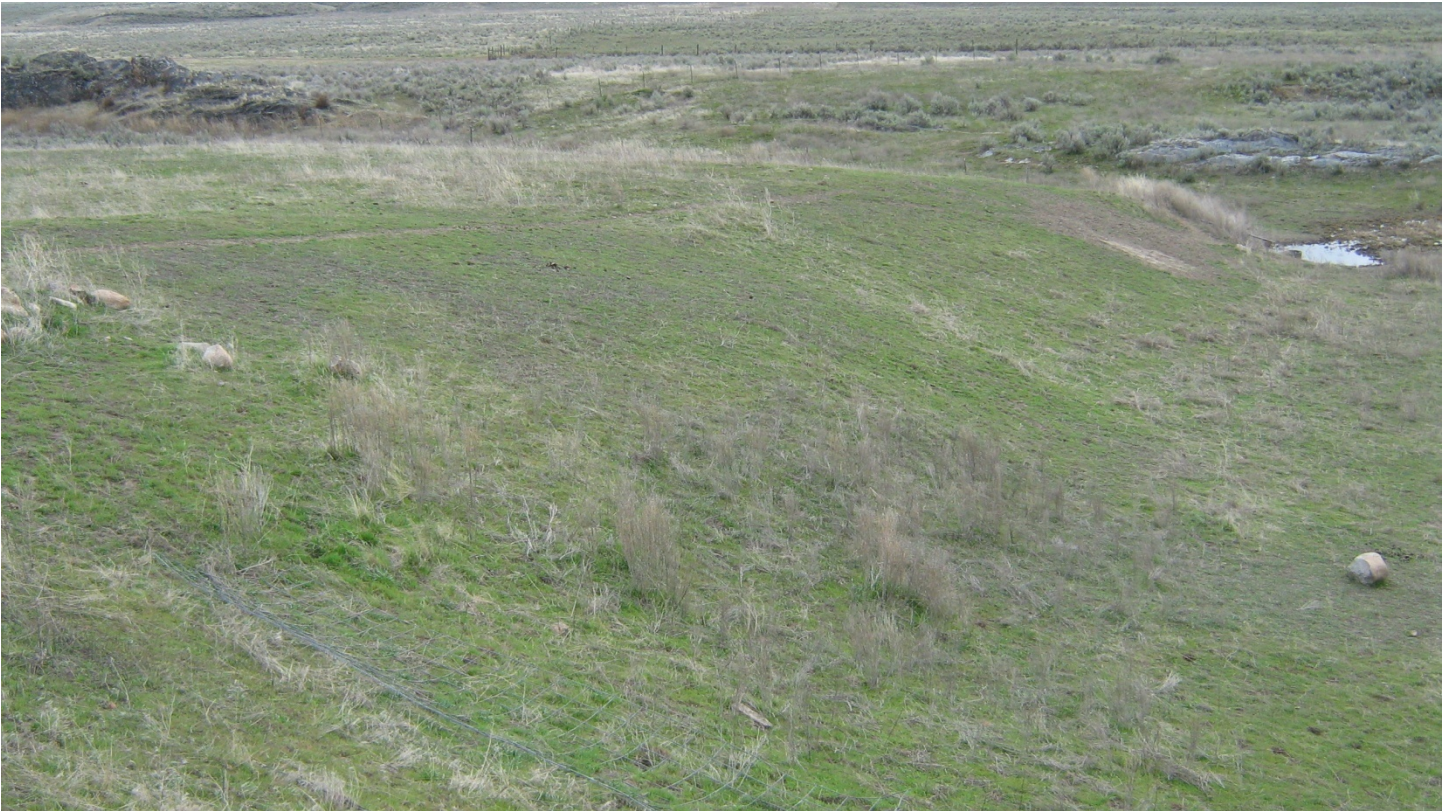
SMM Tailings Cap from the Southwest

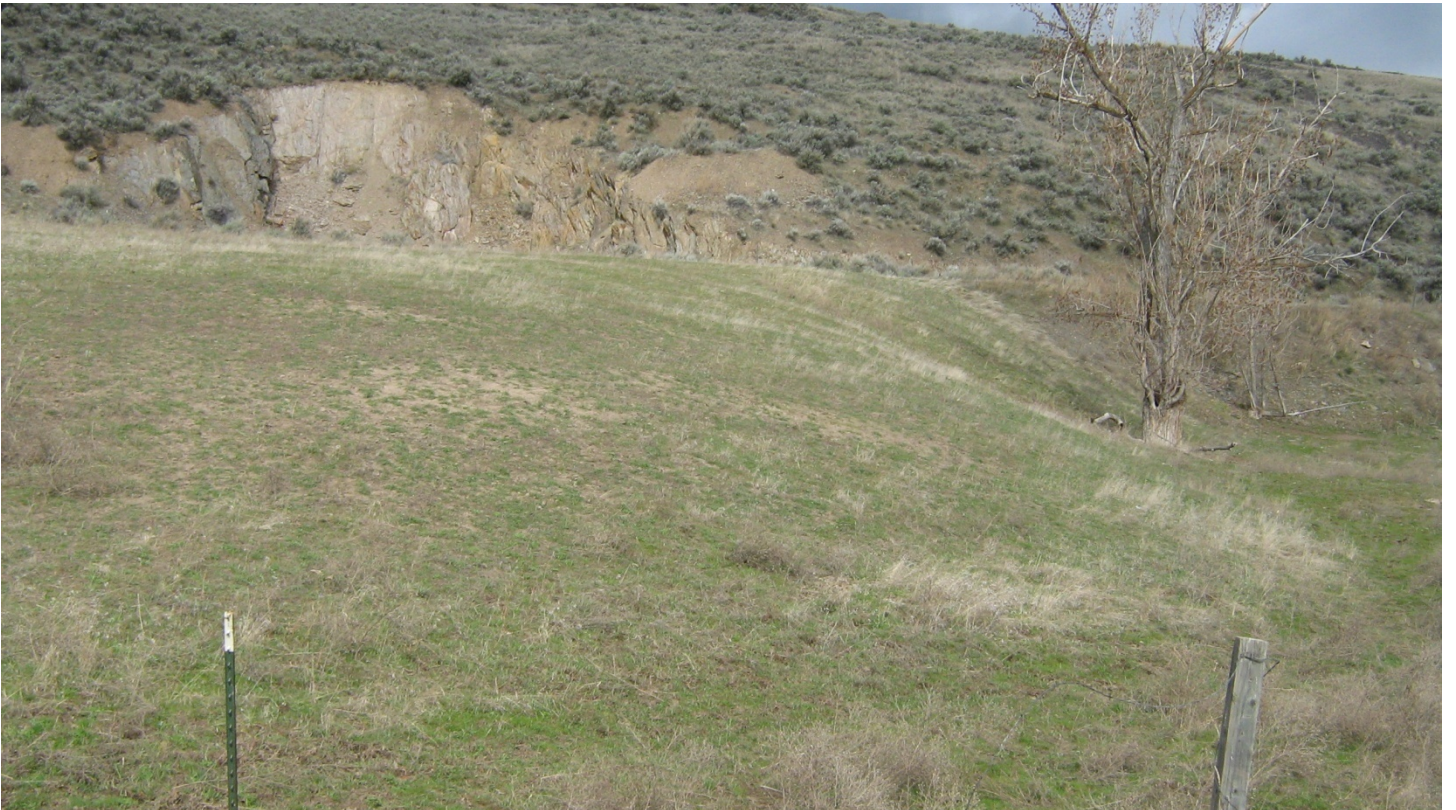
SMM North Slope of Tailings Cap from the East

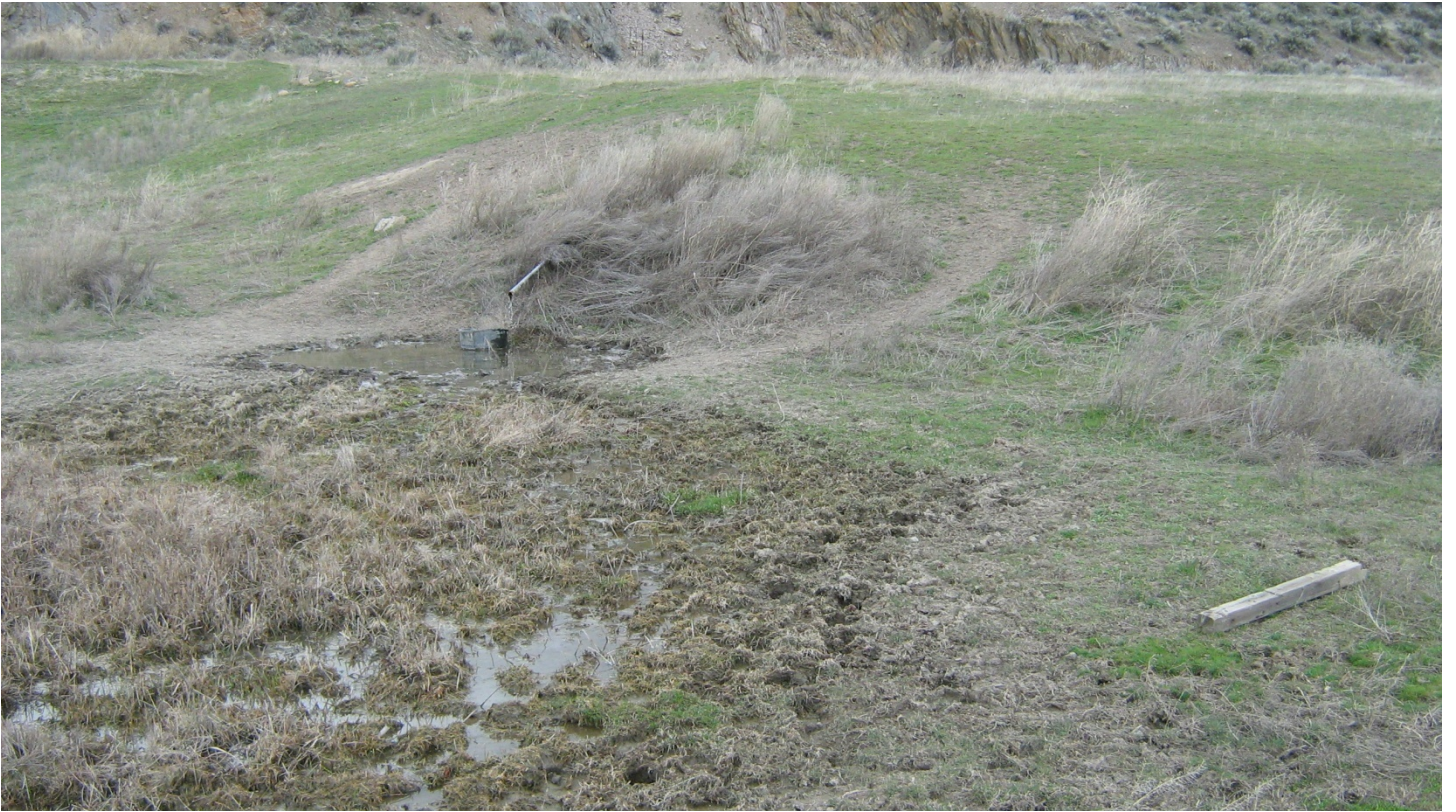
SMM Mine Drainage Stock Water Location from the East

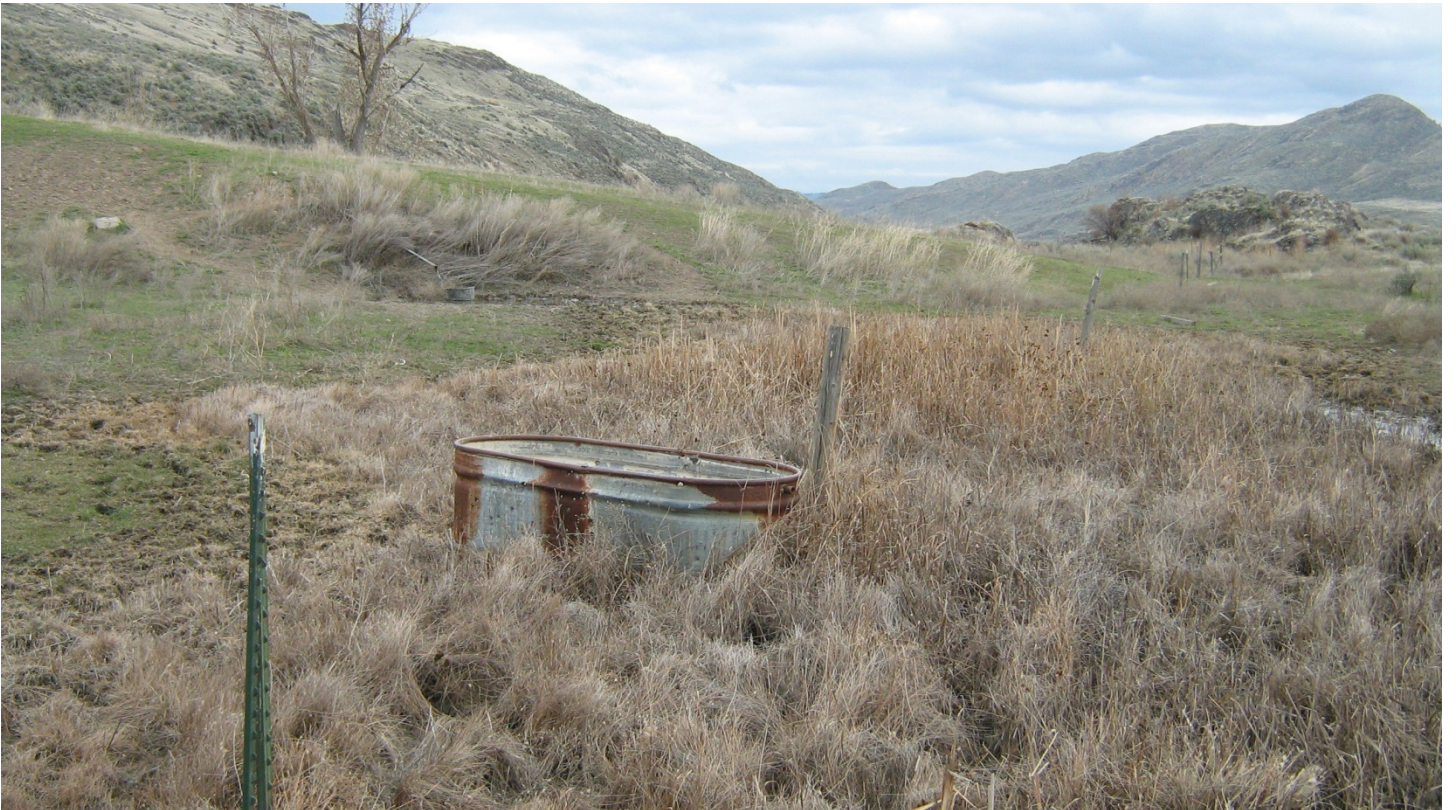
- 1) Fence Installed During the Remedial Action No Longer Exists - The fence installed as part of the remedial action is gone, except for the fence posts; a newer fence surrounding the property (owned by an adjacent neighbor) prevents general access to the Site. The newer fence, containing a gate, still provides for controlled access of cattle to the watering hole near the mine adit. Access control at the Site would be compromised should the existing fence be damaged or removed.

3) Inspect fence	<u>Y</u>	None	Fence around cap is destroyed. Exterior fence in excellent condition
4) Inspect drainage ditch to ensure water is draining away from cap	<u>Y</u>	None	No effective ditch. All seepage is piped below cap. No evidence of surface drainage problems

SMM Original Tailings Cap Fence from the Southeast

1. During site inspections, inspect fencing installed by adjacent property owner and confirm it remains in place and undamaged. If fence is damaged or removed, require Site property owner to replace or repair the fence to ensure access to the Site remains controlled.
2. Ecology and EPA will work with the current property owner to develop a new environmental covenant that follows the guidelines of UECA. This will be done to resolve some questions about legal ownership of the Site and to ensure long-term protectiveness of the cap and restrictions on the use of groundwater for human consumption.

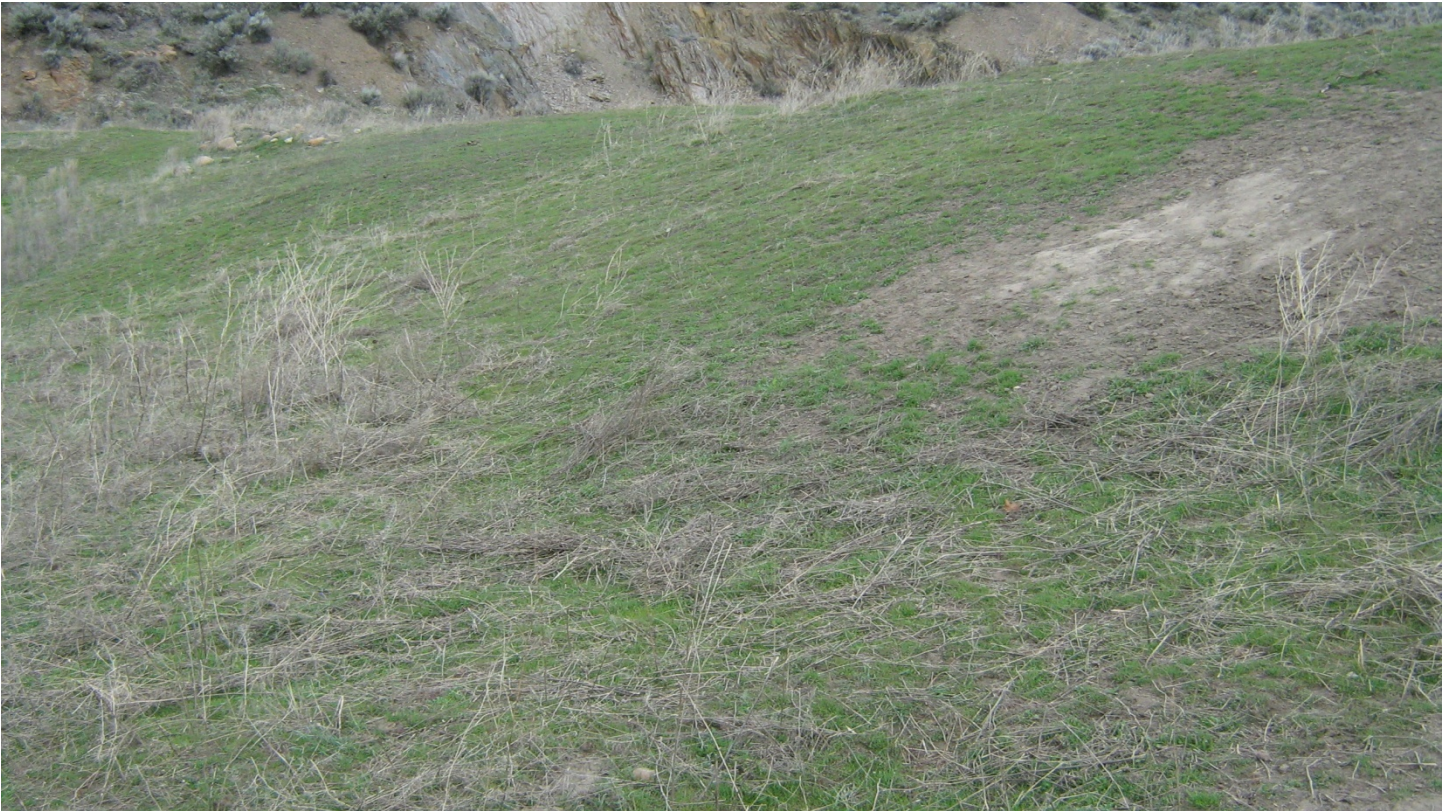
2) Inspect cover for: a) Adequate vegetation b) Weeds c) Holes d) Minimal woody vegetation on cap ^a	<u>Y</u> <u>Y</u> <u>Y</u> <u>Y</u>	None	Cap is in excellent condition w/ some bare spots and evidence of livestock travel which is not impacting cap.

SMM Tailings Cap with Exposed Soil from the Southeast

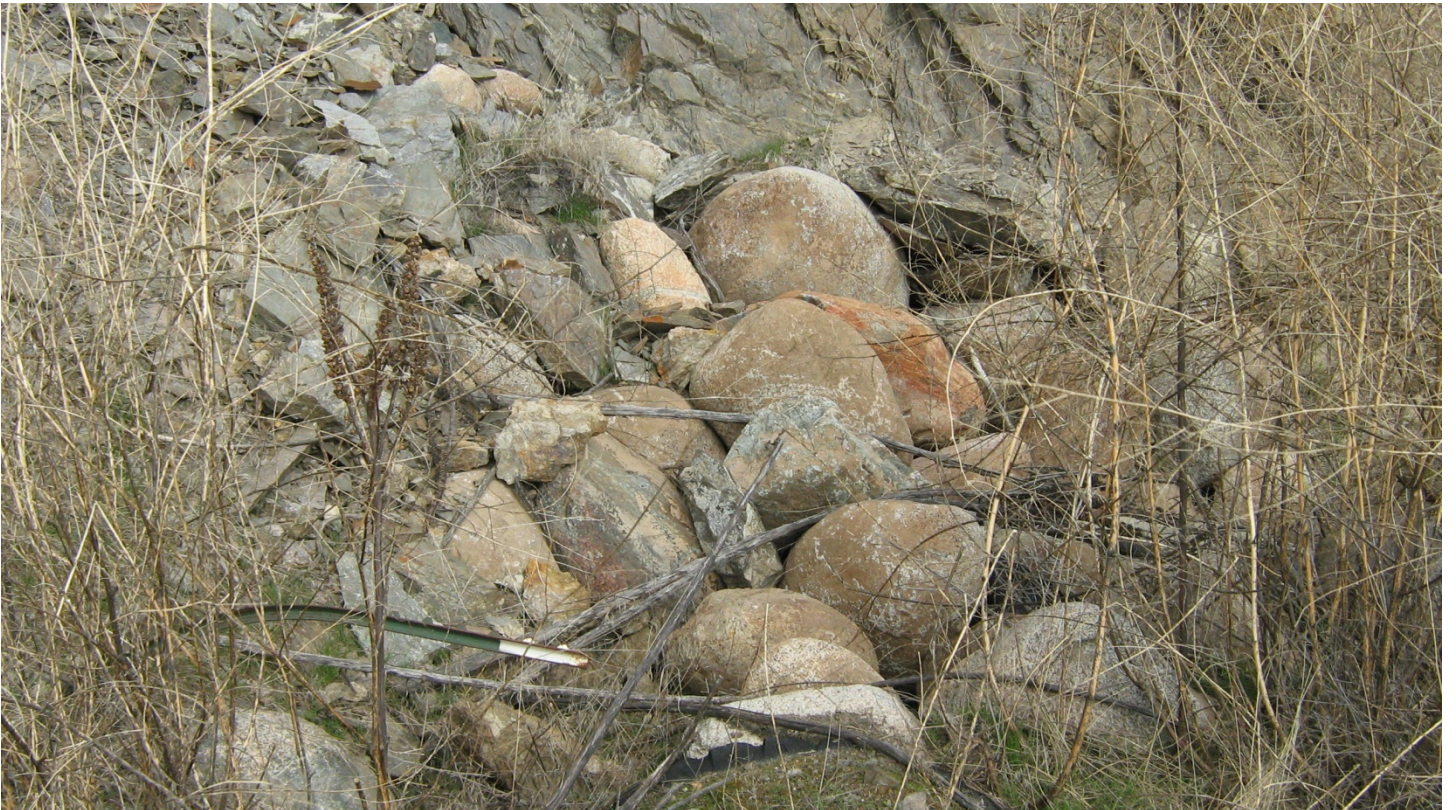
SMM Closed Adit from the Southeast

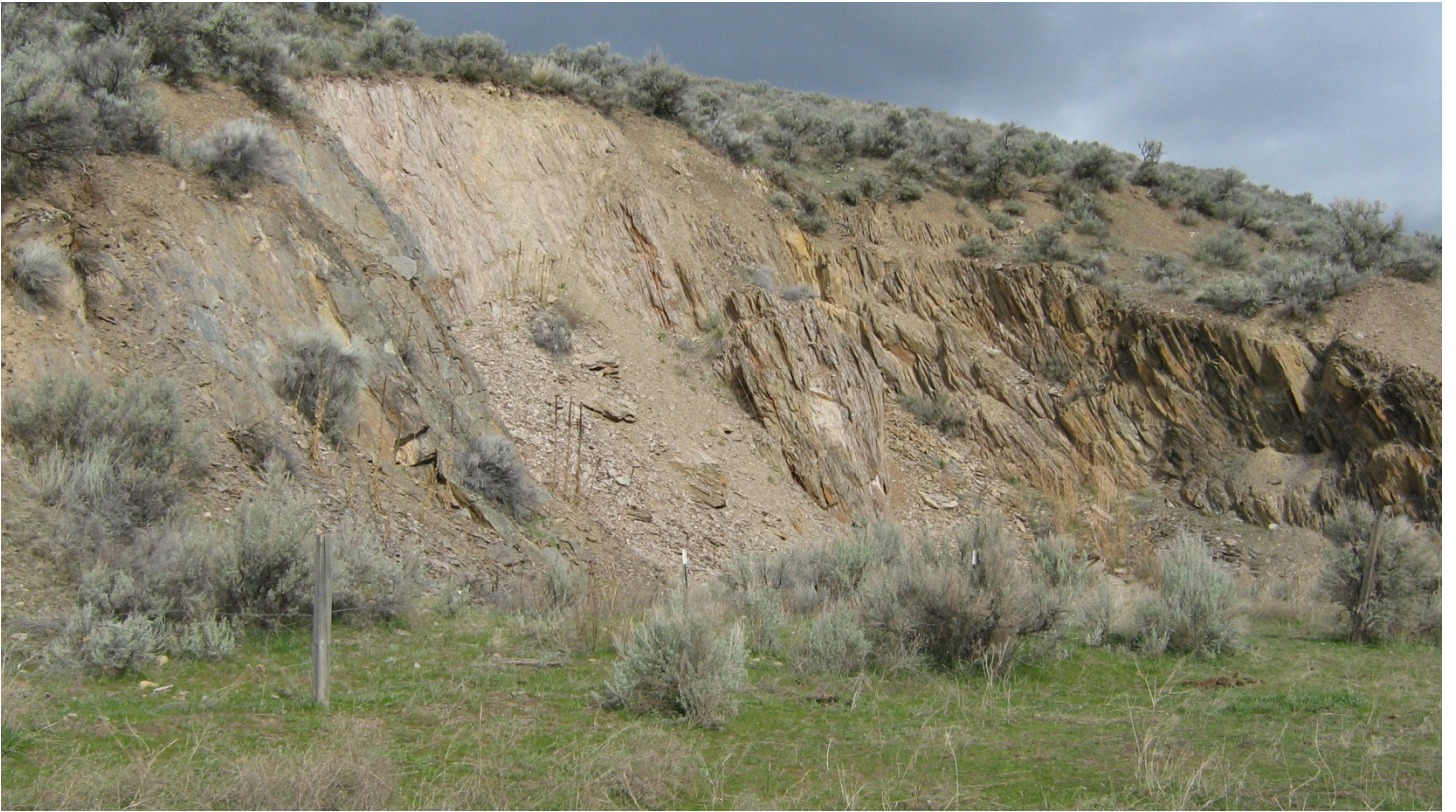
SMM Closed Adit Vicinity from the Southeast

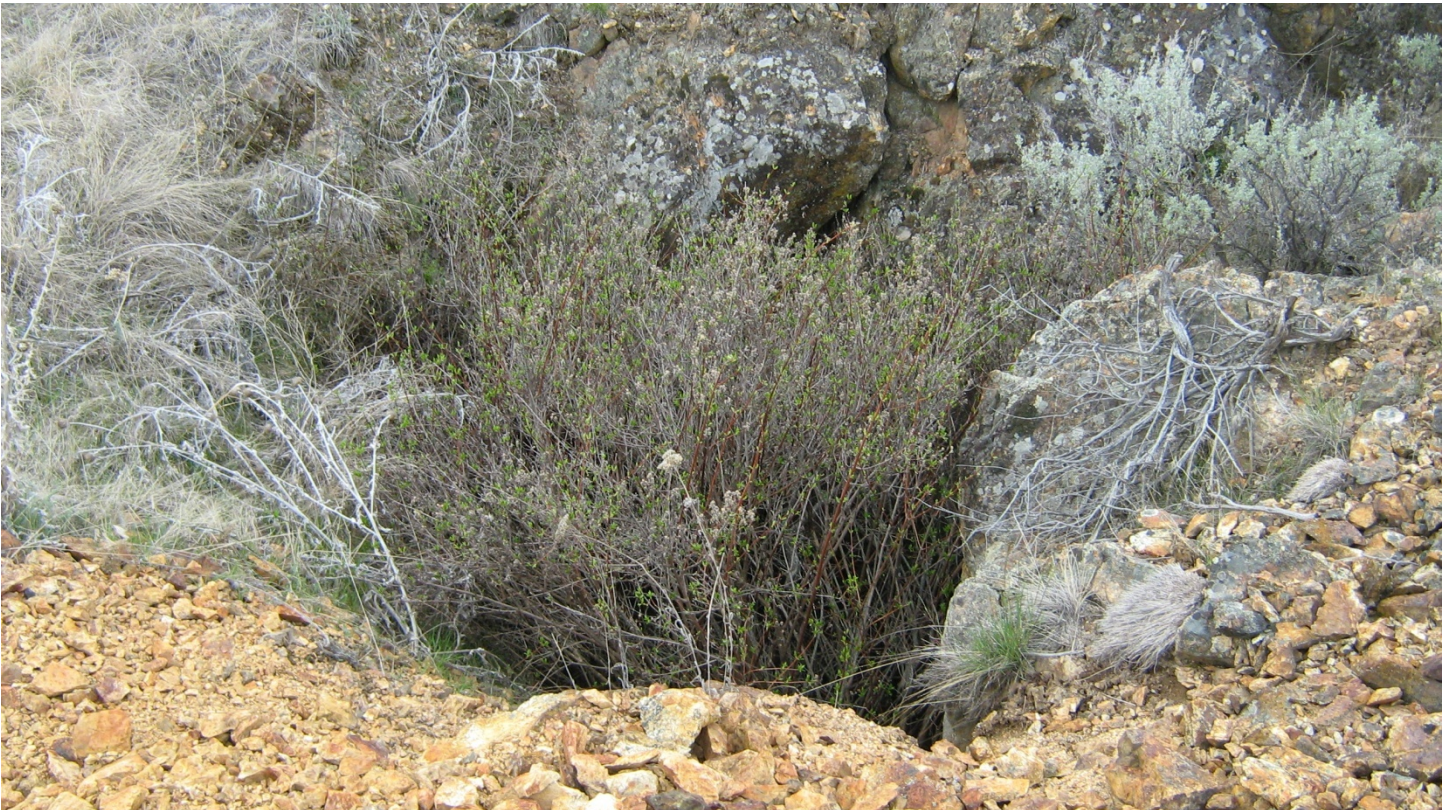
SMM Sealed Mine Workings Vent on Slope Above Adit from the South

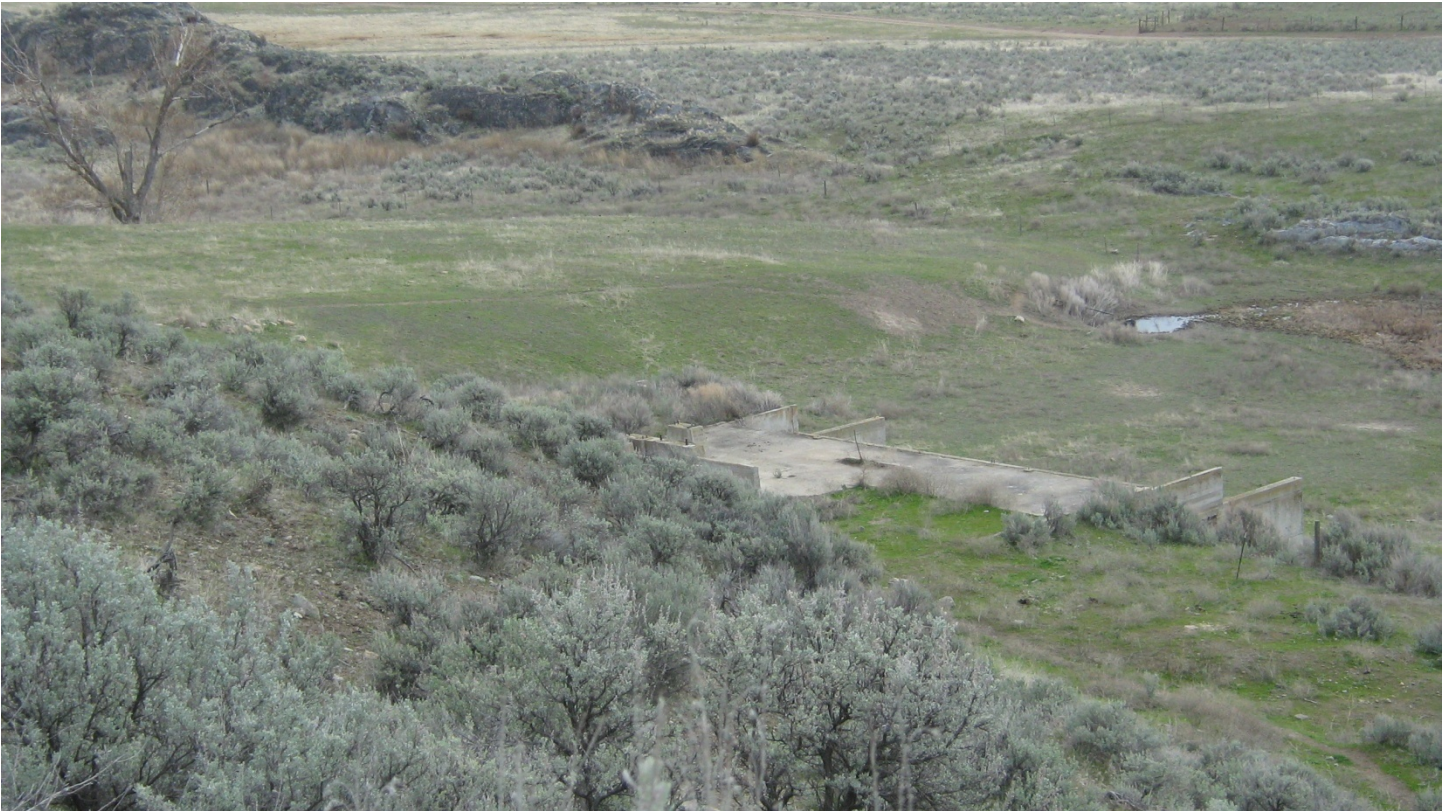
SMM Mill Site and Tailings Cap from Slope to the Southwest

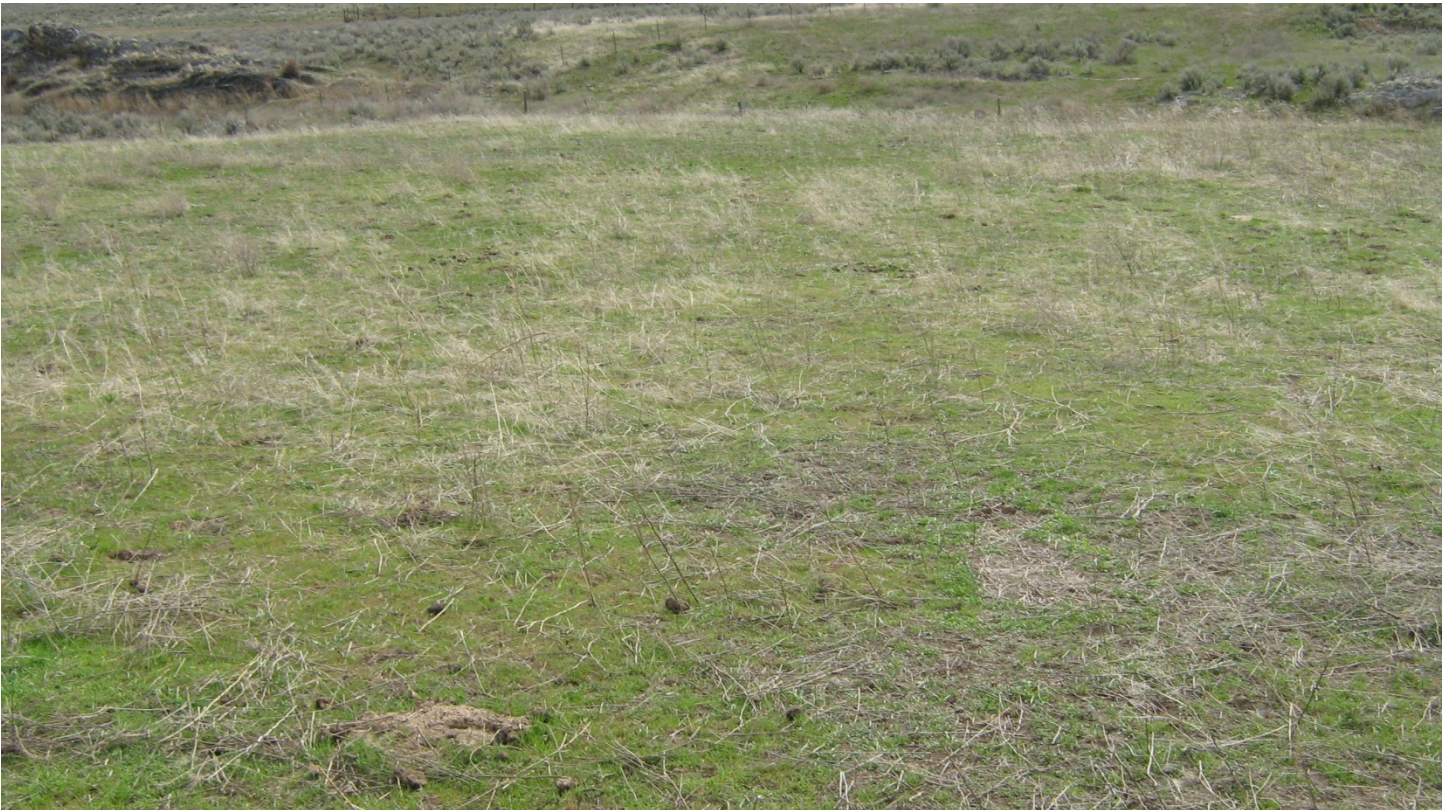
SMM Tailings Cap Surface from the West
