**FIVE-YEAR REVIEW REPORT FOR
SILVER MOUNTAIN MINE SUPERFUND SITE
OKANOGAN COUNTY, WASHINGTON**

**Washington State Department of Ecology
Central Regional Office
Yakima, Washington**

**U.S. Environmental Protection Agency
Region 10
Seattle, Washington**

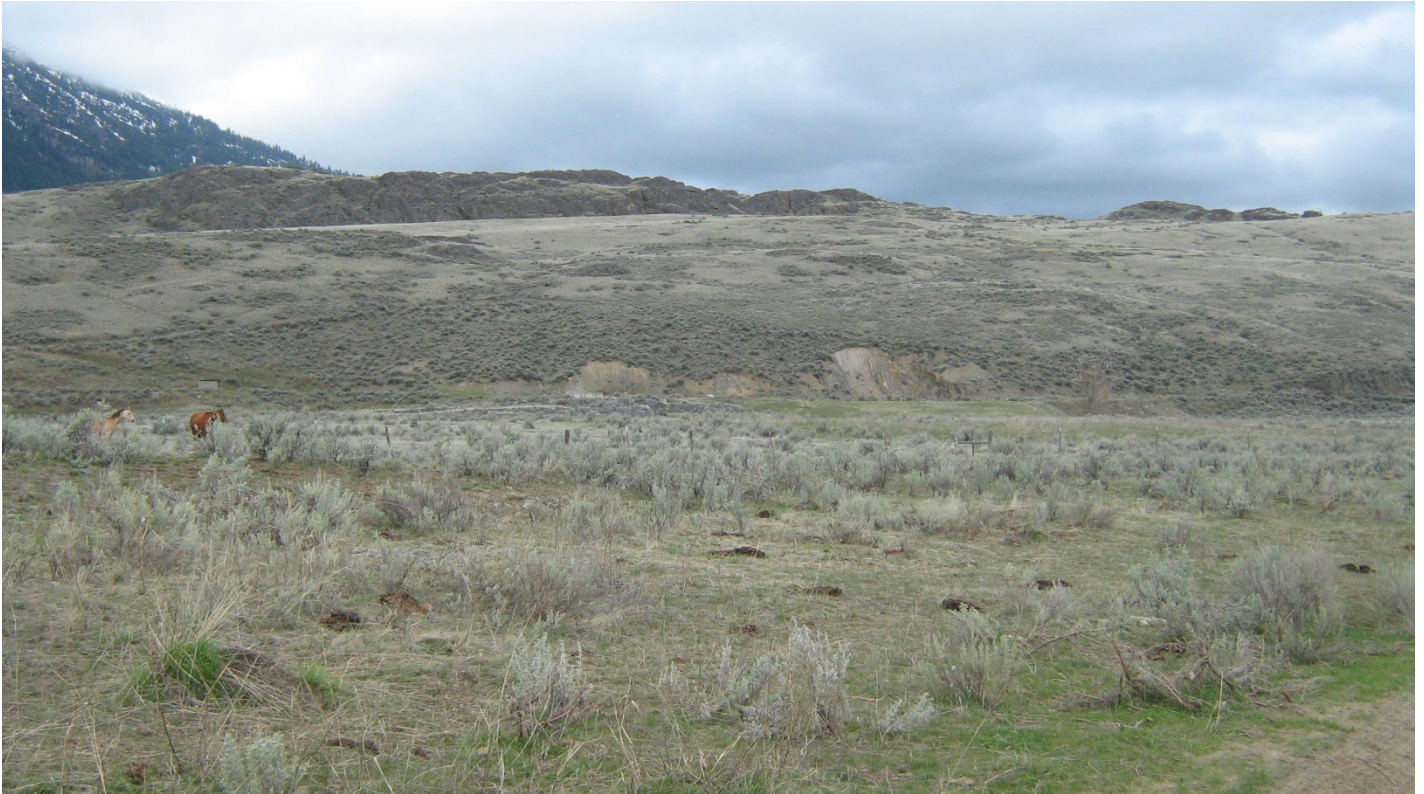
SMM Vicinity from the East

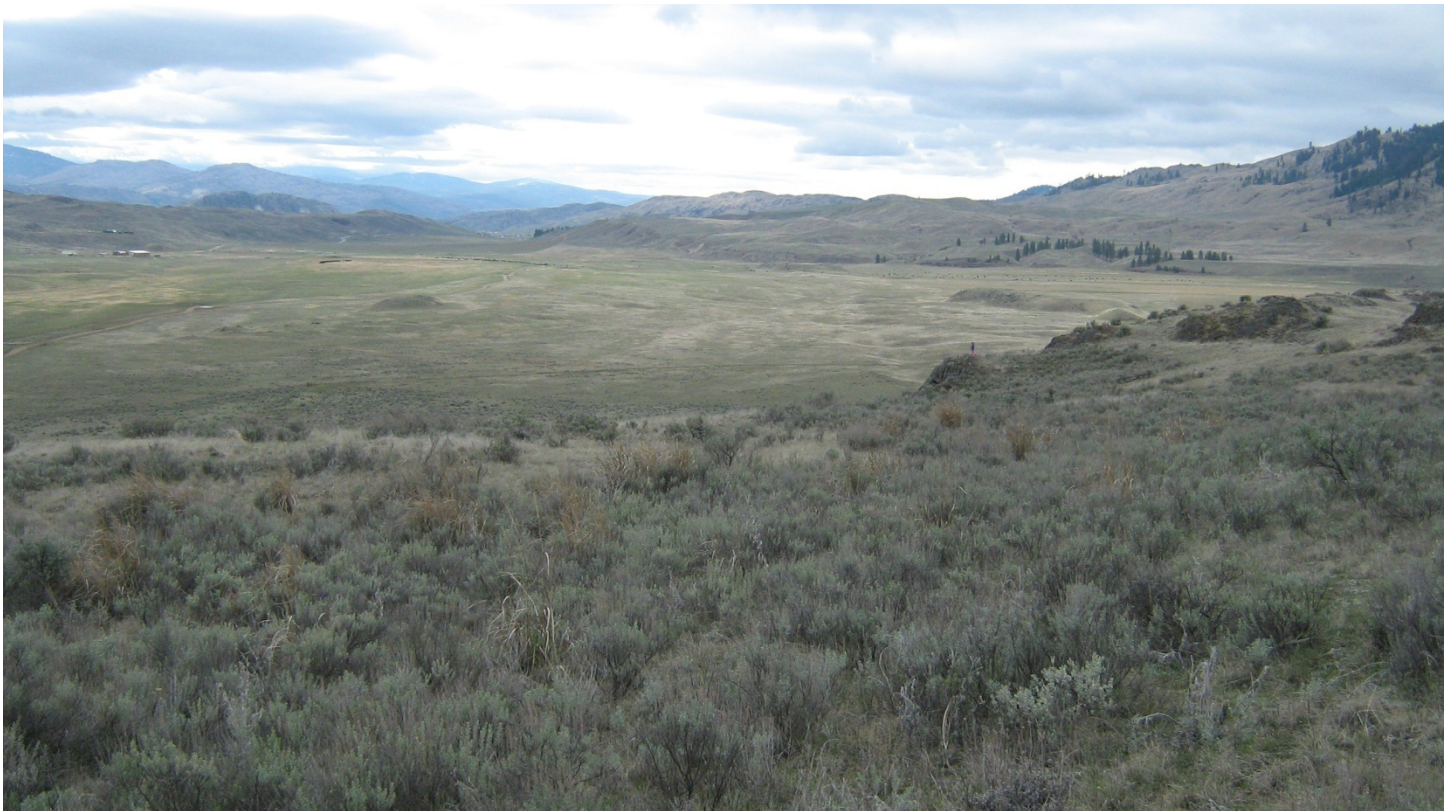
SMM Vicinity from the Northwest

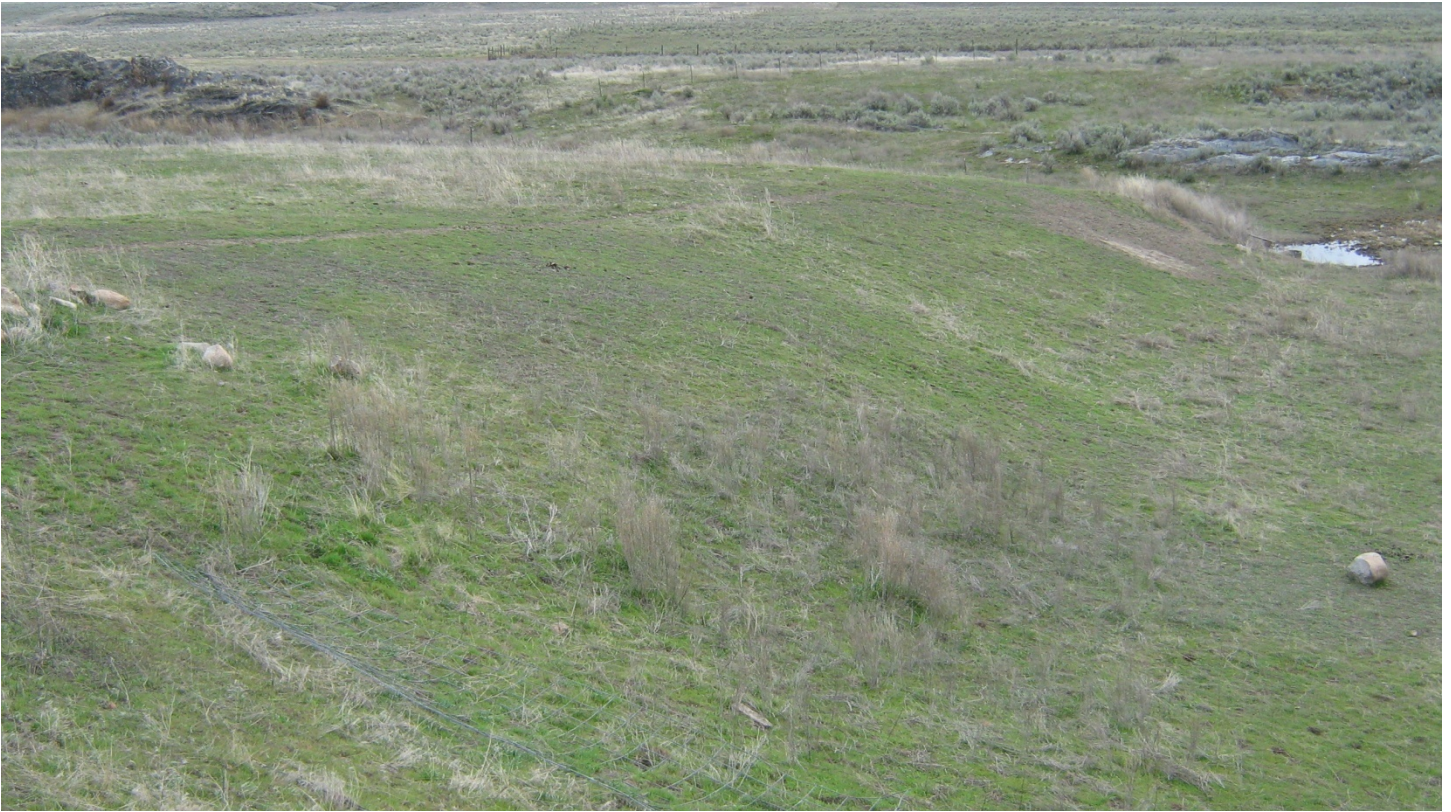
2) Inspect cover for: a) Adequate vegetation b) Weeds c) Holes d) Minimal woody vegetation on cap ^a	<u>Y</u> <u>Y</u> <u>Y</u> <u>Y</u>	None	Cap is in excellent condition w/ some bare spots and evidence of livestock travel which is not impacting cap.

SMM Tailings Cap from the Southwest

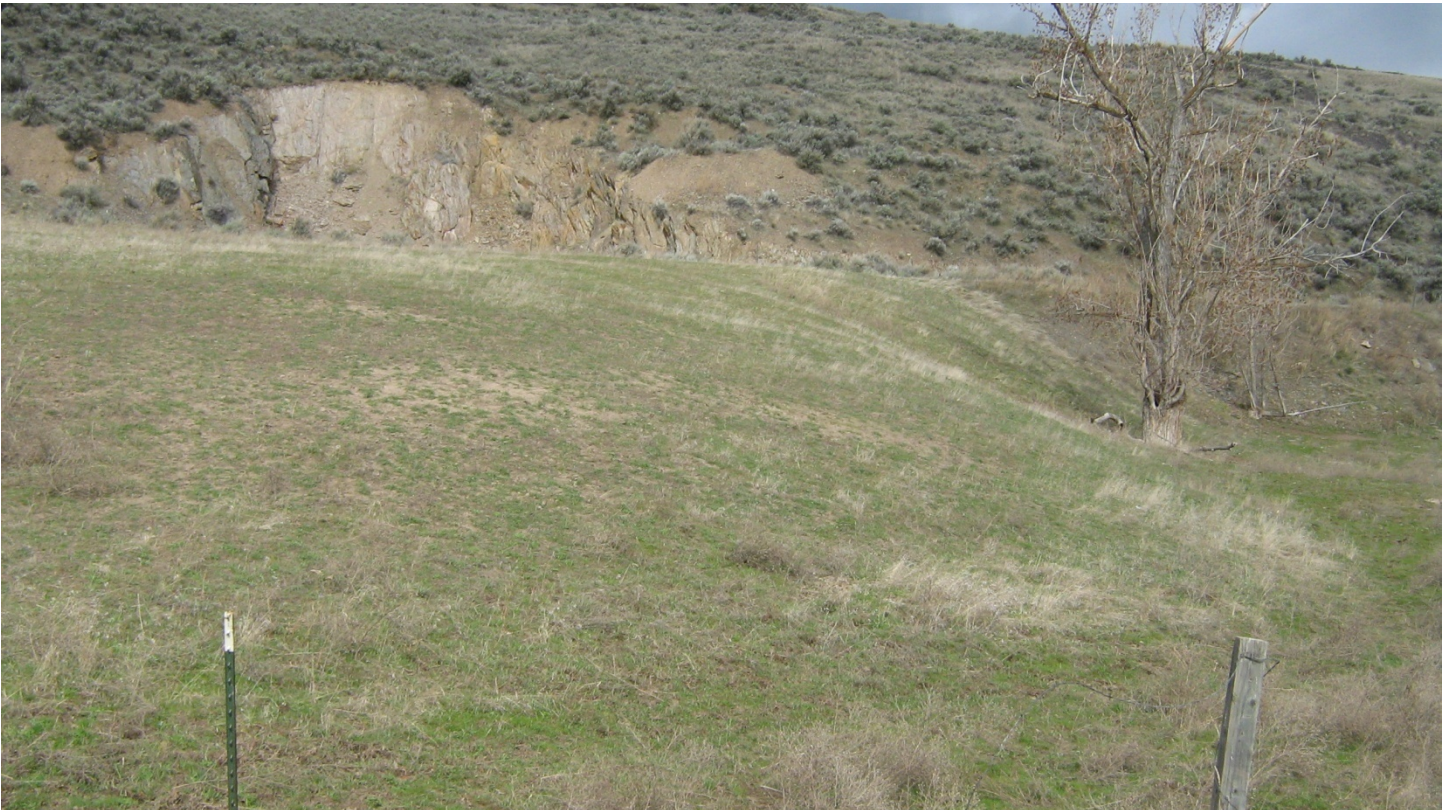
SMM North Slope of Tailings Cap from the East

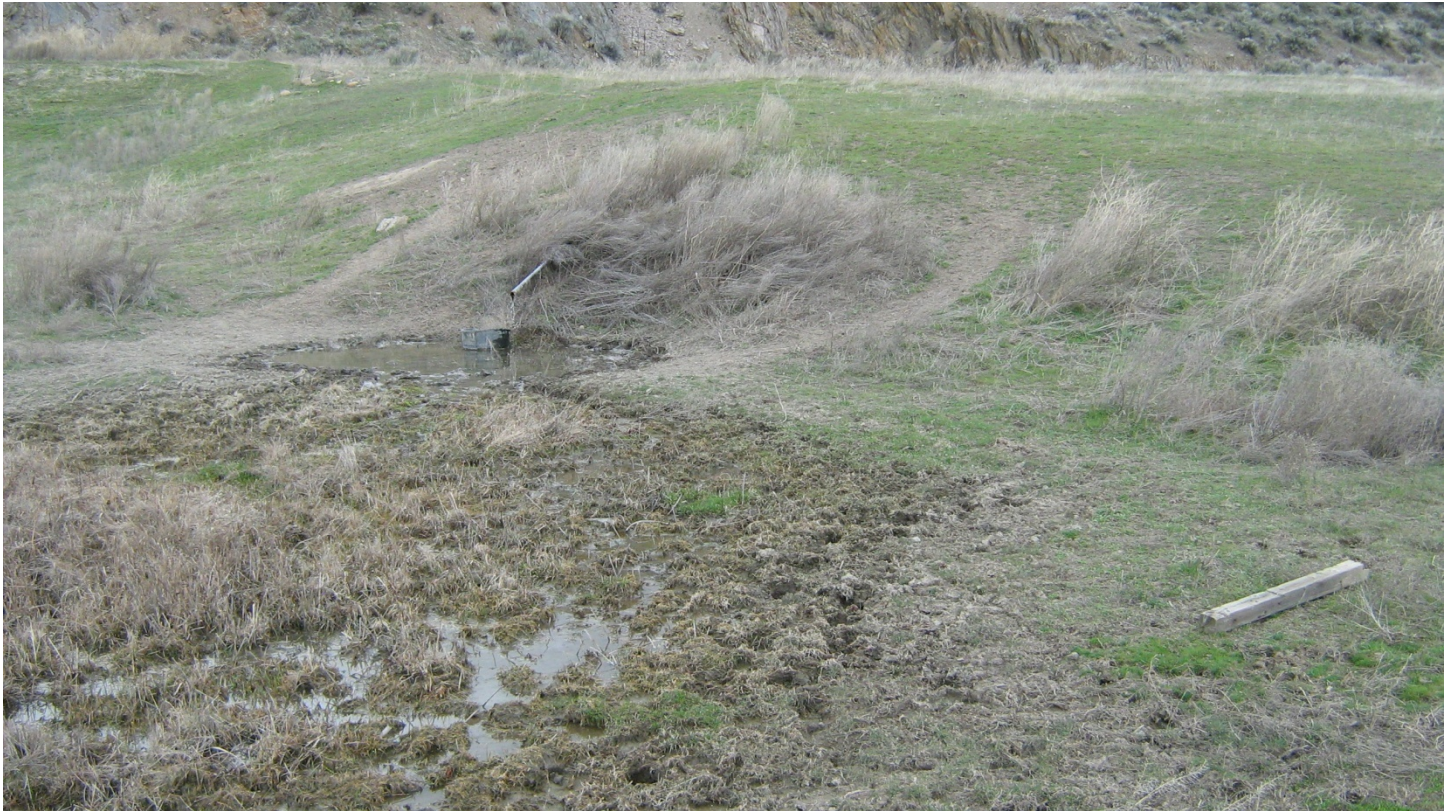
SMM Mine Drainage Stock Water Location from the East

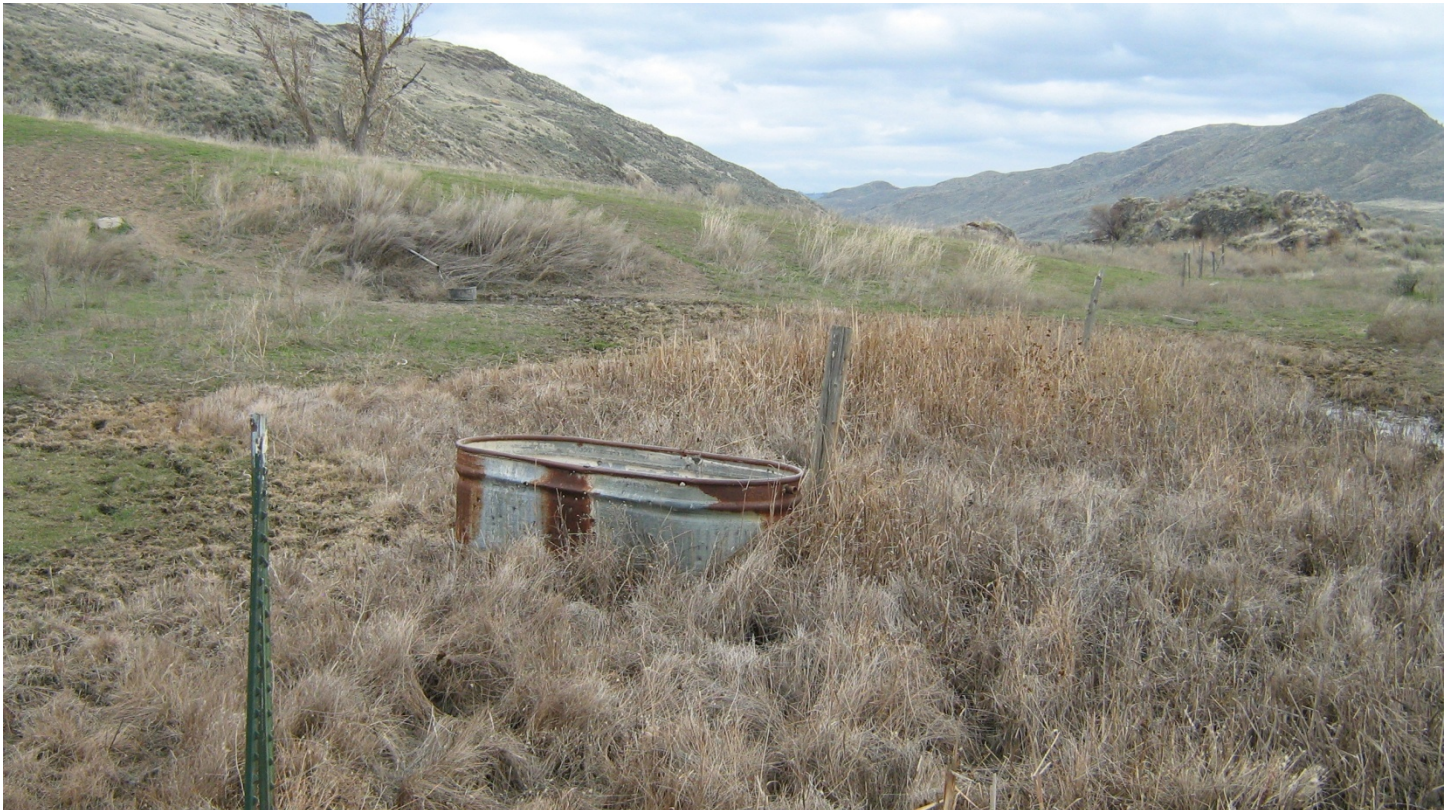
- 1) Fence Installed During the Remedial Action No Longer Exists - The fence installed as part of the remedial action is gone, except for the fence posts; a newer fence surrounding the property (owned by an adjacent neighbor) prevents general access to the Site. The newer fence, containing a gate, still provides for controlled access of cattle to the watering hole near the mine adit. Access control at the Site would be compromised should the existing fence be damaged or removed.

3) Inspect fence	<u>Y</u>	None	Fence around cap is destroyed. Exterior fence in excellent condition
4) Inspect drainage ditch to ensure water is draining away from cap	<u>Y</u>	None	No effective ditch. All seepage is piped below cap. No evidence of surface drainage problems

SMM Original Tailings Cap Fence from the Southeast

1. During site inspections, inspect fencing installed by adjacent property owner and confirm it remains in place and undamaged. If fence is damaged or removed, require Site property owner to replace or repair the fence to ensure access to the Site remains controlled.
2. Ecology and EPA will work with the current property owner to develop a new environmental covenant that follows the guidelines of UECA. This will be done to resolve some questions about legal ownership of the Site and to ensure long-term protectiveness of the cap and restrictions on the use of groundwater for human consumption.

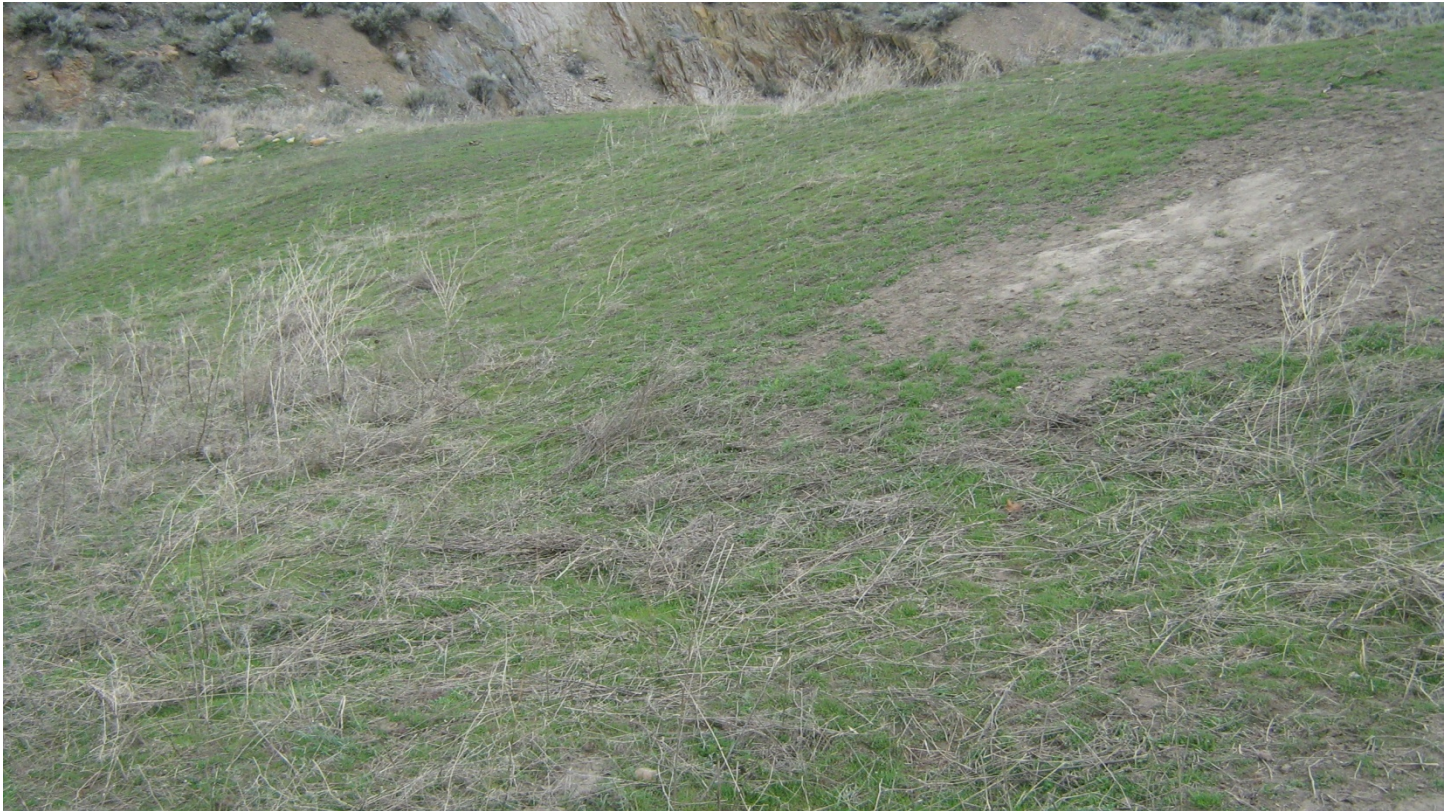
SMM Tailings Cap with Exposed Soil from the Southeast

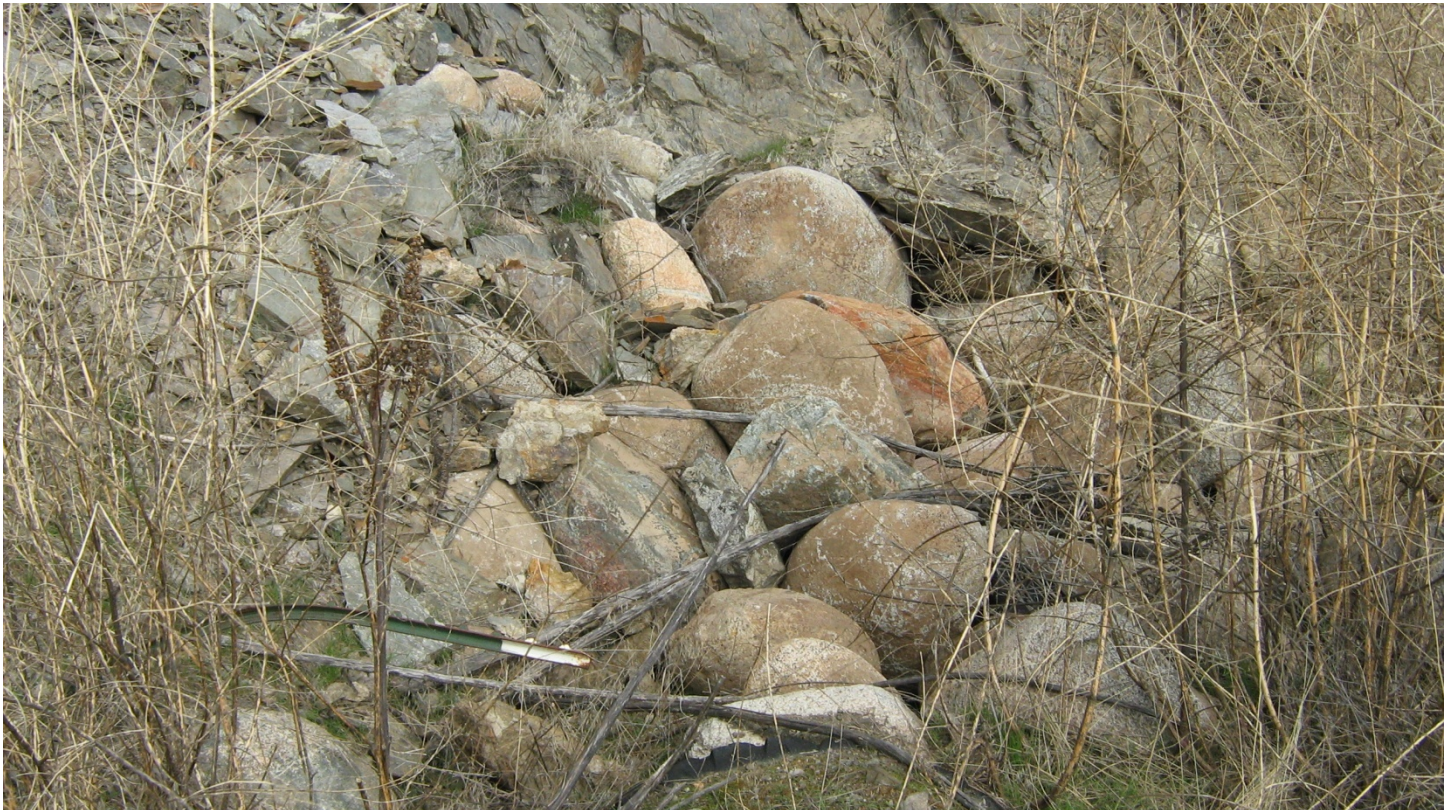
SMM Closed Adit from the Southeast

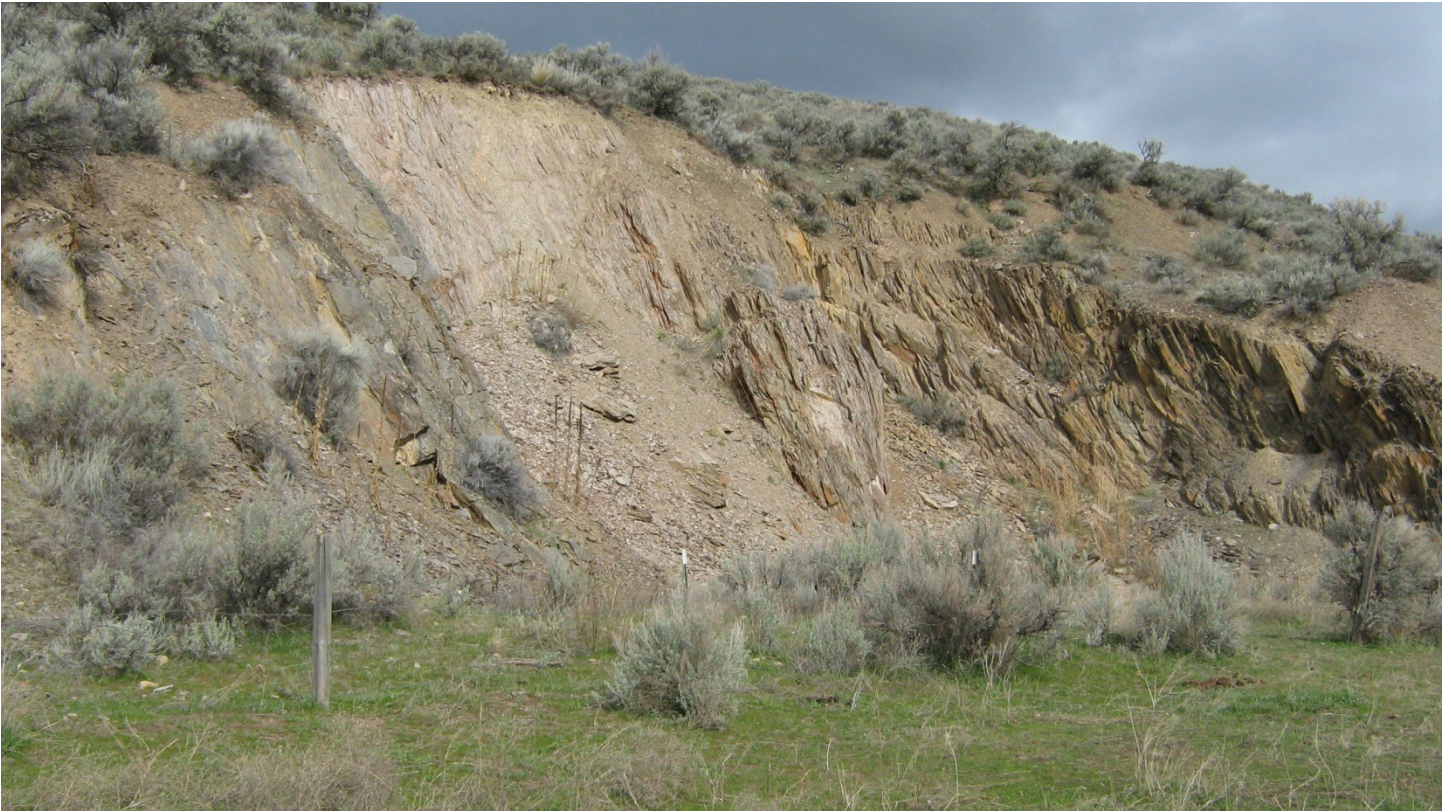
SMM Closed Adit Vicinity from the Southeast

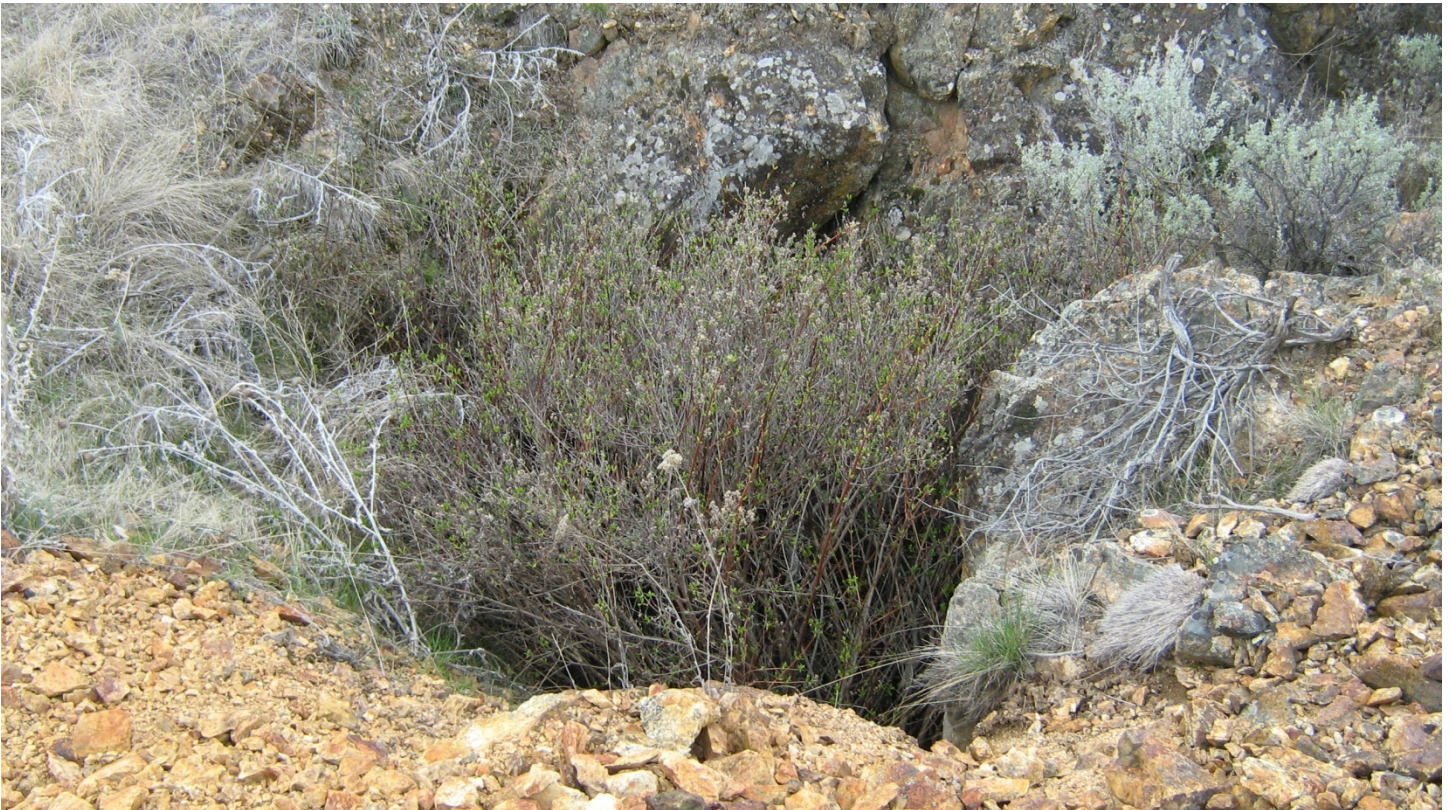
SMM Sealed Mine Workings Vent on Slope Above Adit from the South

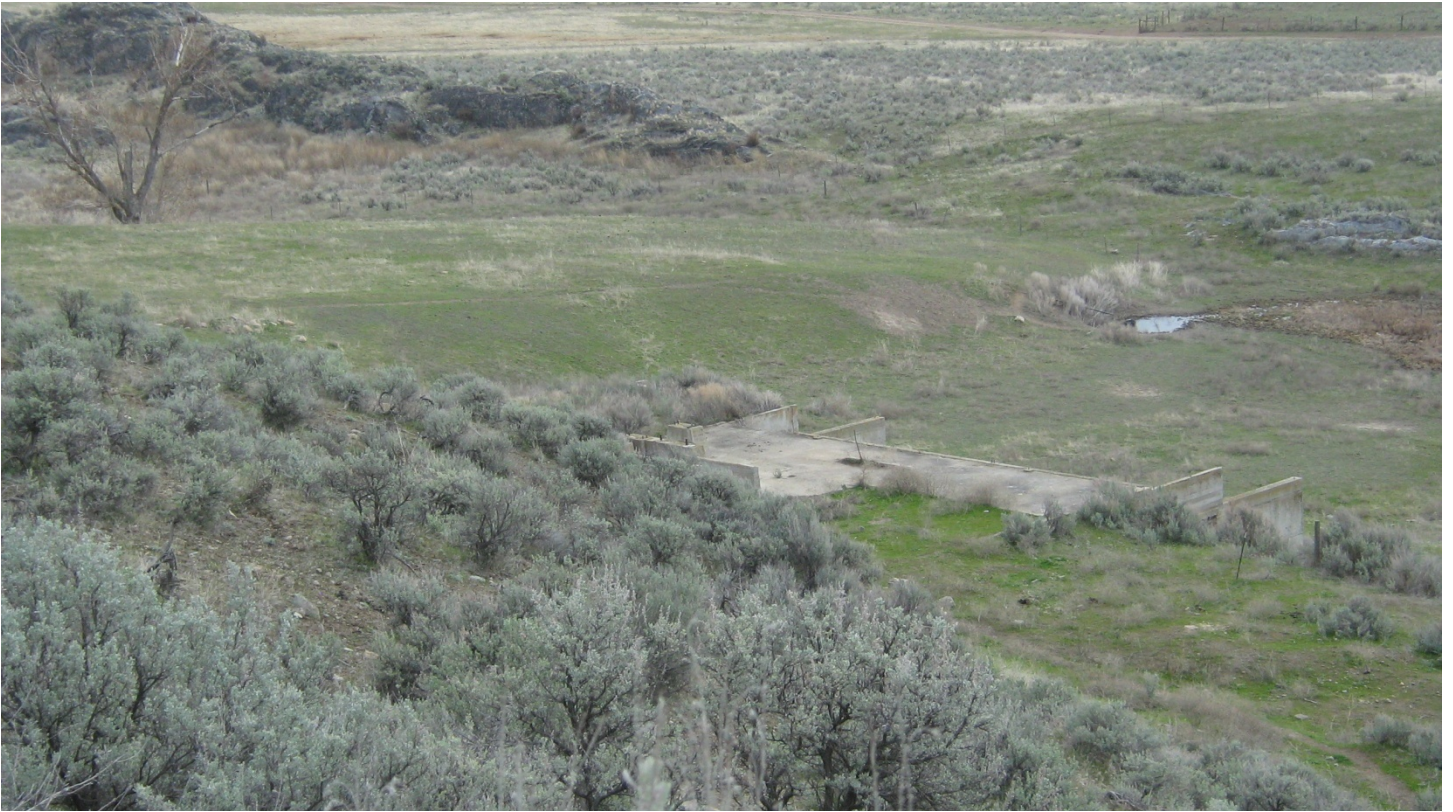
SMM Mill Site and Tailings Cap from Slope to the Southwest

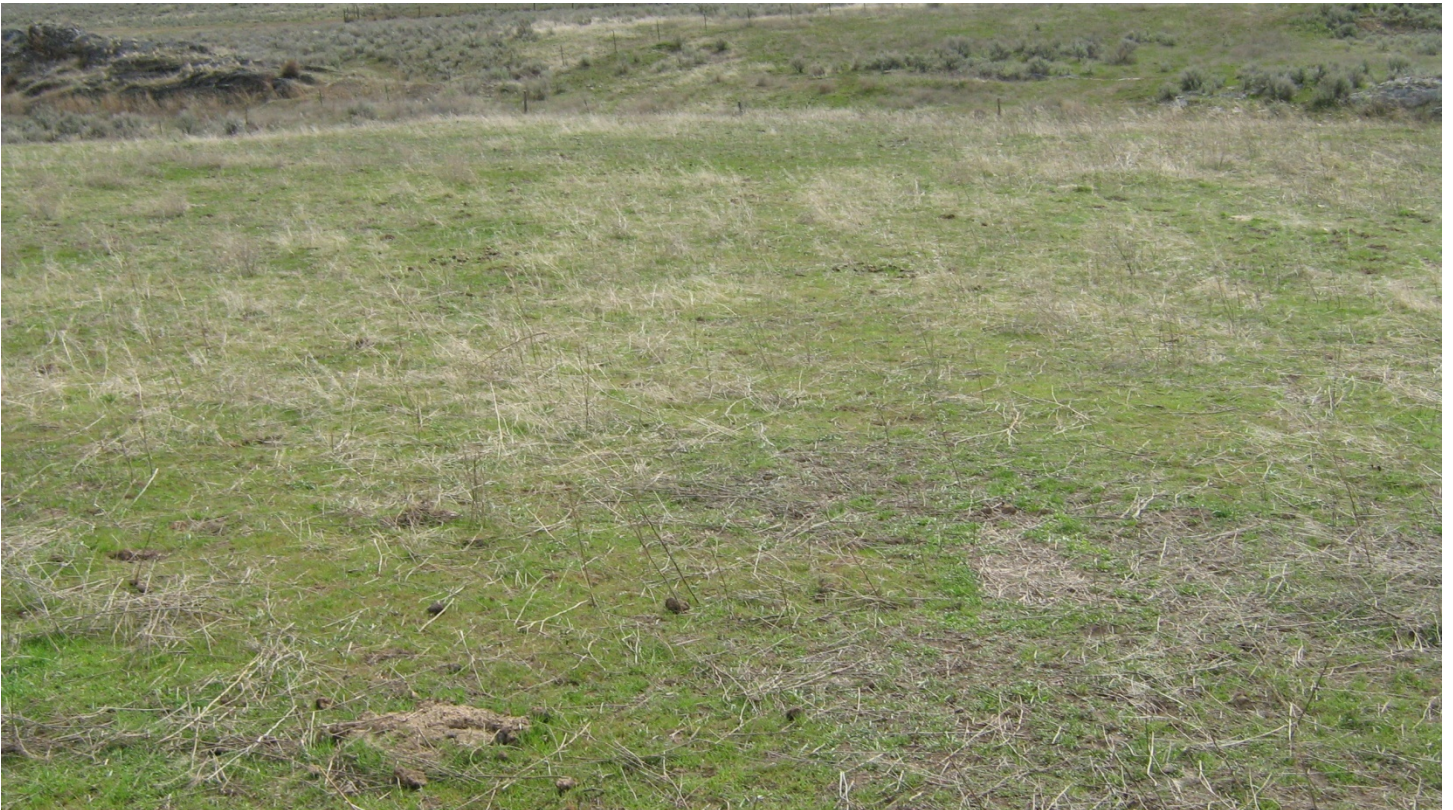
SMM Tailings Cap Surface from the West
